Appendix F CCTV Assessment

Client: CIMA
 Project: Pre-Rehabilitation Survey
 Date: 12/18/2020
 File: 14257

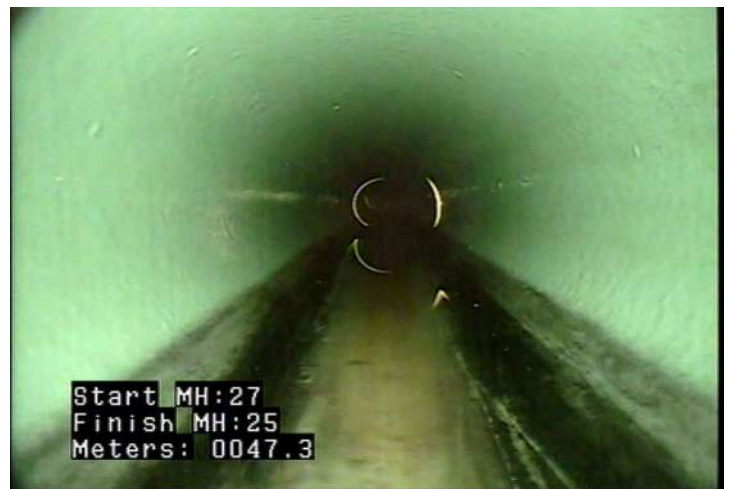
MWLS - Water Level: Sag @ 47.3 m.
Stain looks worse (20%)

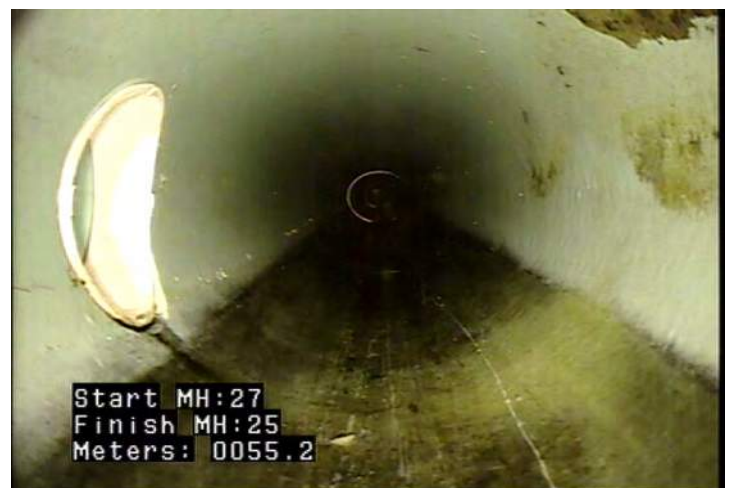
MWM - Water Mark @ 54.1 m. Pipe is 90% stained black from holding material from this point to MH.

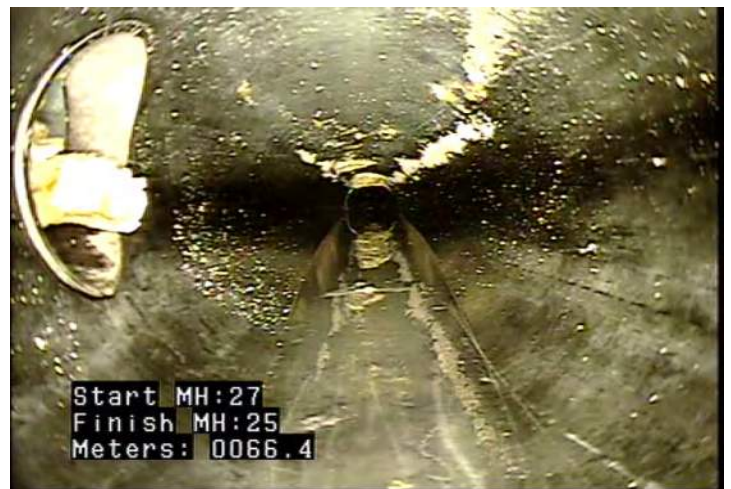
TSD - Tap, Saddle: Defective @ 66.4 m.
Full of grease.

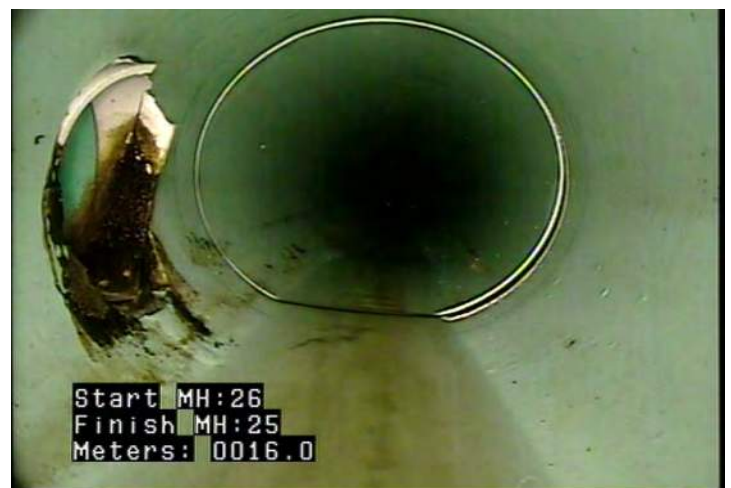
TS - Tap, Saddle @ 16.0 m. Broken

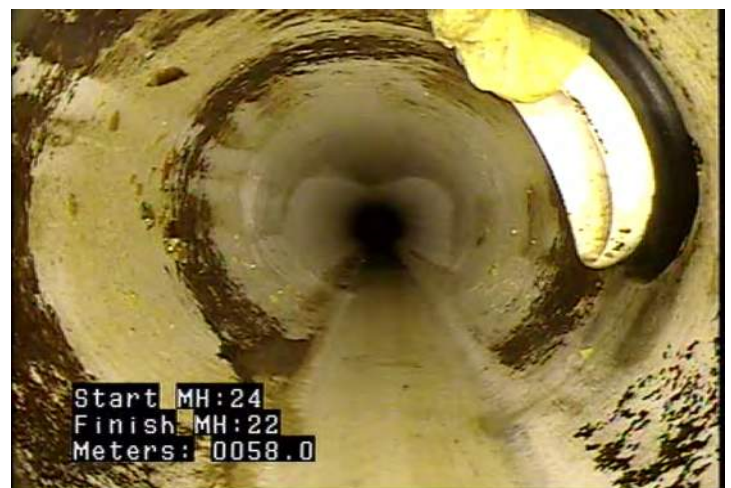
TSI - Tap, Saddle: Intruding @ 50.9 m.
Broken

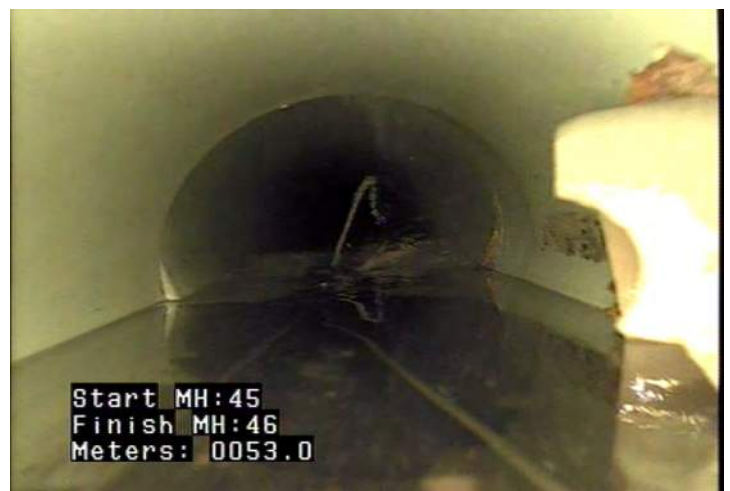
TSI - Tap, Saddle: Intruding @ 53.0 m.
Connecting pipe broken

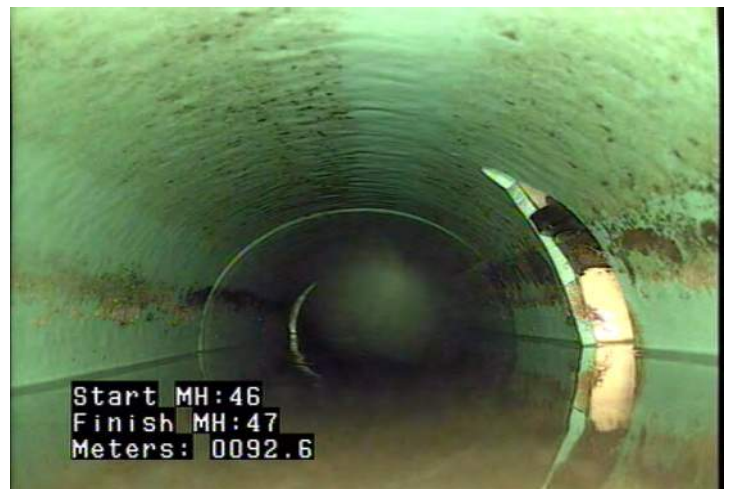
TSD - Tap, Saddle: Defective @ 92.6 m.
Service offset from hole cut in pipe.

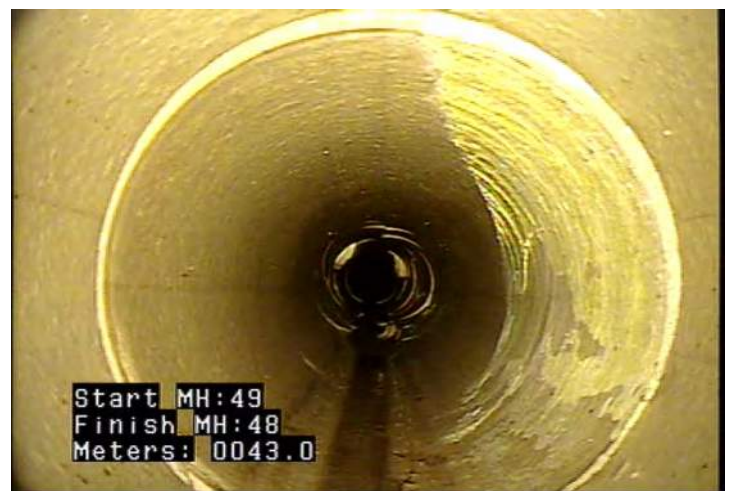
DAE - Deposits Attached: Encrustation @ 43.0 m. Possible hairline crack at 12-1:00

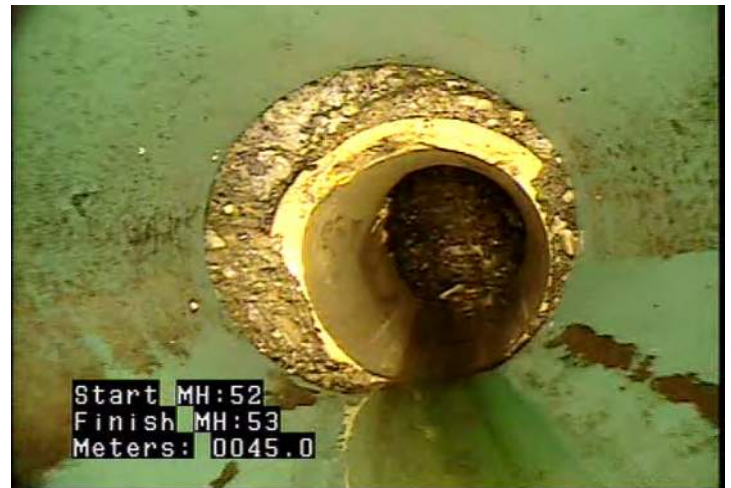
MGO - General Observation @ 0.0 m.
Concrete patch repair

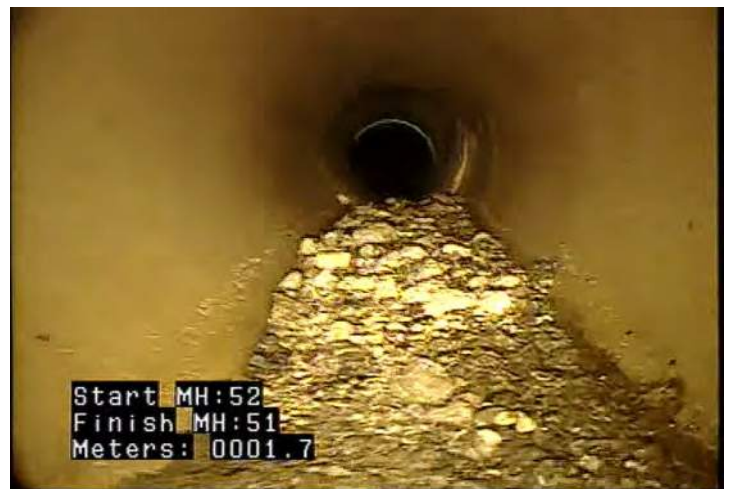
CC - Crack Circumferential @ 0.5 m. At
MH opening

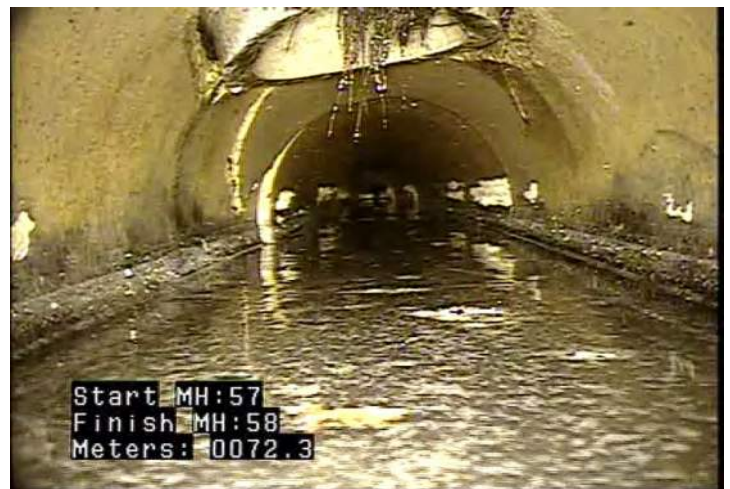
TBD - Tap, Break-in / Hammer: Defective @ 72.3 m. Roots in service

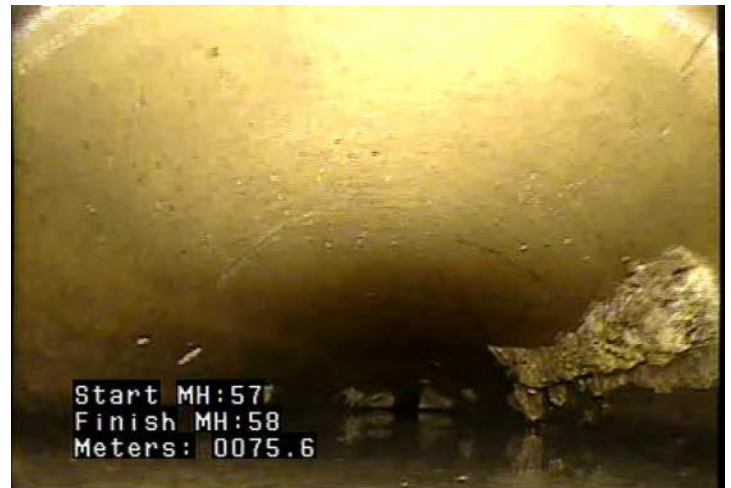
B - Pipe Broken @ 72.4 m. After tap

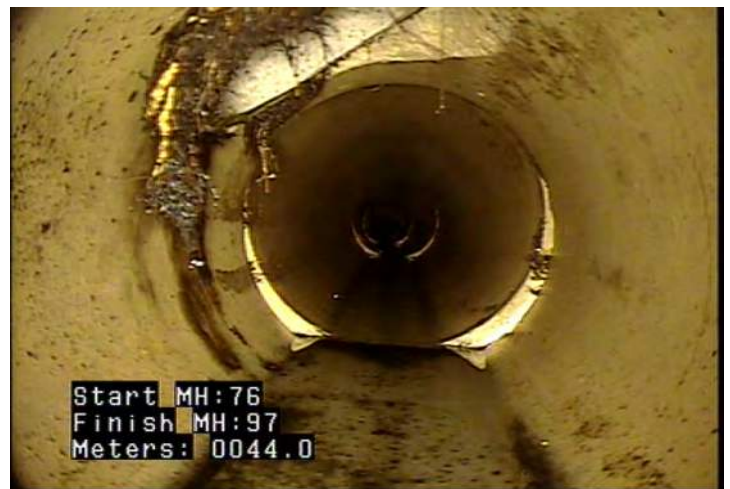
TBD - Tap, Break-in / Hammer: Defective @ 44.0 m. Roots around service

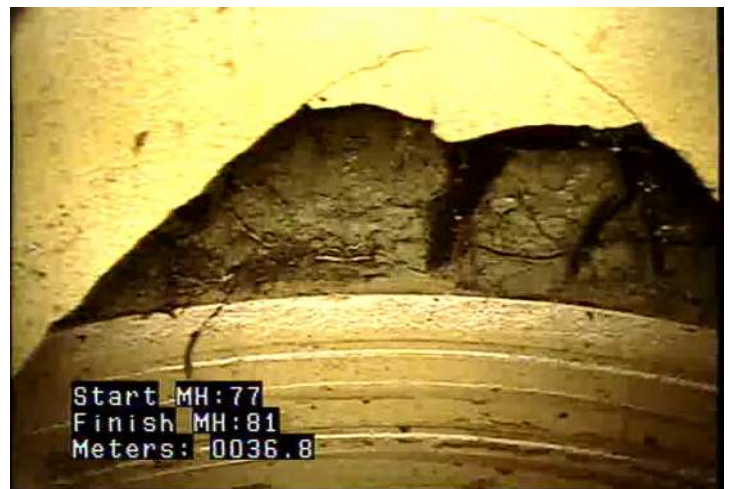
H - Hole in Pipe @ 36.4 m. Piece of pipe missing at joint, ground visible, roots

MGP - General Photograph @ 36.8 m. Additional view of hole at joint

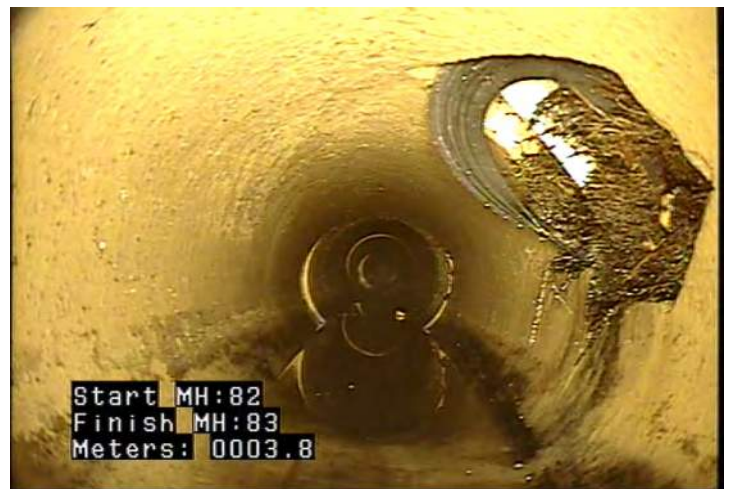
TBD - Tap, Break-in / Hammer: Defective @ 3.8 m. Gasket off

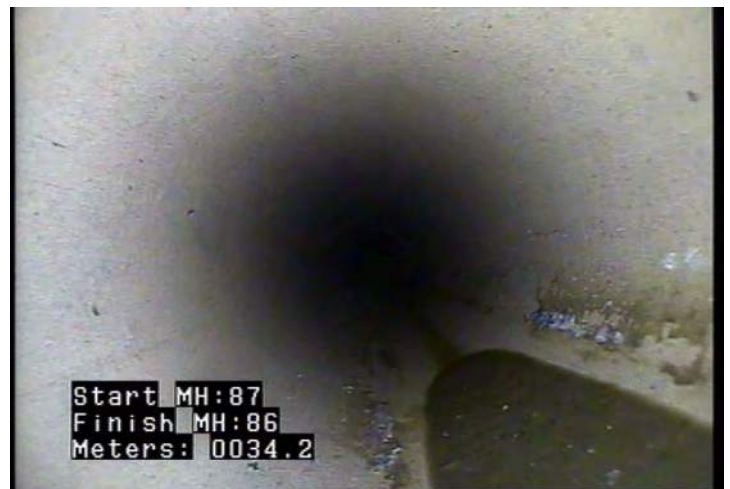
B - Pipe Broken @ 26.6 m. Broken joint, piece missing
