# Village of Linden

## Infrastructure Master Plan

2021

CIMA+ file number : C04-00343  
10 August 2021 – Review FINAL

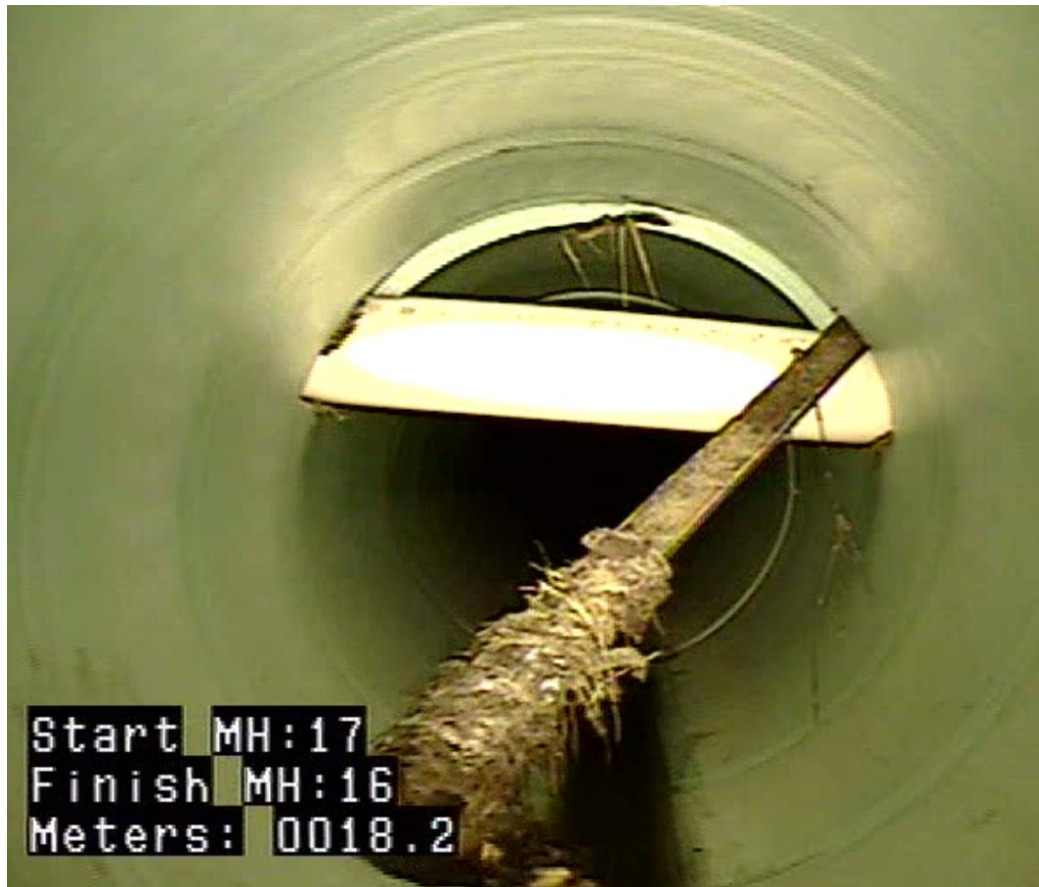
CCTV capture of the sewer systems in Linden identified two locations with blockages in the network. The CCTV of the storm sewer on 1st Ave N found a second pipe intercepting the storm sewer and noted a concrete blockage along the 1st St NE storm sewer immediately south of Central Ave. The concrete blockage was later identified by Linden Operations as an abandoned pipe, with a new line running parallel to the east of it.

Figure 5-9: Second Pipe Intercepting the Storm Sewer on 1<sup>st</sup> Ave N

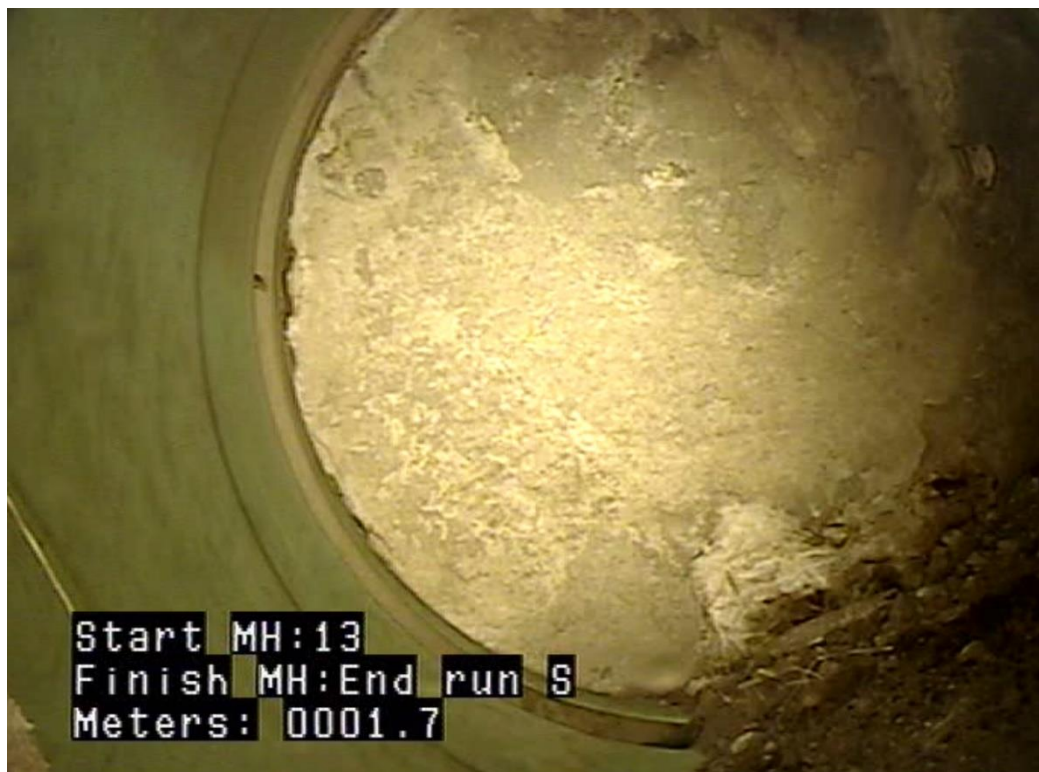
Figure 5-10: Concrete Blockage in the Storm Sewer Along 1<sup>st</sup> St NE

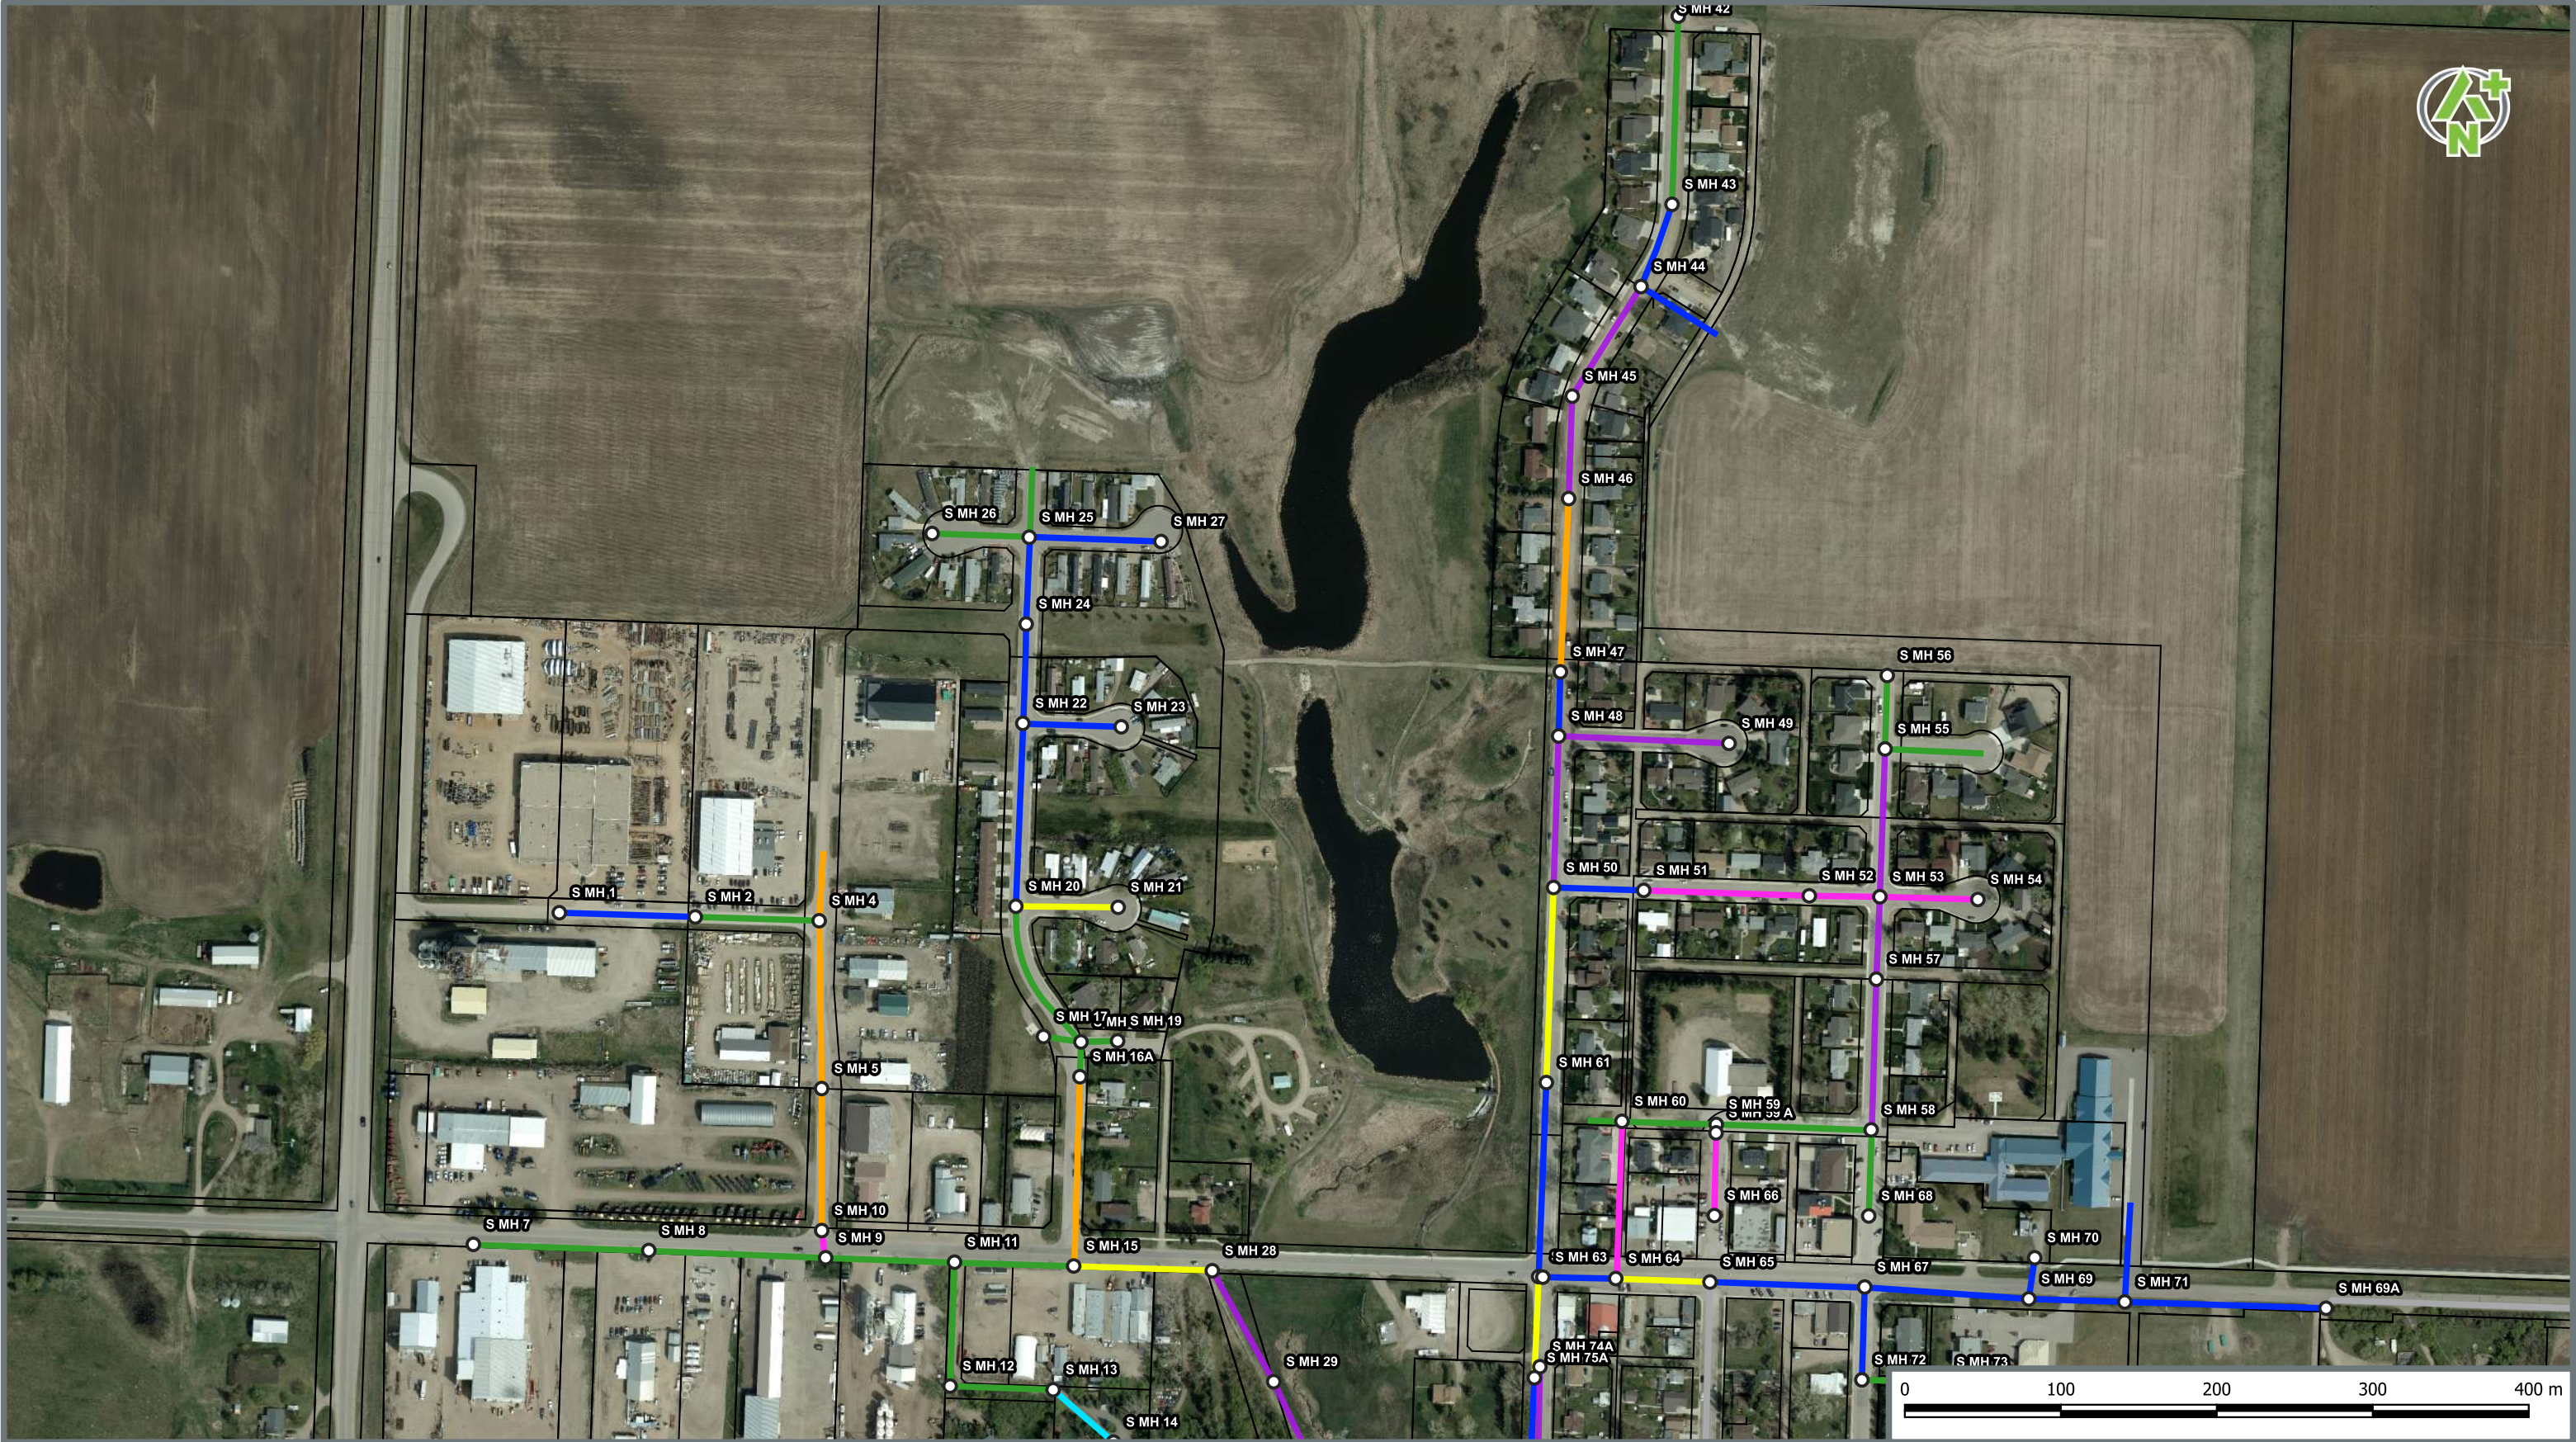
Figure S14A - CCTV Results

A CCTV investigation of the majority of the pipes in the Village was performed. The major outlier that was not captured is the trunk line leading to the Lagoon. The CCTV contractor was not willing to drive down the access road in the winter conditions that were present, and as such did not complete that portion of the investigation. This portion of the trunk line should still be investigated if possible, as it consists of Vitrified Clay Tile (VCT) pipe, which at its age is prone to failure. The majority of defects identified during the investigation were VCT pipe.

Nearly all of the severe defects identified can be addressed through a Cured in Place (CIPP) pipe lining program. This is a trenchless remediation solution that is much less disruptive and cost effective than excavation. Pipes identified as Severe condition were all candidates for CIPP lining, and are addressed as projects in the existing system. One pipe section, in front of 203 Linview Dr, was identified as repair requiring excavation due to a defective service connection. This appears to be a connection made after the installation of the sewer pipe, and appears to be the service for a new house. If this is the case, the cost for repair could potentially be the responsibility of the builder.

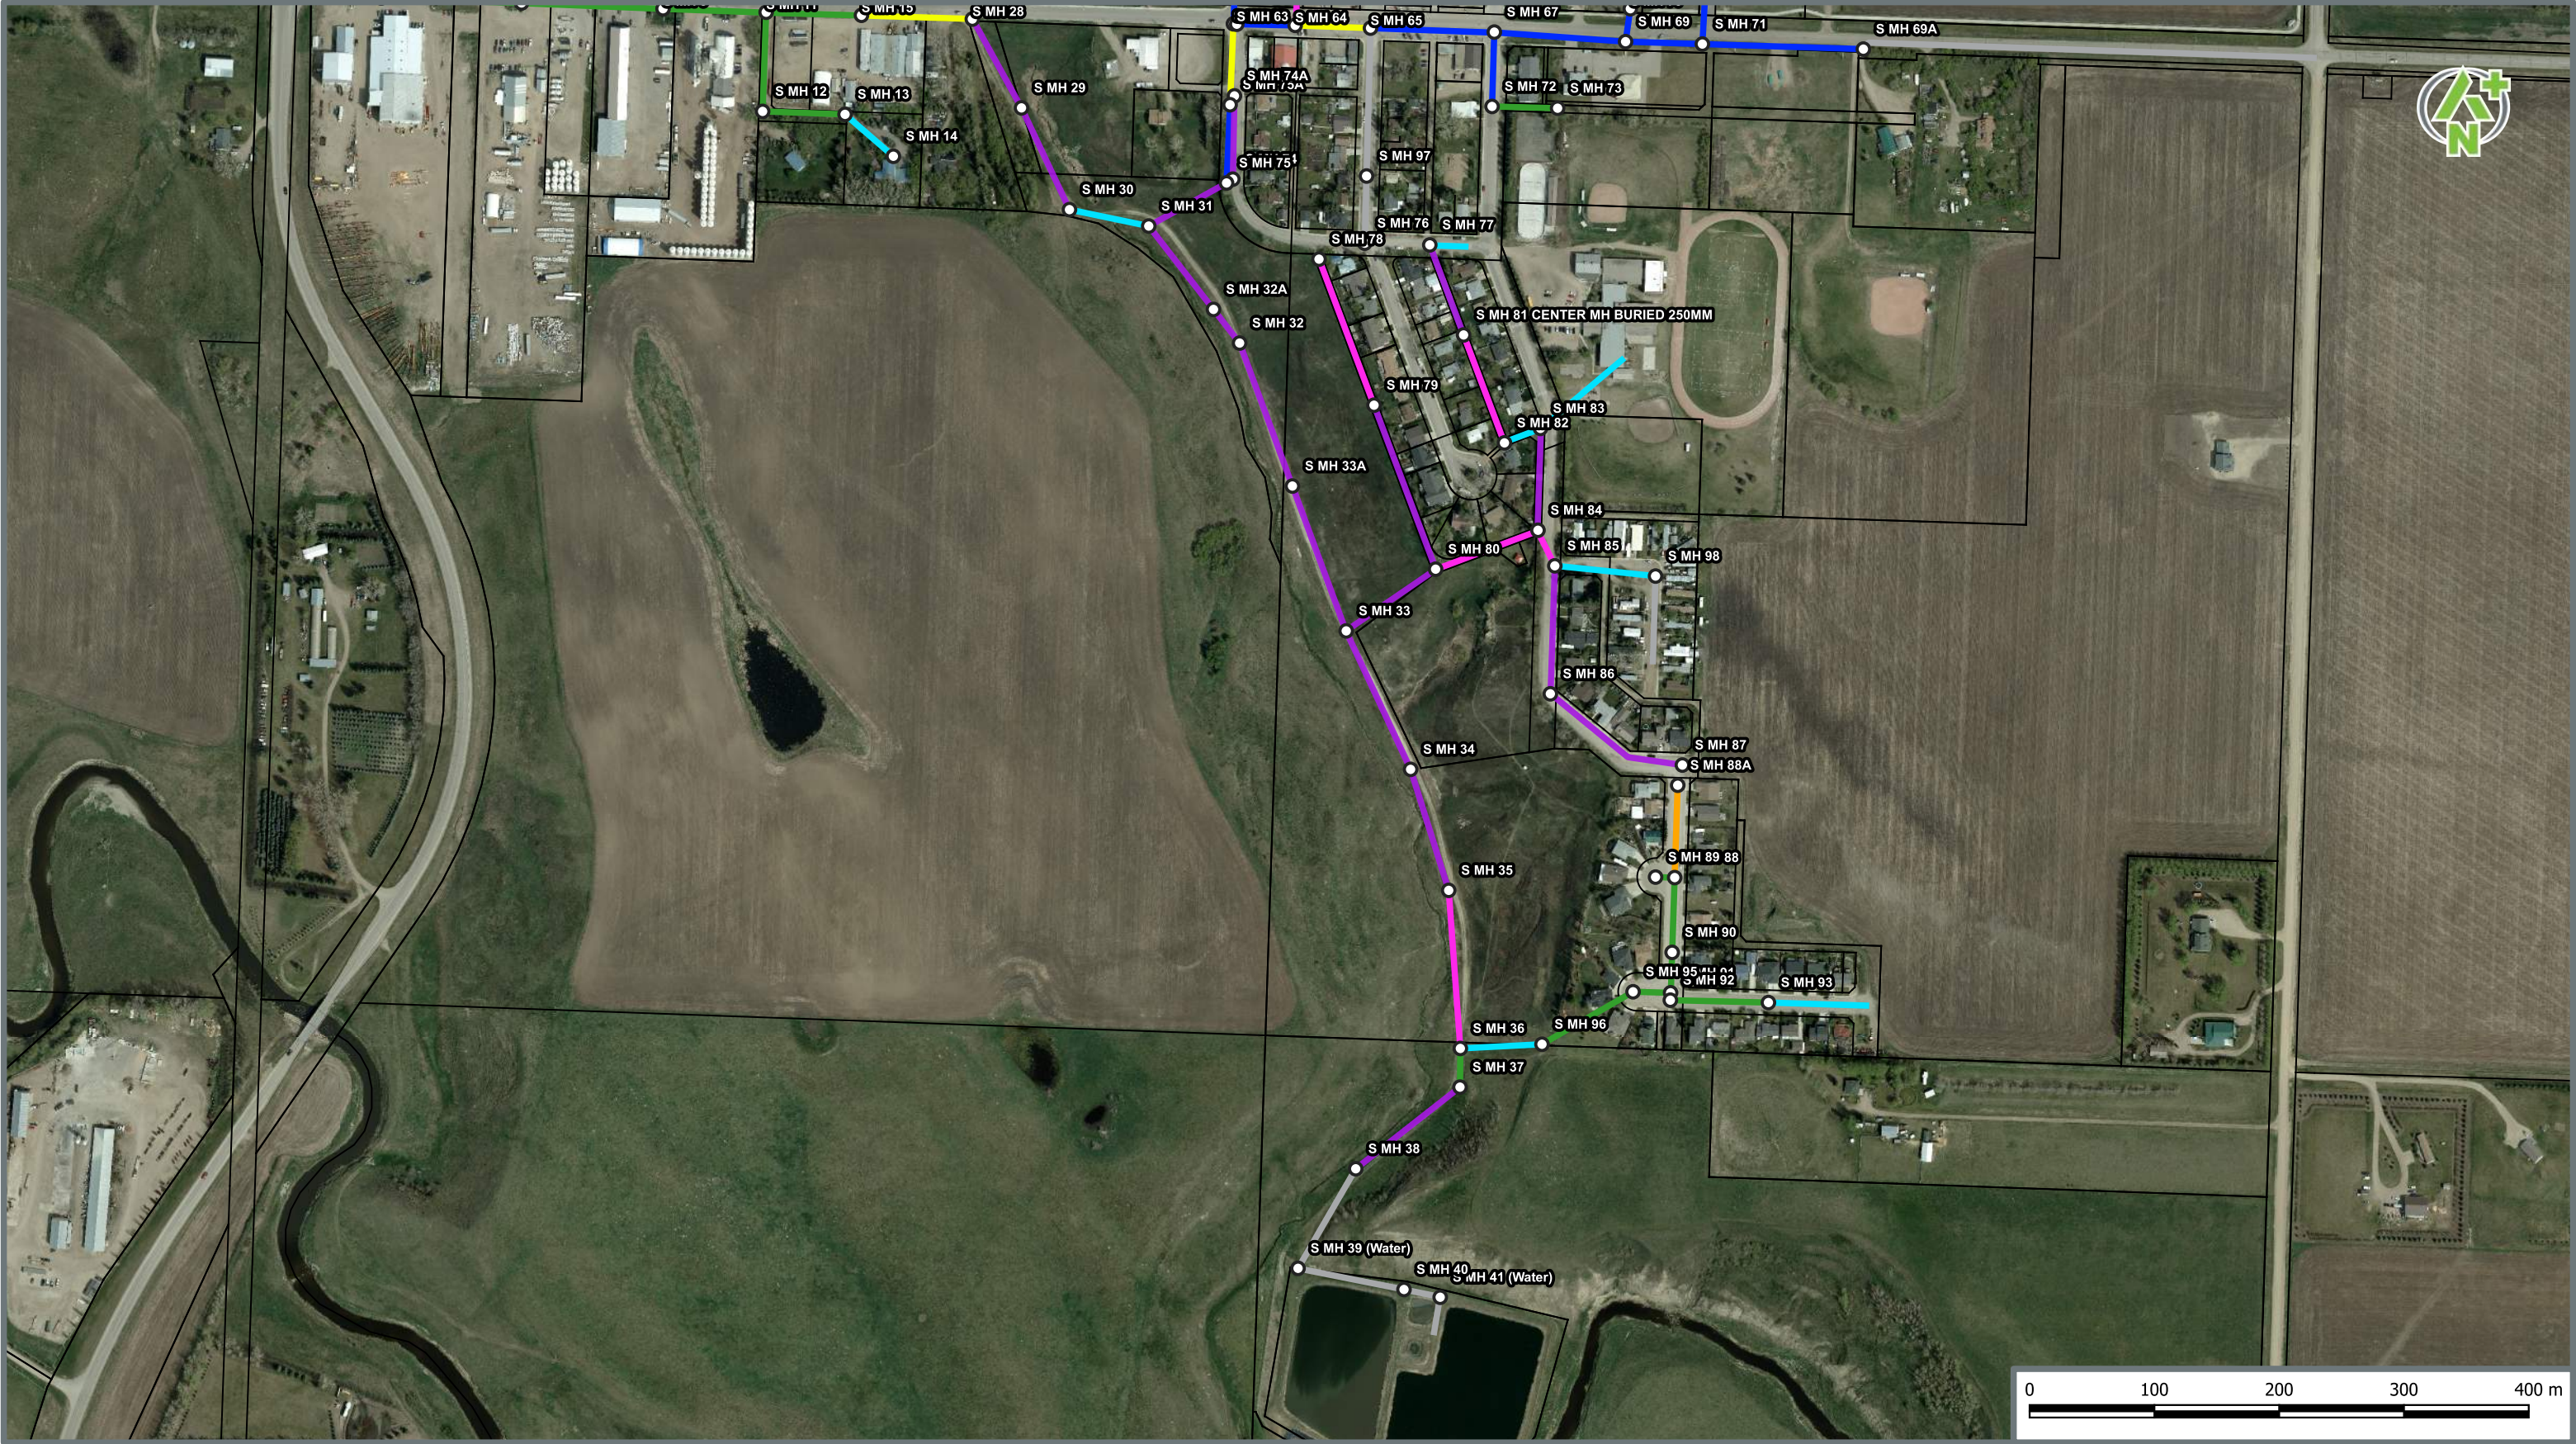
Figure S14B - CCTV Results

*2021 Update – The lagoon trunk line was investigated in May 2021, and the majority of it presented significant defects, with three runs requiring immediate attention. In all cases, CIPP lining was identified as the preferred solution.*
