Appendix F CCTV Assessment

Client: CIMA
 Project: Pre-Rehabilitation Survey
 Date: 12/18/2020
 File: 14257

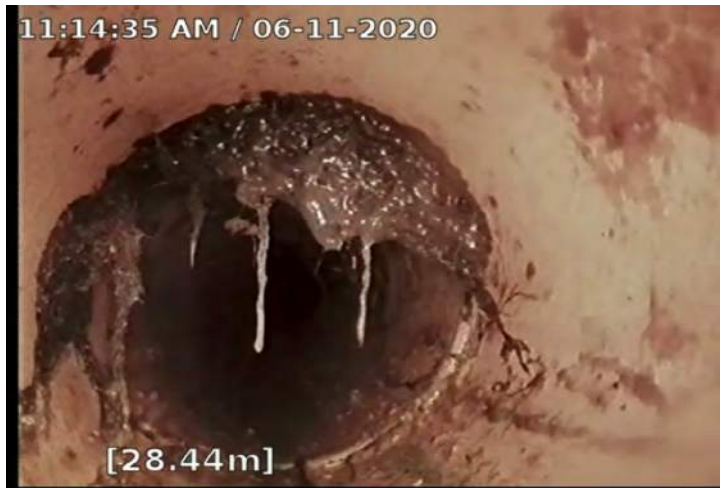
RMJ - Roots, Medium, Joint @ 26.9 m.
