# Village of Linden

## Infrastructure Master Plan

2021

CIMA+ file number : C04-00343  
10 August 2021 – Review FINAL

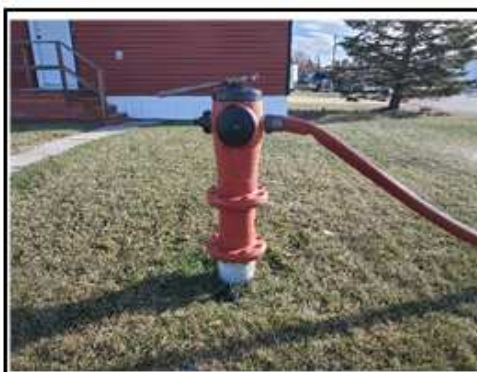
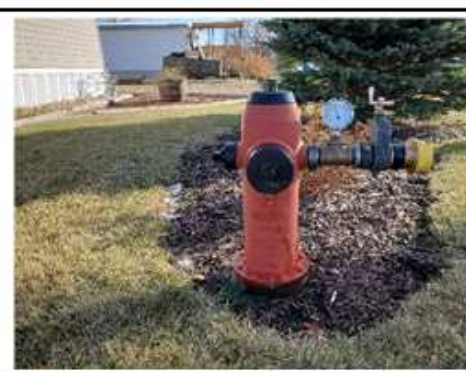
Test ID: 1 Test: 1 of 5 Date: 27-Oct-20

Flow Hyd 1		Flow Hyd 2		Residual Hydrant			Flow Summary (igpm)	
Start Time	End Time	Port 1-1 psi	Port 1-2 psi	Port 2-1 psi	Port 2-2 psi	Static psi	Residual psi	Static psi		
11:10	11:12	9				75	28	75	Flow 1-1	420
									Flow 1-2	
									Flow 2-1	
									Flow 2-2	
									Total Flow	420
									Flow @ 20 psi	457
Notes: Residual hydrant hard to turn.										
Starting static pressure 70 psi.

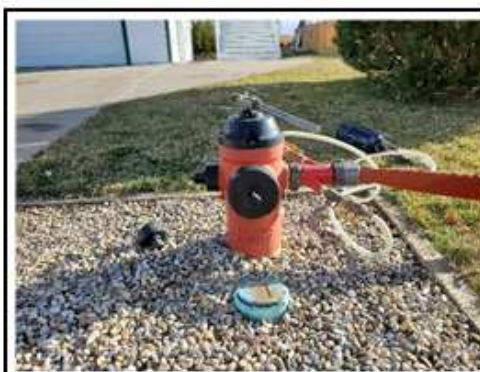
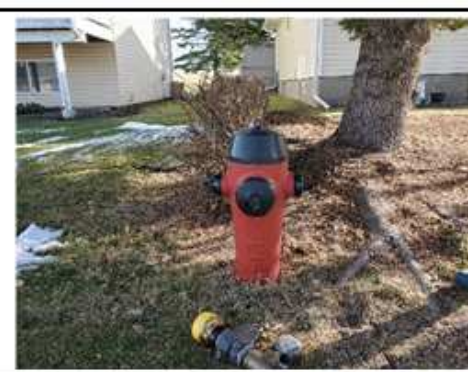
Test ID: 3 Test: 3 of 5 Date: 27-Oct-20

Flow Hyd 1		Flow Hyd 2		Residual Hydrant			Flow Summary (igpm)	
Start Time	End Time	Port 1-1 psi	Port 1-2 psi	Port 2-1 psi	Port 2-2 psi	Static psi	Residual psi	Static psi		
11:53	11:55	8				67	40	67	Flow 1-1	404
									Flow 1-2	
									Flow 2-1	
									Flow 2-2	
									Total Flow	404
									Flow @ 20 psi	545
Notes: Chosen residual hydrant siezed, picked alternate.										
Starting static pressure 66 psi.

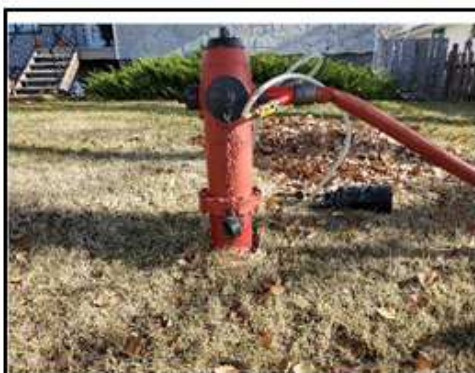
Test ID: 4 Test: 4 of 5 Date: 27-Oct-20

Flow Hyd 1		Flow Hyd 2		Residual Hydrant			Flow Summary (igpm)	
Start Time	End Time	Port 1-1 psi	Port 1-2 psi	Port 2-1 psi	Port 2-2 psi	Static psi	Residual psi	Static psi		
12:11	12:12	10				62	37	60	Flow 1-1	444
									Flow 1-2	
									Flow 2-1	
									Flow 2-2	
									Total Flow	444
									Flow @ 20 psi	588
Notes: Chosen residual hydrant hard to turn.										
Starting static pressure 60 psi.
