Appendix F CCTV Assessment

Client: CIMA
 Project: Pre-Rehabilitation Survey
 Date: 12/18/2020
 File: 14257

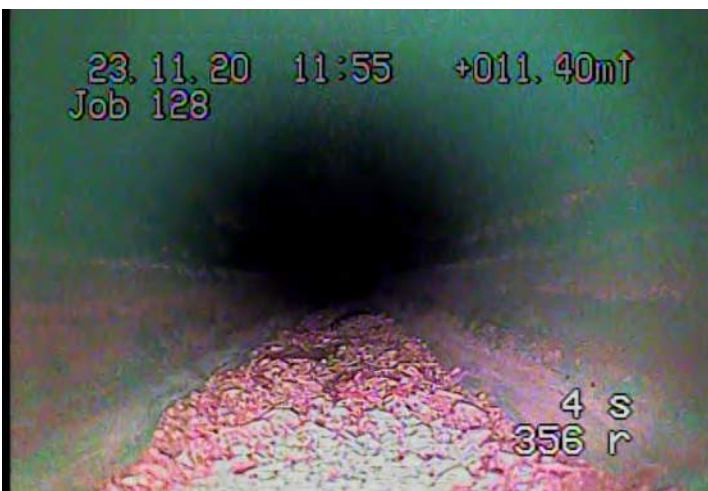
DSGV - Deposits Settled: Gravel @ 9.9 m.

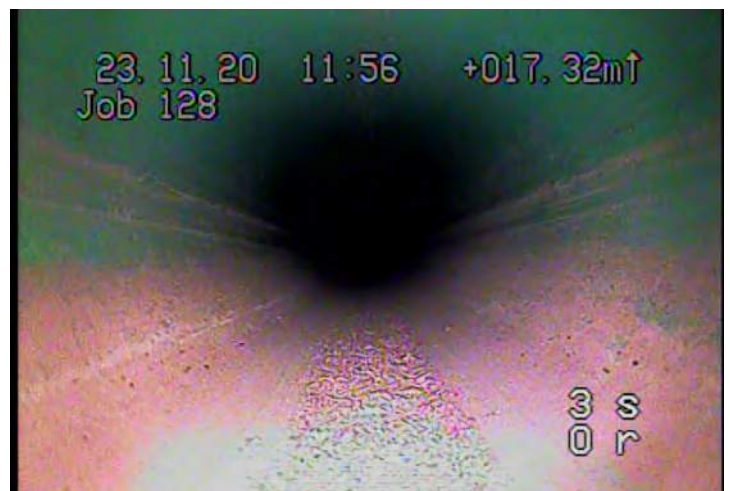
DSGV - Deposits Settled: Gravel @ 15.3 m.

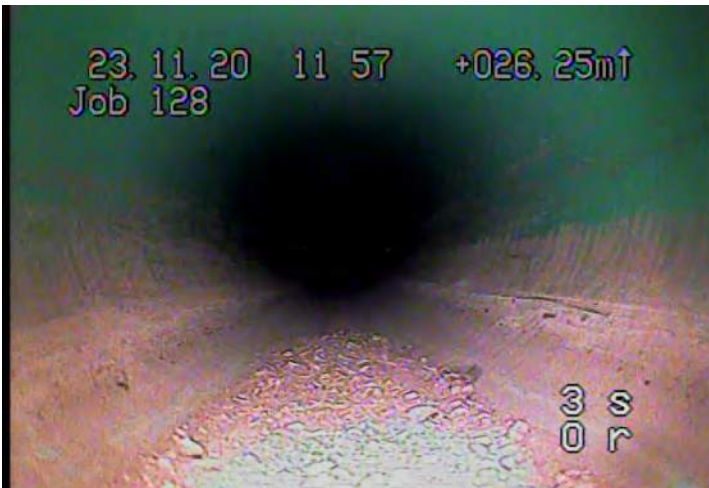
DSGV - Deposits Settled: Gravel @ 24.5 m.

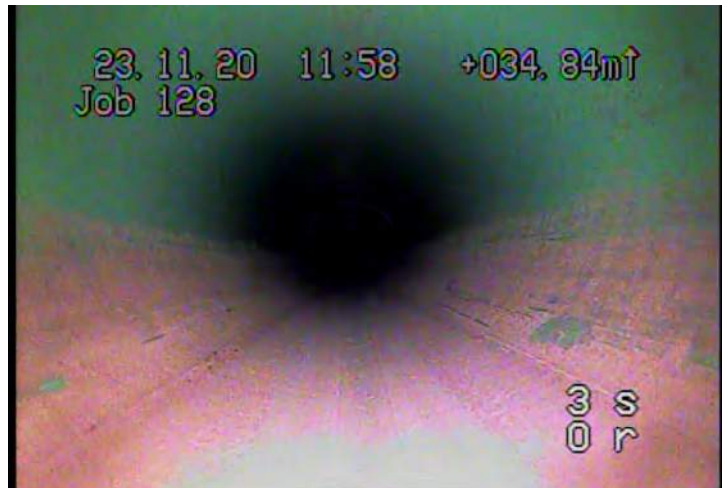
DSGV - Deposits Settled: Gravel @ 33.3 m.

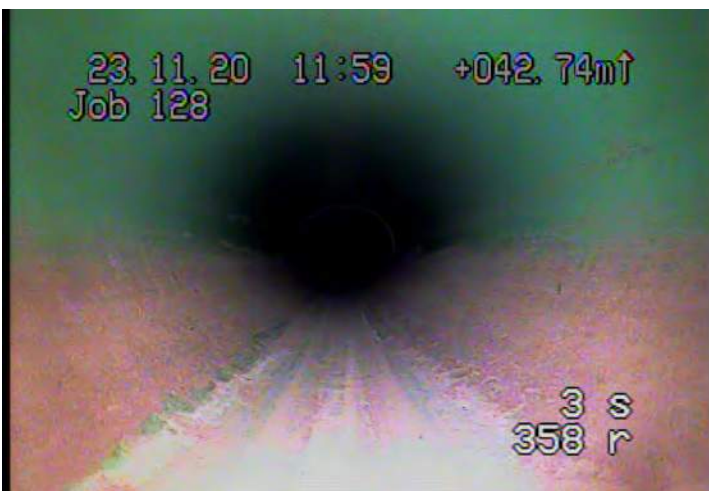
DSGV - Deposits Settled: Gravel @ 41.1 m.

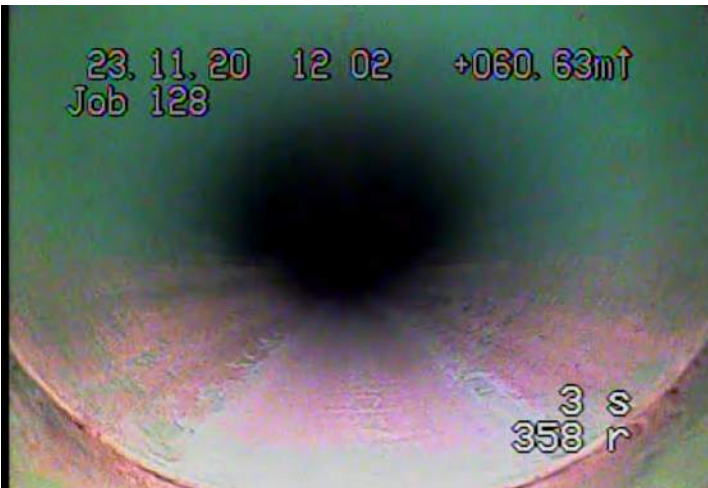
DSGV - Deposits Settled: Gravel @ 59.9 m.

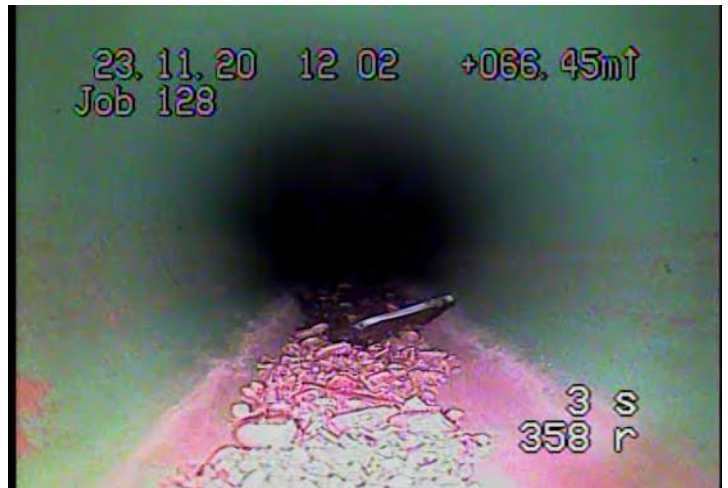
DSGV - Deposits Settled: Gravel @ 66.1 m.

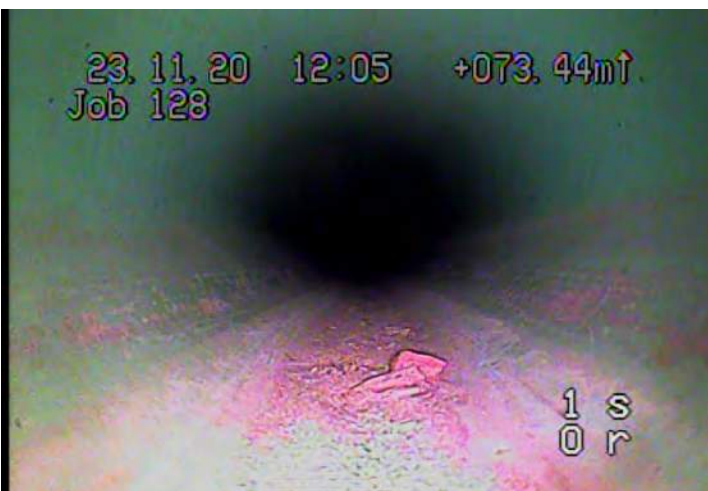
DSGV - Deposits Settled: Gravel @ 73.0 m.

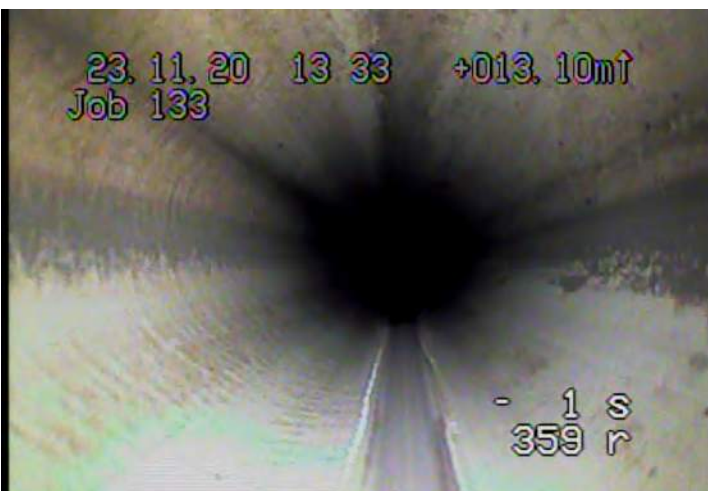
JOL - Joint Offset (displaced): Large @ 10.8 m.

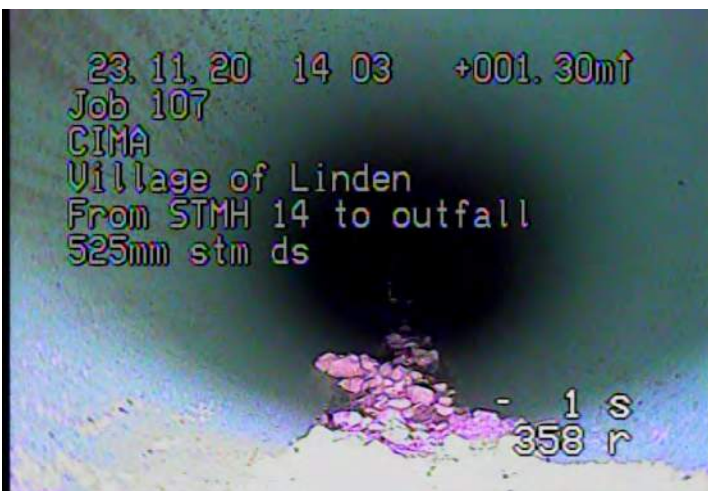
DSGV - Deposits Settled: Gravel @ 0.0 m.

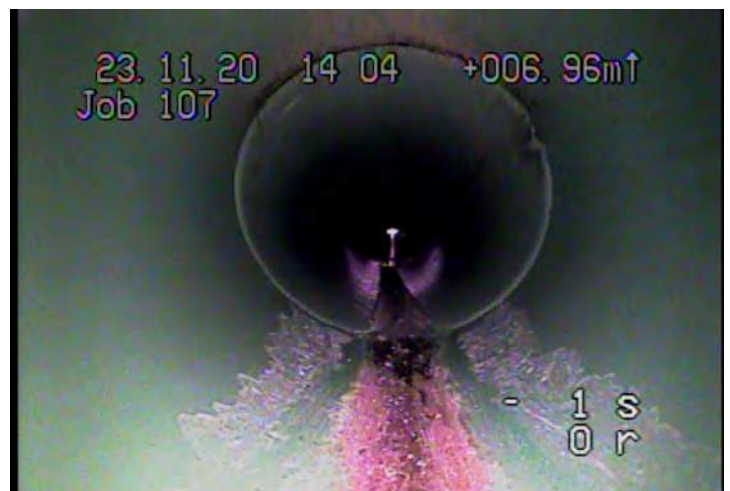
DSGV - Deposits Settled: Gravel @ 4.2 m.

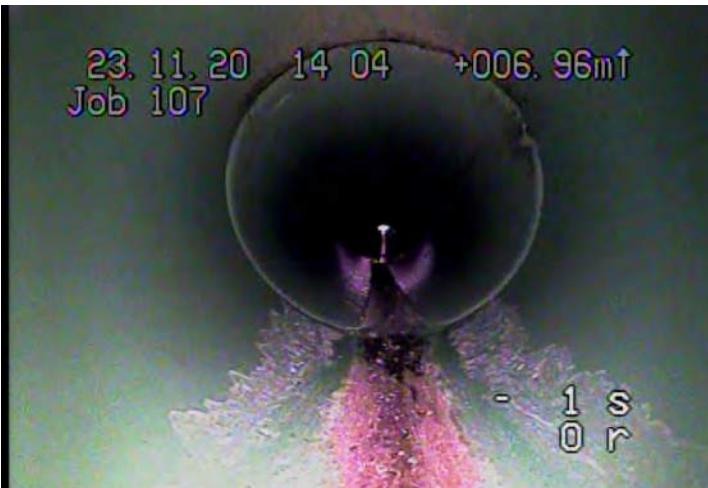
OBJ - Obstacle - Object Wedged in Joint
@ 4.2 m. Branch

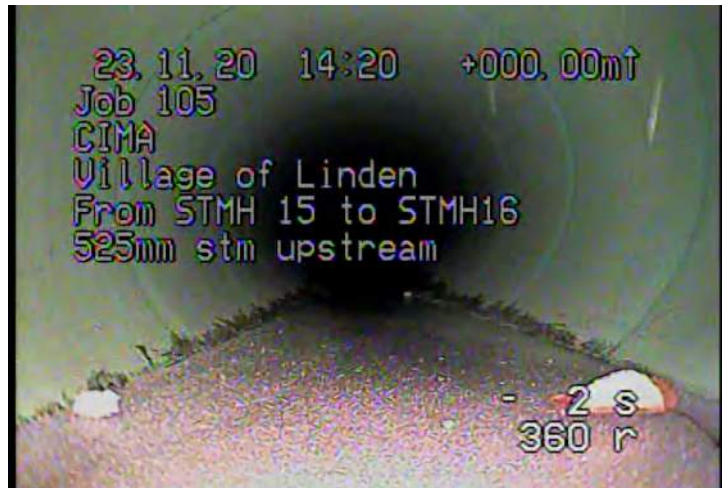
MWL - Water Level @ 0.0 m. Ice

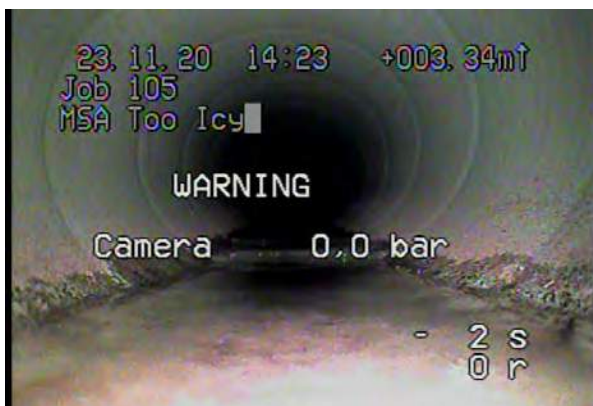
MSA - Survey Abandoned @ 3.3 m.
Unable to crawl due to icy conditions.
Unable to go downstream due to ST MH
16 being buried.

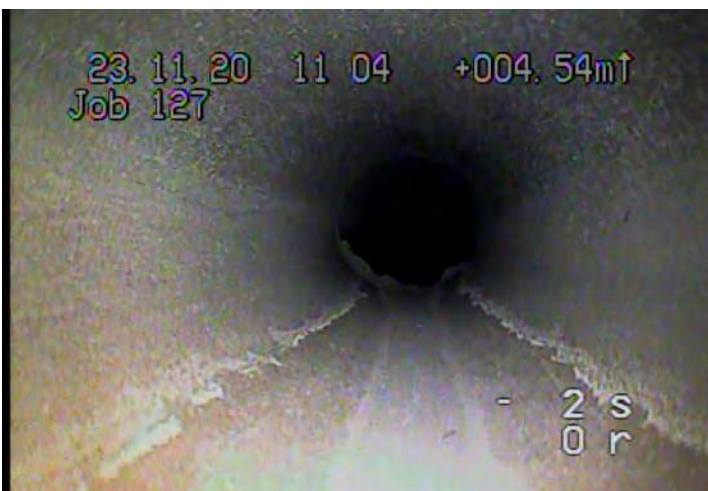
ISGT - Intruding Seal Material - Grout @
2.9 m.

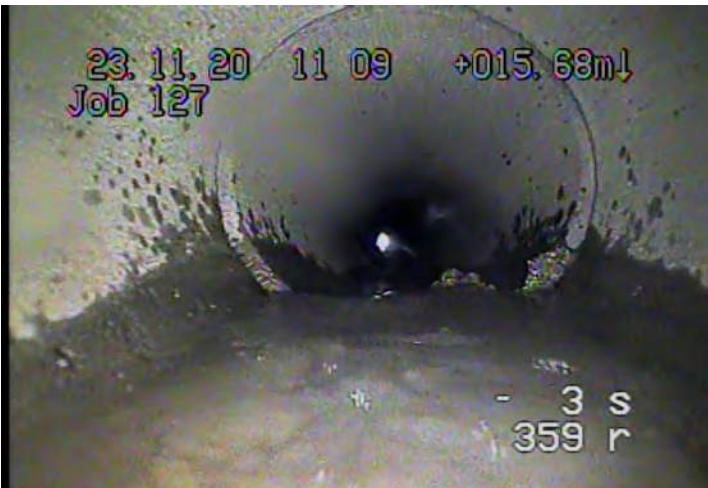
ISGT - Intruding Seal Material - Grout @ 17.1 m.

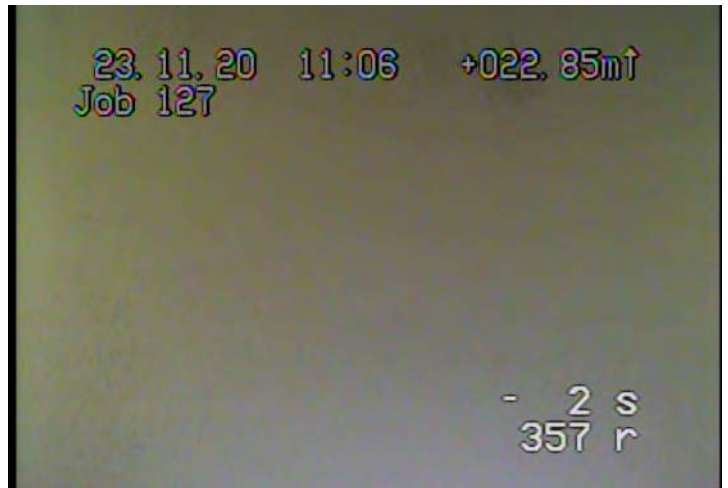
MCU - Camera Underwater @ 21.3 m.

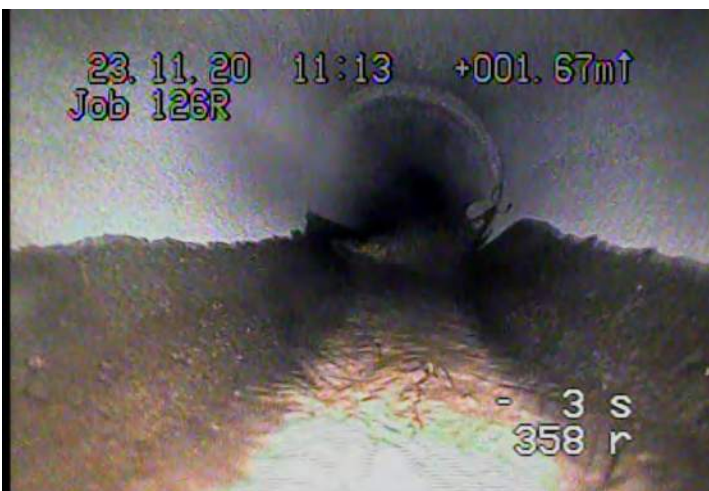
ISGT - Intruding Seal Material - Grout @
1.3 m.

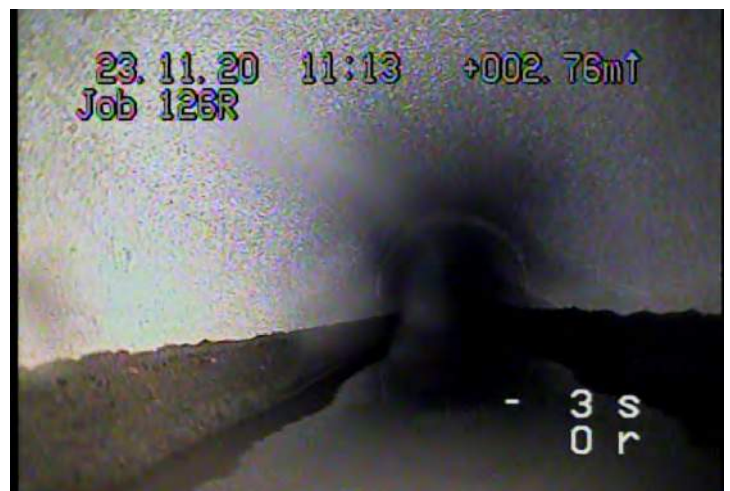
ISGT - Intruding Seal Material - Grout @
2.3 m.

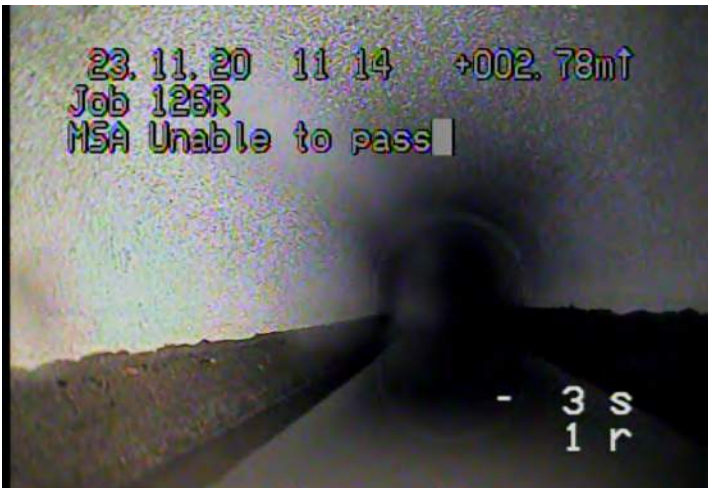
MSA - Survey Abandoned @ 2.8 m.
 Unable to get over grout.

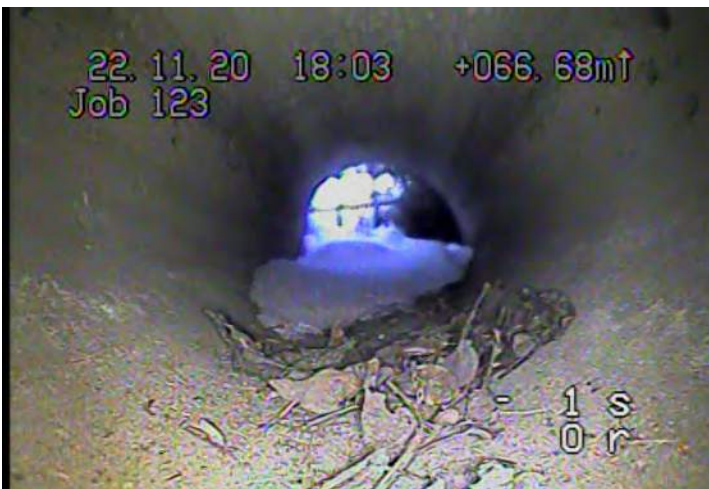
MMC - Material Change @ 66.4 m. PVC
to Concrete

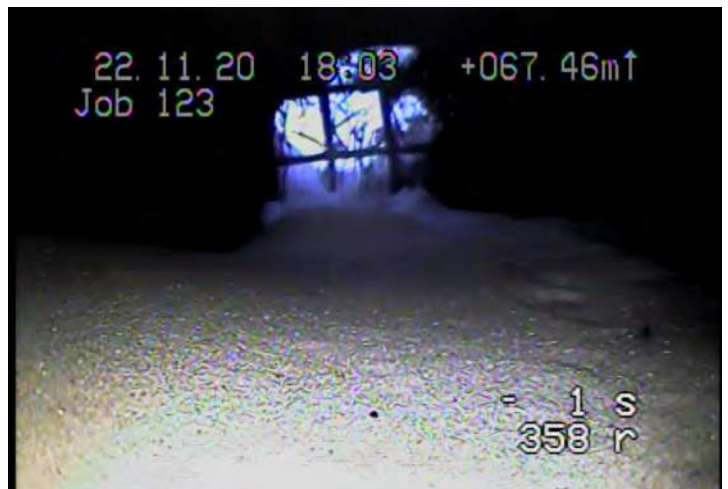
MWL - Water Level @ 67.1 m. Snow

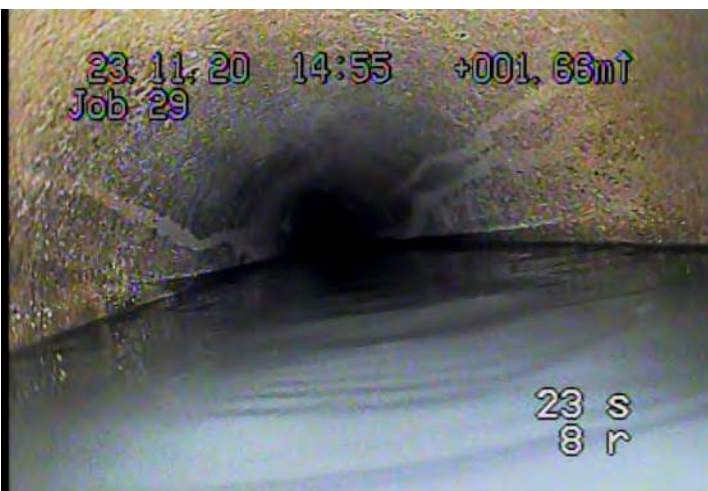
DSGV - Deposits Settled: Gravel @ 1.6 m.

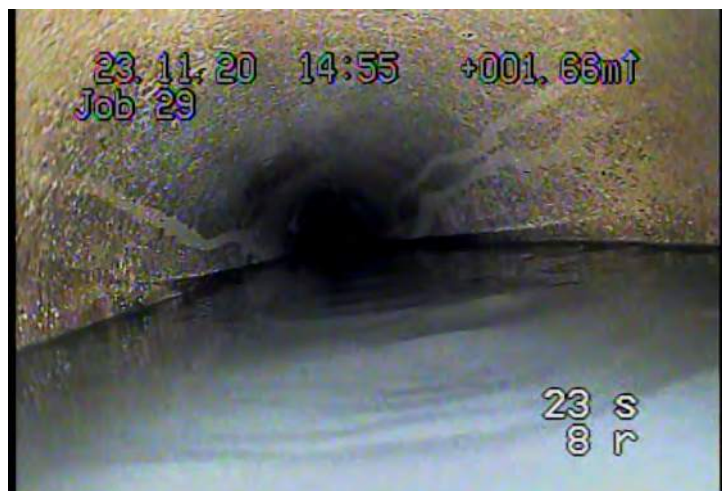
MSA - Survey Abandoned @ 1.6 m.
Unable to pass debris in water.

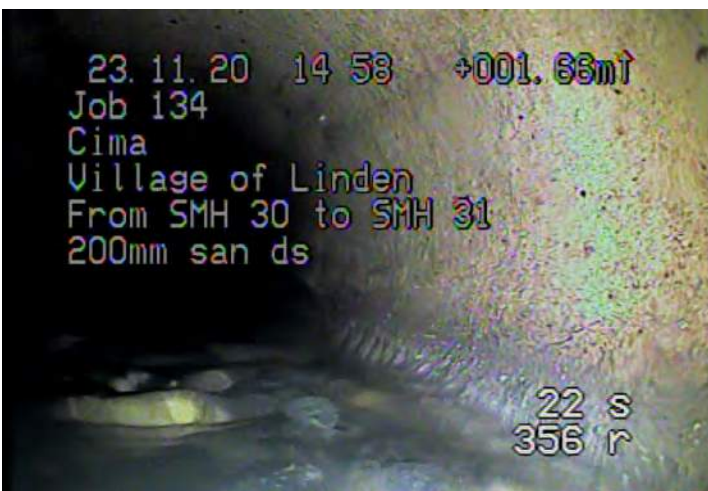
DSGV - Deposits Settled: Gravel @ 0.5 m.

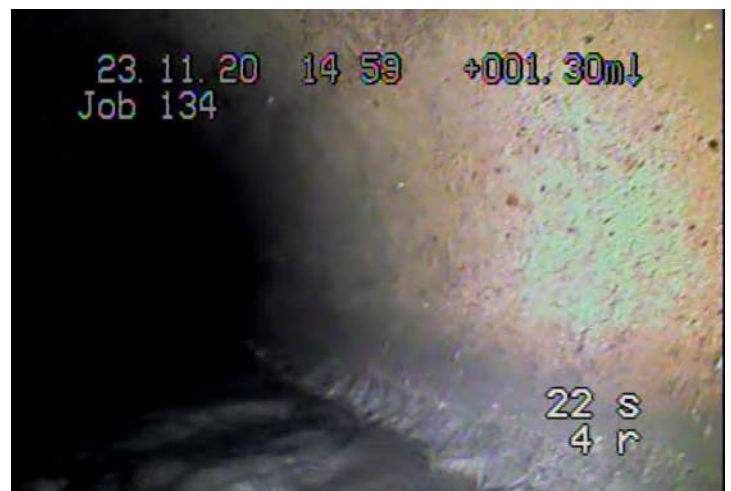
MSA - Survey Abandoned @ 1.0 m.
Unable to pass gravel in line.

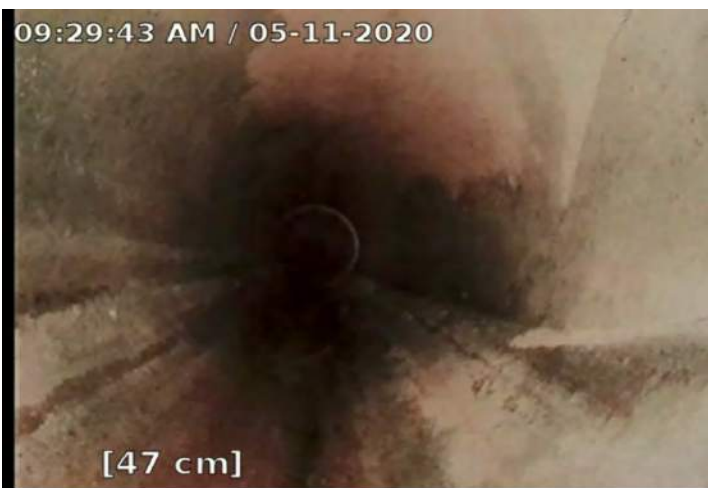
CC - Crack Circumferential @ 0.5 m.

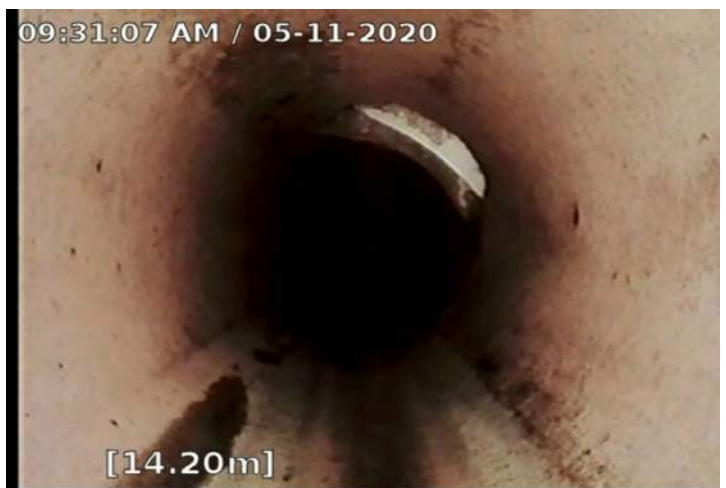
TB - Tap, Break-in / Hammer @ 14.2 m.

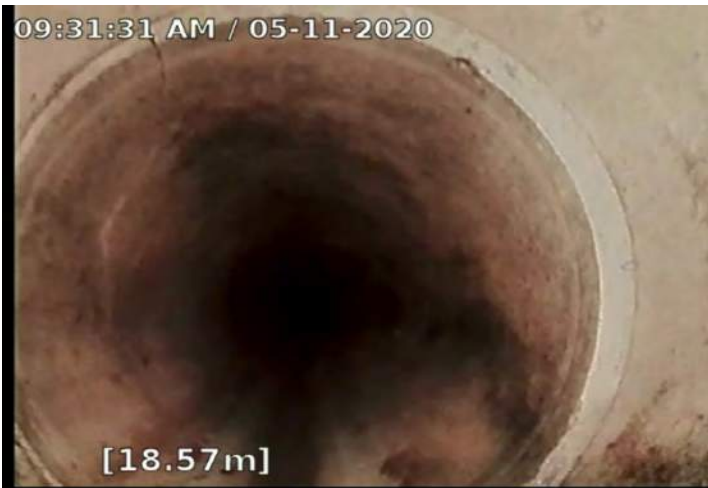
FS - Fracture Spiral @ 18.6 m.

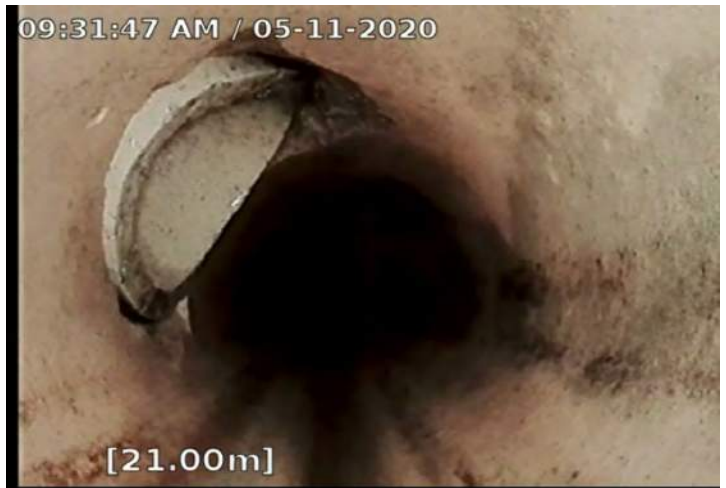
TB - Tap, Break-in / Hammer @ 21.0 m.

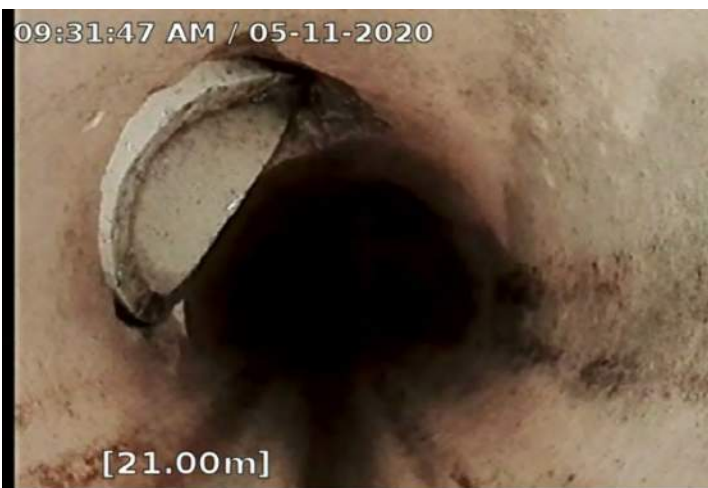
MSA - Survey Abandoned @ 21.0 m. @ Service. Rest of line seen in Job 52.

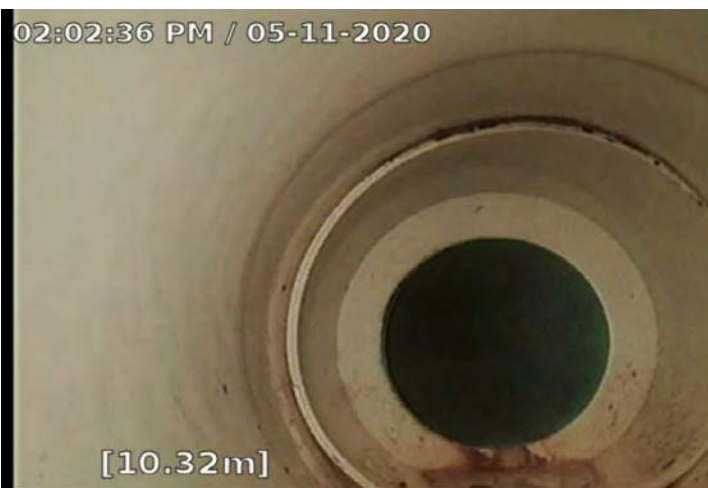
MSC - Dimension/Shape Change @ 10.3 m.

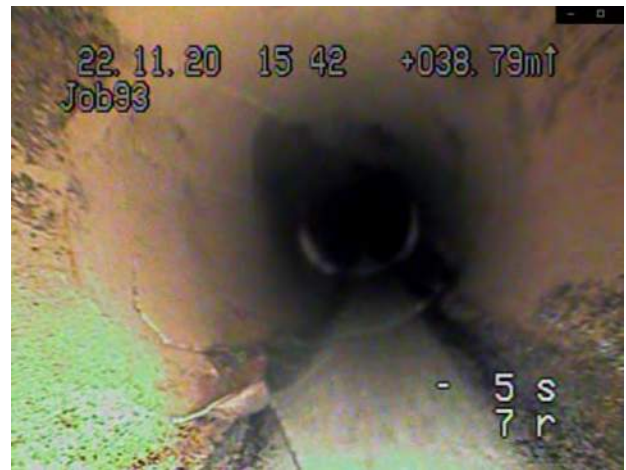
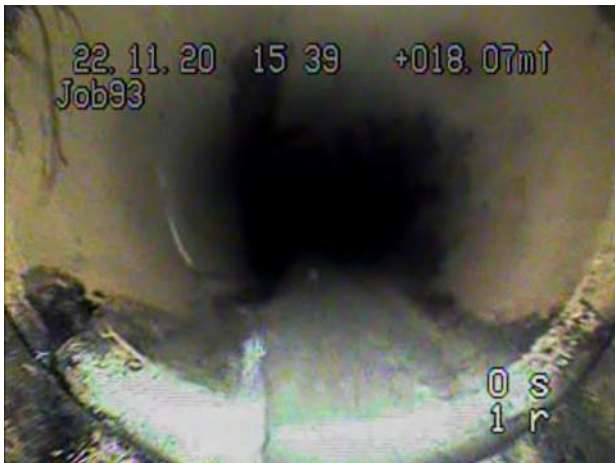
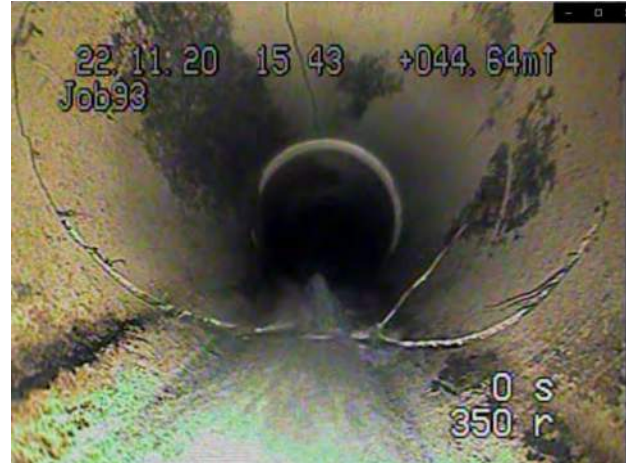
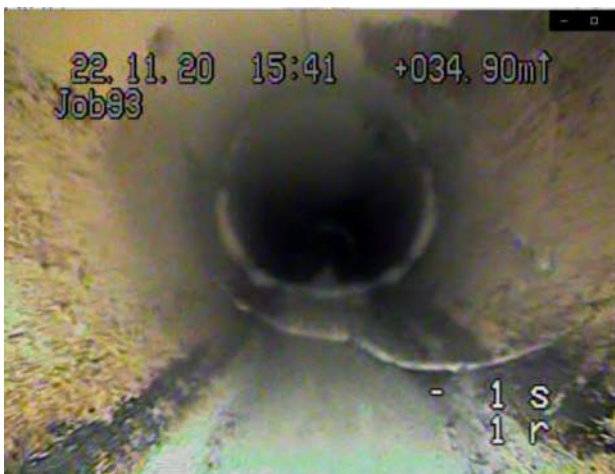
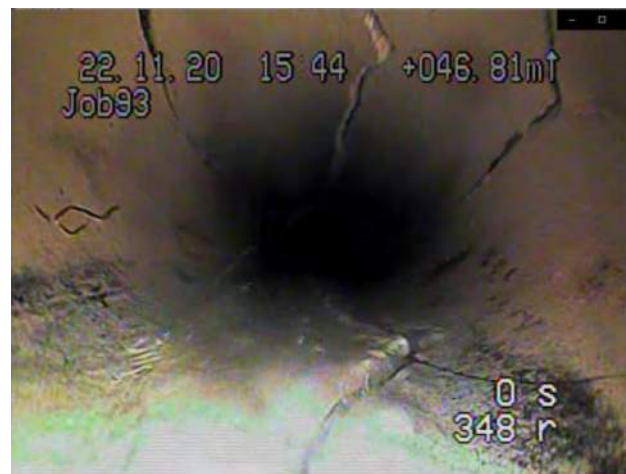
SMH 80 – SMH 33

Dist.	Cont.	Code	Defect Description	Clock	%	mm	Joint	Remark
0.0		AMH	Access Point - Manhole					S MH 80
0.0		MWL	Water Level		5			
0.5		JSL	Joint Separated (open): Large

3.3	S01	RFJ	Roots, Fine: Joint	3 to 9			J	Roots at most joints
3.6		JSM	Joint Separated (open): Medium					
12.3		FC	Fracture Circumferential	5 to 10

18.1		FC	Fracture Circumferential	7 to 10			J	
35.0		FM	Fracture Multiple	4 to 8				
38.5		FM	Fracture Multiple	5 to 8				
44.6		FM	Fracture Multiple	12 to 12

46.5	S02	B	Pipe Broken	12 to 12				
47.3		D	Pipe Deformed		15			
47.9	F02	B	Pipe Broken	12 to 12				
49.4	S03	B	Pipe Broken	12 to 12				
50.9	F03	B	Pipe Broken	12 to 12

59.3		JOL	Joint Offset (displaced): Large					
59.6		FH4	Fracture Longitudinal Hinge, 4	12 to 12				
60.8		B	Pipe Broken	7 to 5				
63.7		JOM	Joint Offset (displaced): Medium

64.3		FM	Fracture Multiple	3 to 10				
65.0		B	Pipe Broken	12 to 12				
69.2		FC	Fracture Circumferential	2 to 6			J	
73.4		FC	Fracture Circumferential	8 to 11			J

76.0		CC	Crack Circumferential	4 to 8			J	
77.6		FM	Fracture Multiple	12 to 12			J	
79.5		FM	Fracture Multiple	12 to 12				
83.2		RMJ	Roots, Medium, Joint	8 to 4	15

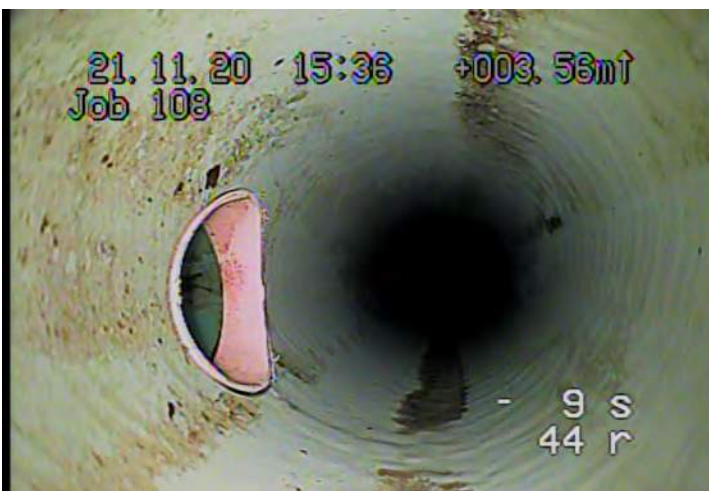
TS - Tap, Saddle @ 3.0 m.

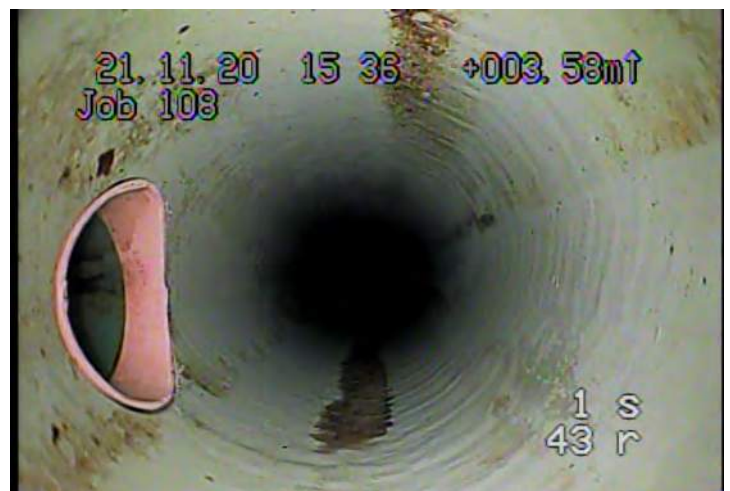
TS - Tap, Saddle @ 3.5 m.

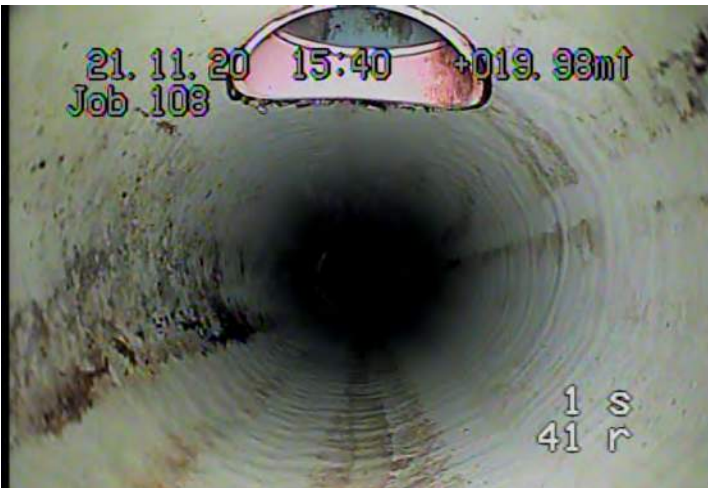
TS - Tap, Saddle @ 20.0 m.

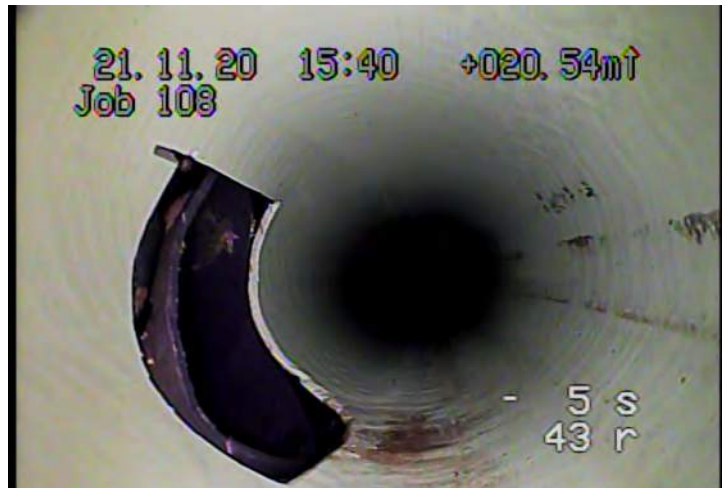
TSD - Tap, Saddle: Defective @ 20.5 m.

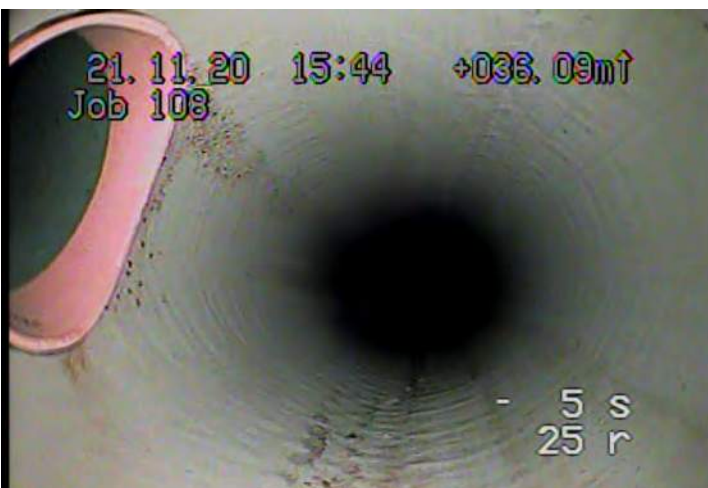
TS - Tap, Saddle @ 36.7 m.

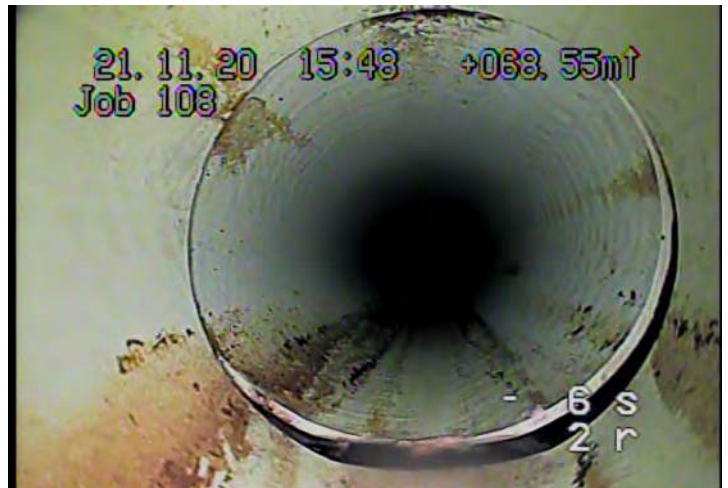
JOM - Joint Offset (displaced): Medium @ 68.4 m.

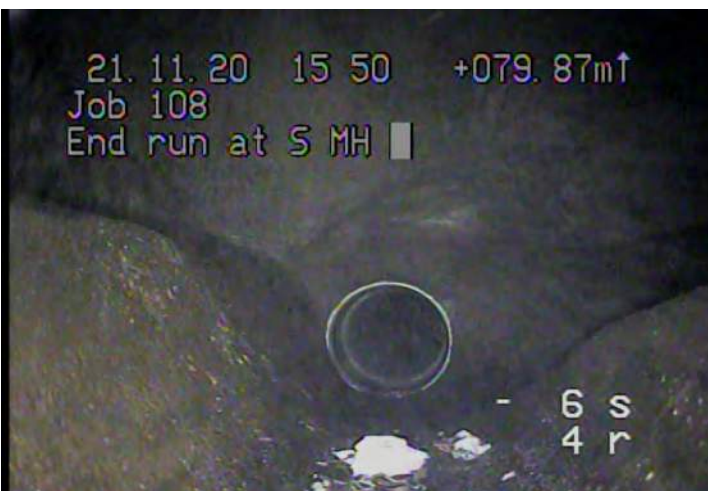
AMH - Access Point - Manhole @ 79.9 m.
S MH 88

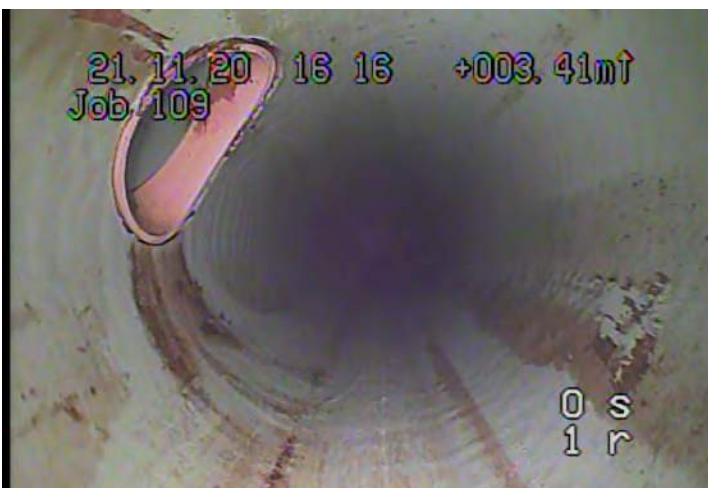
TS - Tap, Saddle @ 3.2 m.

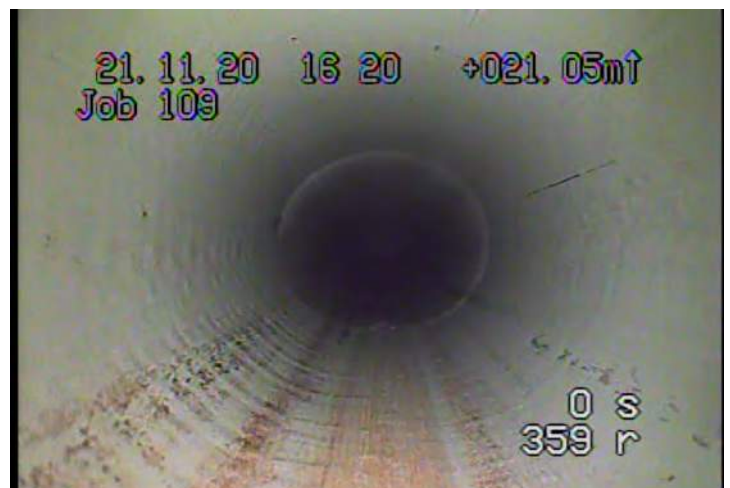
TS - Tap, Saddle @ 20.1 m.

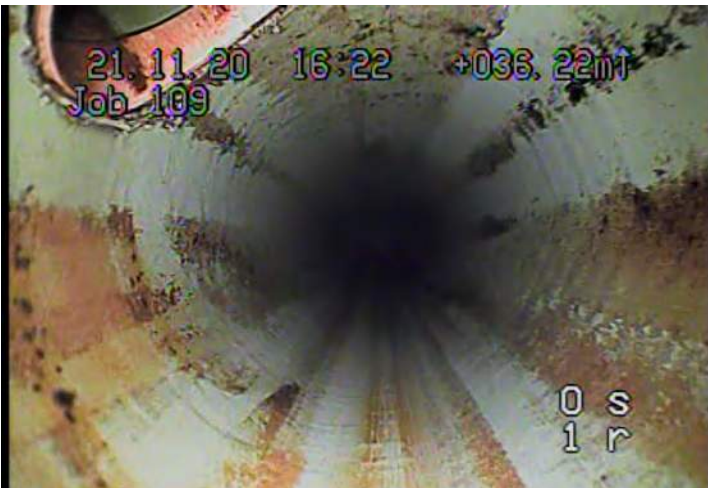
TS - Tap, Saddle @ 36.1 m.

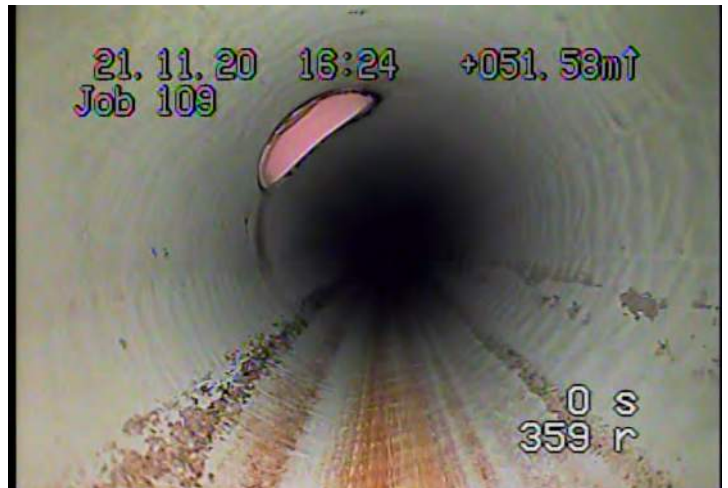
TS - Tap, Saddle @ 51.6 m.

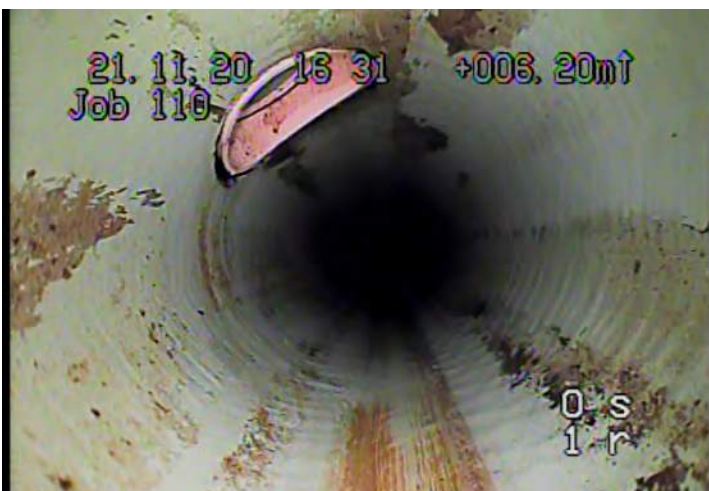
TS - Tap, Saddle @ 6.2 m.

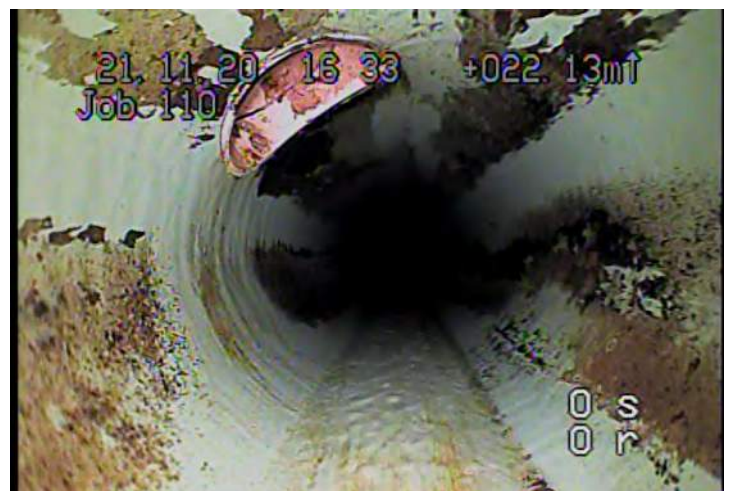
TS - Tap, Saddle @ 22.1 m.

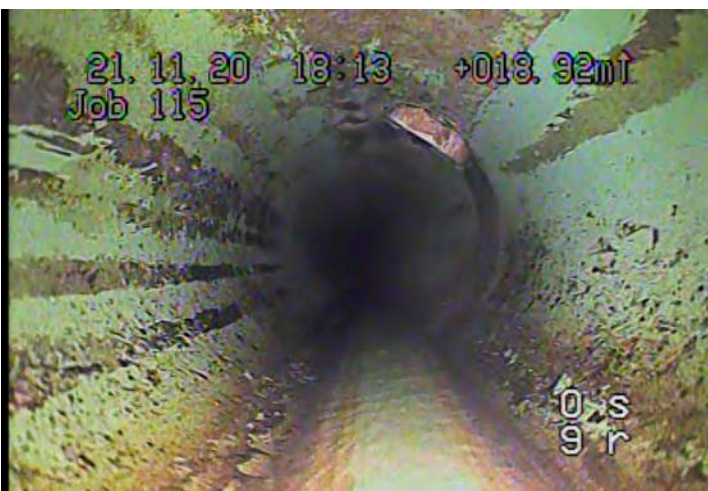
TS - Tap, Saddle @ 18.4 m.

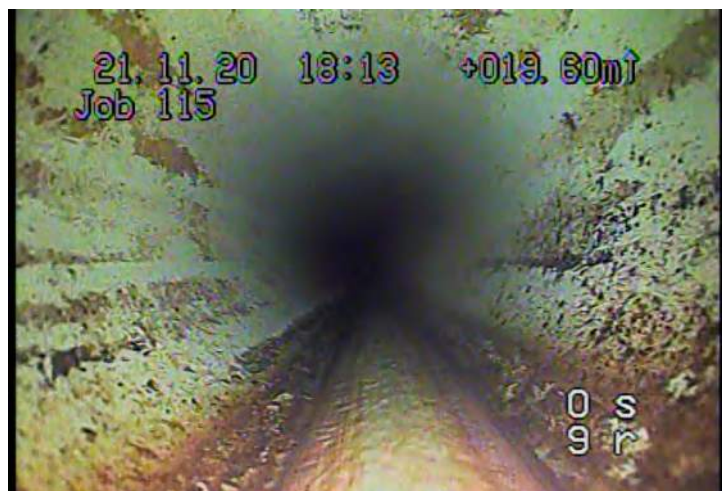
TS - Tap, Saddle @ 19.0 m.

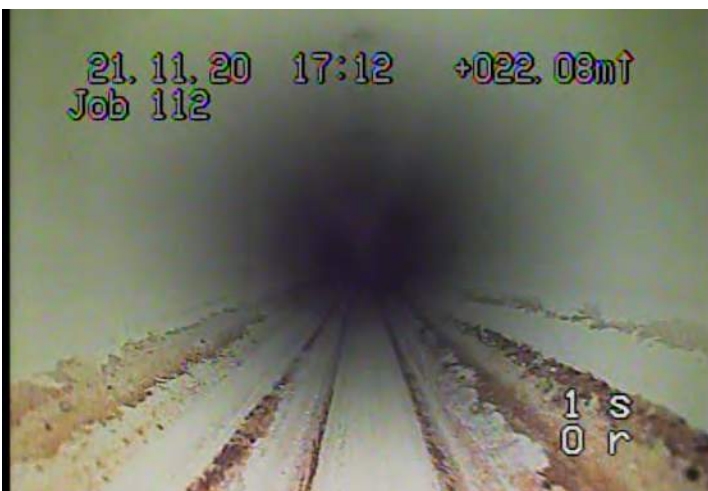
TS - Tap, Saddle @ 20.2 m.

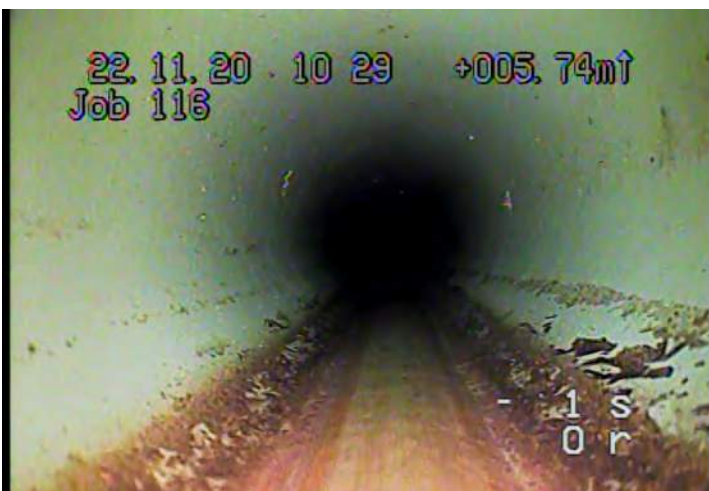
DAE - Deposits Attached: Encrustation @
3.8 m.

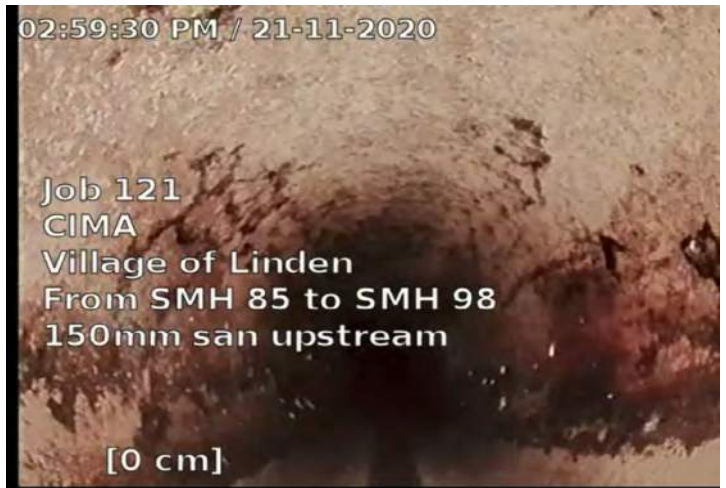
RMJ - Roots, Medium, Joint @ 13.3 m.

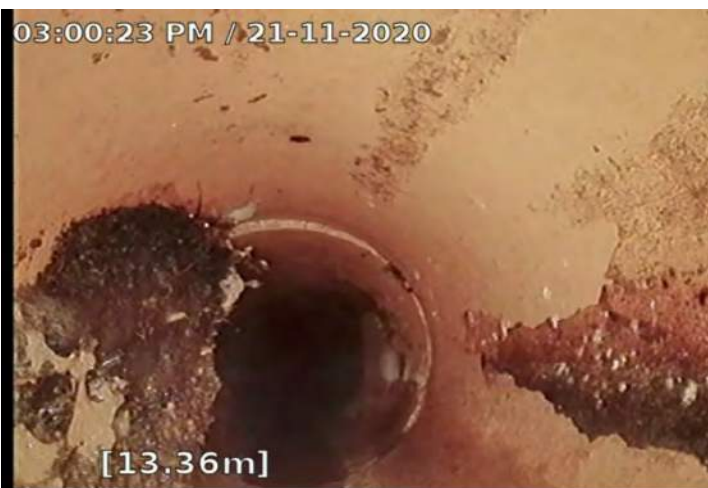
RFJ - Roots, Fine: Joint @ 16.1 m.

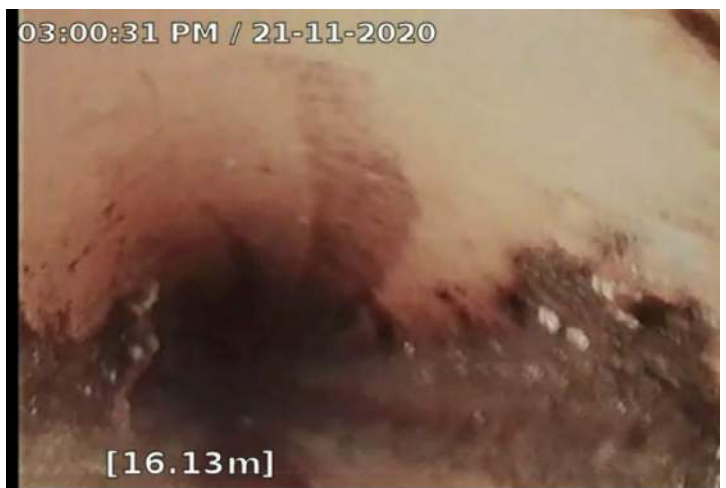
RFJ - Roots, Fine: Joint @ 18.7 m.

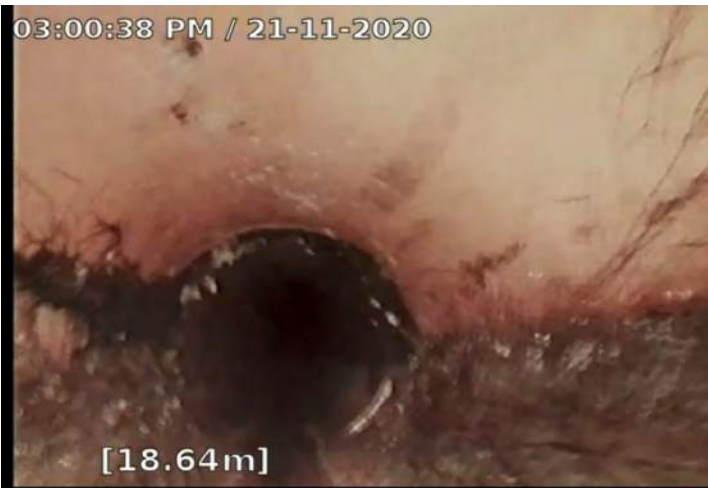
RFJ - Roots, Fine: Joint @ 20.9 m.

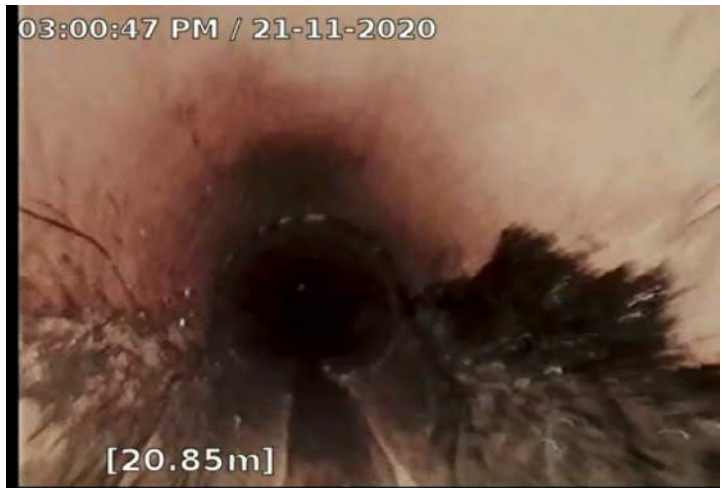
RFJ - Roots, Fine: Joint @ 22.3 m.

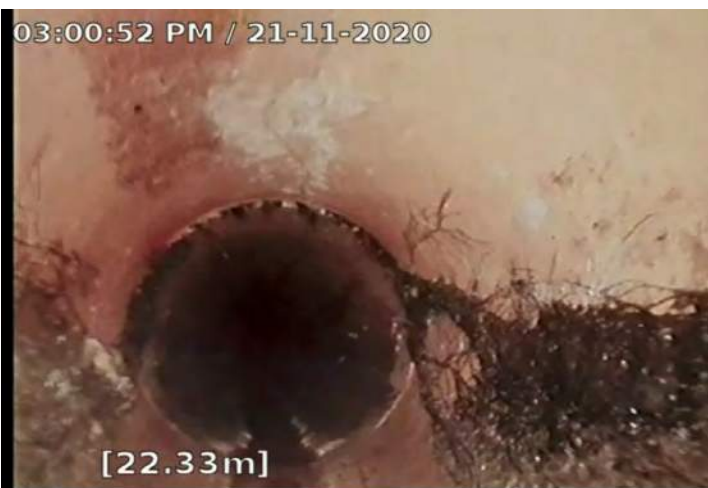
RMJ - Roots, Medium, Joint @ 25.9 m.

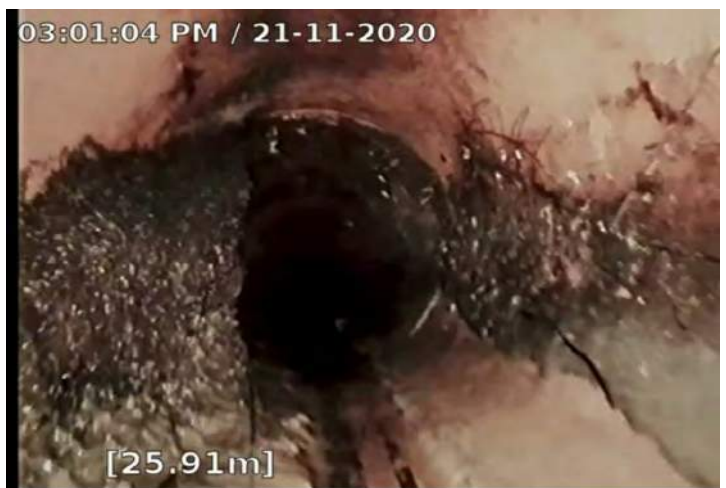
RMJ - Roots, Medium, Joint @ 27.5 m.

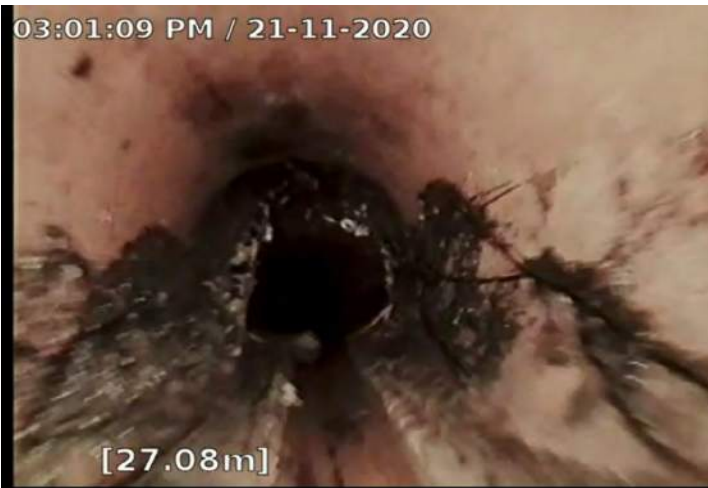
RFJ - Roots, Fine: Joint @ 30.8 m.

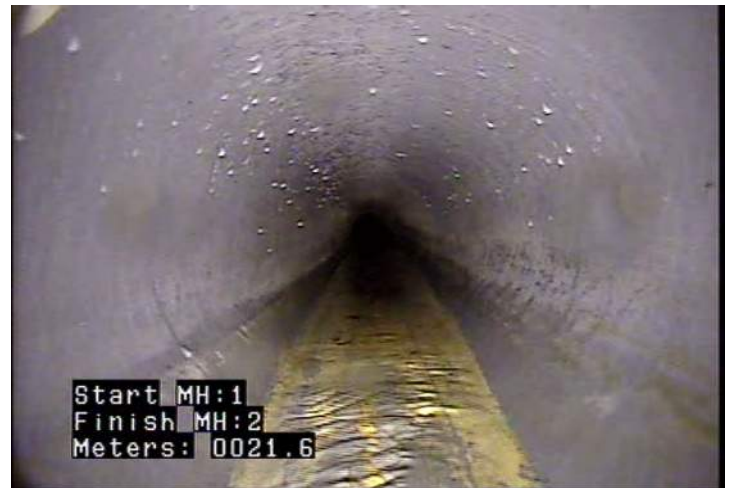
D - Pipe Deformed @ 24.3 m. Pipe oval (visible at joint)

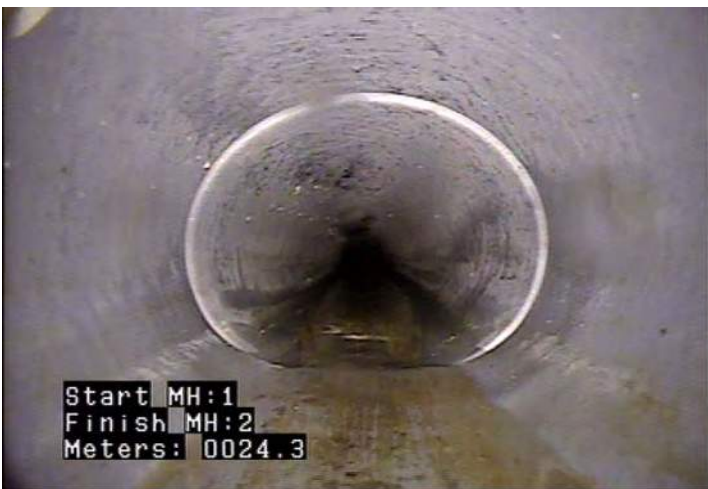
D - Pipe Deformed @ 28.3 m. Pipe oval (visible at joint)
