Appendix F CCTV Assessment

Client: CIMA
 Project: Pre-Rehabilitation Survey
 Date: 12/18/2020
 File: 14257

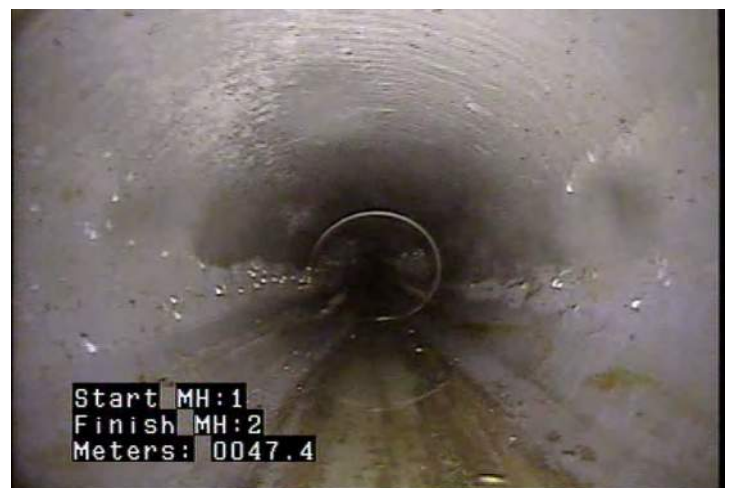
D - Pipe Deformed @ 60.7 m.

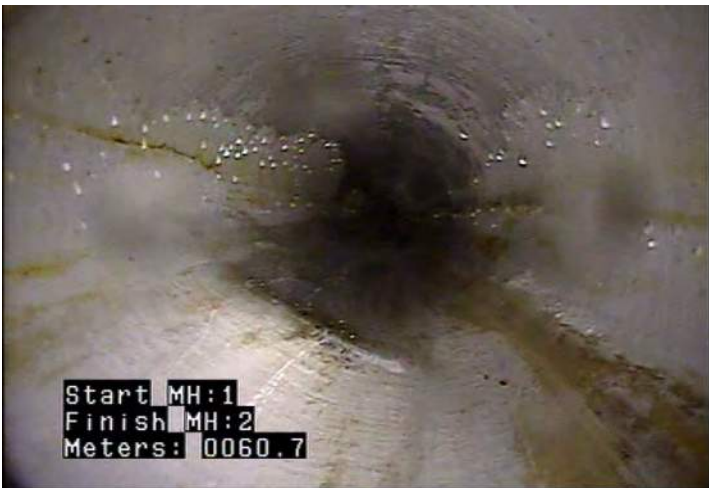
D - Pipe Deformed @ 62.0 m.

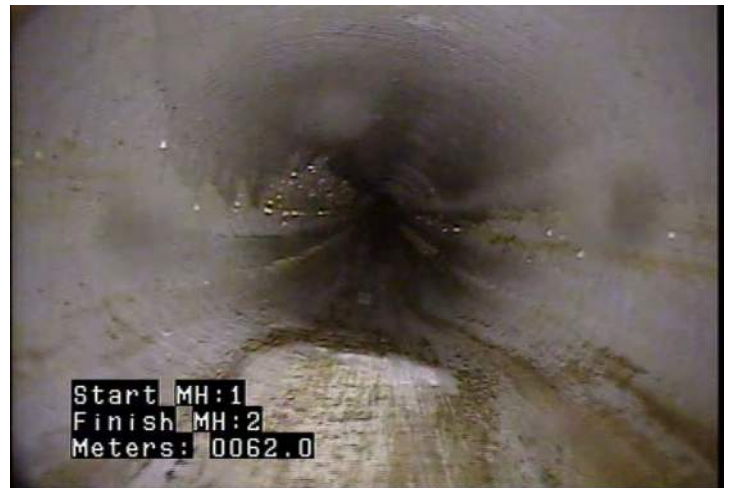
D - Pipe Deformed @ 66.9 m.

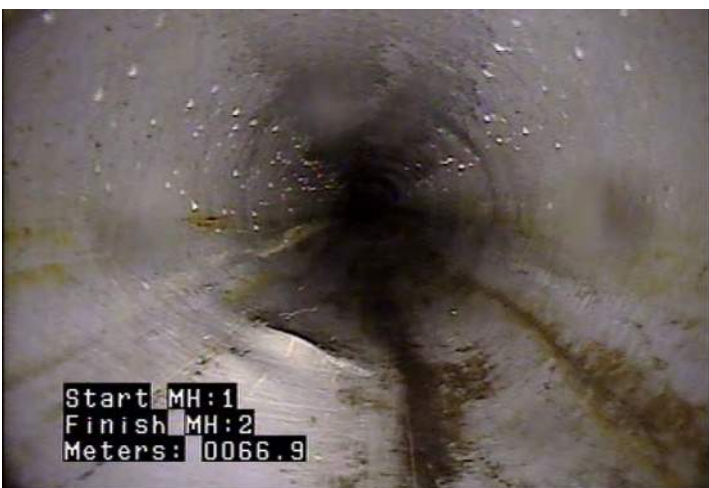
D - Pipe Deformed @ 69.4 m.

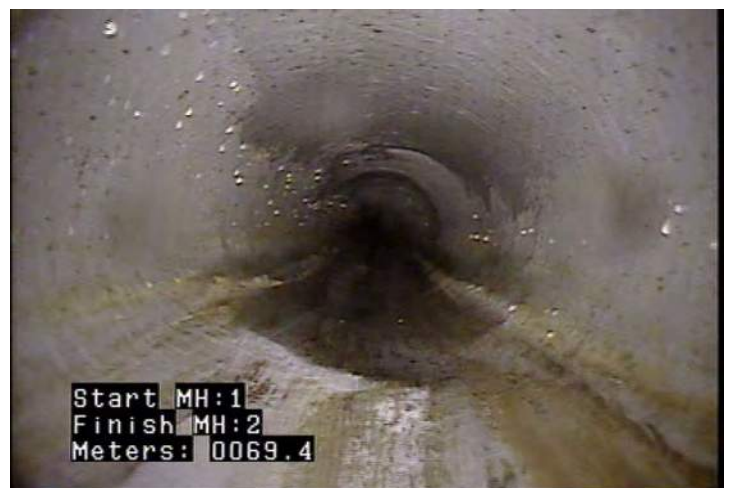
D - Pipe Deformed @ 75.1 m.

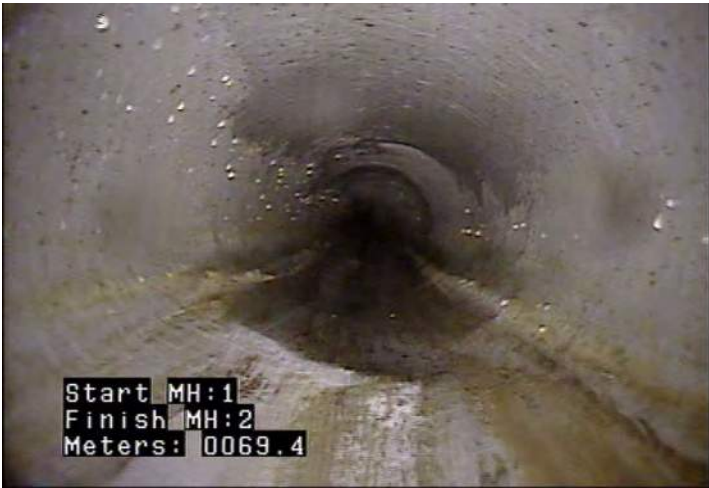
D - Pipe Deformed @ 77.0 m.

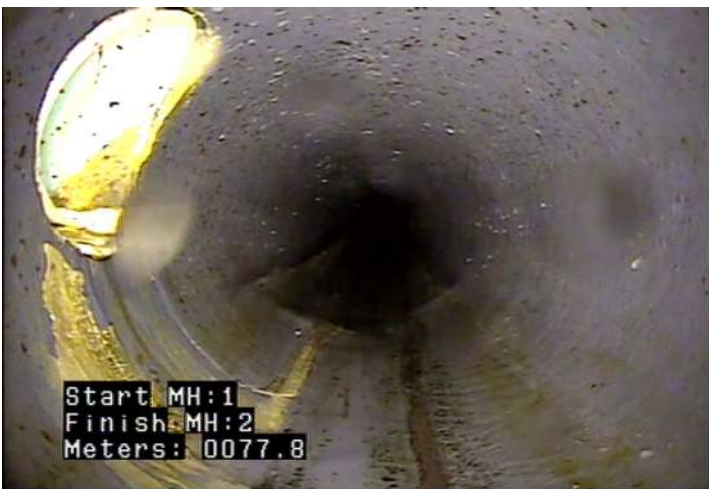
D - Pipe Deformed @ 82.7 m.

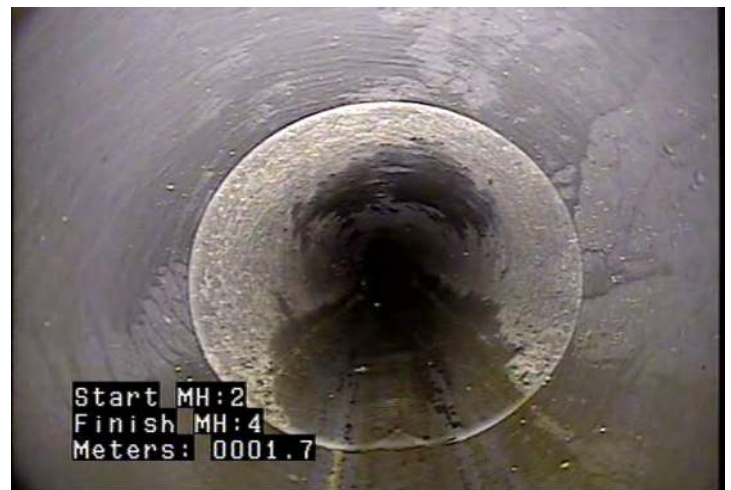
D - Pipe Deformed @ 10.2 m.

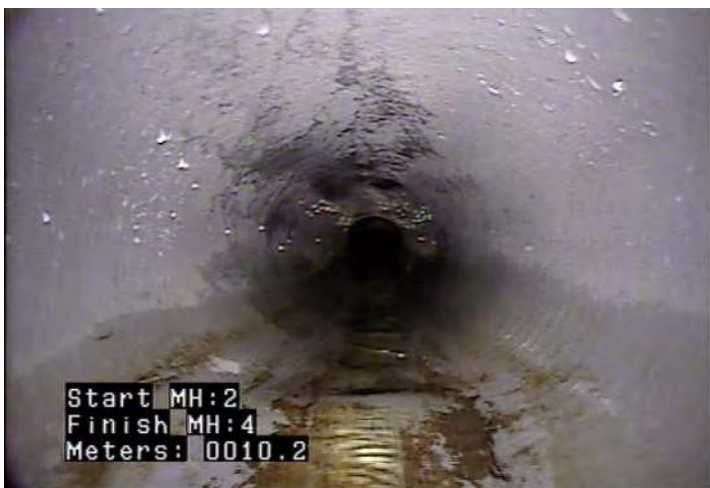
MWLS - Water Level: Sag @ 11.3 m.

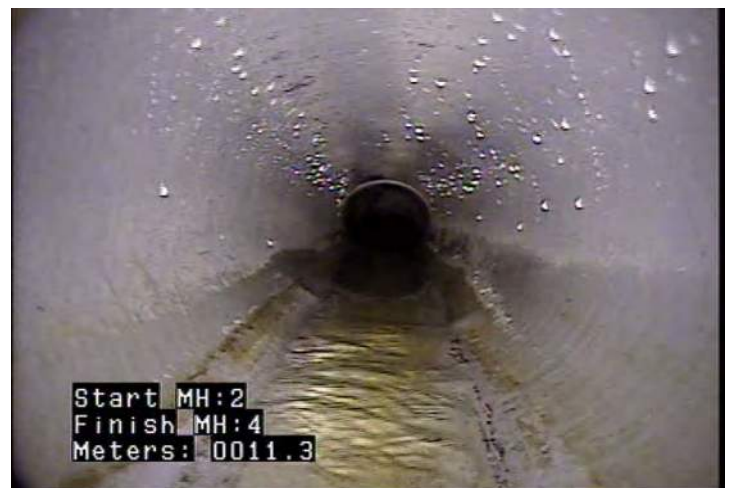
D - Pipe Deformed @ 12.8 m. Pipe ovalled (possible offset joint)

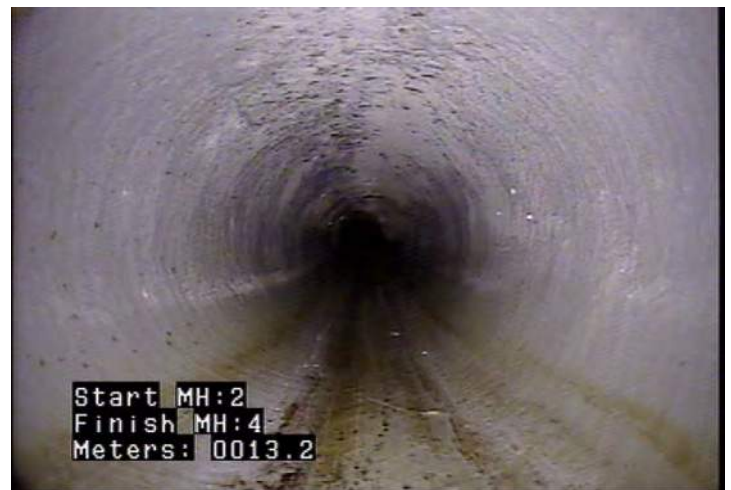
D - Pipe Deformed @ 18.7 m.

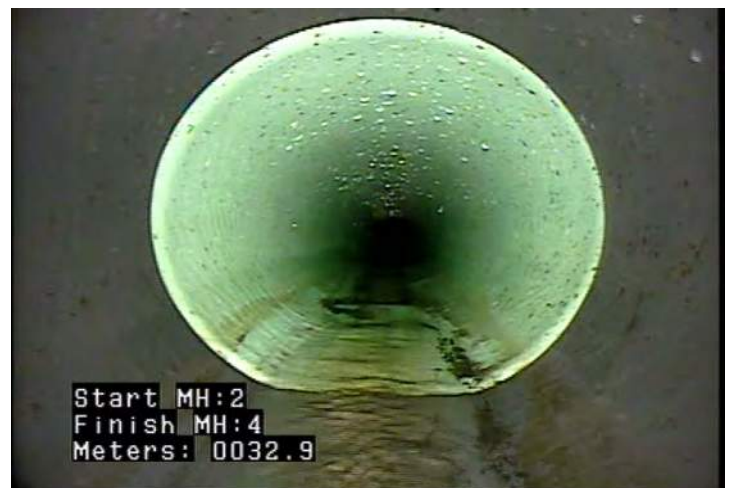
D - Pipe Deformed @ 36.2 m.

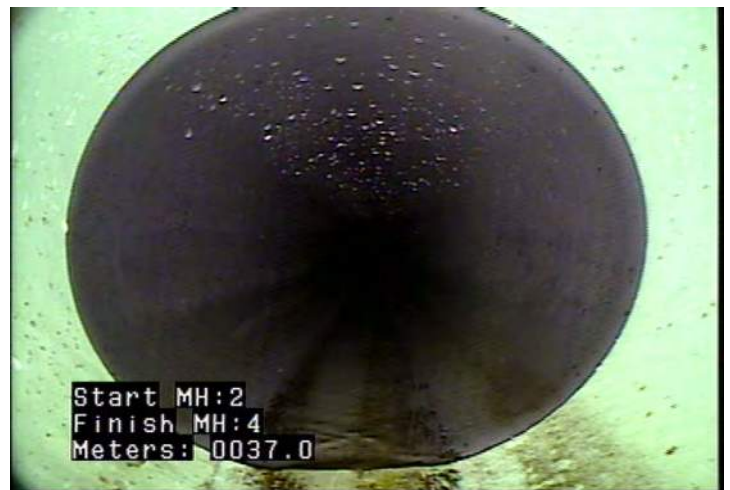
MMC - Material Change @ 37.0 m. Blue PVC to Grey PVC

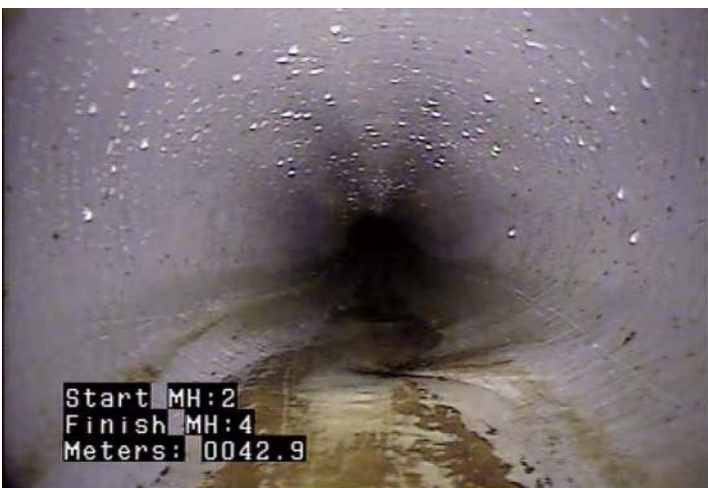
D - Pipe Deformed @ 42.9 m.

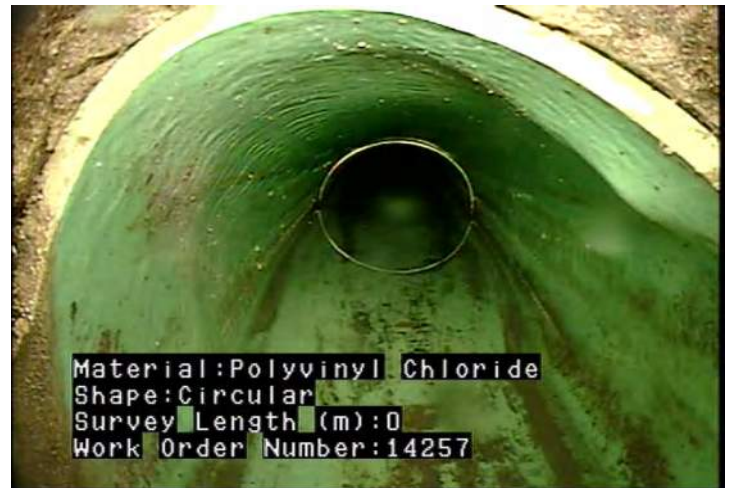
Dist.	Cont.	Code	Defect Description	Clock	%	mm	Joint	Remark
0.0		AMH	Access Point - Manhole					S MH 4
0.5	S04	MWLS	Water Level: Sag		50			
6.6		MMC	Material Change					Blue PVC to Grey PVC

MWLS - Water Level: Sag @ 0.5 m.

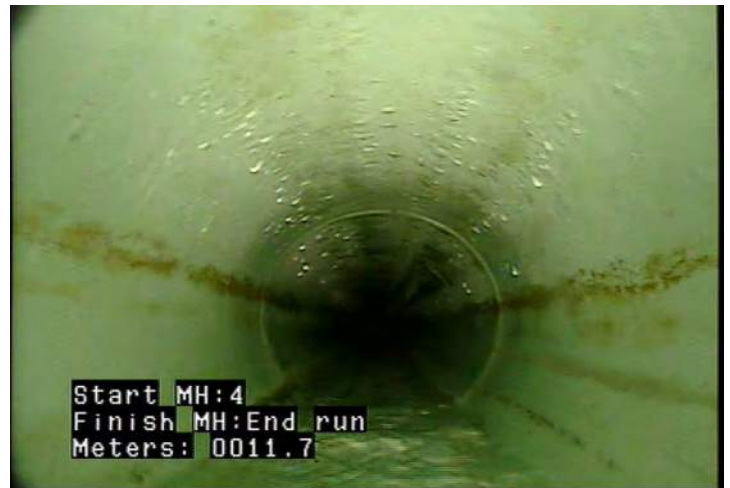
MWLS - Water Level: Sag @ 11.7 m.

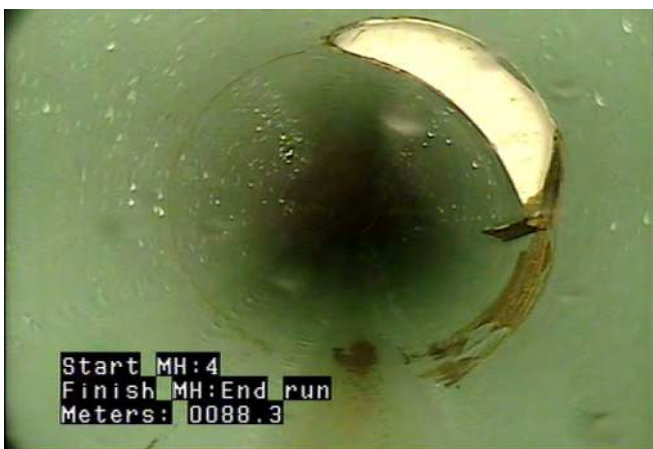
68.0		MWL	Water Level		5			
72.8		MWL	Water Level		0			
88.3		TSD	Tap, Saddle: Defective	2				Broken gasket intruding at bottom of service.
123.7	S01	DSF	Deposits Settled: Fine	5 to 7	10

TSD - Tap, Saddle: Defective @ 88.3 m.
Broken gasket intruding at bottom of service.

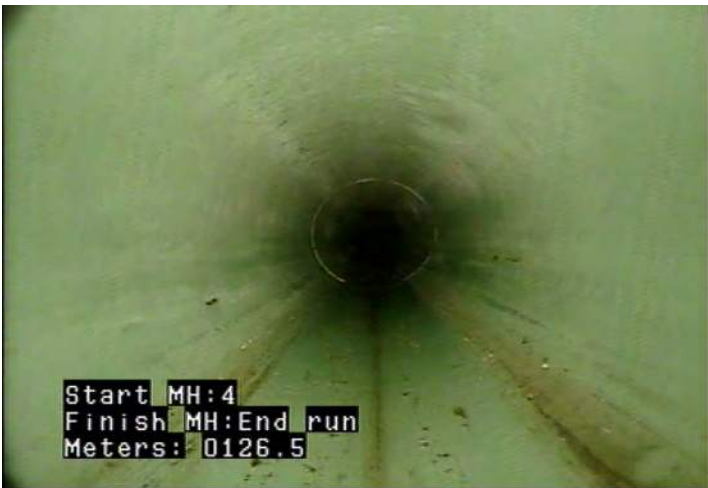
DSF - Deposits Settled: Fine @ 126.5 m.

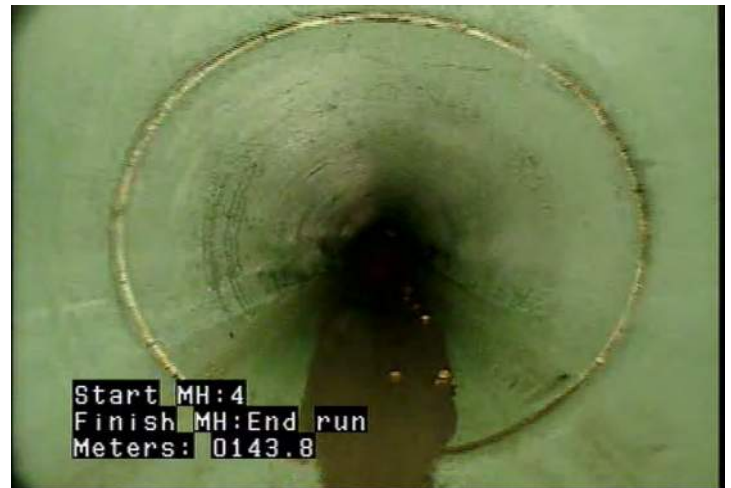
DSF - Deposits Settled: Fine @ 143.8 m.

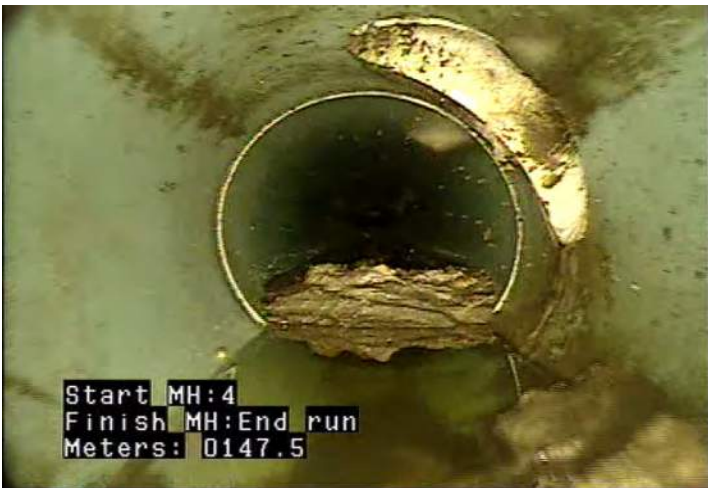
DSF - Deposits Settled: Fine @ 147.5 m.

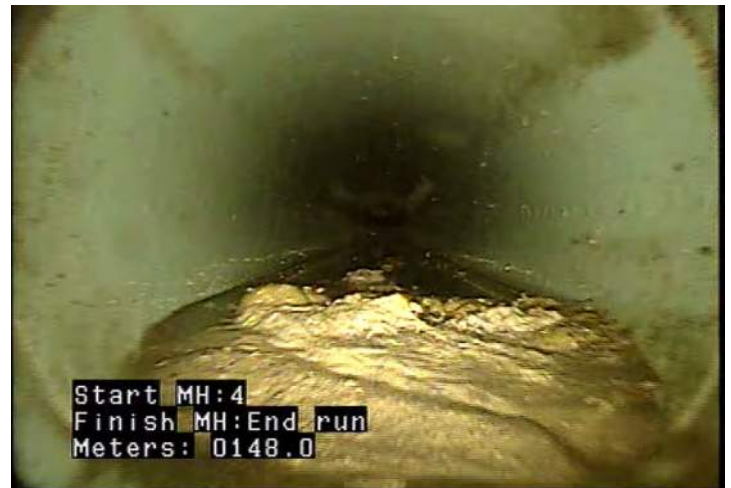
DSF - Deposits Settled: Fine @ 148.0 m.

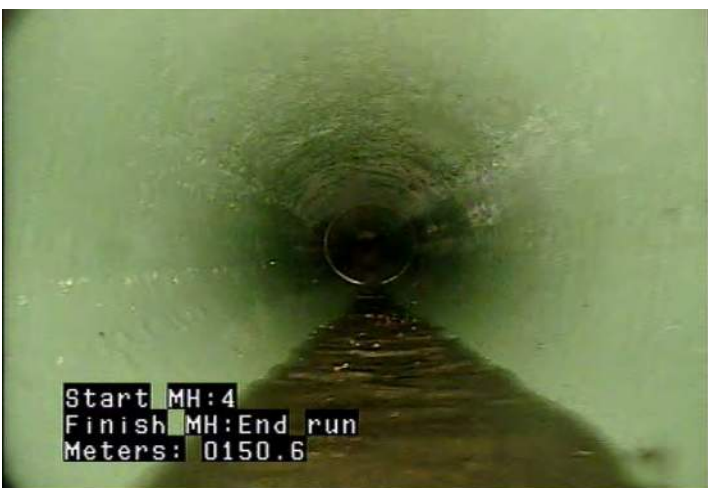
DSF - Deposits Settled: Fine @ 150.6 m.

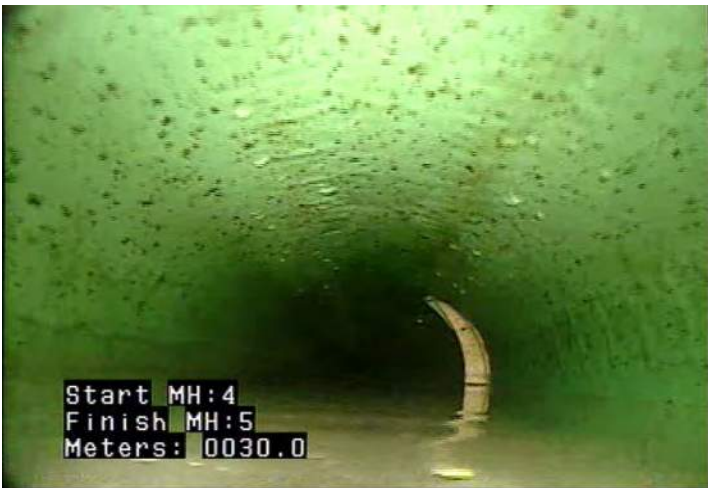
MWLS - Water Level: Sag @ 30.0 m.

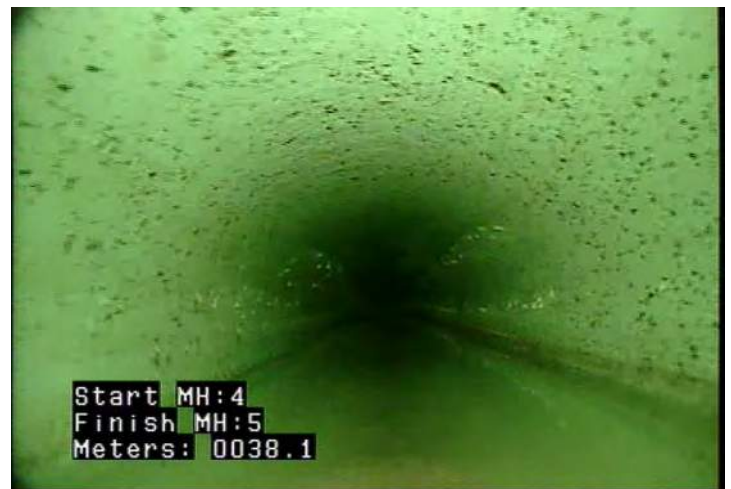
MWLS - Water Level: Sag @ 38.1 m.

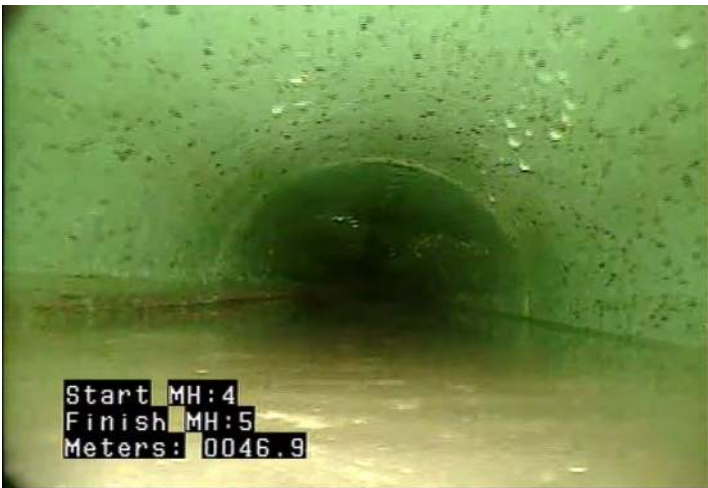
MWLS - Water Level: Sag @ 46.9 m.

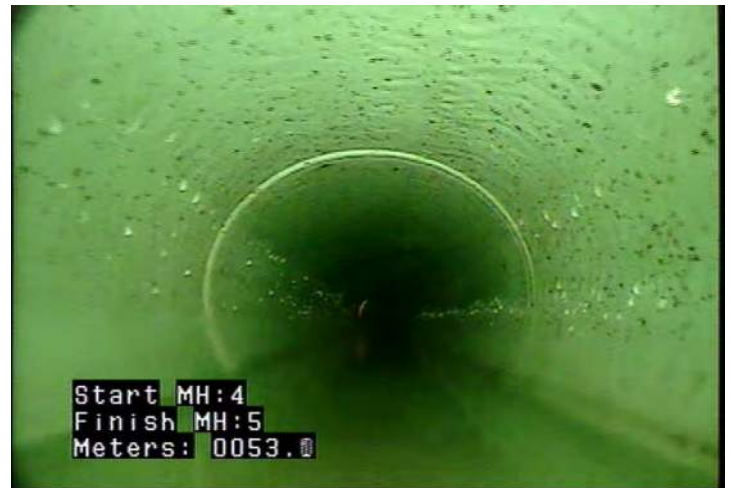
MWLS - Water Level: Sag @ 53.0 m.

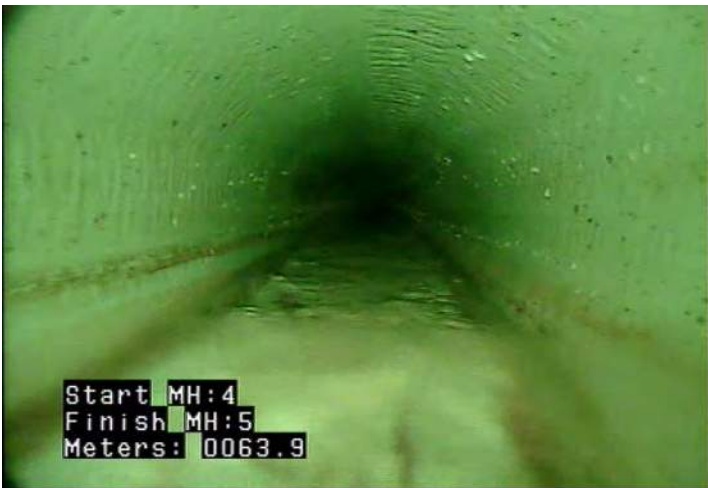
MWLS - Water Level: Sag @ 63.9 m.

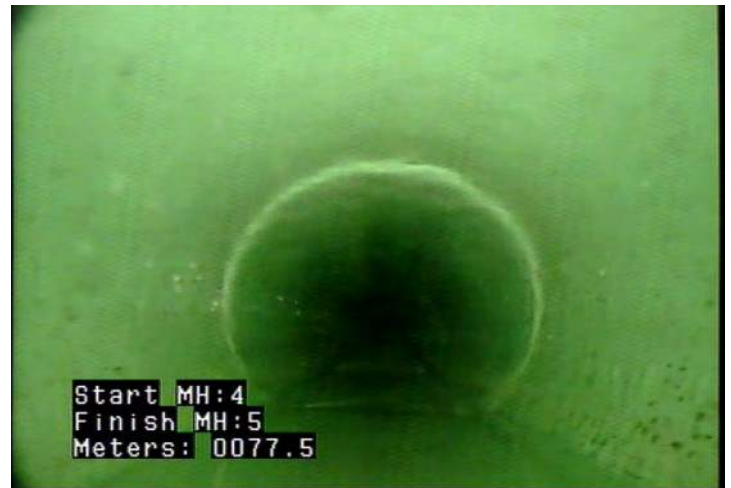
MWLS - Water Level: Sag @ 77.5 m.

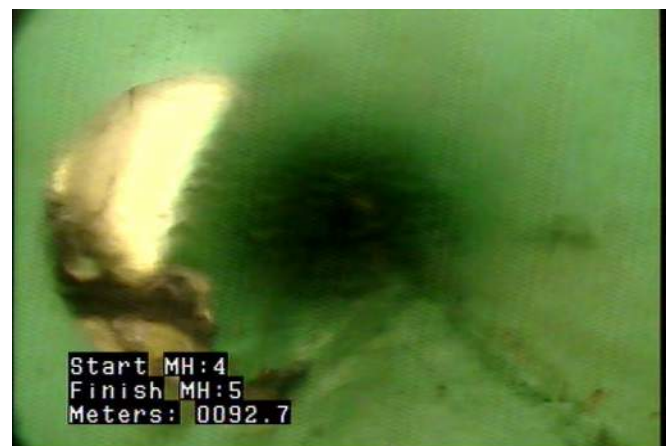
TSD - Tap, Saddle: Defective @ 92.7 m.
Gasket at bottom of service holding back debris.

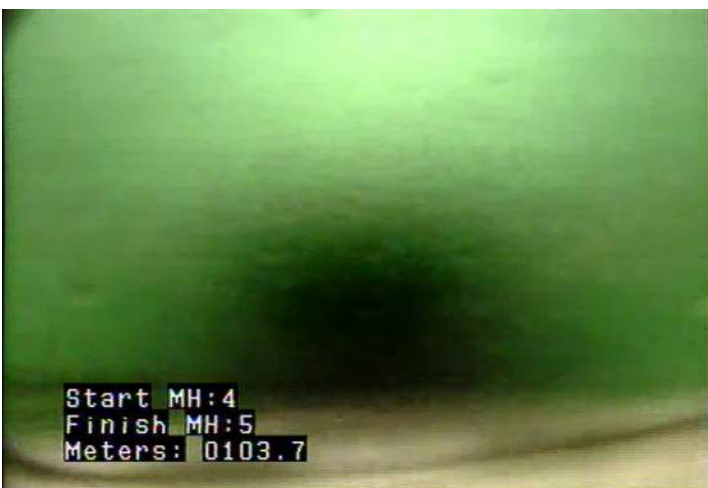
MWLS - Water Level: Sag @ 103.7 m.

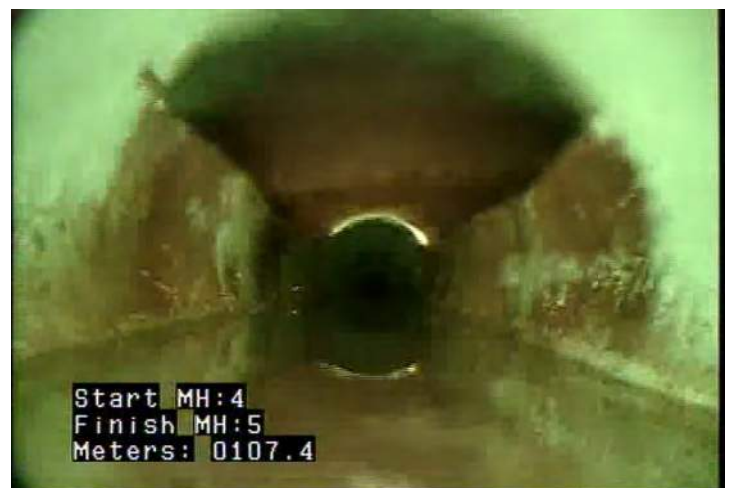
MWLS - Water Level: Sag @ 107.4 m.

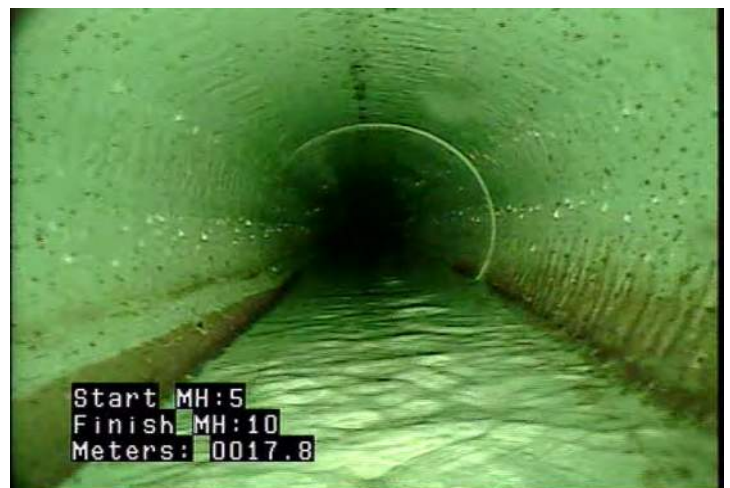
MWLS - Water Level: Sag @ 17.8 m.

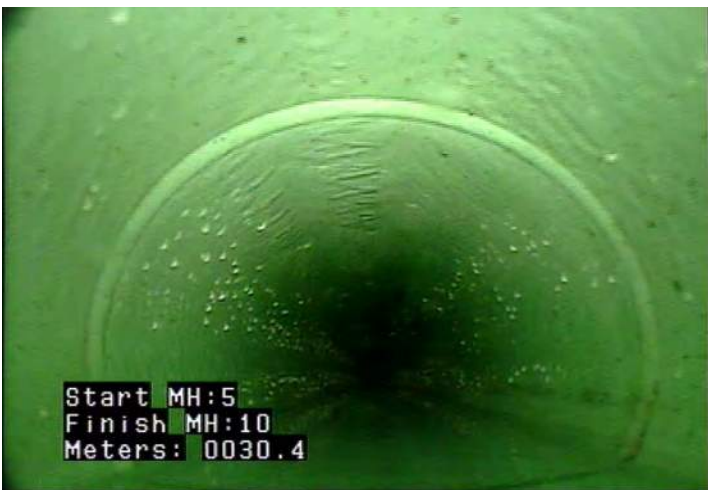
MWLS - Water Level: Sag @ 30.4 m.

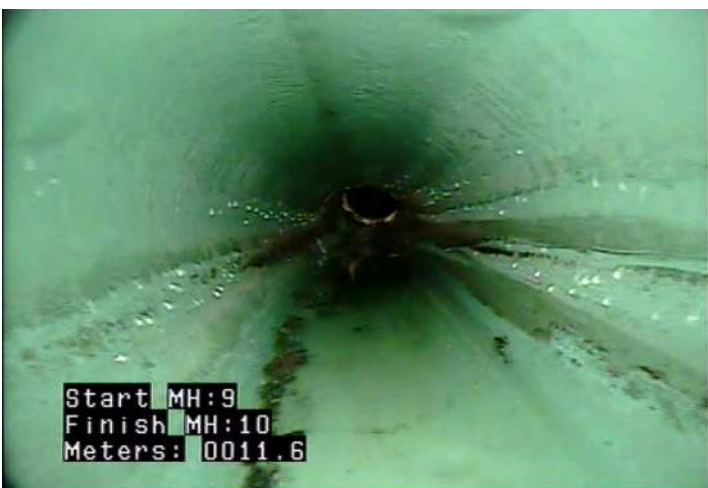
MWLS - Water Level: Sag @ 11.6 m.

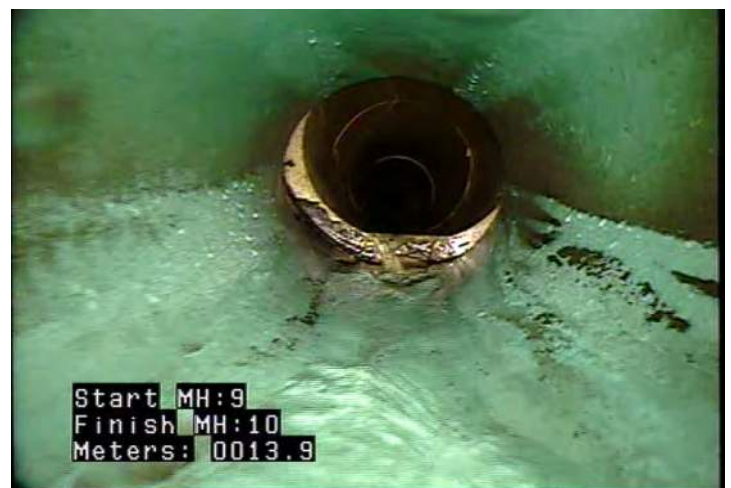
MWLS - Water Level: Sag @ 13.9 m.

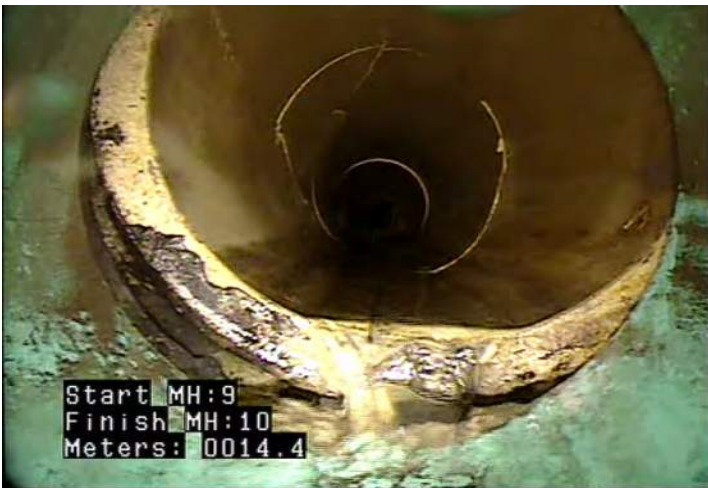
MMC - Material Change @ 14.4 m. PVC to Clay tile

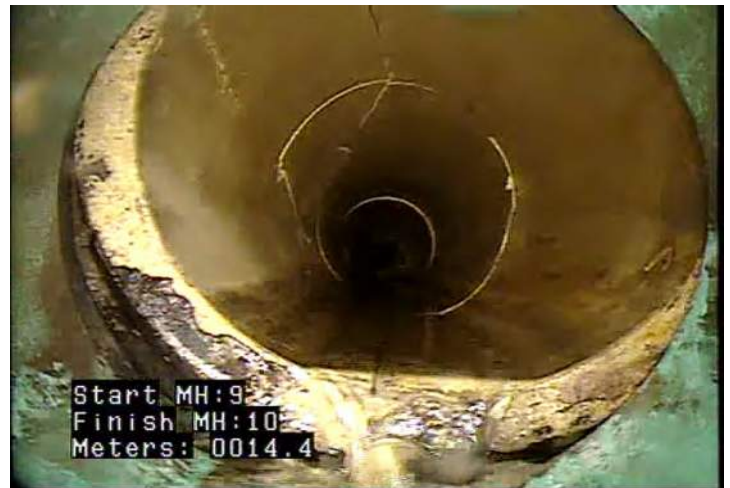
Rest of line observed with camera zoom to S MH 10. First length of clay tile line full of fractures. Second length fine. Joint going into S MH 10 is offset large.

JOL - Joint Offset (displaced): Large @ 14.4 m.

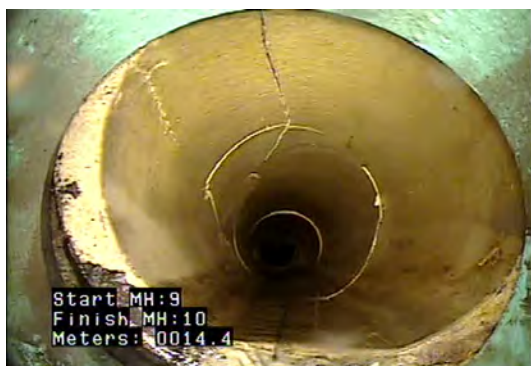
FM - Fracture Multiple @ 14.4 m. Rest of line observed with camera zoom to S MH 10. First length of clay tile line full of fractures. Second length fine. Joint going into S MH 10 is offset large.

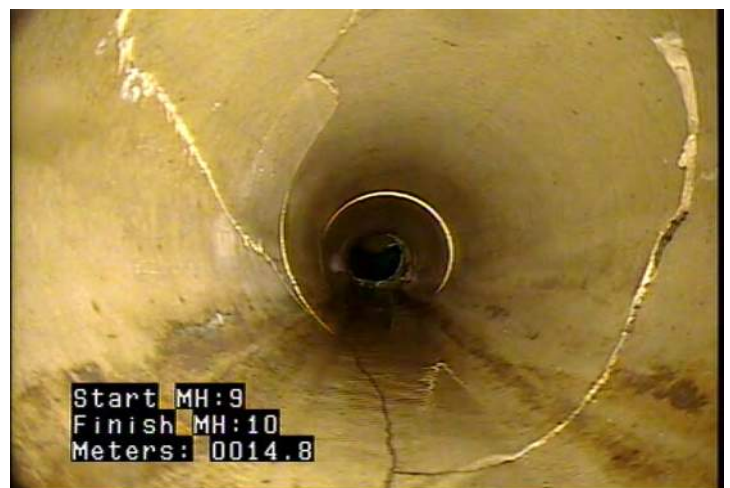
MSA - Survey Abandoned @ 14.8 m. Unable to go over joint with crawler.

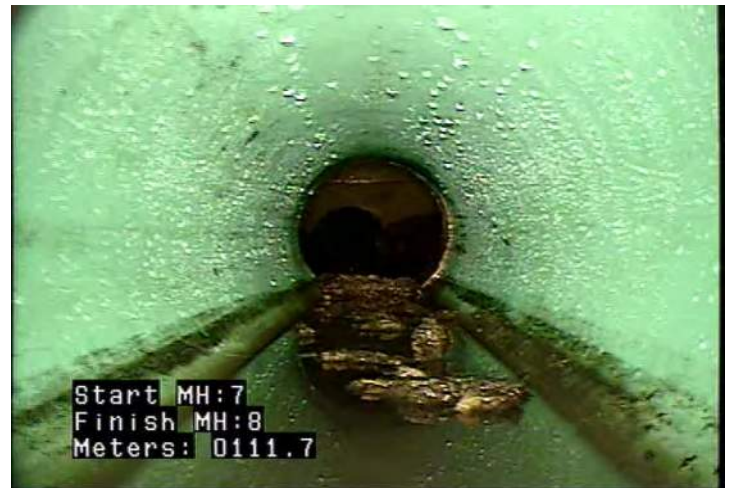
DSGV - Deposits Settled: Gravel @ 111.7 m.

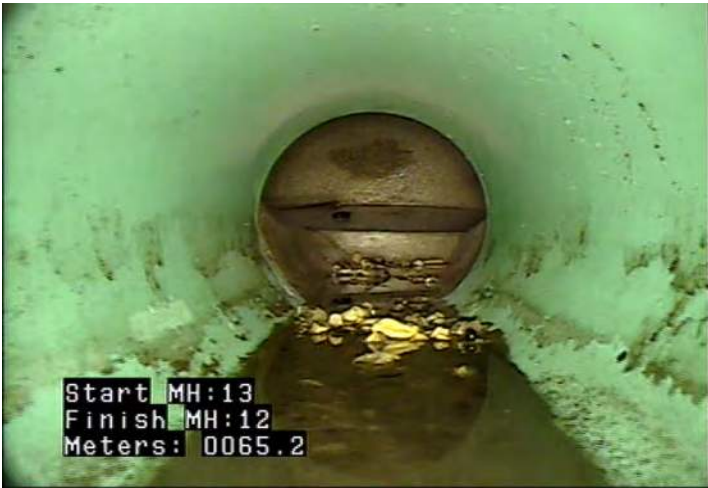
DSGV - Deposits Settled: Gravel @ 65.2 m.

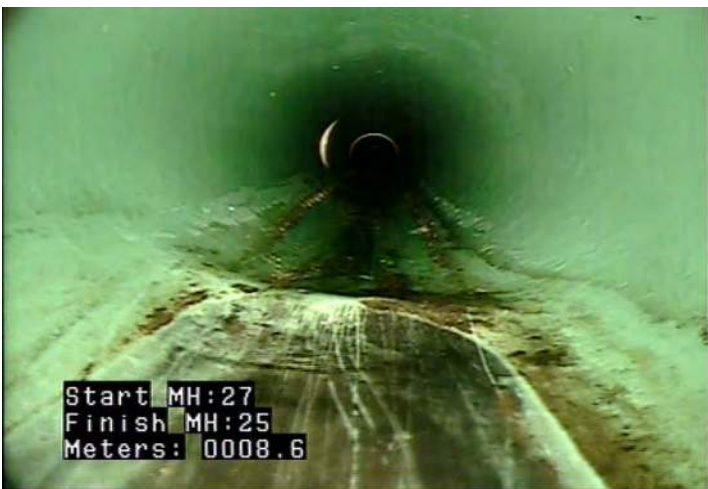
D - Pipe Deformed @ 8.6 m.

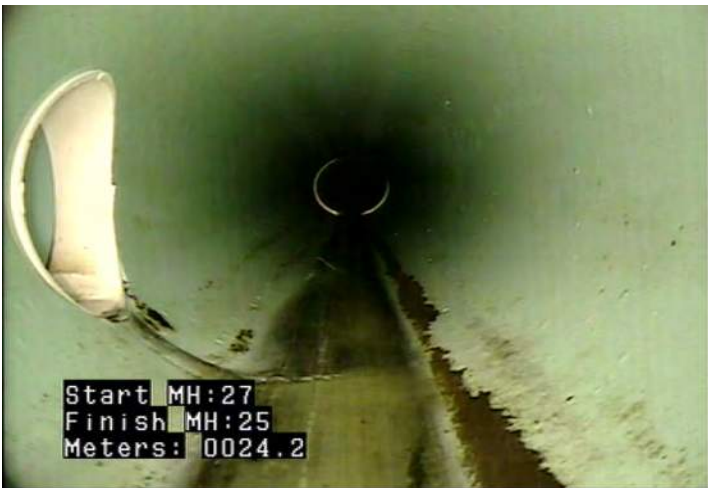
TSA - Tap, Saddle: Active @ 24.2 m.

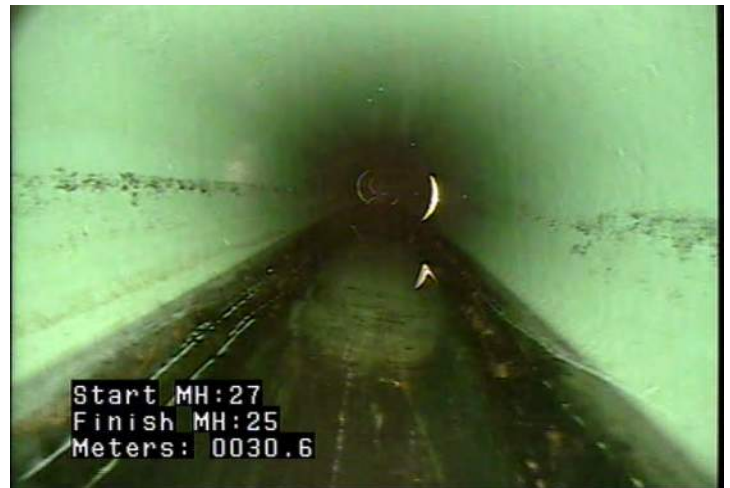
9.9		TS	Tap, Saddle	9				
24.2		TSA	Tap, Saddle: Active	9				
30.6	S02	MWLS	Water Level: Sag		10			Stain looks worse 25%
32.0		TS	Tap, Saddle	3				
32.7	F02	MWLS	Water Level: Sag		5

MWLS - Water Level: Sag @ 30.6 m.
Stain looks worse 25%

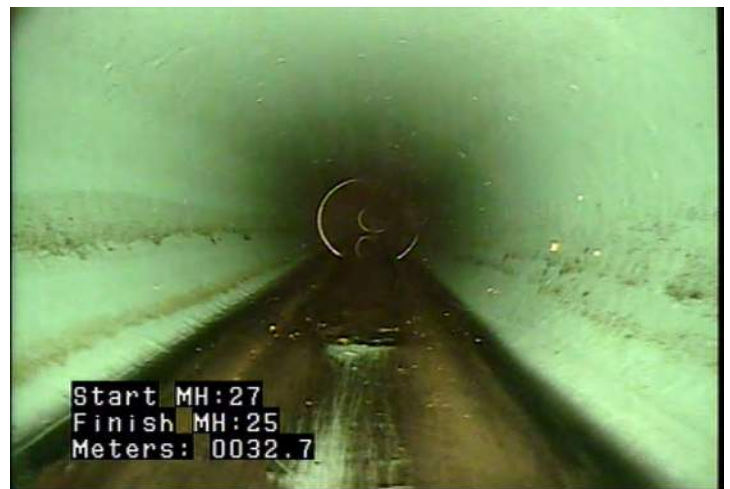
MWLS - Water Level: Sag @ 32.7 m.

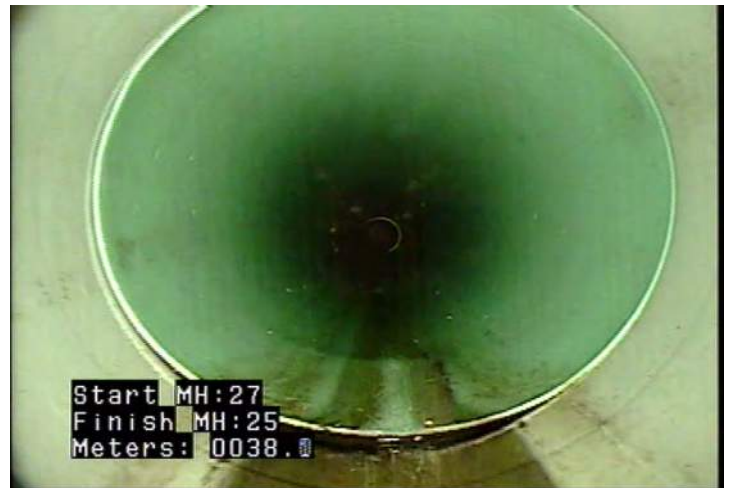
D - Pipe Deformed @ 38.0 m.

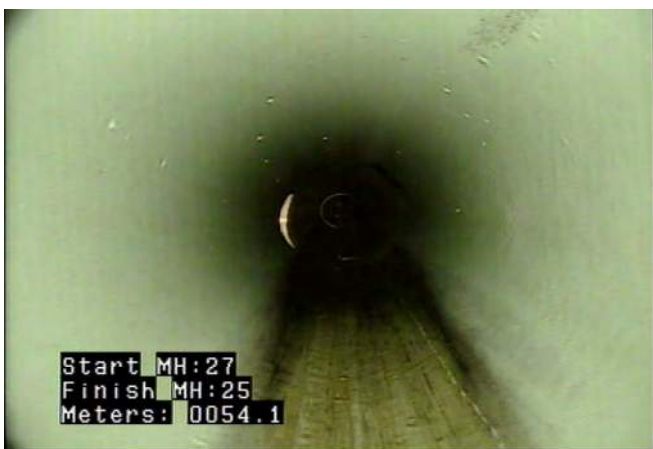
52.1		MWL	Water Level		0			
54.1		MWM	Water Mark		90			Pipe is 90% stained black from holding material from this point to MH.
55.2		TS	Tap, Saddle	9				
62.9	S01	DAGS	Deposits Attached: Grease	10 to 1	10

MWM - Water Mark @ 54.1 m. Pipe is 90% stained black from holding material from this point to MH.

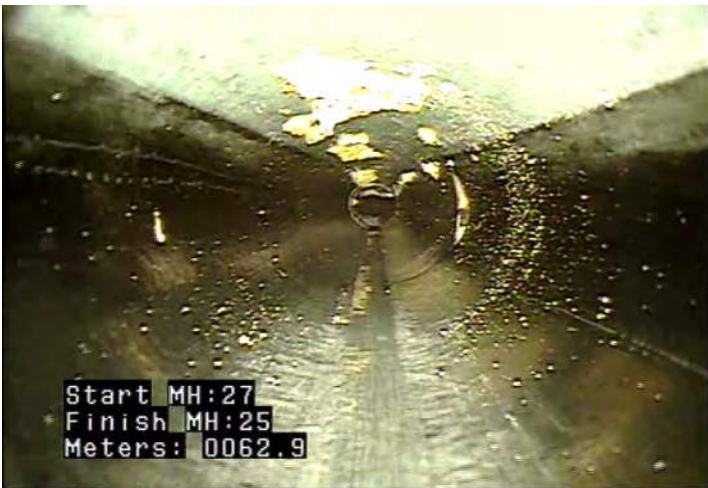
DAGS - Deposits Attached: Grease @ 62.9 m.

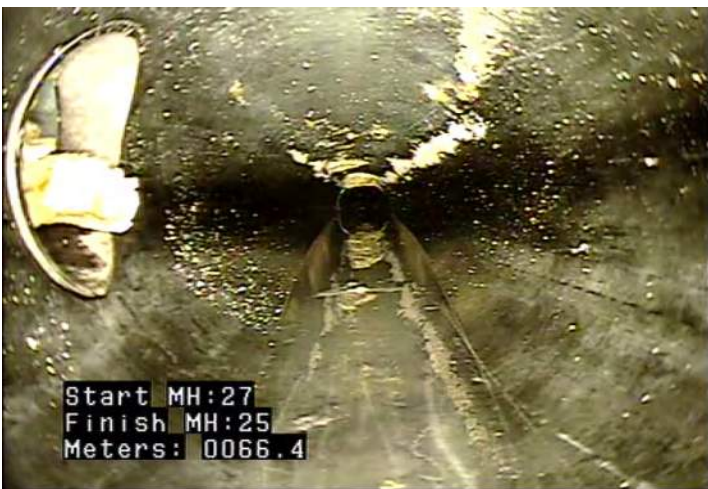
63.5		TS	Tap, Saddle	3				
66.4		TSD	Tap, Saddle: Defective	9				Full of grease.
66.7		MWLS	Water Level: Sag		25			
71.4		MWL	Water Level		0			
73.2	F01	DAGS	Deposits Attached: Grease	10 to 1	10

TSD - Tap, Saddle: Defective @ 66.4 m.
Full of grease.

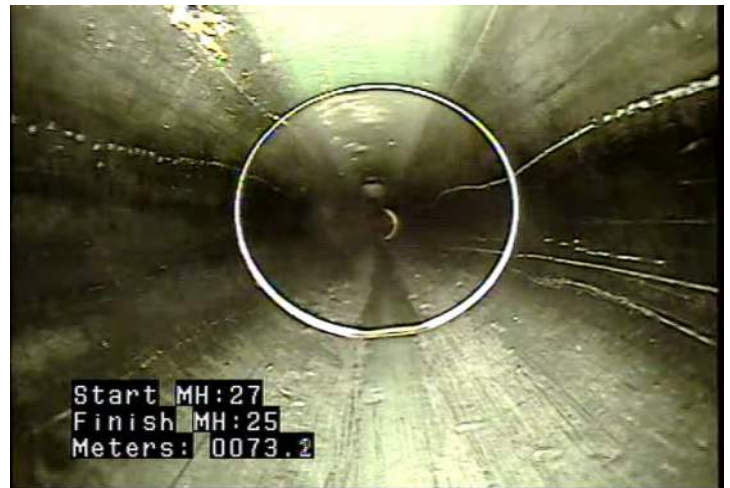
DAGS - Deposits Attached: Grease @ 73.2 m.

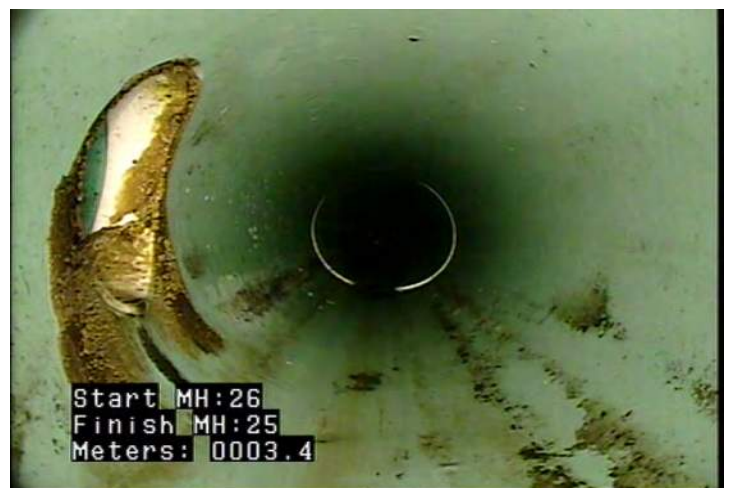
DAE - Deposits Attached: Encrustation @ 3.4 m. Around service.

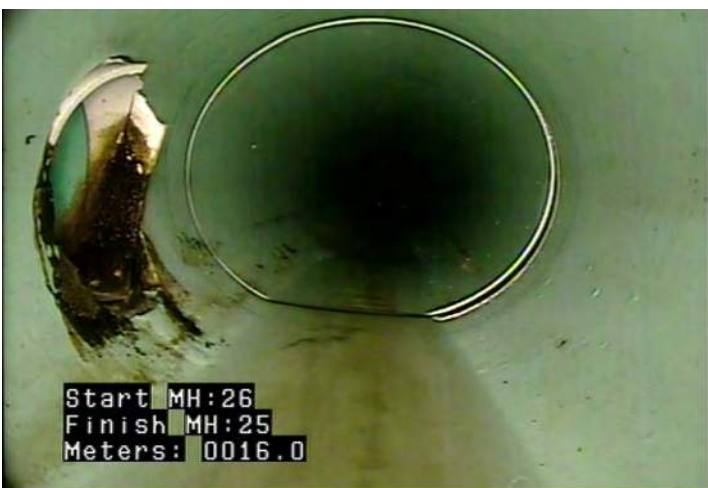
DAE - Deposits Attached: Encrustation @ 16.0 m.

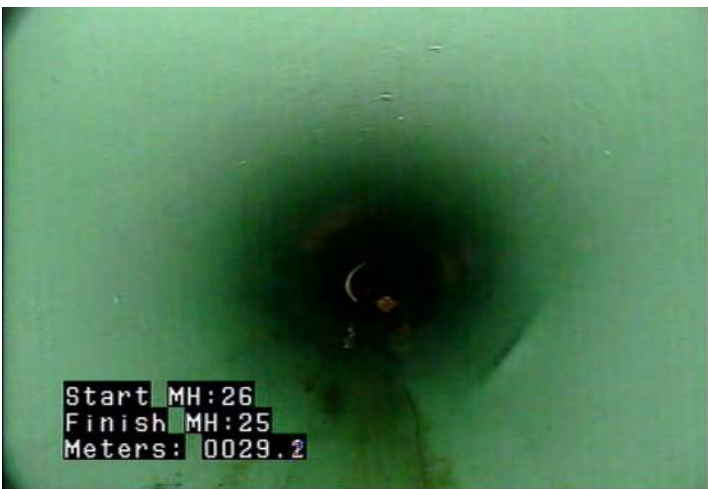
D - Pipe Deformed @ 29.2 m.

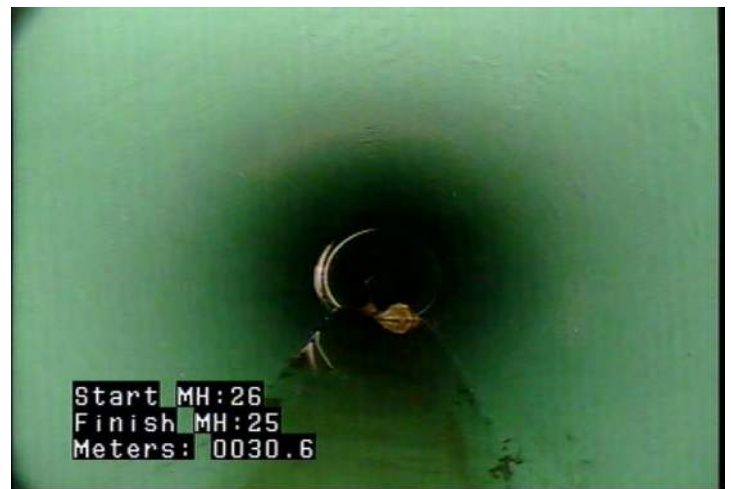
MWLS - Water Level: Sag @ 30.6 m.

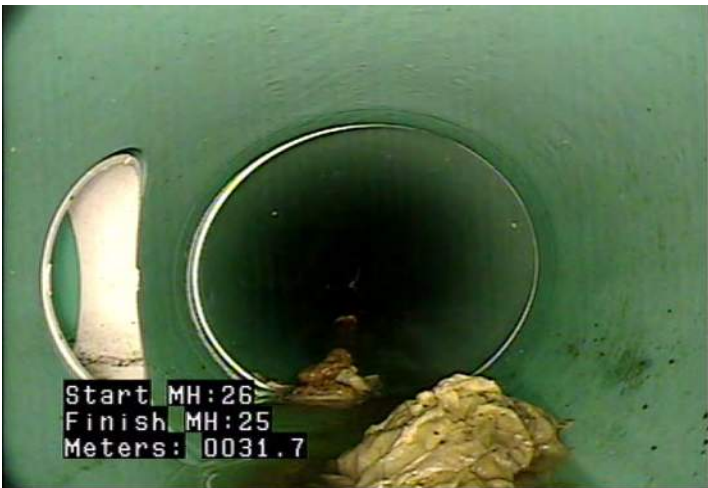
D - Pipe Deformed @ 31.7 m. Oval

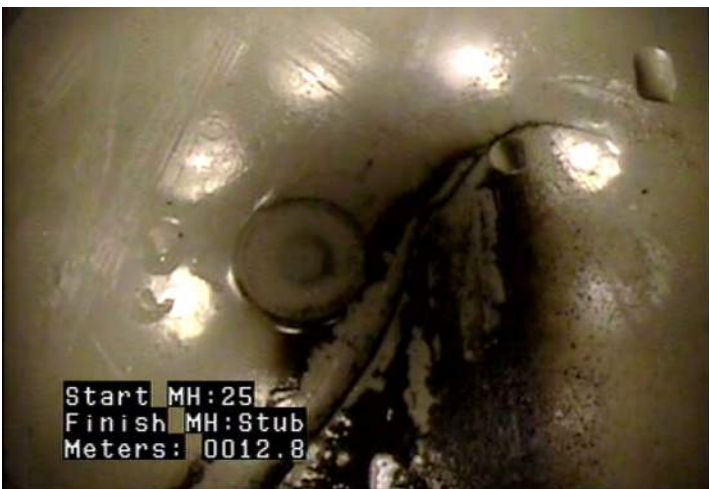
AEP - Access Point - End of Pipe @ 12.8 m. Stub - Crack in cap.

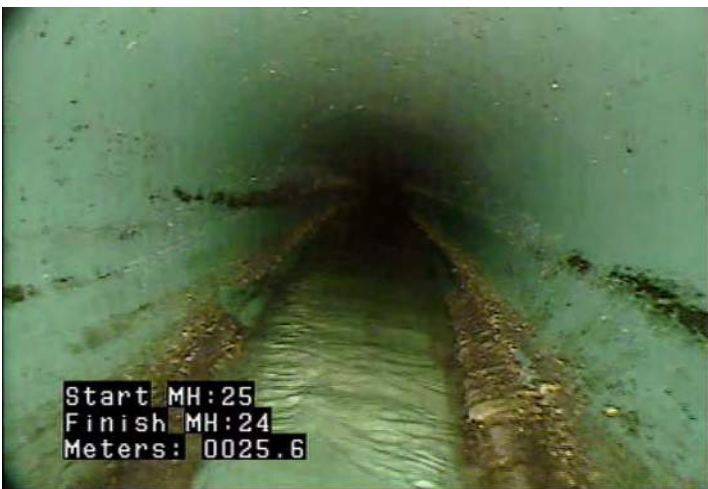
MWLS - Water Level: Sag @ 25.6 m.

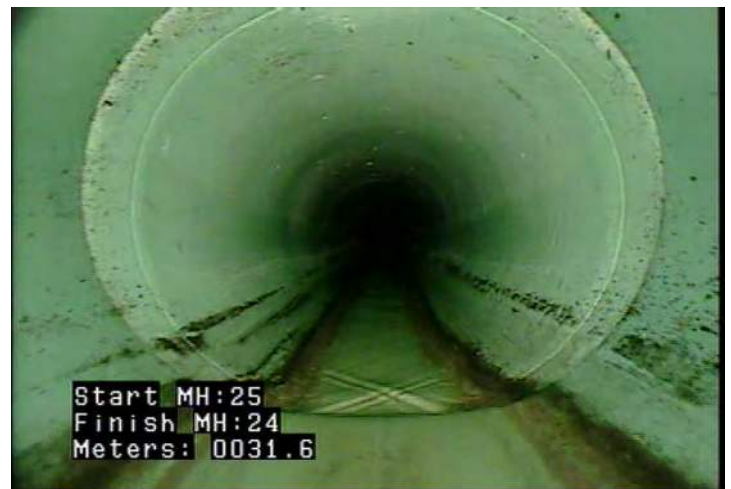
MWLS - Water Level: Sag @ 31.6 m.

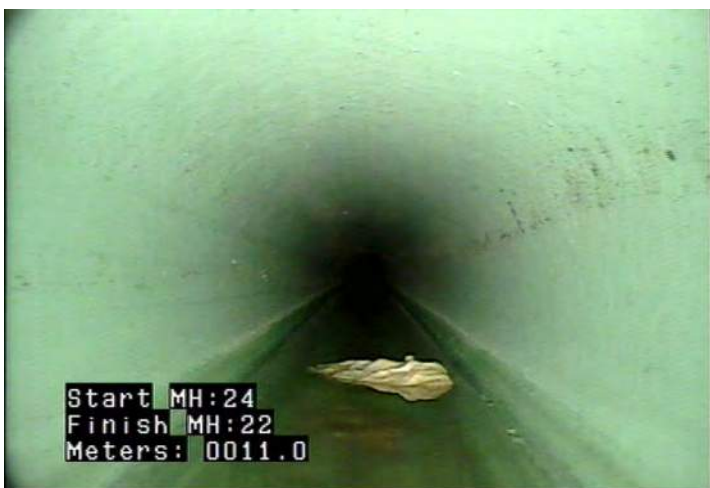
MWLS - Water Level: Sag @ 11.0 m.

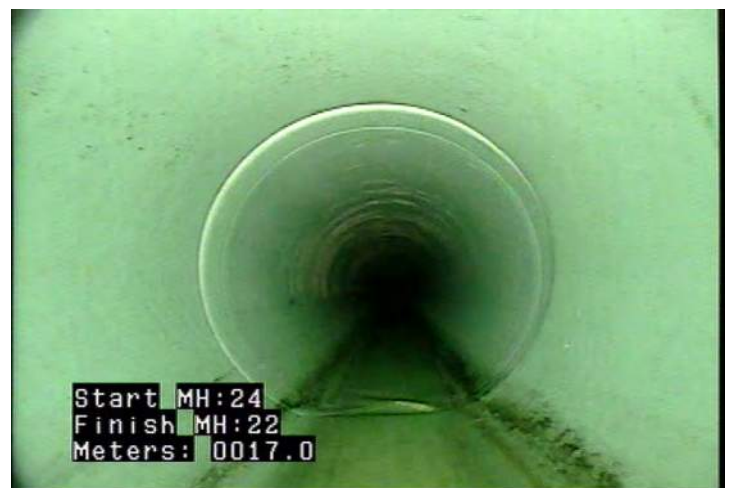
MWLS - Water Level: Sag @ 17.0 m.

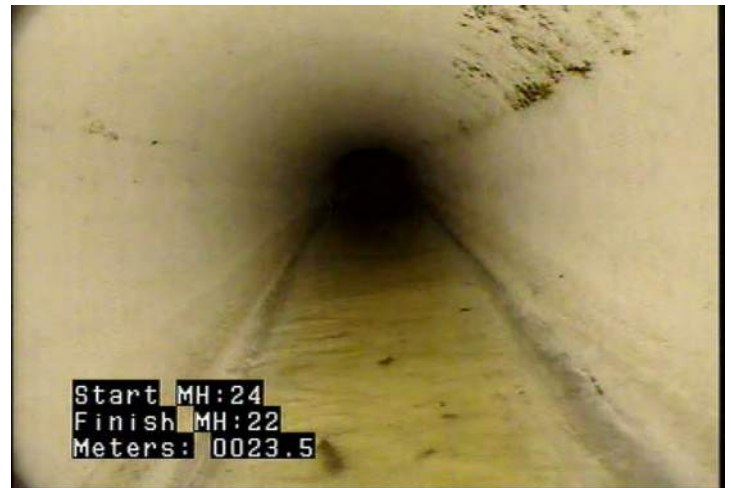
MWLS - Water Level: Sag @ 23.5 m.

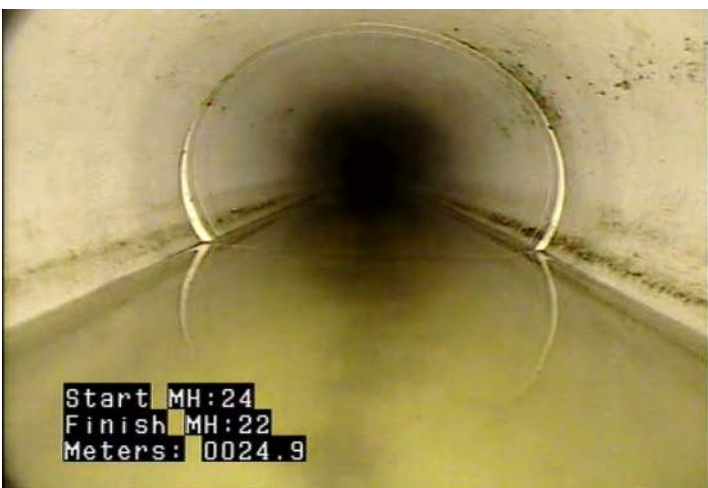
D - Pipe Deformed @ 24.9 m.

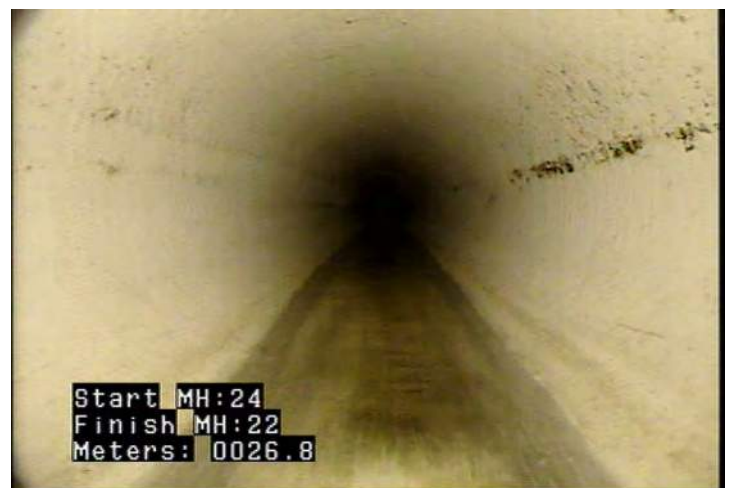
MWLS - Water Level: Sag @ 26.8 m.

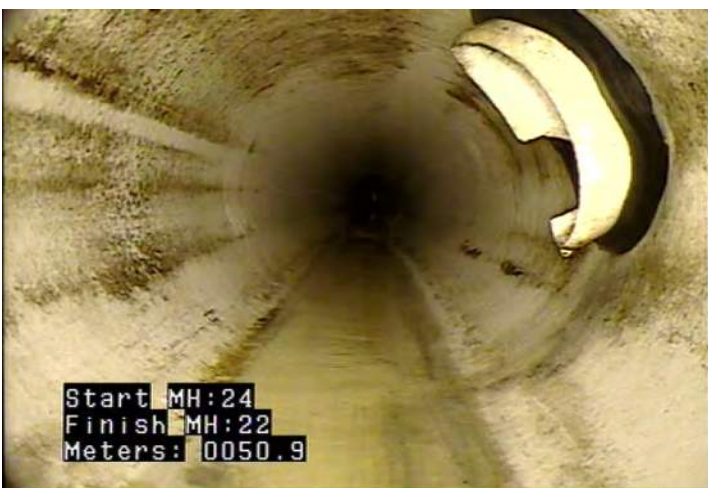
TSI - Tap, Saddle: Intruding @ 50.9 m.
Broken
