Appendix F CCTV Assessment

Client: CIMA
 Project: Pre-Rehabilitation Survey
 Date: 12/18/2020
 File: 14257

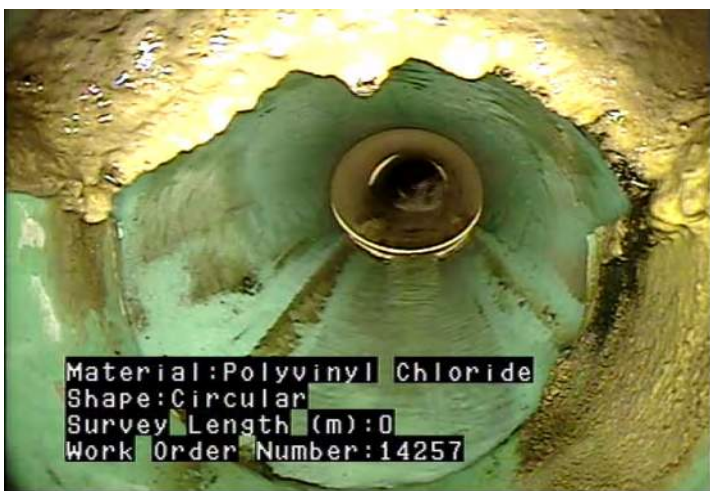
DAE - Deposits Attached: Encrustation @ 0.0 m. At pipe opening

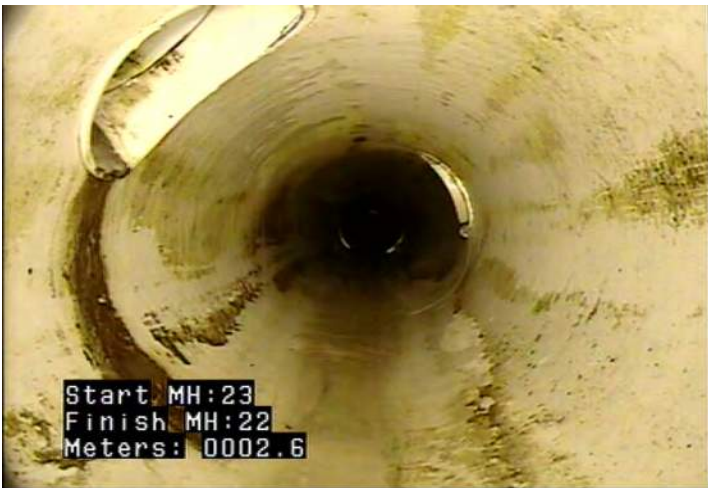
TS - Tap, Saddle @ 2.6 m.

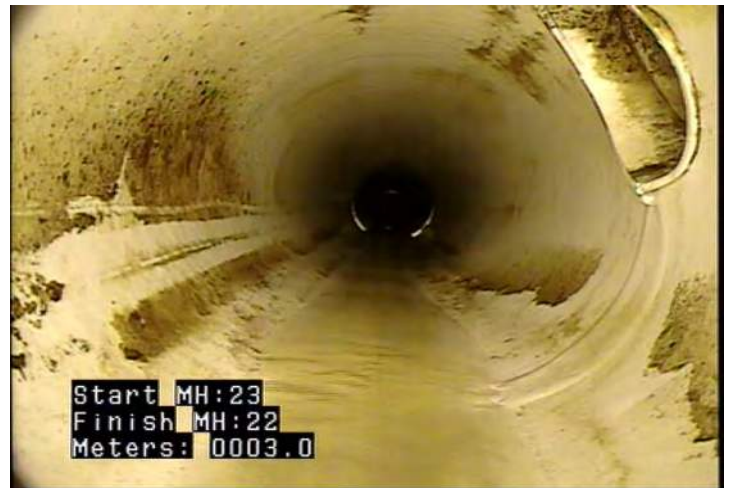
TSA - Tap, Saddle: Active @ 3.0 m.

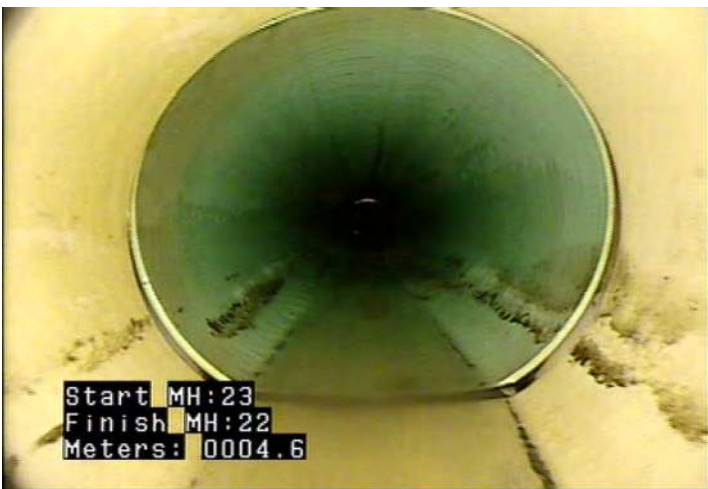
MMC - Material Change @ 4.6 m. White to Blue PVC

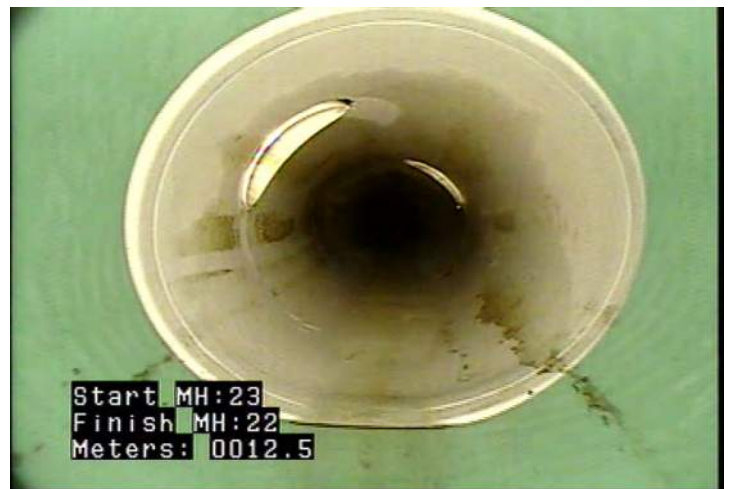
MMC - Material Change @ 12.5 m. Blue to White PVC

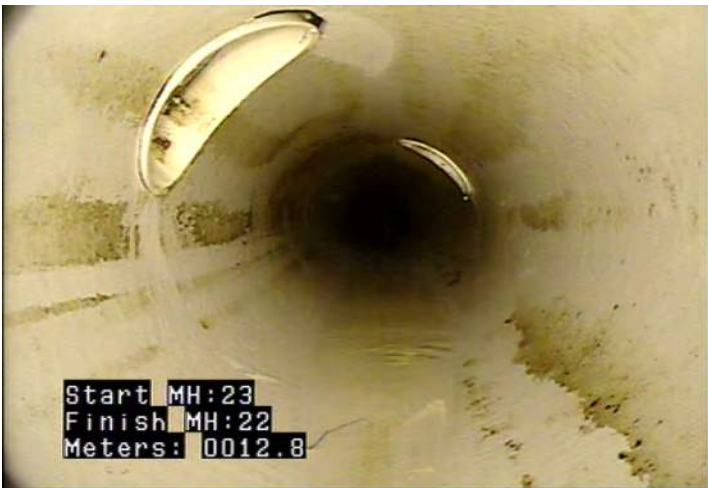
TS - Tap, Saddle @ 12.8 m.

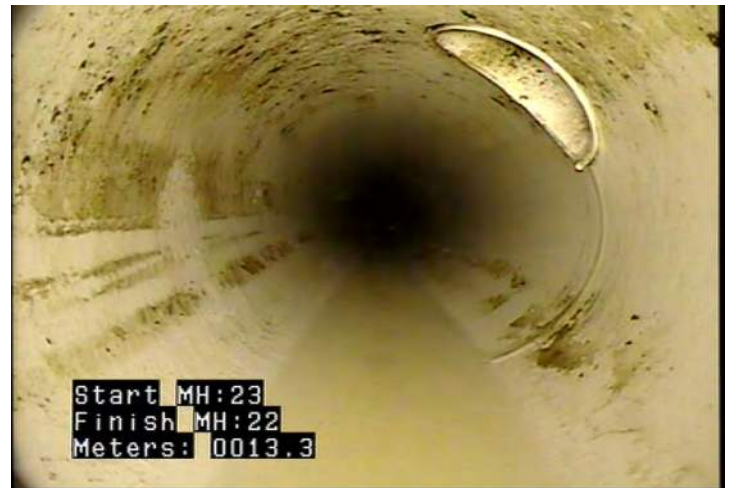
TS - Tap, Saddle @ 13.3 m.

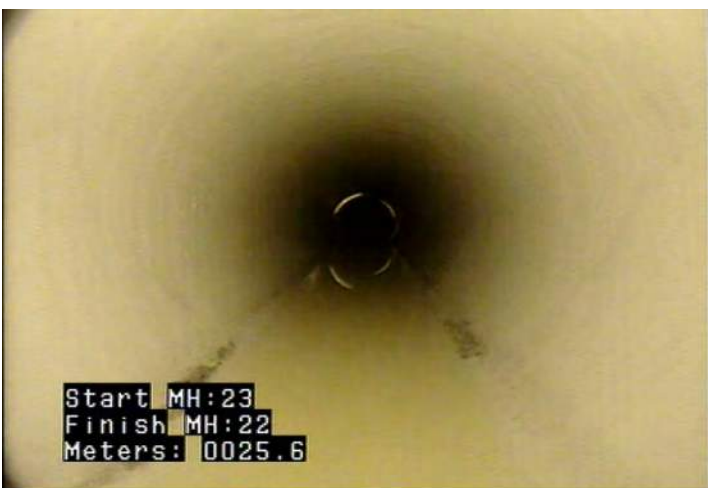
MWLS - Water Level: Sag @ 25.6 m.

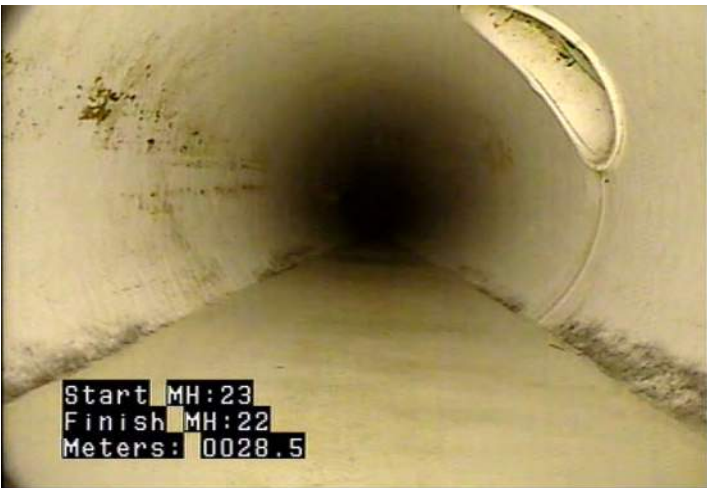
TS - Tap, Saddle @ 28.5 m.

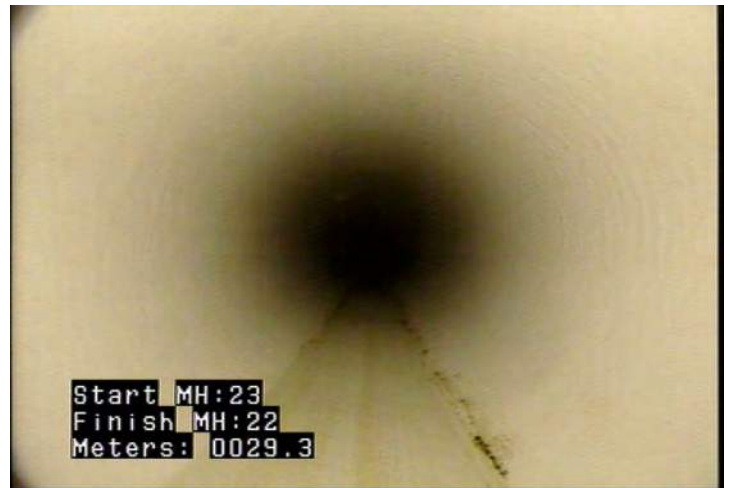
MWLS - Water Level: Sag @ 29.3 m.

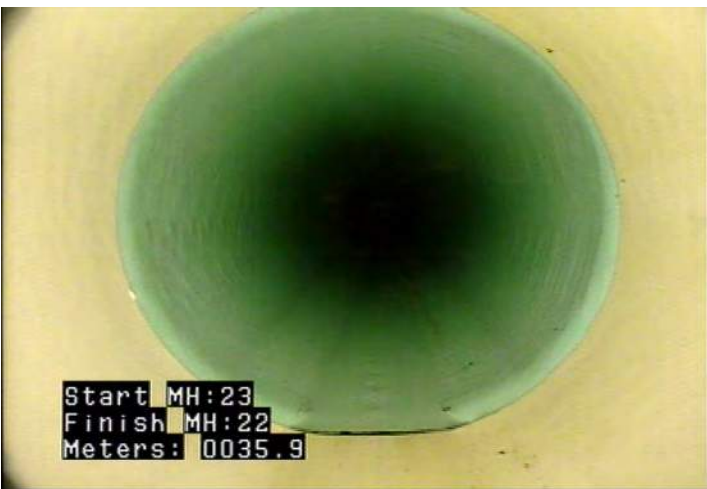
MMC - Material Change @ 35.9 m. White to Blue PVC

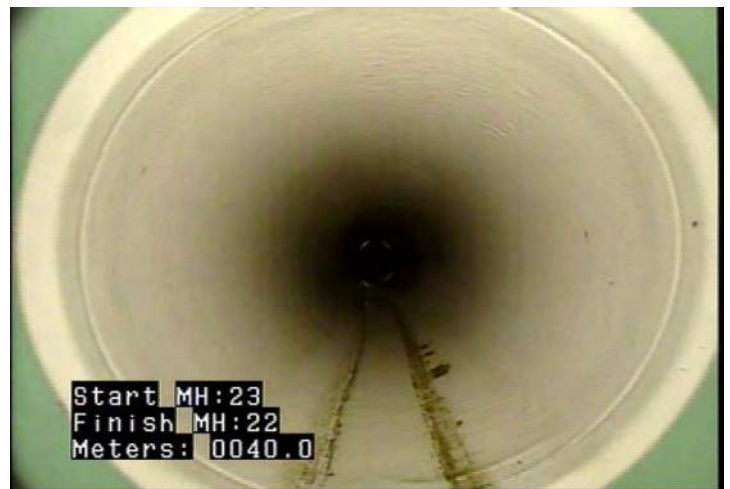
MMC - Material Change @ 40.0 m. Blue to White PVC

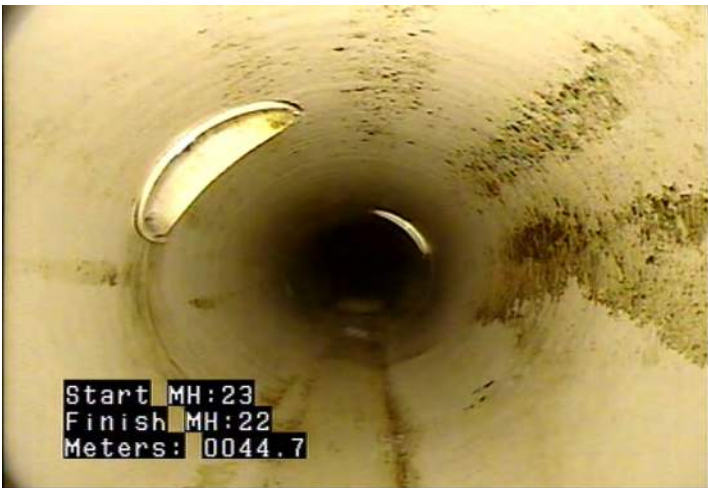
TS - Tap, Saddle @ 44.7 m.

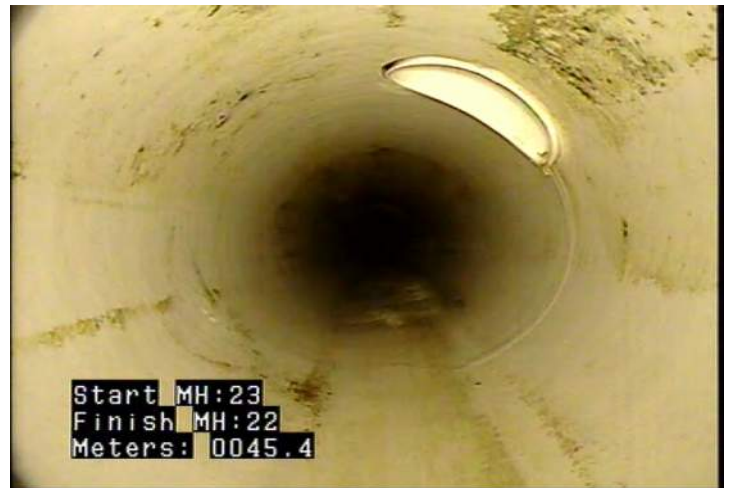
TS - Tap, Saddle @ 45.4 m.

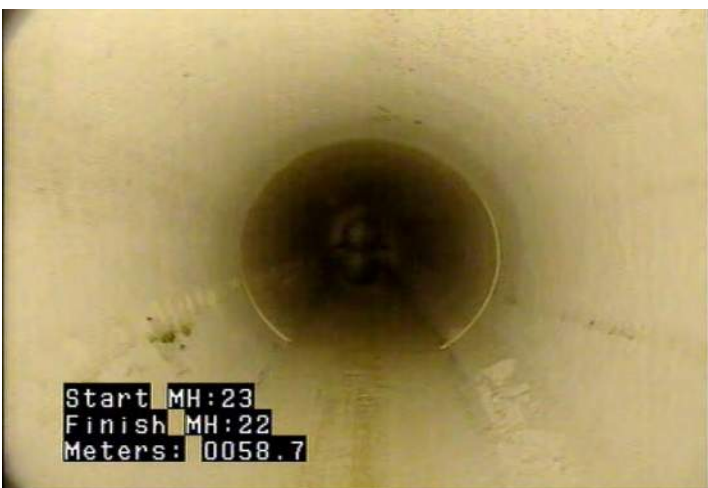
MWL - Water Level @ 58.7 m.

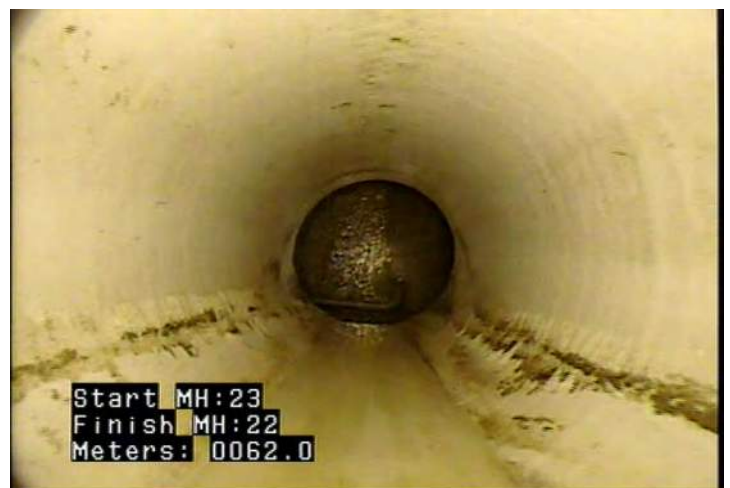
MWL - Water Level @ 62.0 m.

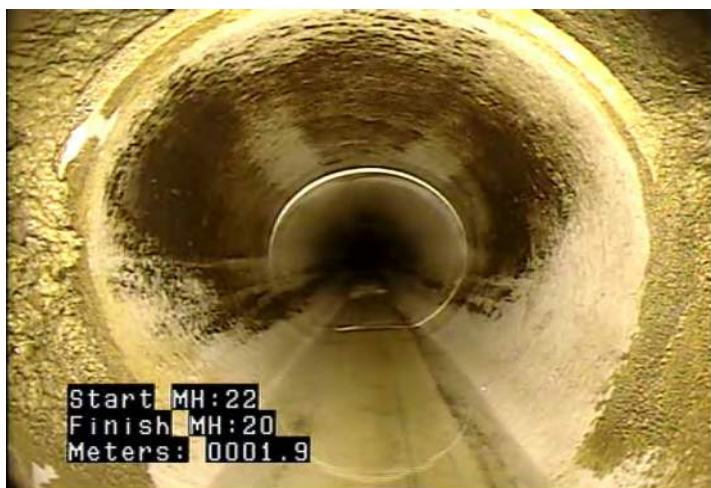
MWL - Water Level @ 0.0 m.

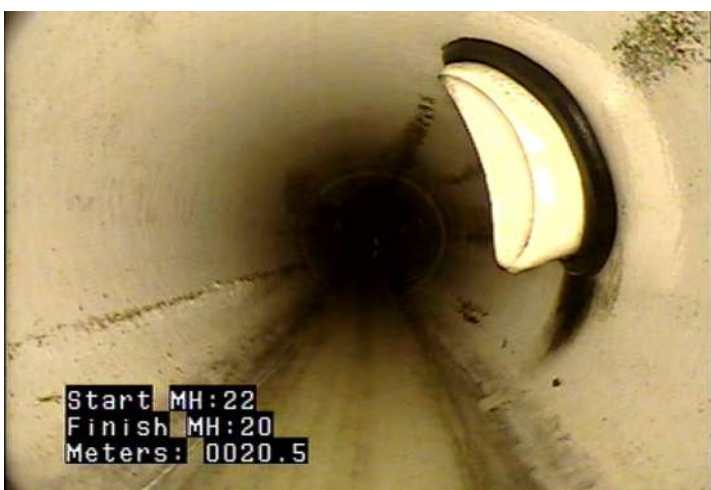
TSI - Tap, Saddle: Intruding @ 20.5 m.

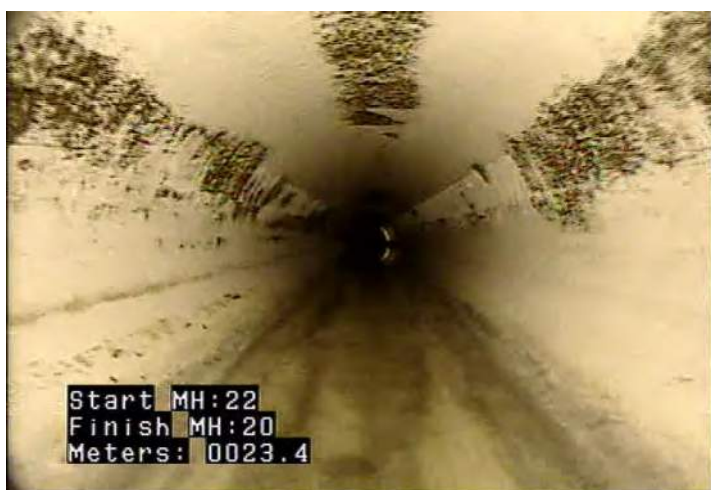
MWLS - Water Level: Sag @ 23.4 m.

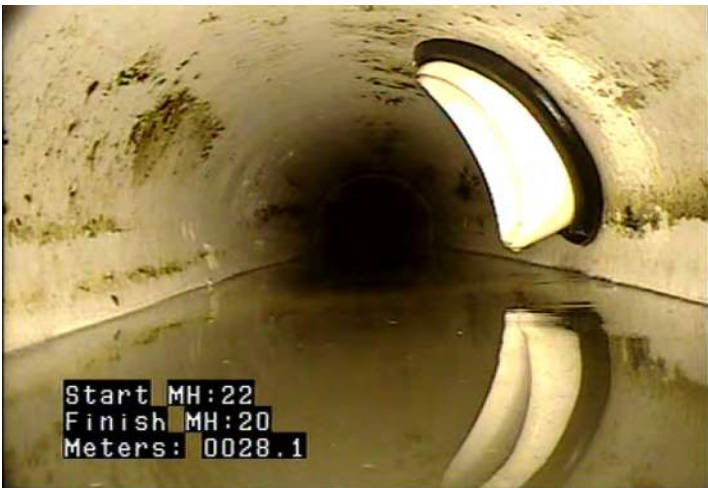
TSI - Tap, Saddle: Intruding @ 28.1 m.

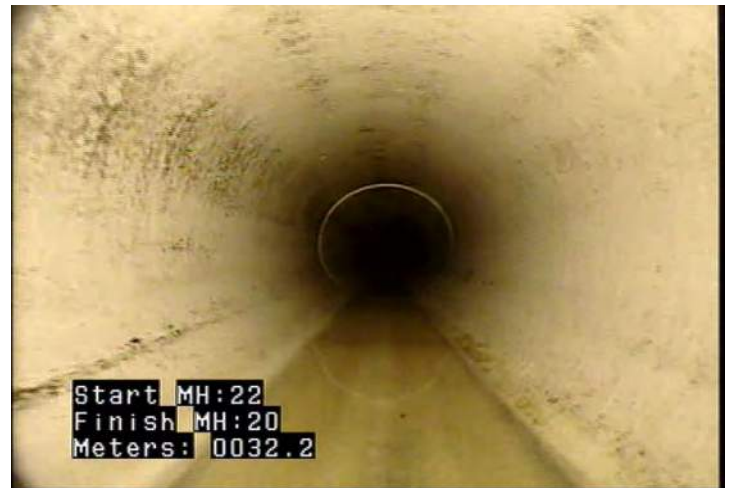
MWLS - Water Level: Sag @ 32.2 m.

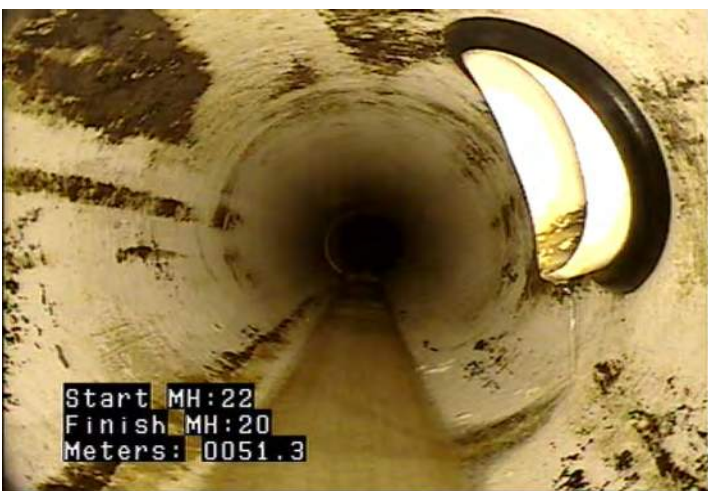
TSI - Tap, Saddle: Intruding @ 51.3 m.

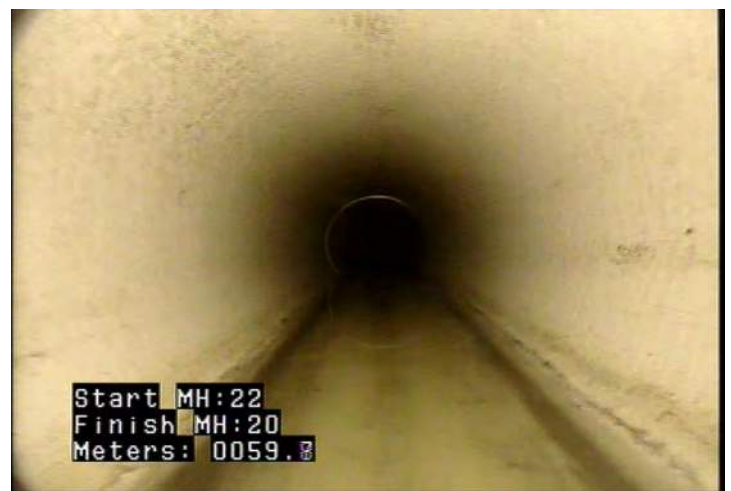
MWLS - Water Level: Sag @ 59.7 m.

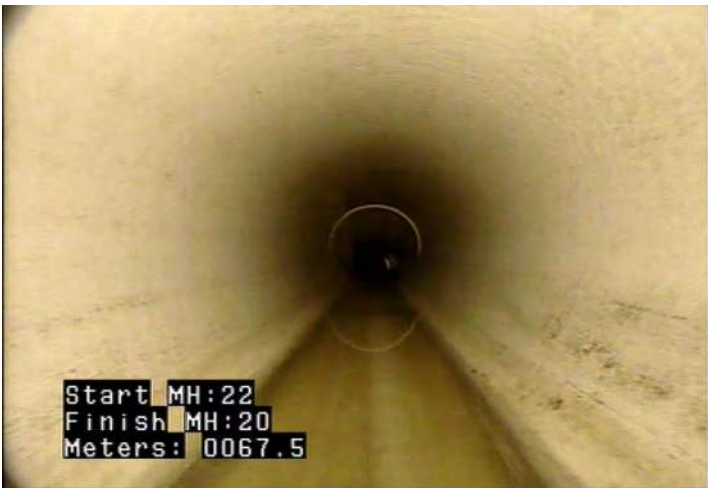
MWLS - Water Level: Sag @ 67.5 m.

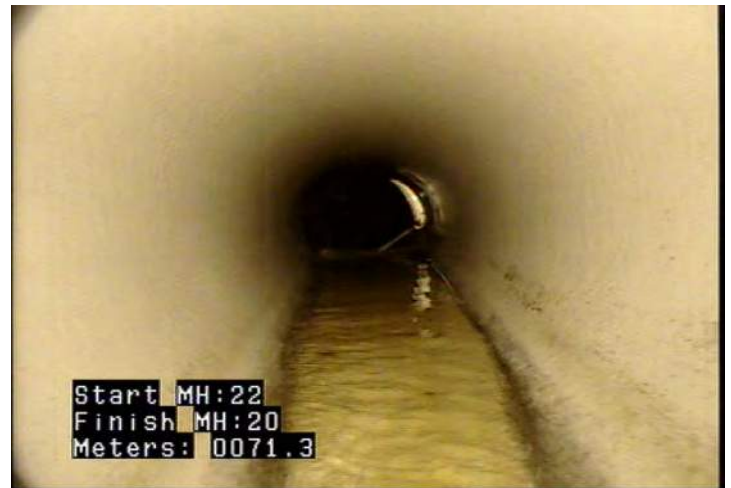
MWLS - Water Level: Sag @ 71.3 m.

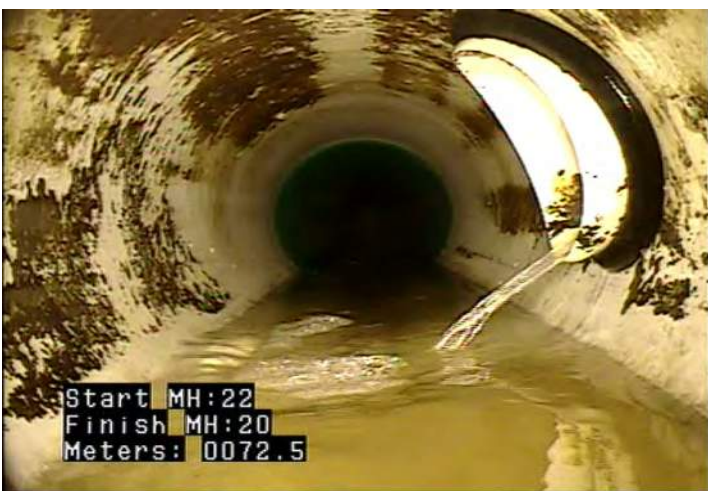
TSI - Tap, Saddle: Intruding @ 72.5 m.

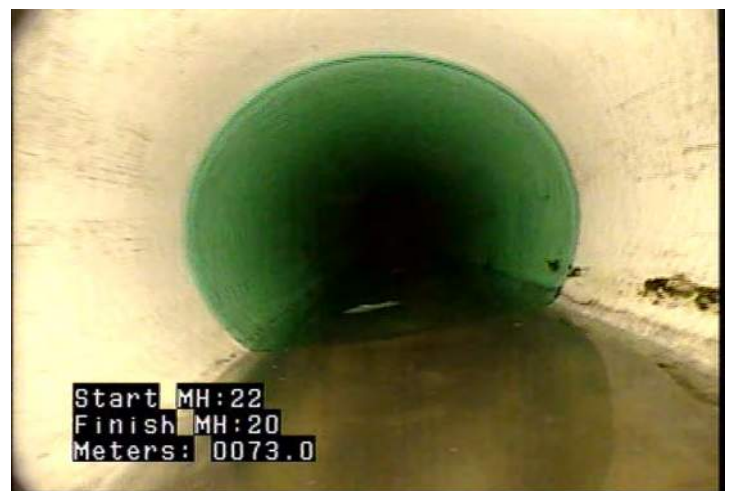
MMC - Material Change @ 73.0 m. White to Blue PVC

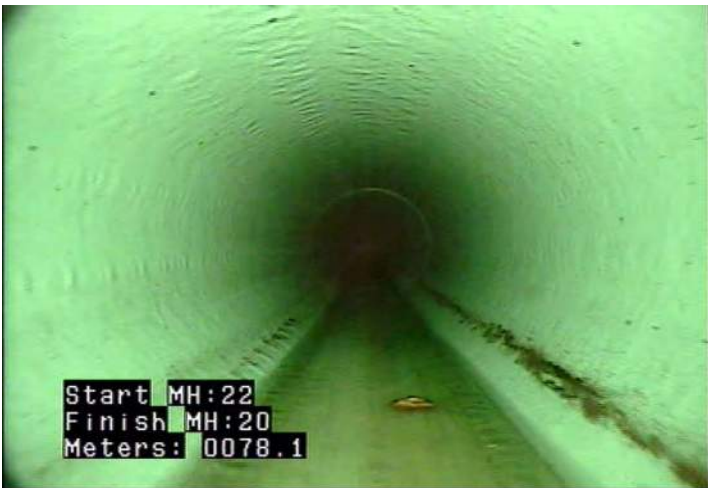
MWLS - Water Level: Sag @ 78.1 m.

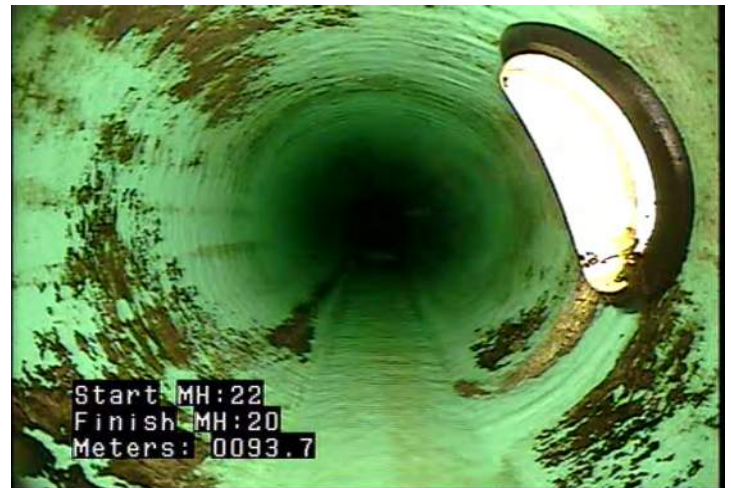
TS - Tap, Saddle @ 93.7 m.

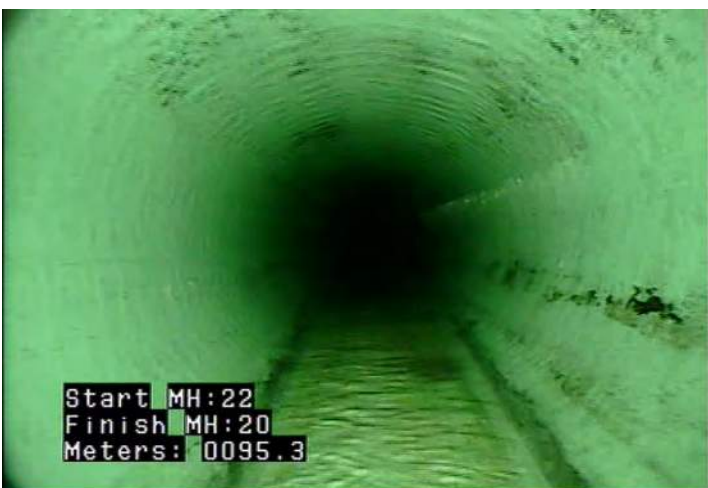
MWL - Water Level @ 95.3 m.

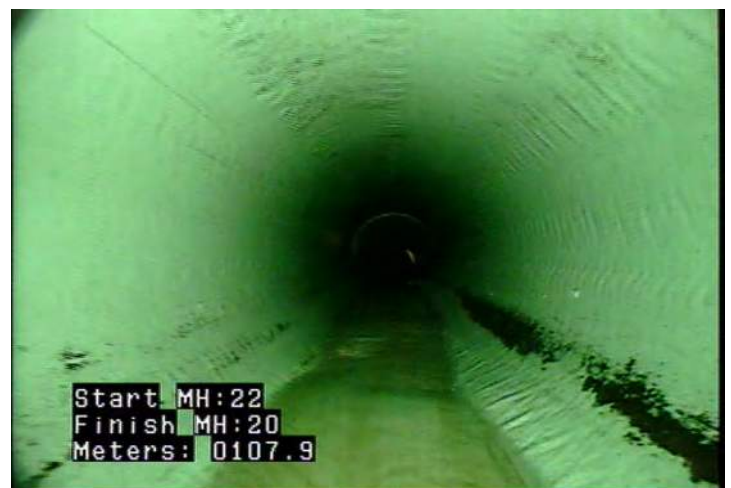
MWL - Water Level @ 107.9 m.

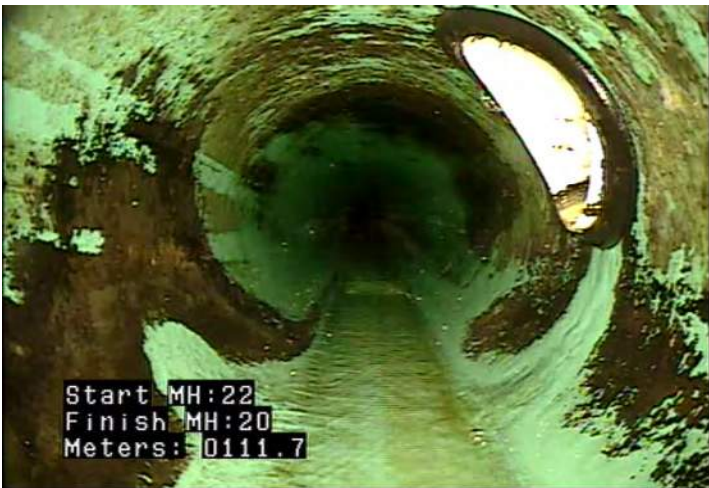
TS - Tap, Saddle @ 111.7 m.

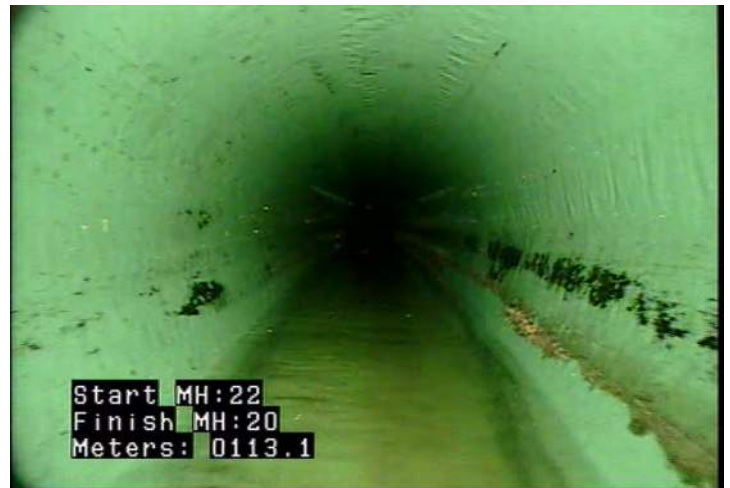
MWLS - Water Level: Sag @ 113.1 m.

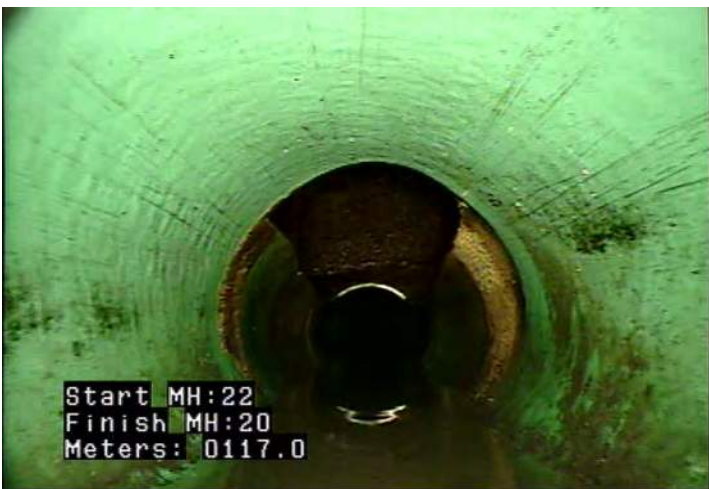
MWL - Water Level @ 117.0 m.

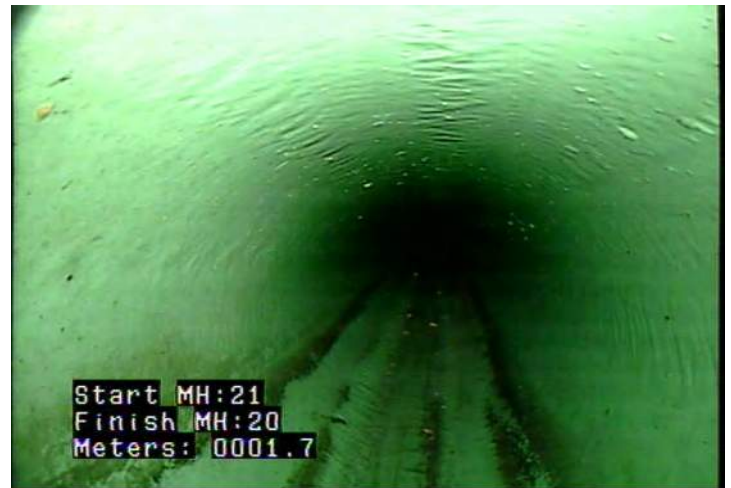
MWL - Water Level @ 0.0 m.

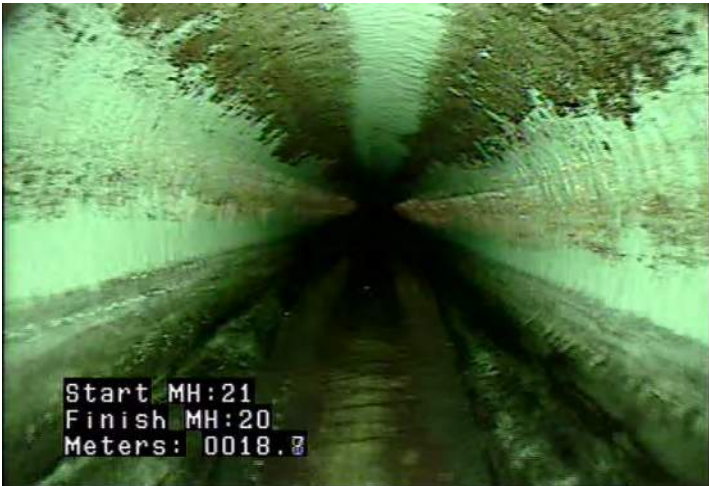
MWLS - Water Level: Sag @ 18.7 m.

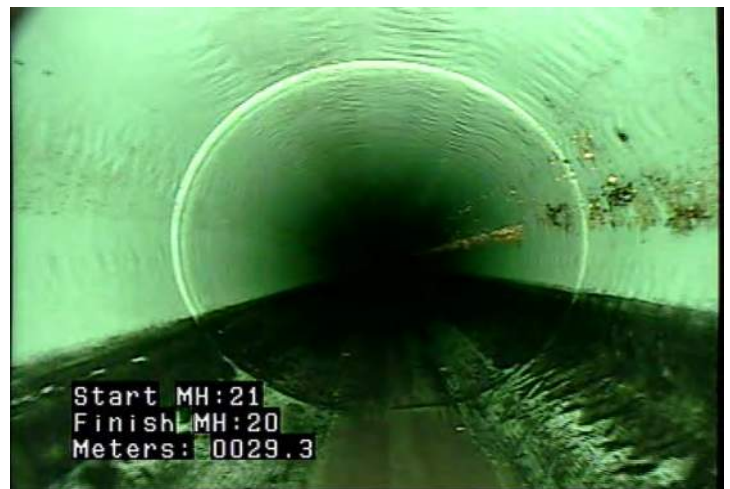
MWLS - Water Level: Sag @ 29.3 m.

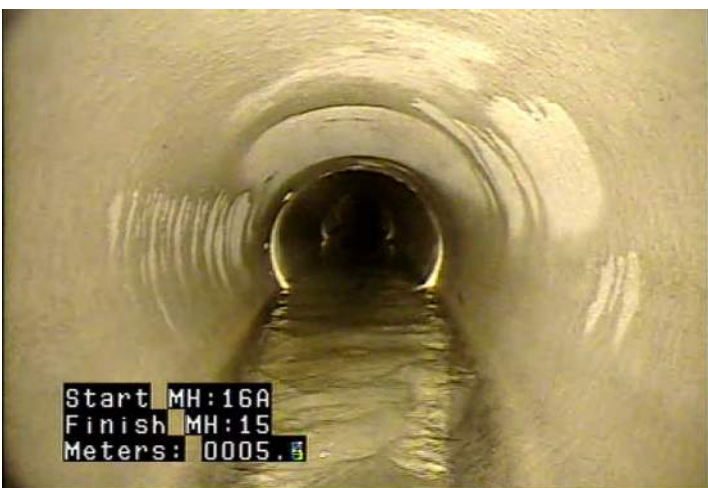
MWLS - Water Level: Sag @ 5.5 m.

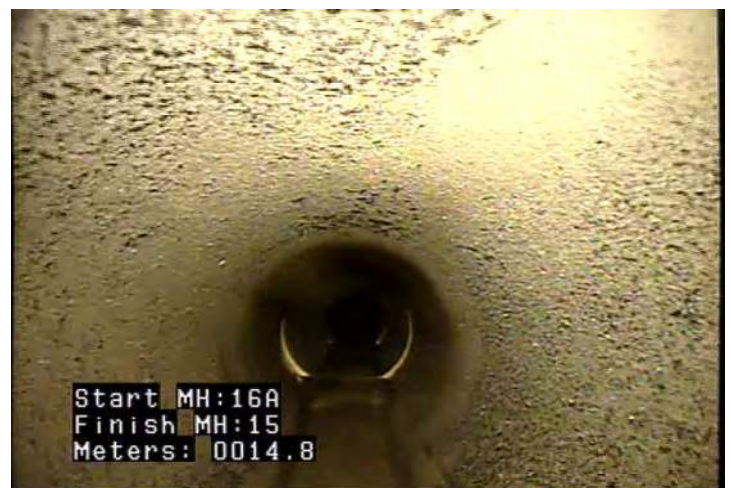
MWLS - Water Level: Sag @ 14.8 m.

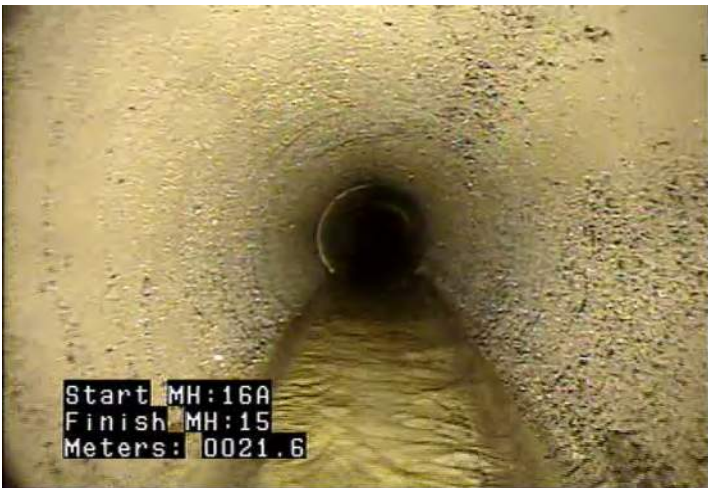
MWLS - Water Level: Sag @ 21.6 m.

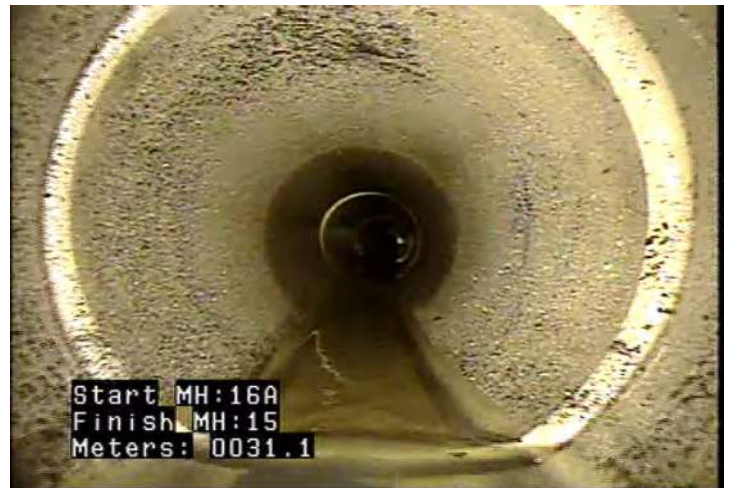
MWLS - Water Level: Sag @ 31.1 m.

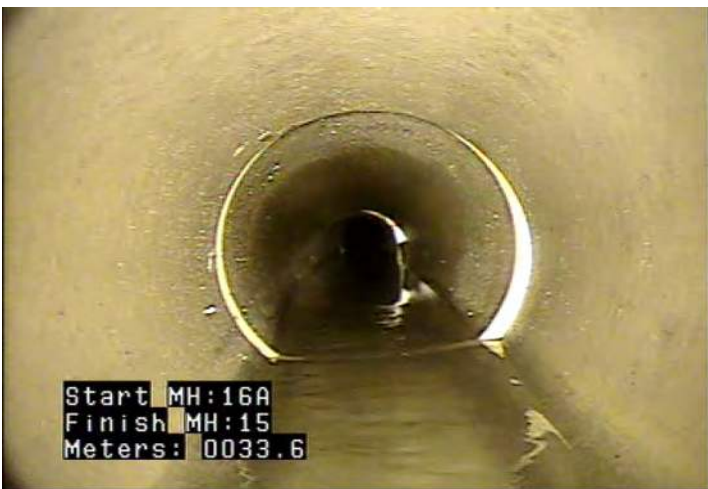
MWLS - Water Level: Sag @ 33.6 m.

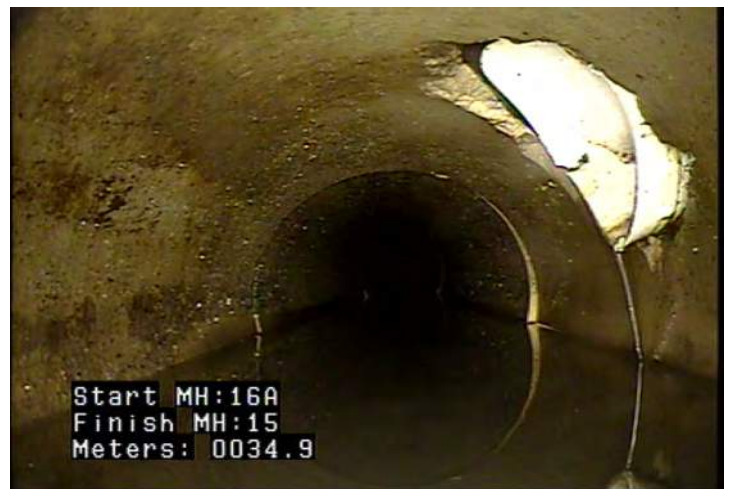
TB - Tap, Break-in / Hammer @ 34.9 m.

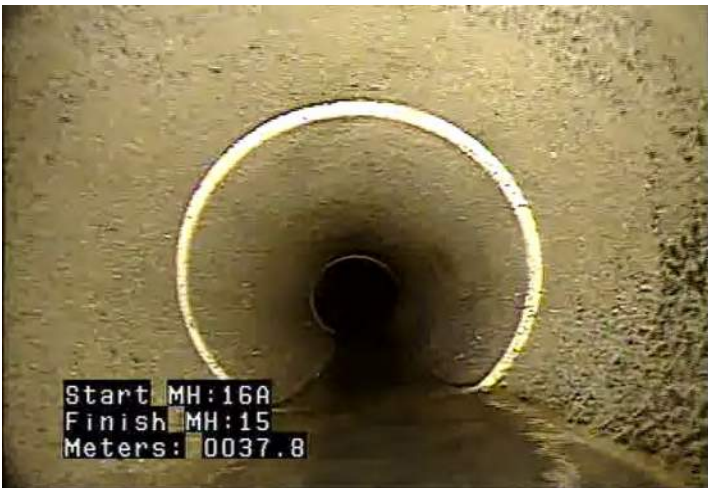
MWLS - Water Level: Sag @ 37.8 m.

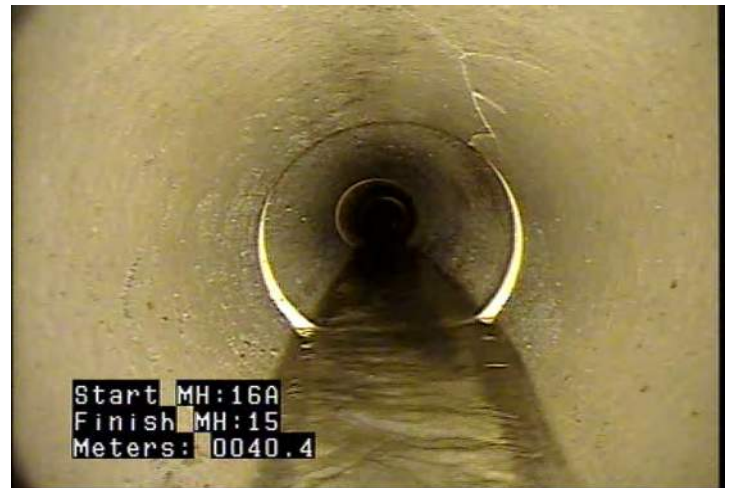
CL - Crack Longitudinal @ 40.4 m.

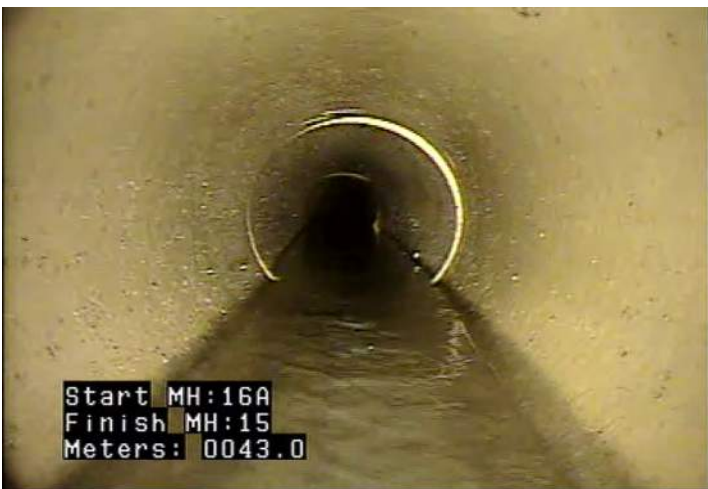
MWLS - Water Level: Sag @ 43.0 m.

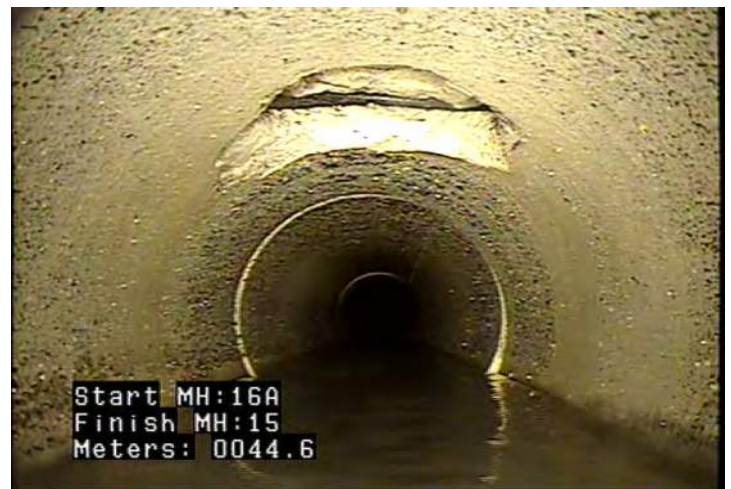
TB - Tap, Break-in / Hammer @ 44.6 m.

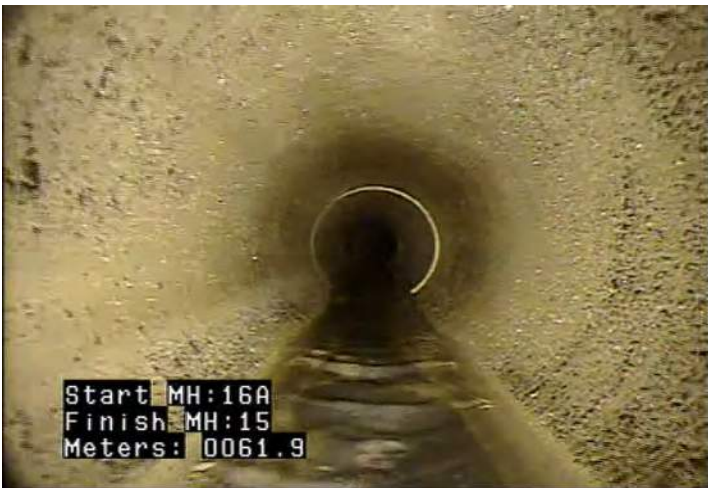
MWLS - Water Level: Sag @ 61.9 m.

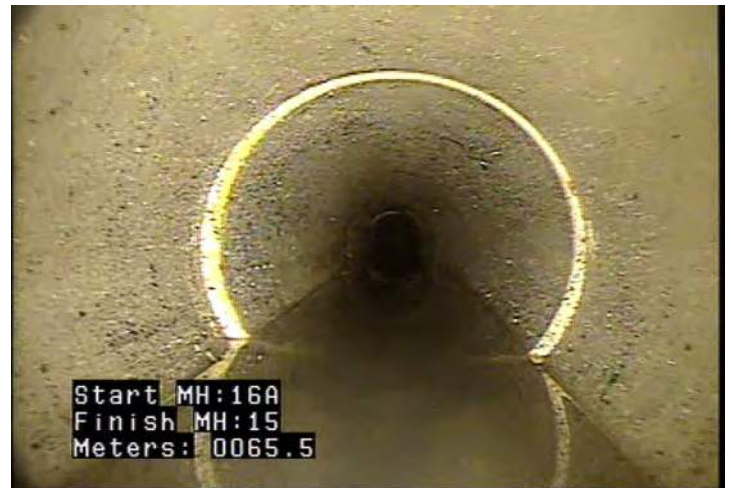
MWLS - Water Level: Sag @ 65.5 m.

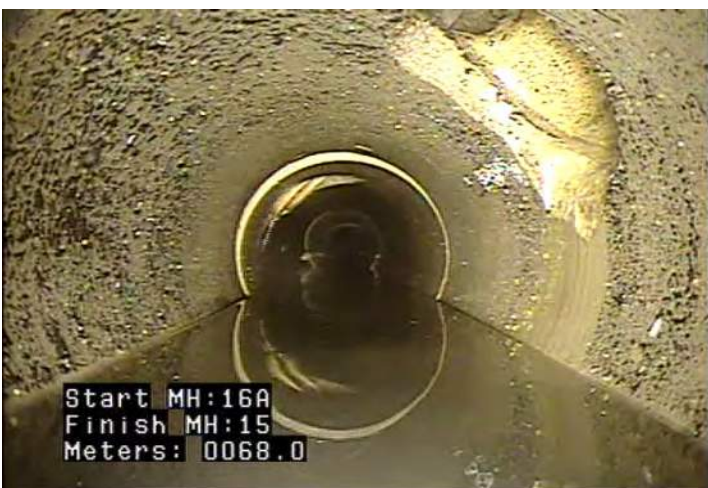
TB - Tap, Break-in / Hammer @ 68.0 m.

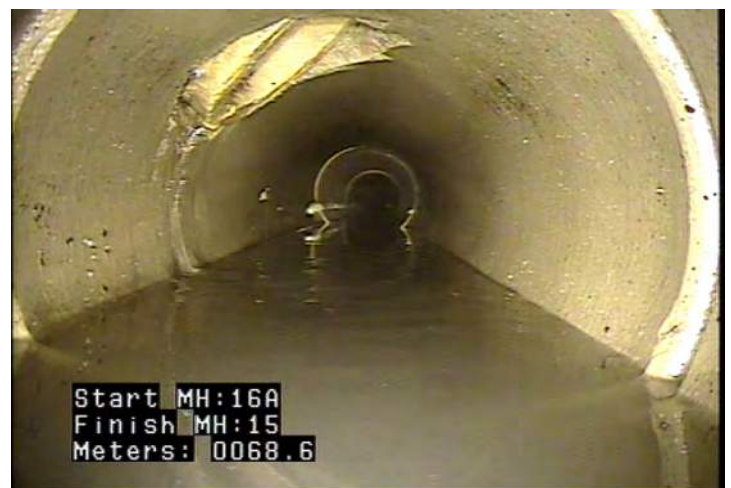
TB - Tap, Break-in / Hammer @ 68.6 m.

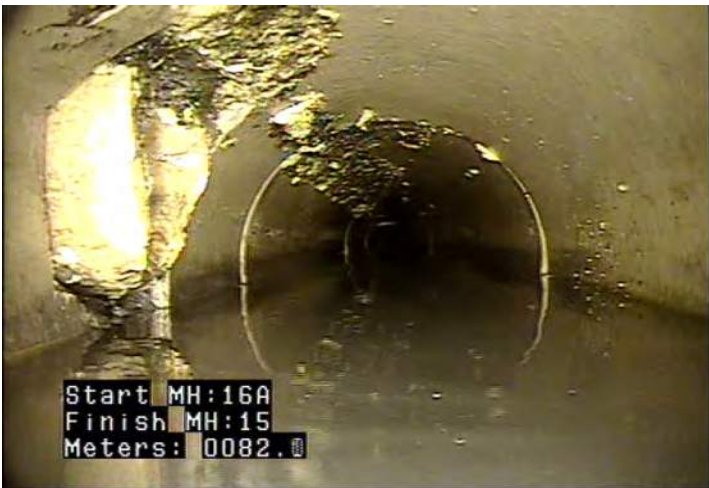
DAGS - Deposits Attached: Grease @ 82.0 m.

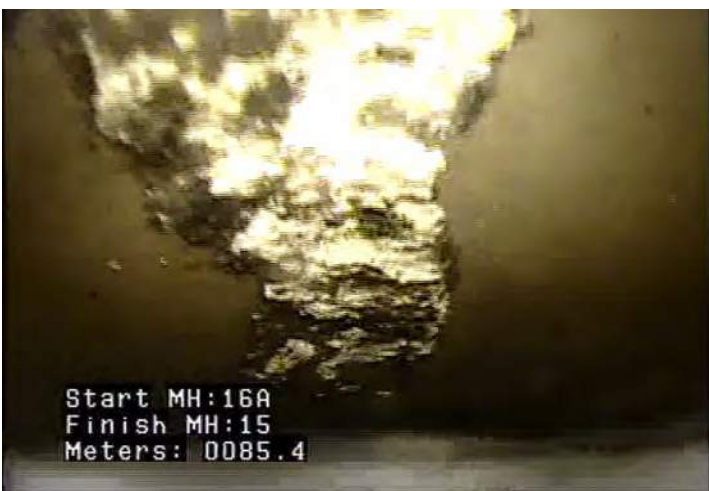
DAGS - Deposits Attached: Grease @ 85.6 m.

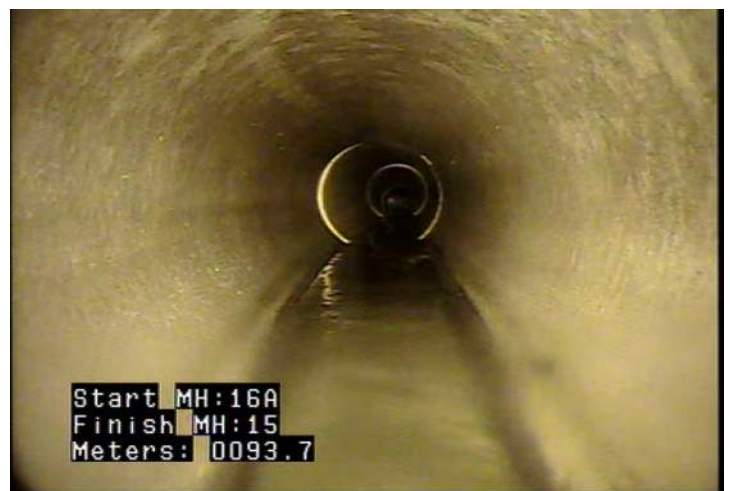
MWLS - Water Level: Sag @ 93.7 m.

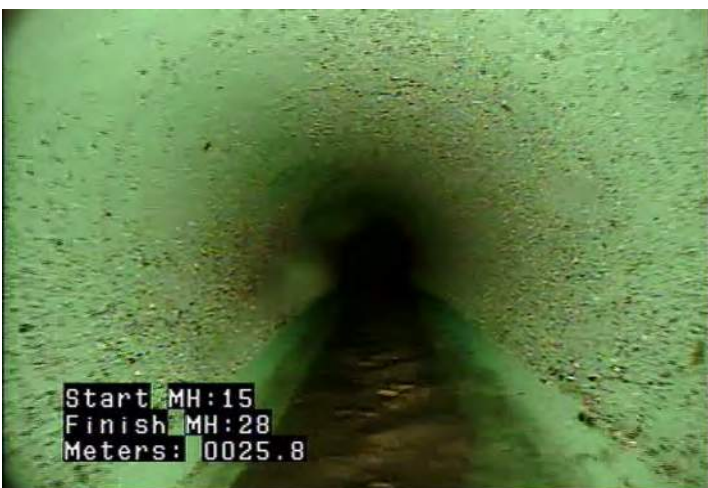
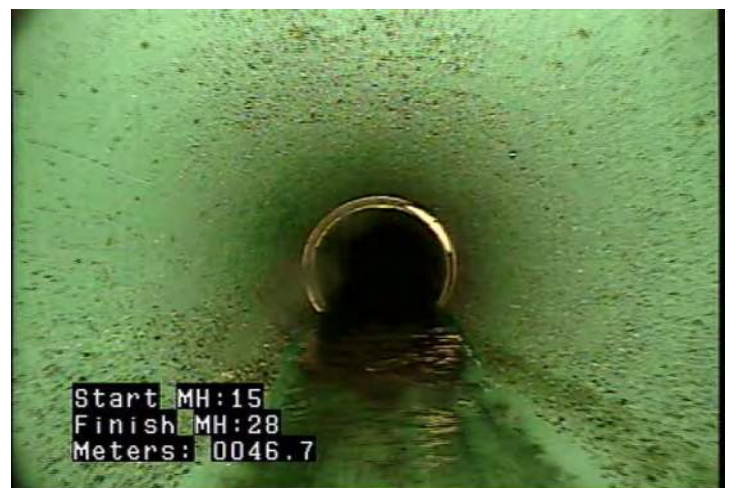
DSF - Deposits Settled: Fine @ 25.8 m.

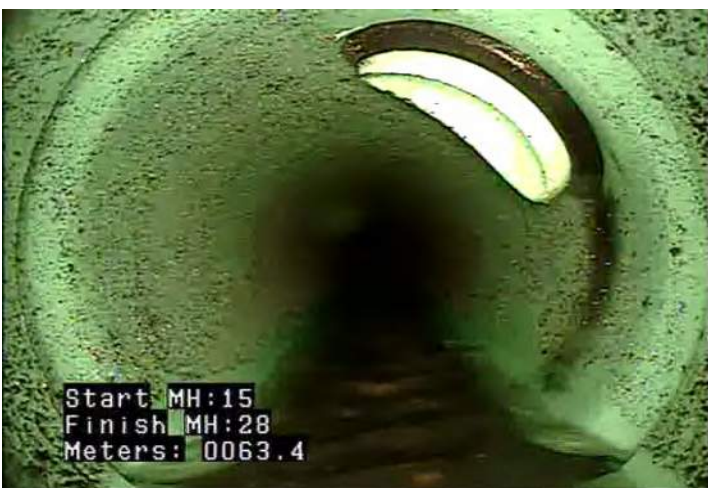
TSI - Tap, Saddle: Intruding @ 63.4 m.

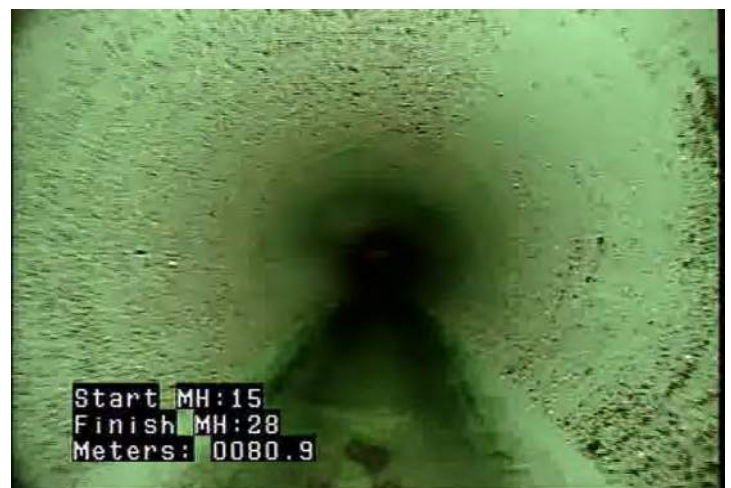
DSF - Deposits Settled: Fine @ 80.9 m.

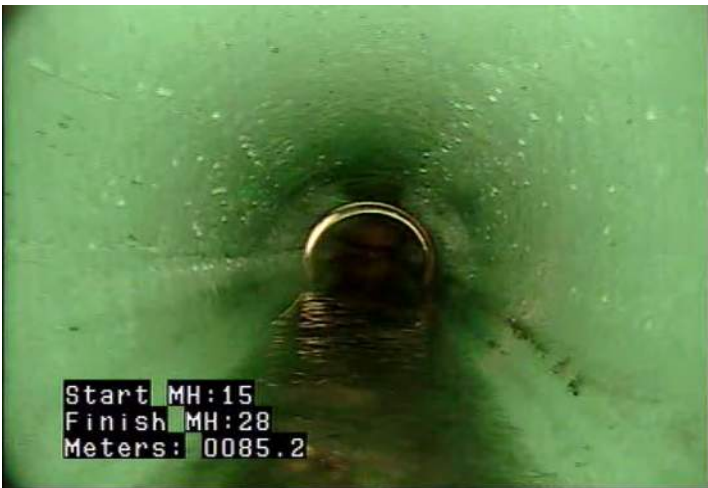
MWLS - Water Level: Sag @ 85.2 m.

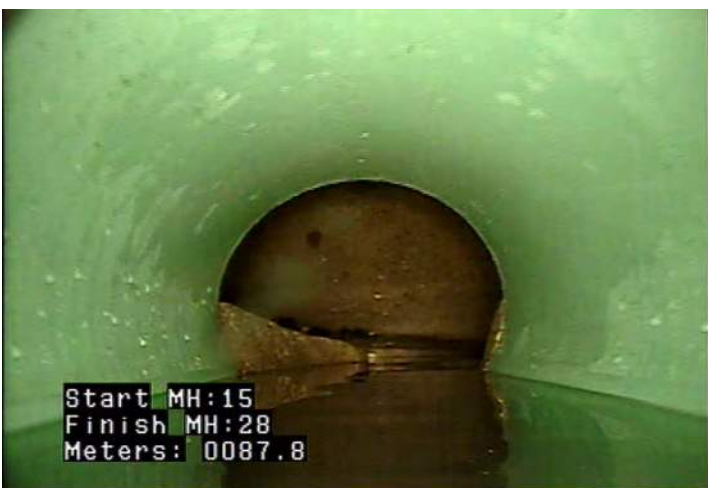
MWLS - Water Level: Sag @ 87.8 m.

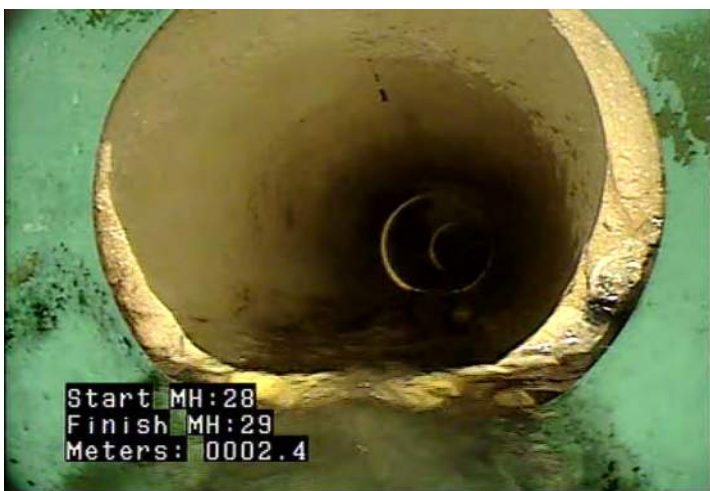
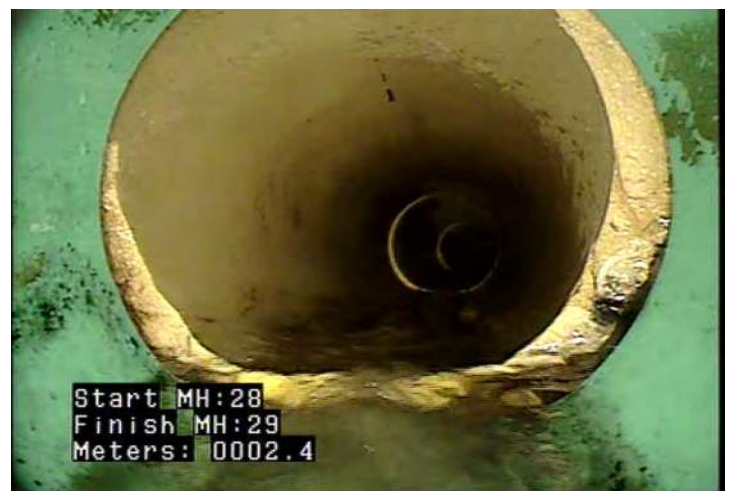
JOM - Joint Offset (displaced): Medium @ 2.4 m.

MMC - Material Change @ 2.4 m. PVC to Clay tile

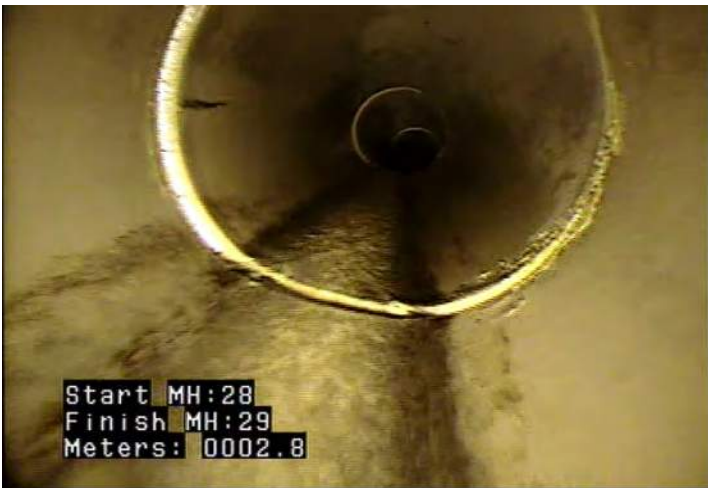
DAE - Deposits Attached: Encrustation @ 2.8 m.

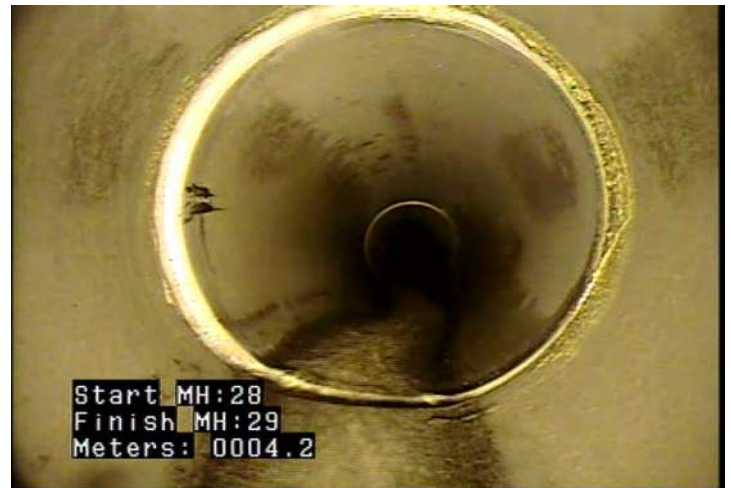
DAE - Deposits Attached: Encrustation @ 4.2 m.
