Appendix F CCTV Assessment

Client: CIMA
 Project: Pre-Rehabilitation Survey
 Date: 12/18/2020
 File: 14257

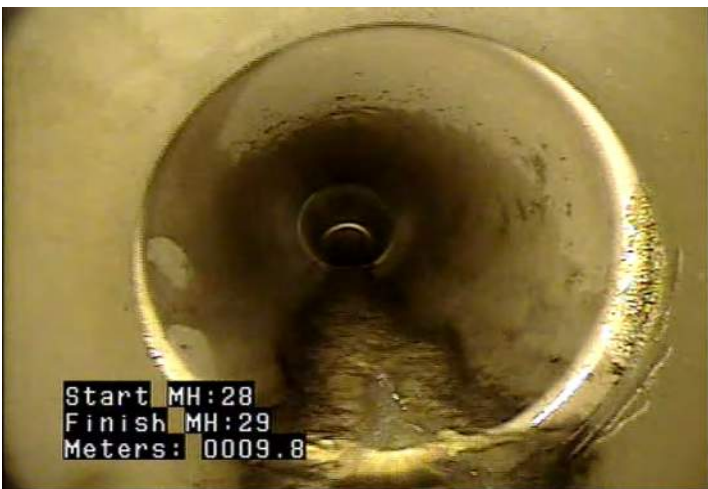
DAE - Deposits Attached: Encrustation @ 9.8 m.

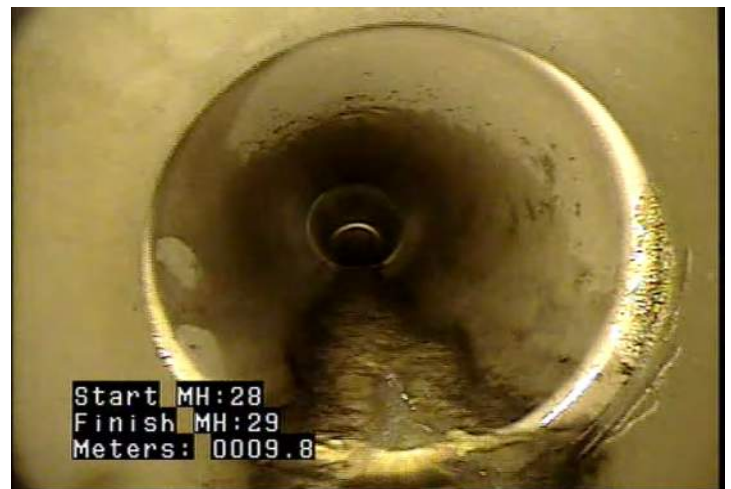
JOM - Joint Offset (displaced): Medium @ 9.8 m.

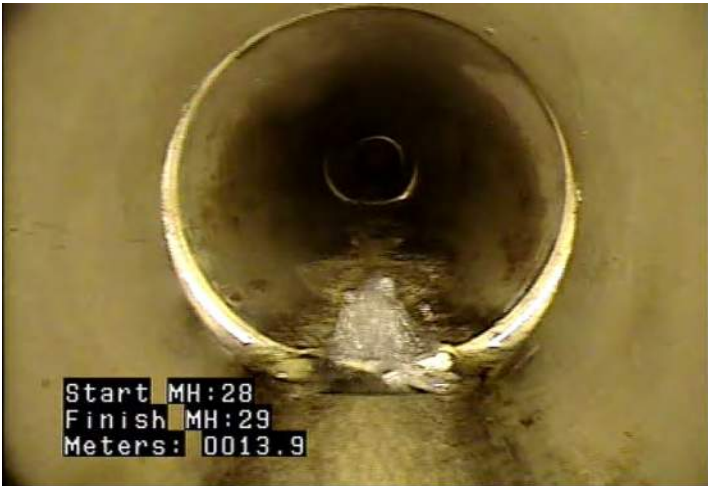
JOM - Joint Offset (displaced): Medium @ 13.9 m.

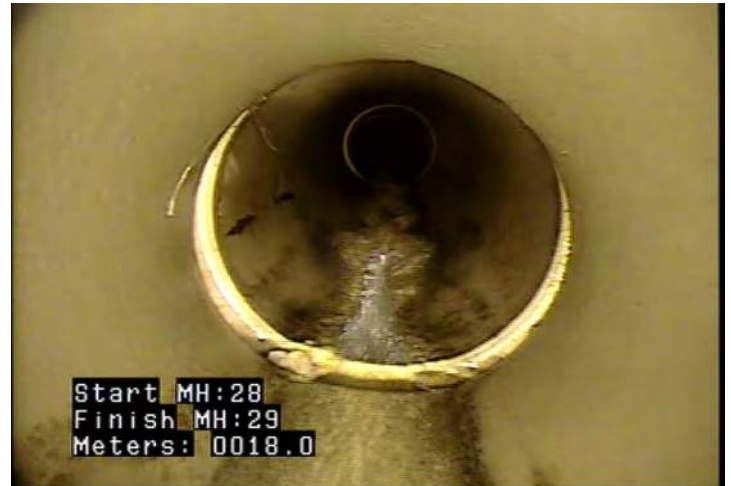
JAM - Joint Angular: Medium @ 18.0 m.

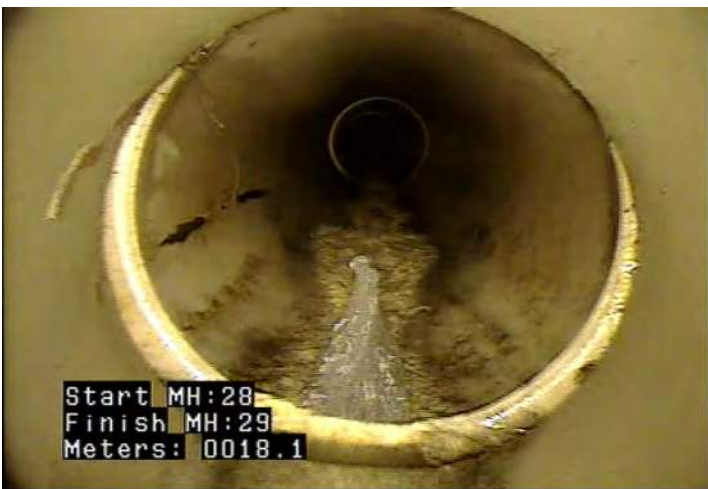
RFJ - Roots, Fine: Joint @ 18.1 m.

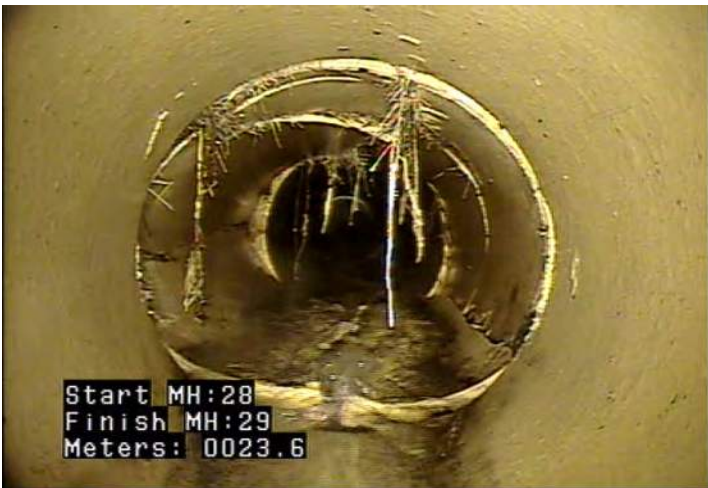
RFB - Roots, Fine: Barrel @ 23.6 m.

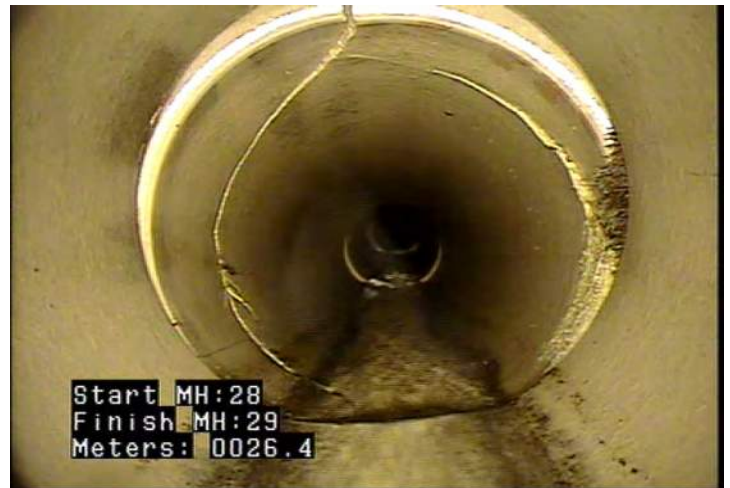
FM - Fracture Multiple @ 26.4 m.

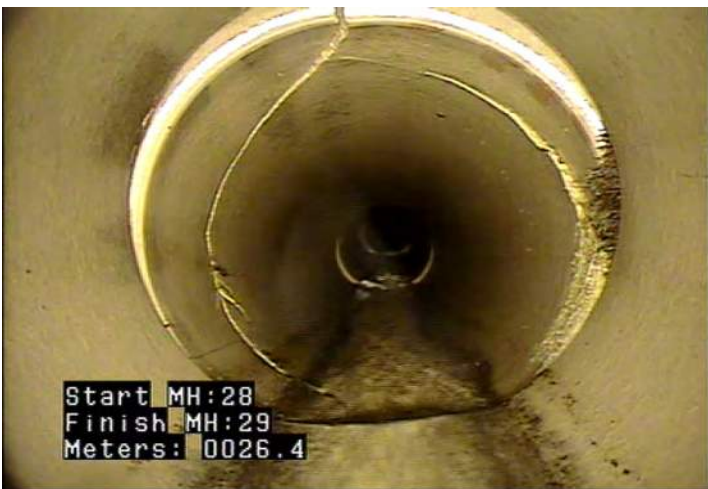
RFJ - Roots, Fine: Joint @ 26.4 m.

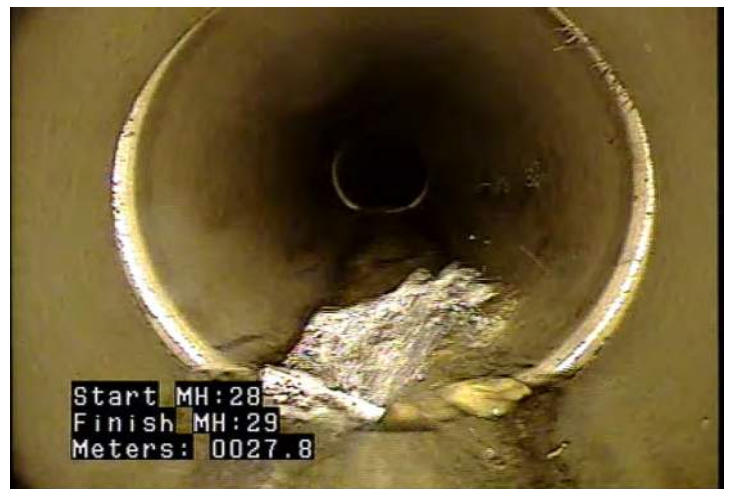
RFJ - Roots, Fine: Joint @ 27.8 m.

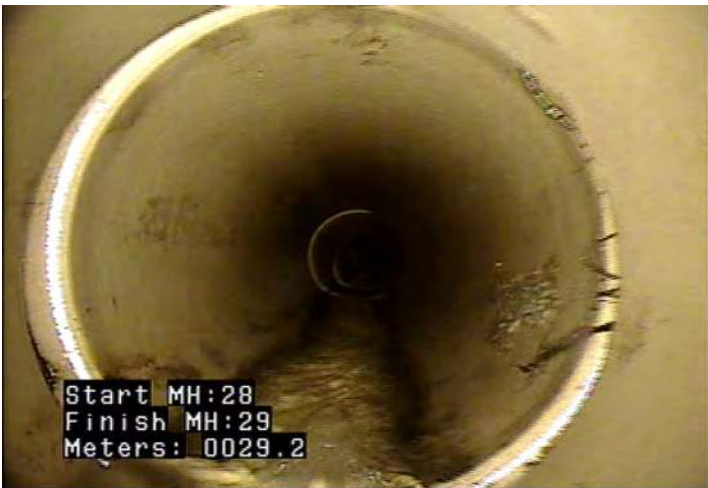
RFJ - Roots, Fine: Joint @ 29.2 m.

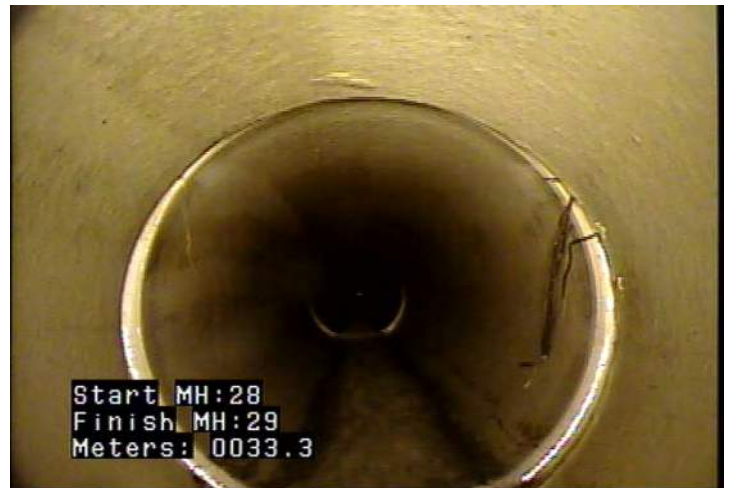
RFJ - Roots, Fine: Joint @ 33.3 m.

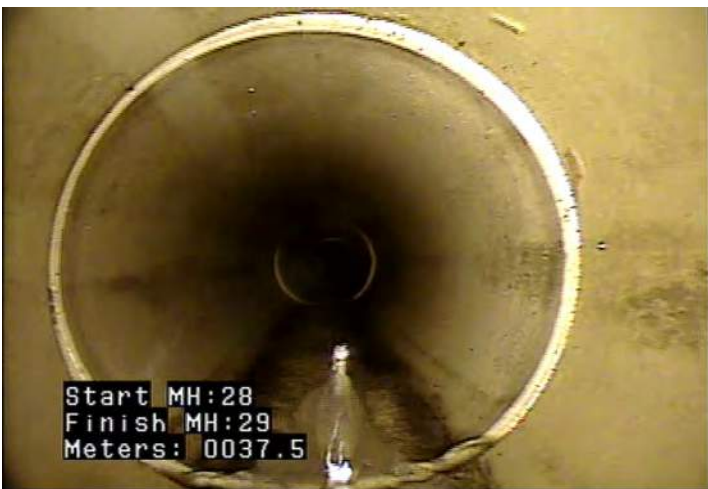
OBJ - Obstacle - Object Wedged in Joint @ 37.5 m. Fork wedged in joint

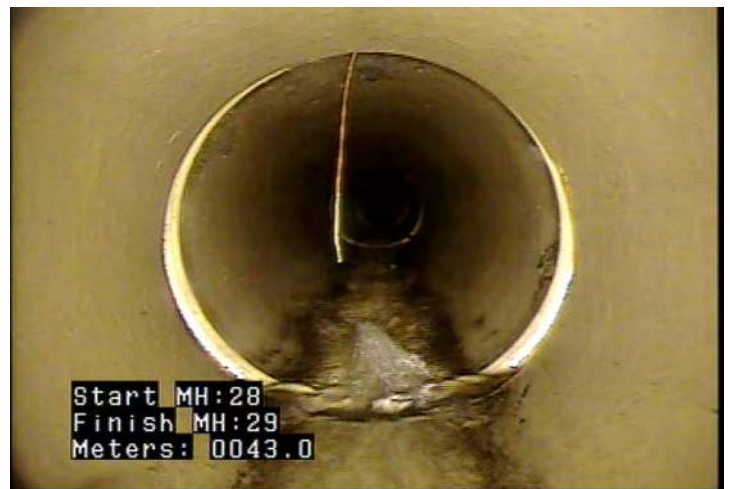
RFJ - Roots, Fine: Joint @ 43.0 m.

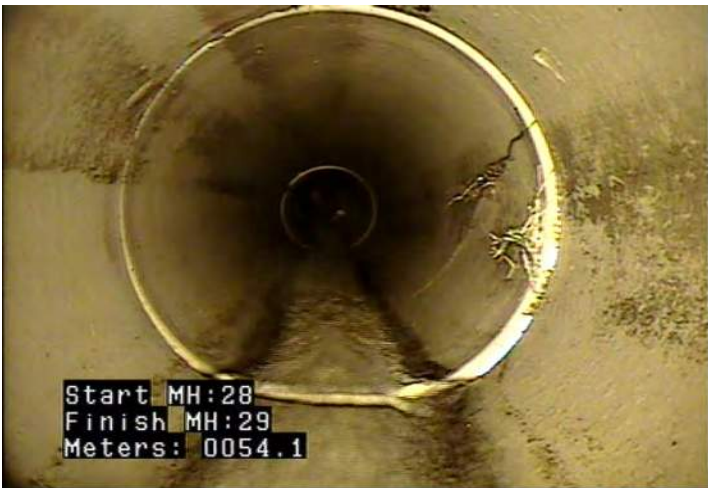
RFJ - Roots, Fine: Joint @ 54.1 m.

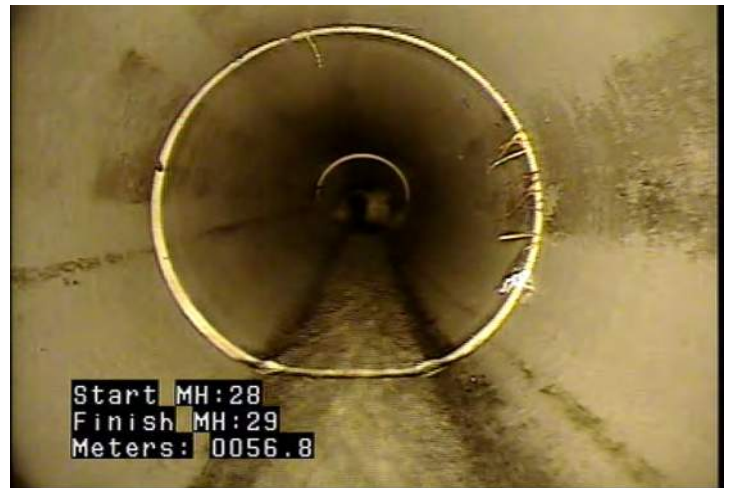
RFJ - Roots, Fine: Joint @ 56.8 m.

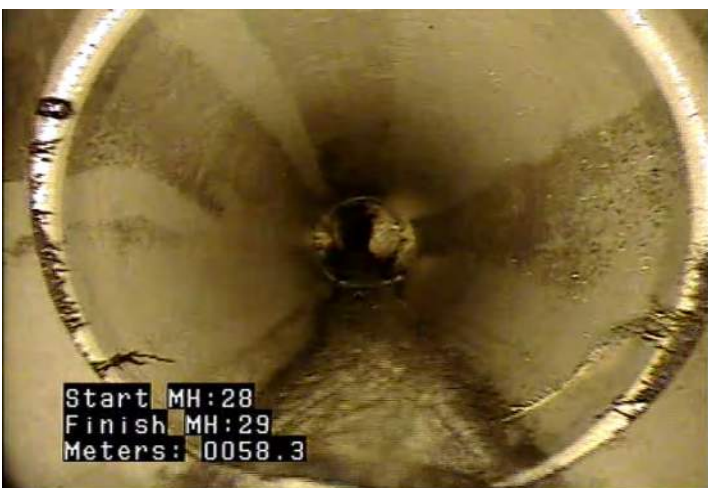
RFJ - Roots, Fine: Joint @ 58.3 m.

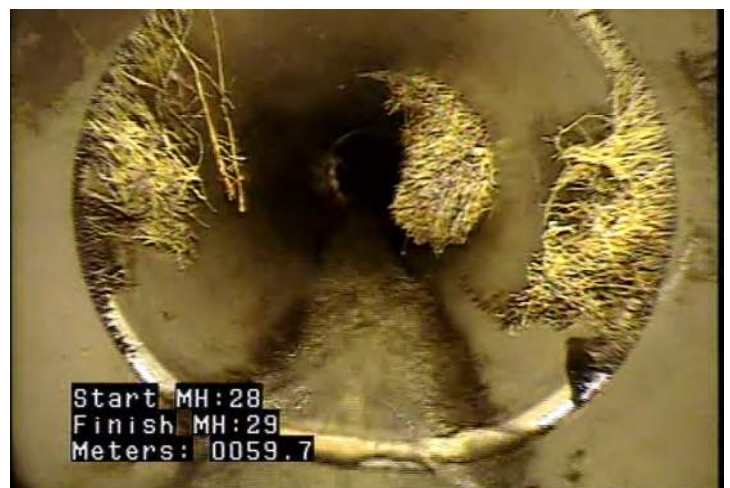
RMJ - Roots, Medium, Joint @ 59.7 m.

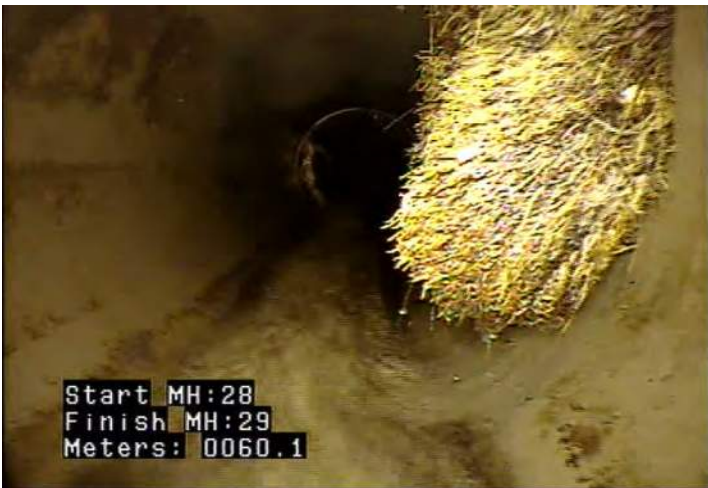
RMB - Roots, Medium: Barrel @ 60.1 m.
Possible hole in pipe at this spot.

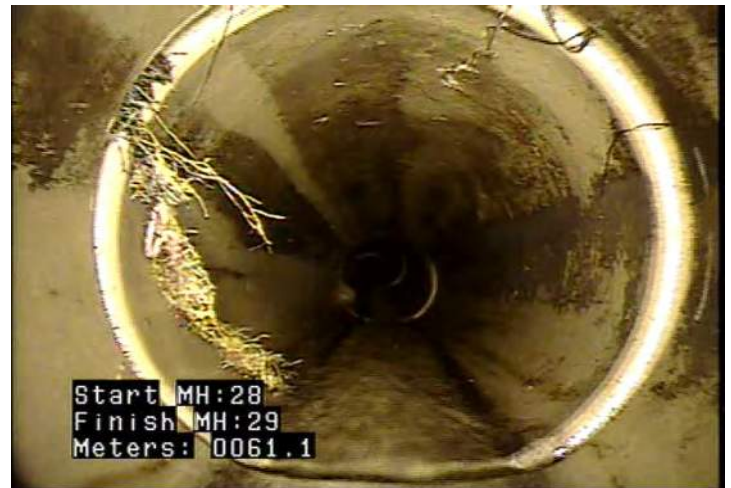
RFJ - Roots, Fine: Joint @ 61.1 m.

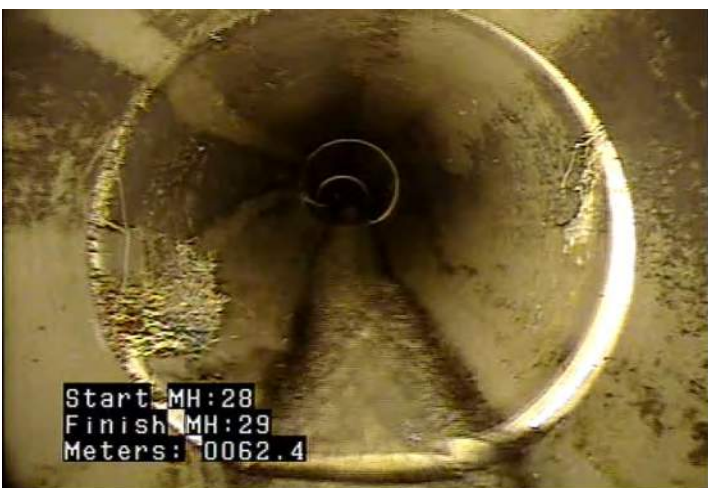
RFJ - Roots, Fine: Joint @ 62.4 m.

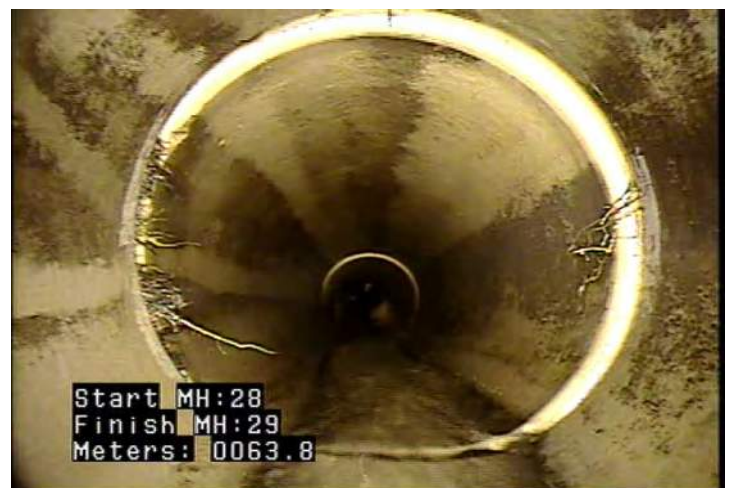
RFJ - Roots, Fine: Joint @ 63.8 m.

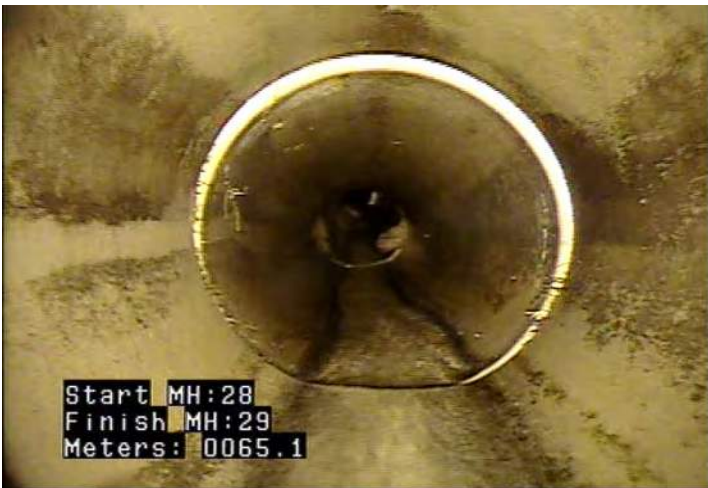
RFJ - Roots, Fine: Joint @ 65.1 m.

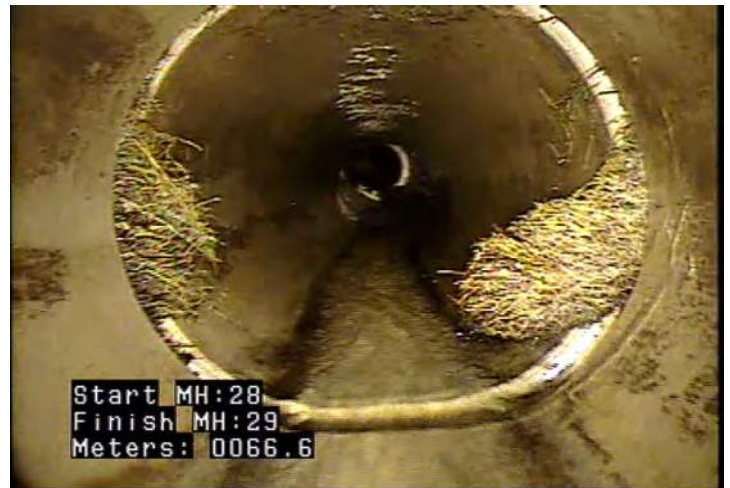
RMJ - Roots, Medium, Joint @ 66.6 m.

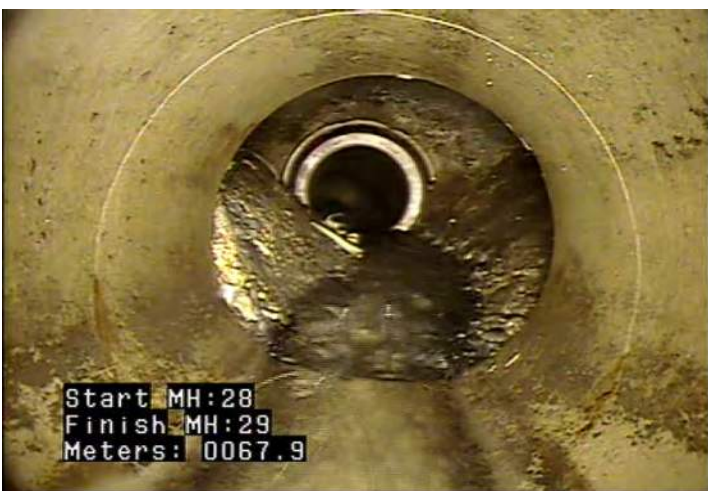
CC - Crack Circumferential @ 67.9 m.

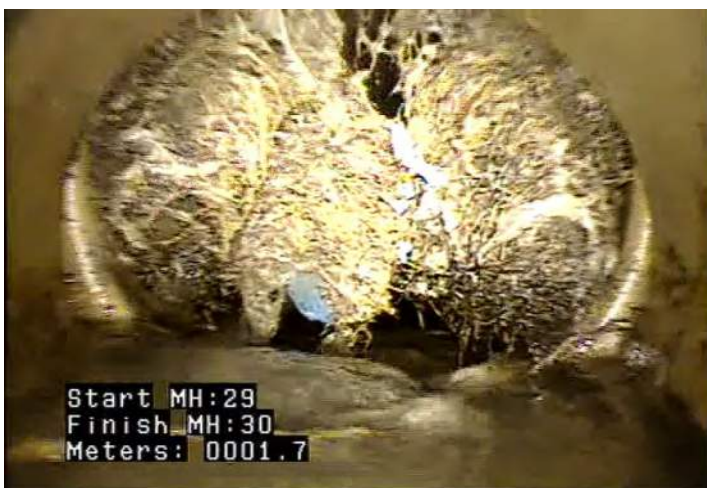
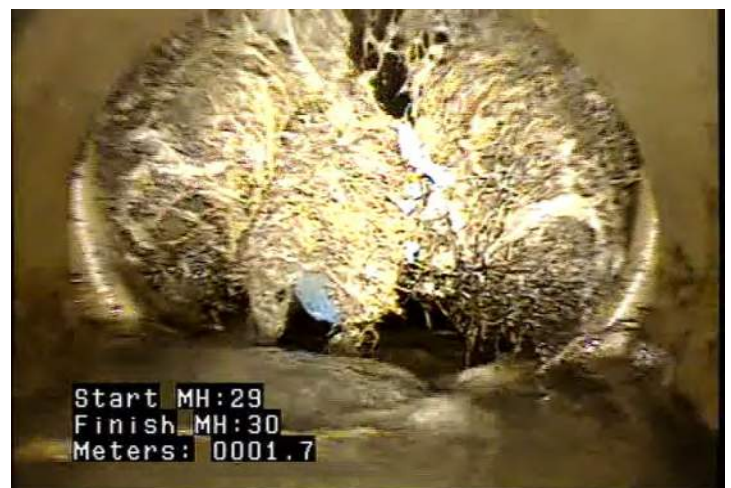
JOL - Joint Offset (displaced): Large @ 1.7 m.

RBJ - Roots, Ball, Joint @ 1.7 m.

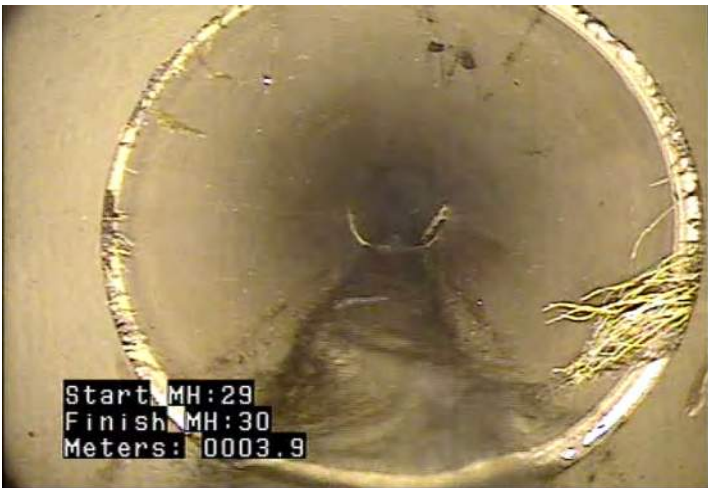
RFJ - Roots, Fine: Joint @ 3.9 m.

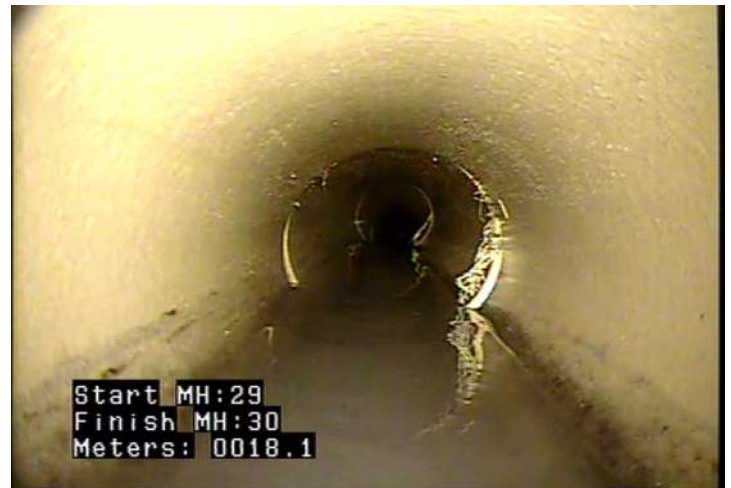
RFJ - Roots, Fine: Joint @ 18.1 m.

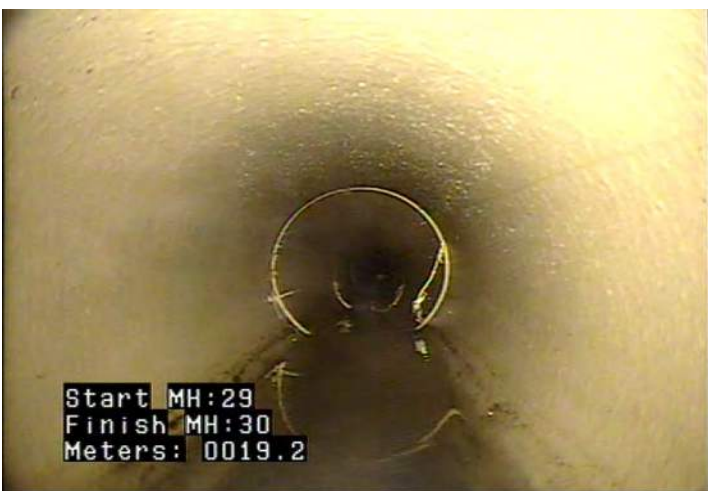
18.1	F01	RFJ	Roots, Fine: Joint	8 to 4			J	
	19.2		MSA	Survey Abandoned					
									Unable to pass rock wedged in joint.

MSA - Survey Abandoned @ 19.2 m.
Unable to pass rock wedged in joint.

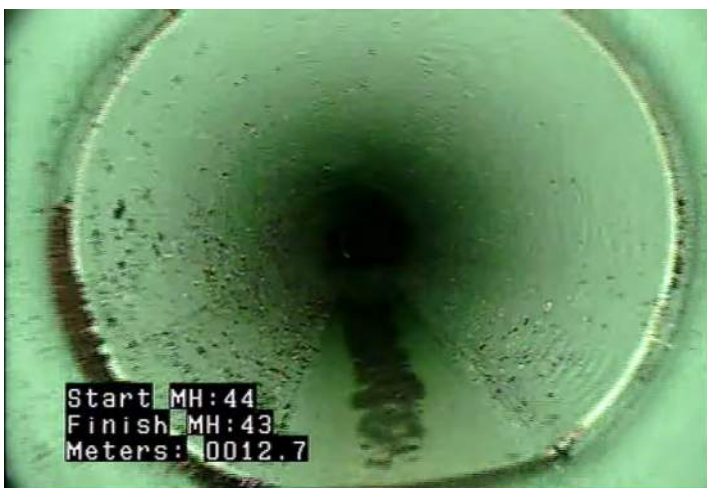
DSF - Deposits Settled: Fine @ 12.7 m.

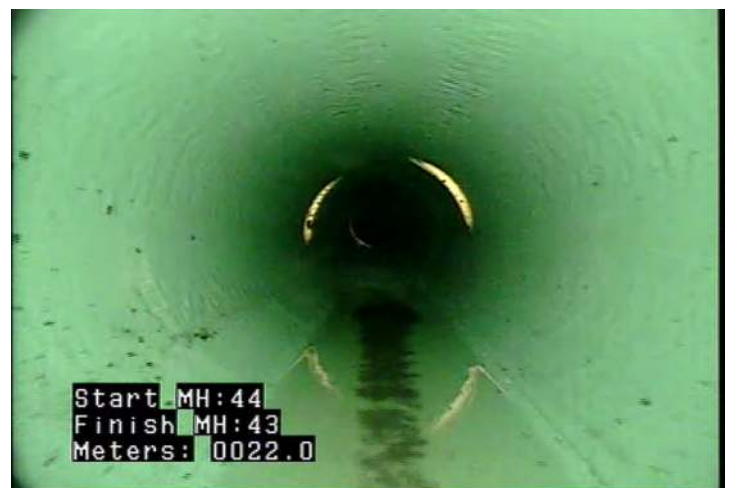
DSF - Deposits Settled: Fine @ 22.0 m.

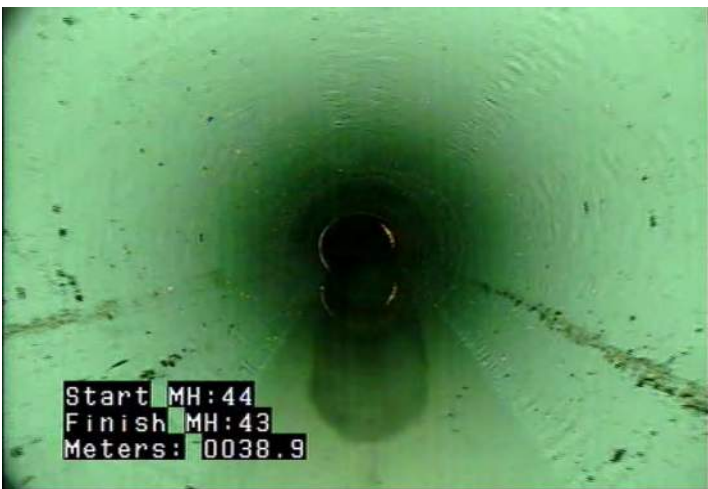
MWLS - Water Level: Sag @ 38.9 m.

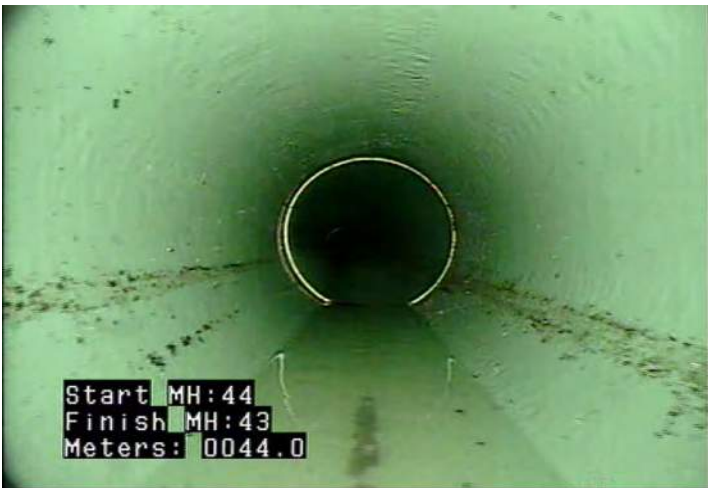
MWLS - Water Level: Sag @ 44.0 m.

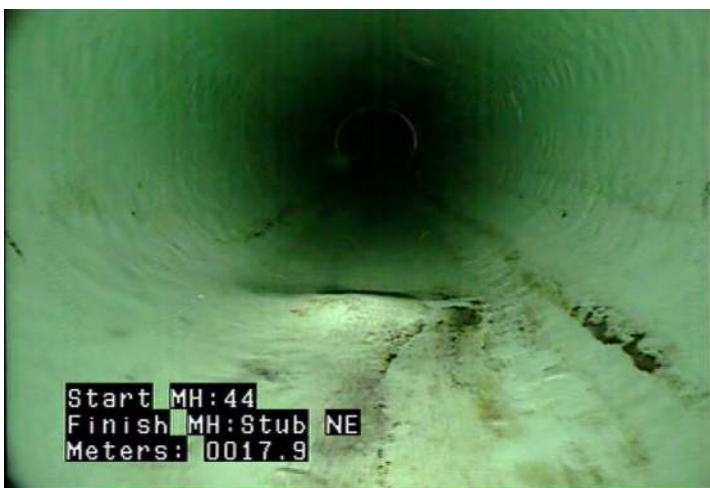
D - Pipe Deformed @ 17.9 m.

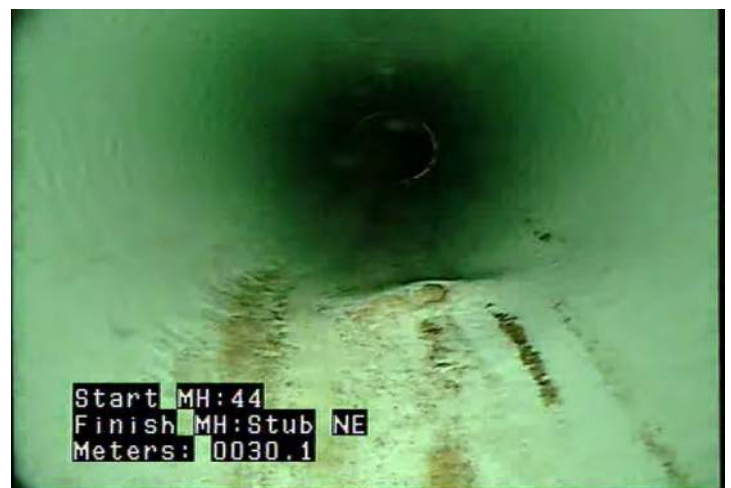
D - Pipe Deformed @ 30.1 m.

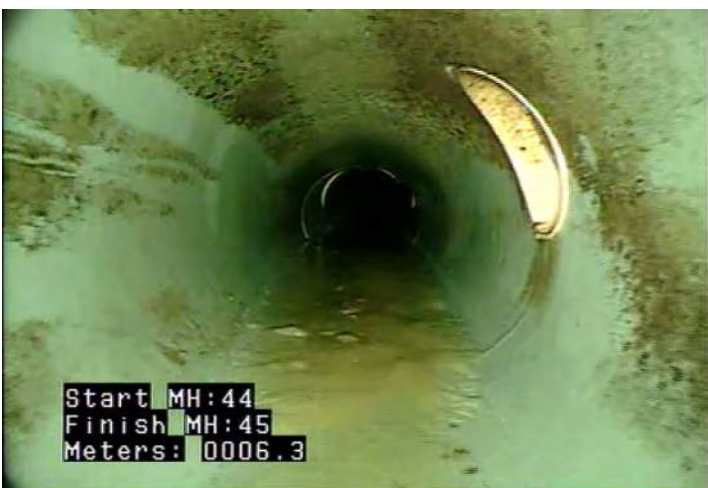
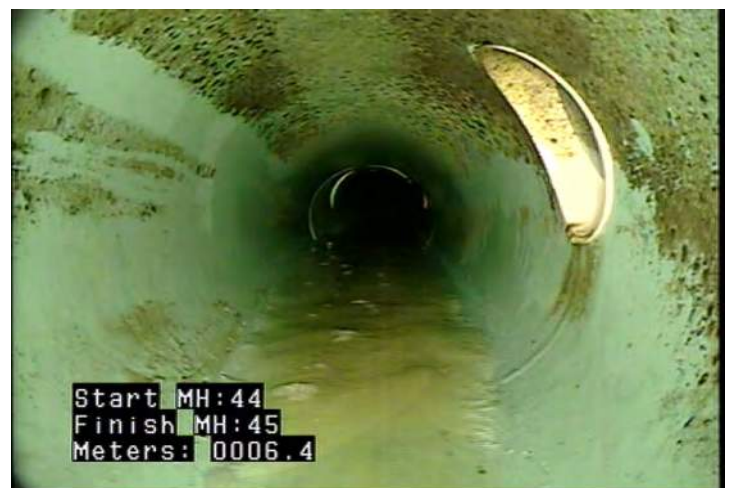
MWLS - Water Level: Sag @ 6.3 m.

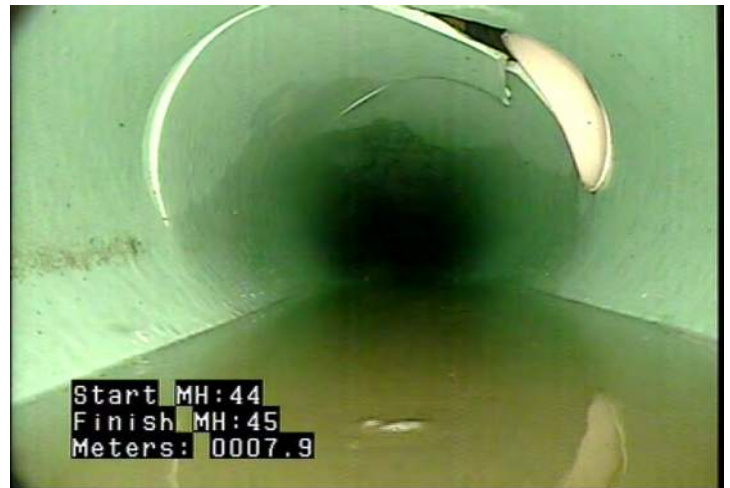
6.4		TS	Tap, Saddle	2				
7.9		TS	Tap, Saddle	1				
8.1		B	Pipe Broken	11 to 3				
8.5		MWL	Water Level		5			
10.6		MWL	Water Level		10			
14.0		MWL	Water Level		5

B - Pipe Broken @ 8.1 m.

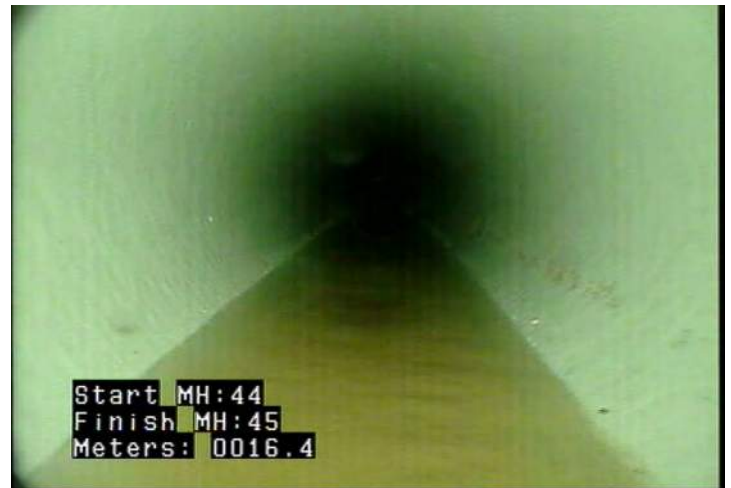
MWLS - Water Level: Sag @ 16.3 m.

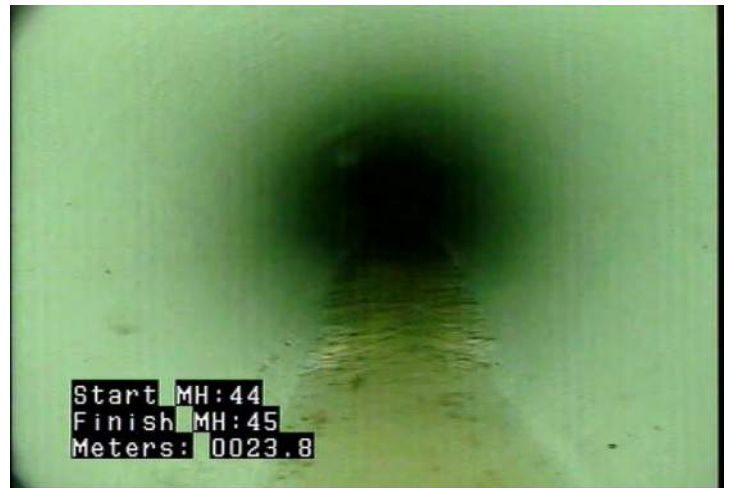
MWL - Water Level @ 23.8 m.

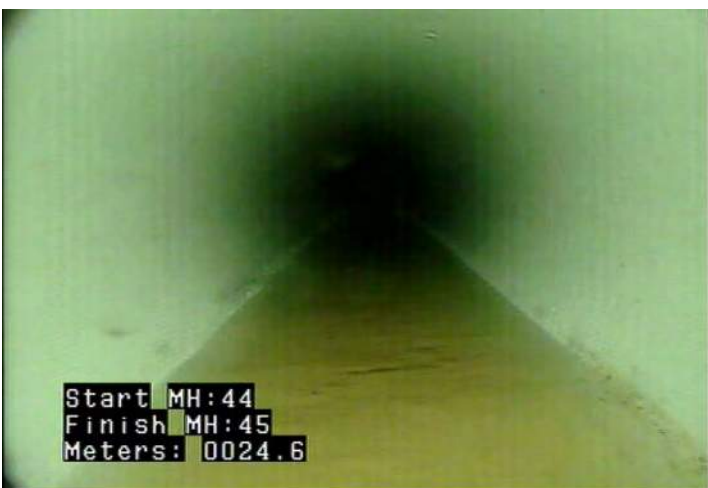
MWLS - Water Level: Sag @ 24.6 m.

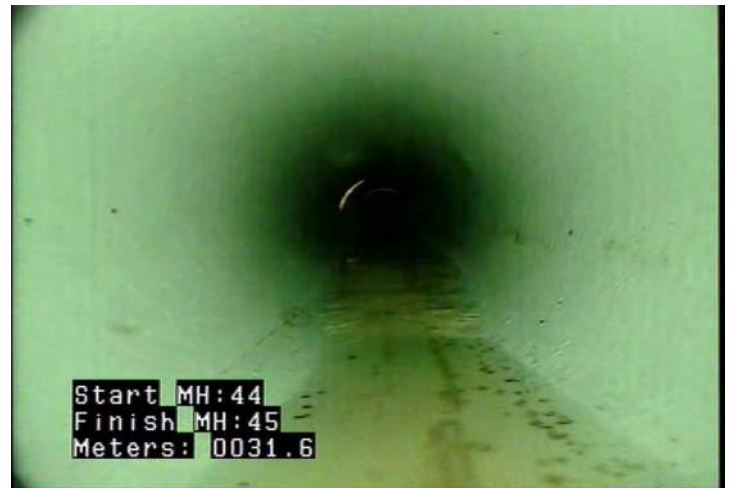
MWLS - Water Level: Sag @ 32.5 m.

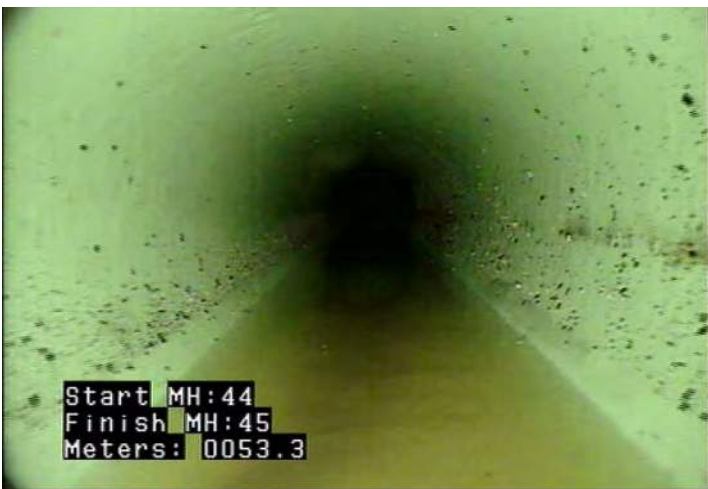
MWLS - Water Level: Sag @ 53.3 m.

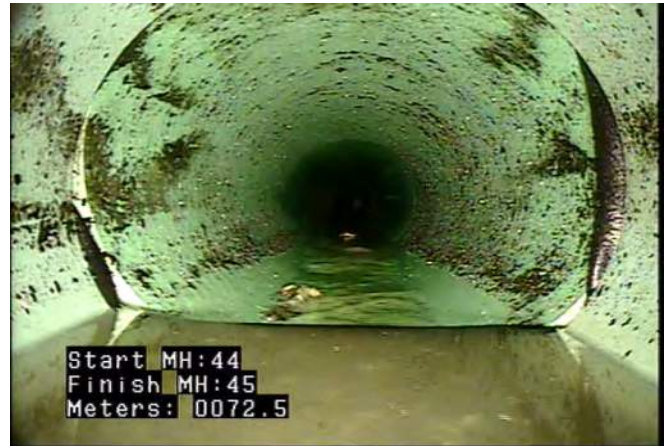
ISSR - Intruding Seal Material - Sealing Ring @ 72.5 m. Possibly sealing ring holding back debris/water at bottom of pipe

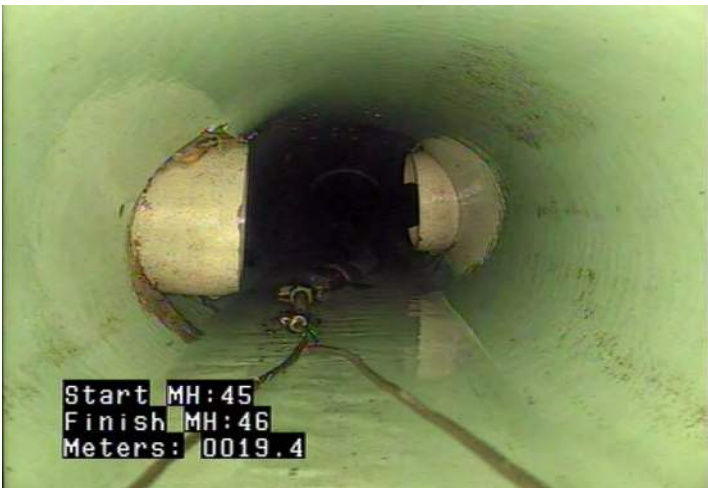
TSI - Tap, Saddle: Intruding @ 19.4 m.

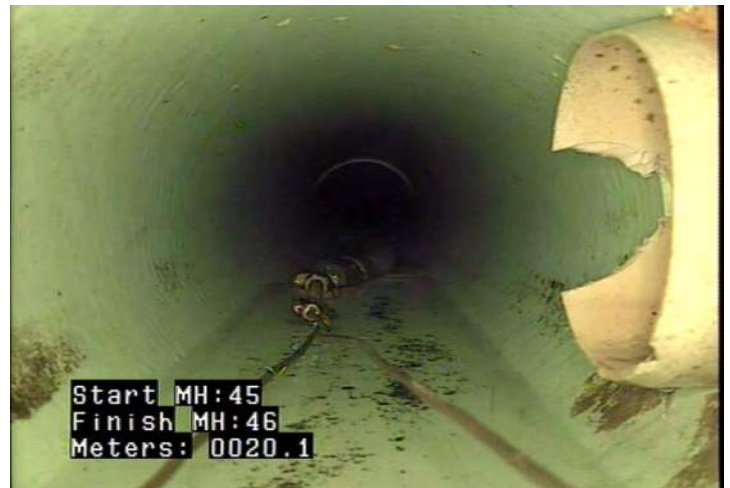
TSI - Tap, Saddle: Intruding @ 20.1 m.
Connecting pipe broken

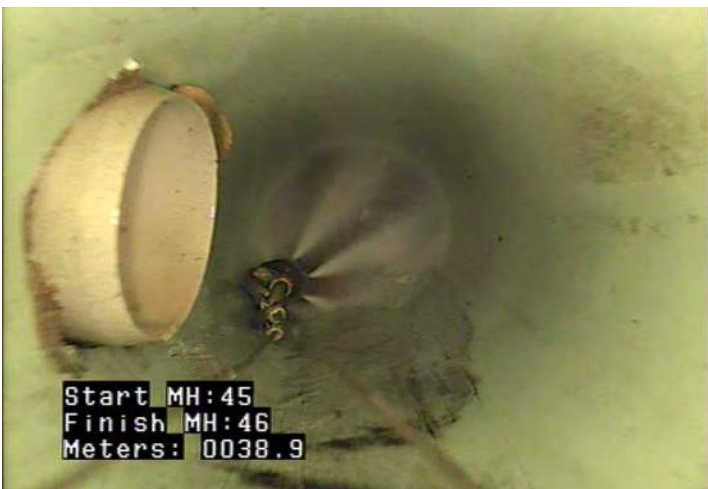
TSI - Tap, Saddle: Intruding @ 38.9 m.

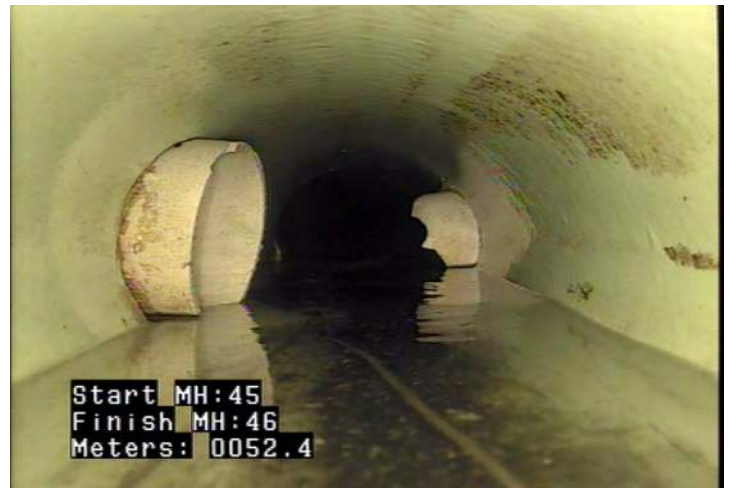
TSI - Tap, Saddle: Intruding @ 52.4 m.

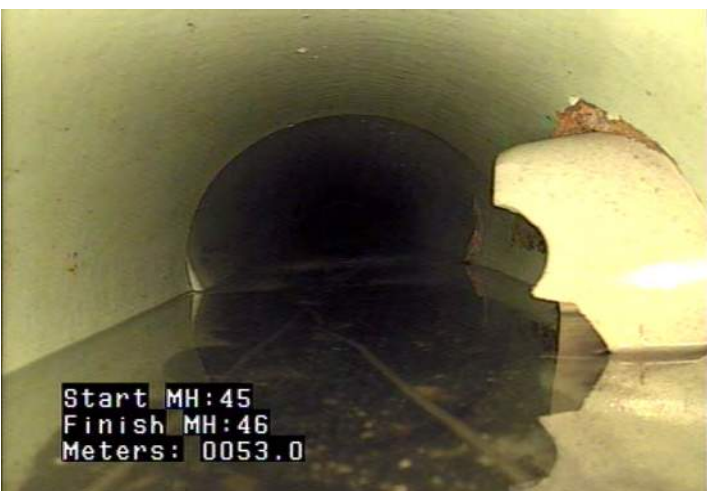
TSI - Tap, Saddle: Intruding @ 53.0 m.
Connecting pipe broken

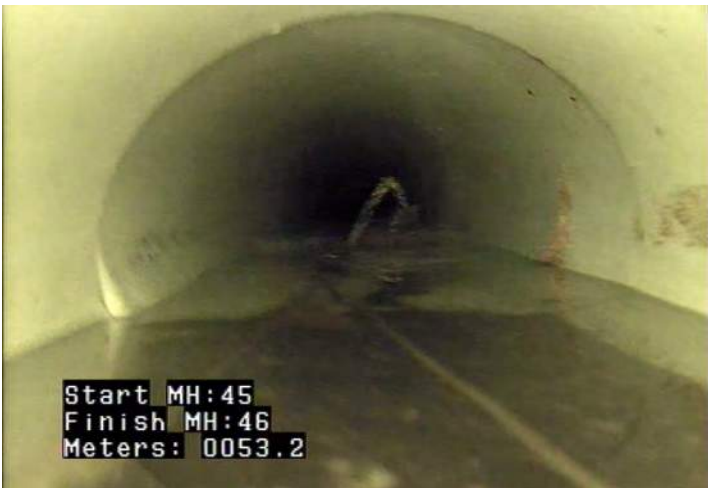
B - Pipe Broken @ 53.2 m. See Job 34R

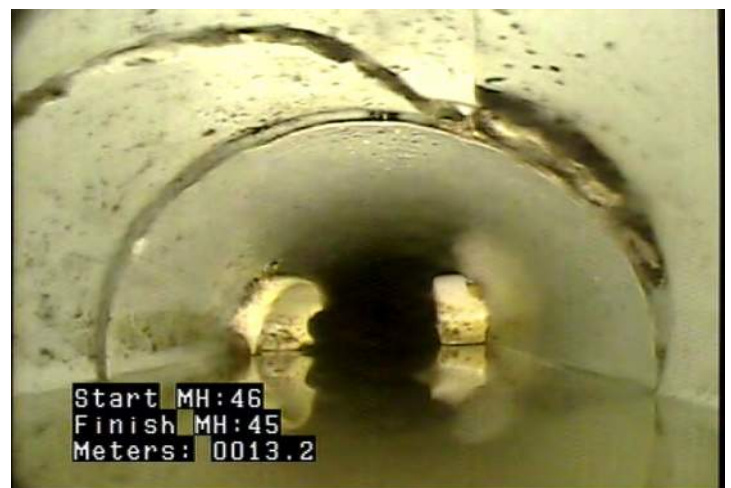
B - Pipe Broken @ 13.2 m.

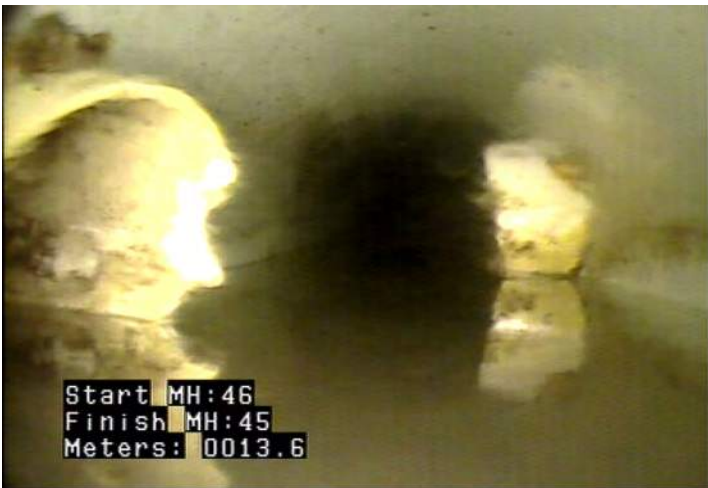
TSI - Tap, Saddle: Intruding @ 13.6 m.

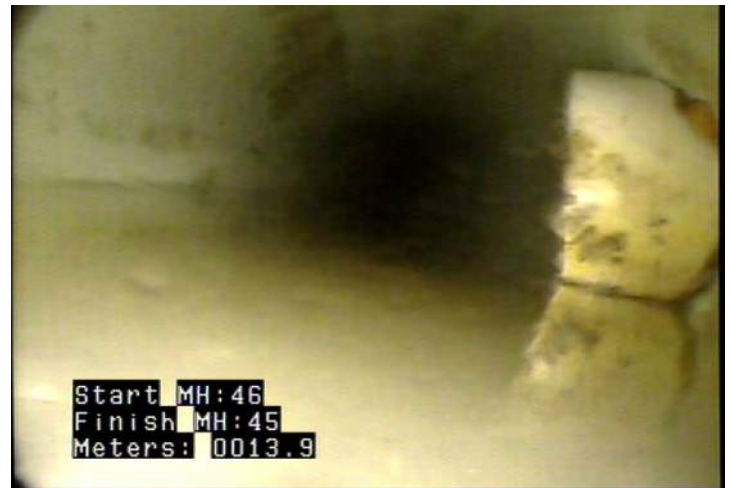
TSI - Tap, Saddle: Intruding @ 13.9 m.

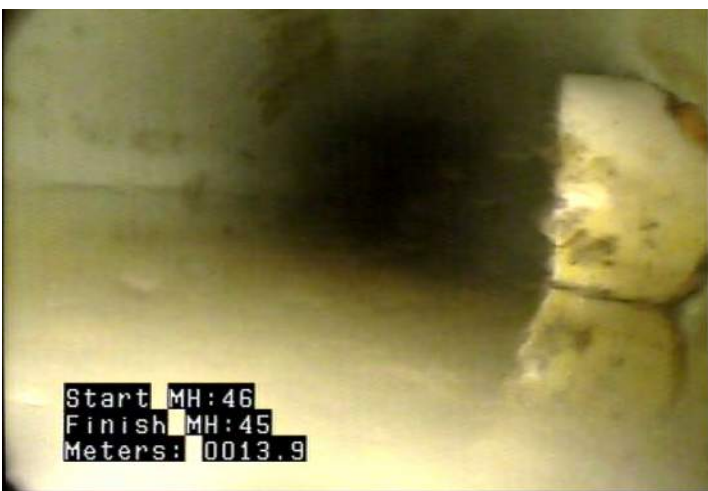
MSA - Survey Abandoned @ 13.9 m.
Unable to pass intruding service.

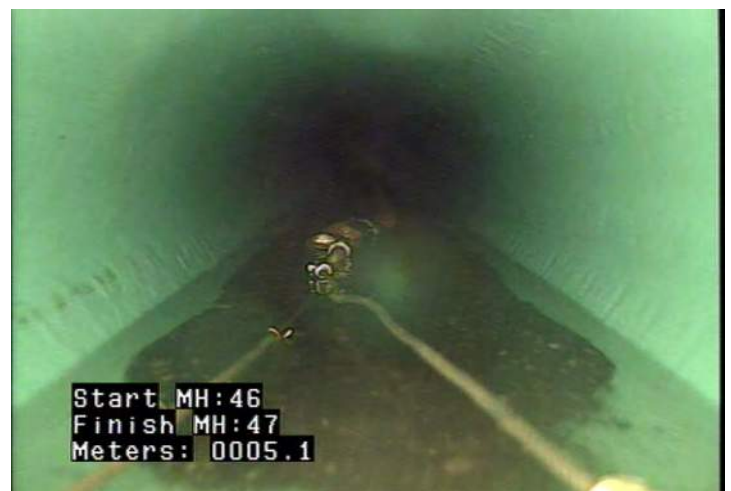
DSGV - Deposits Settled: Gravel @ 5.1 m.

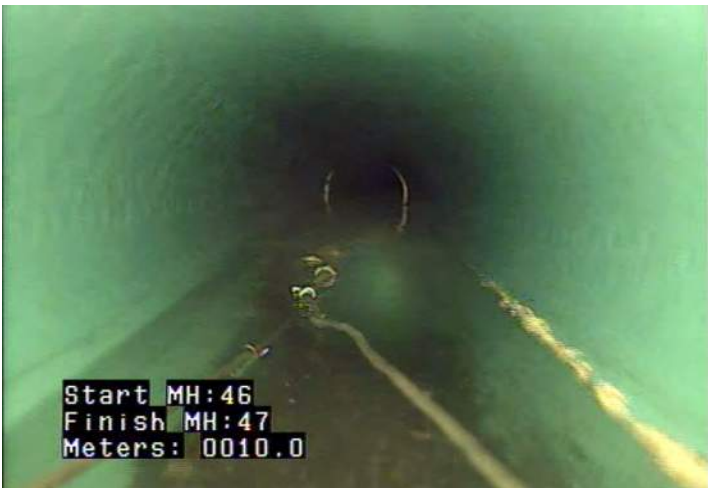
MWLS - Water Level: Sag @ 10.0 m.

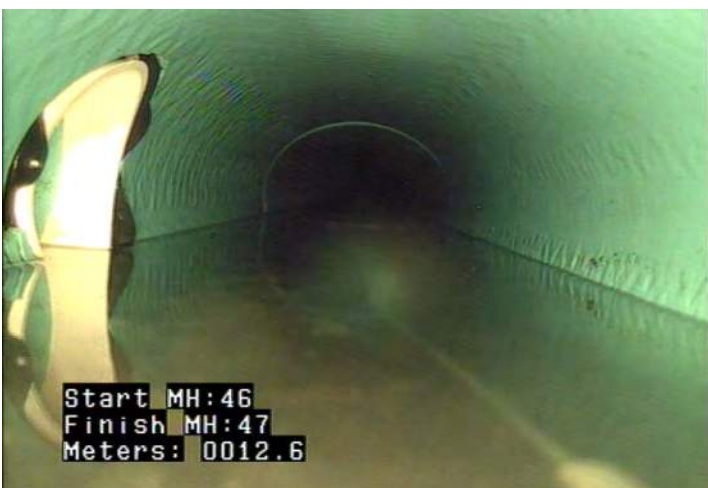
TSD - Tap, Saddle: Defective @ 12.6 m.
Gasket intruding around service.

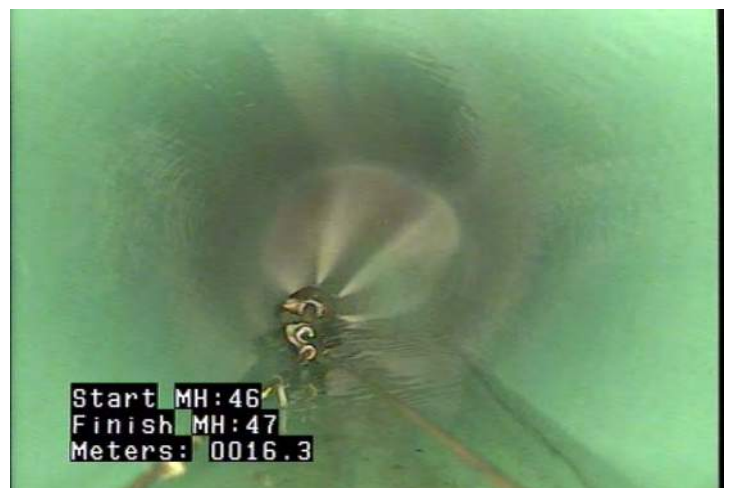
MWLS - Water Level: Sag @ 16.3 m.
Flusher on

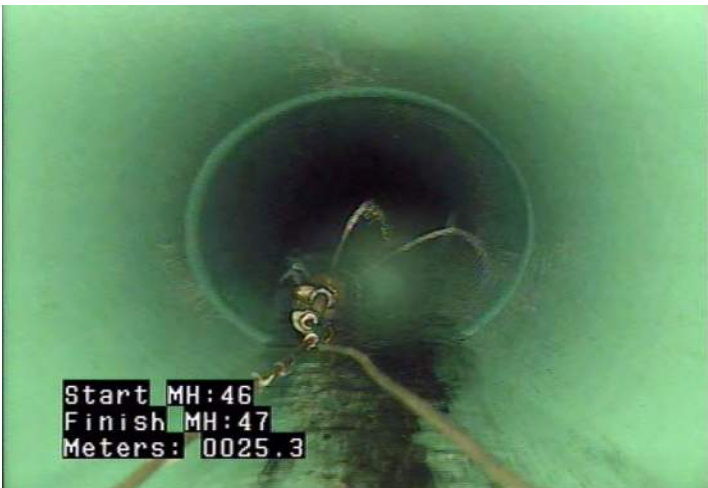
D - Pipe Deformed @ 25.3 m. Oval

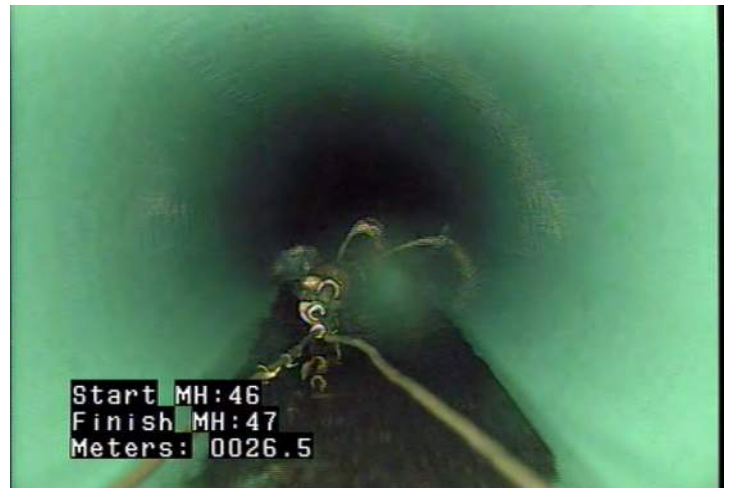
DSGV - Deposits Settled: Gravel @ 26.5 m.

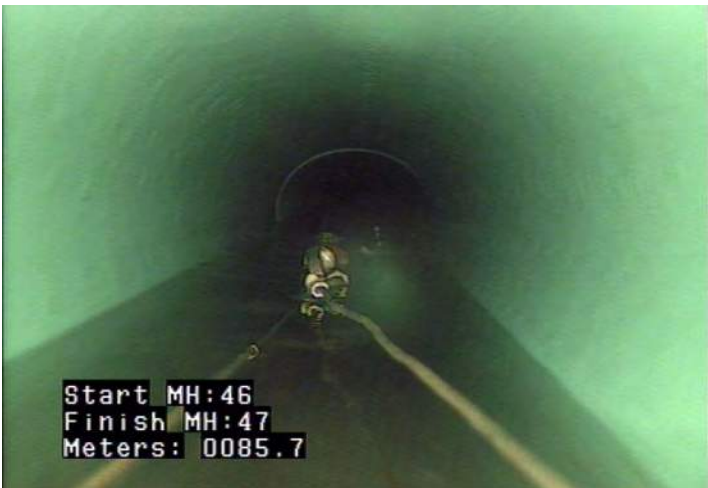
MWLS - Water Level: Sag @ 85.7 m.

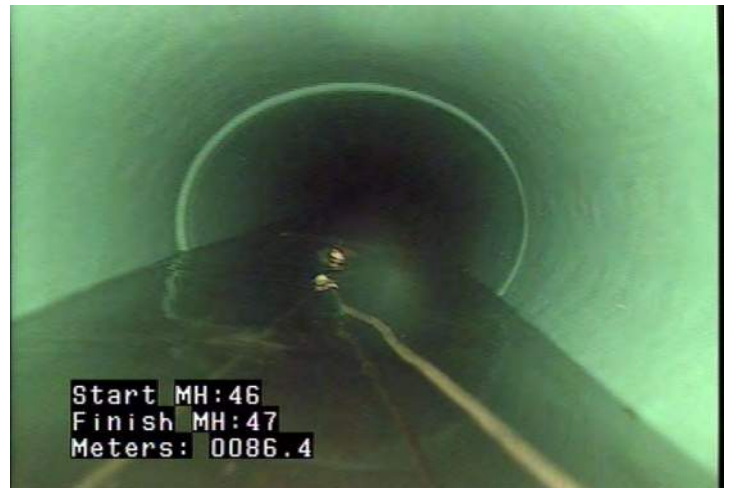
D - Pipe Deformed @ 86.4 m. Oval

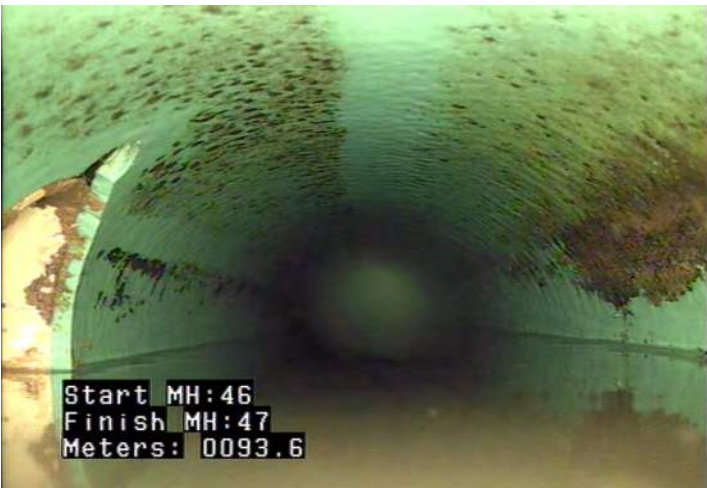
TSD - Tap, Saddle: Defective @ 93.6 m.
Pipe chipped above service.

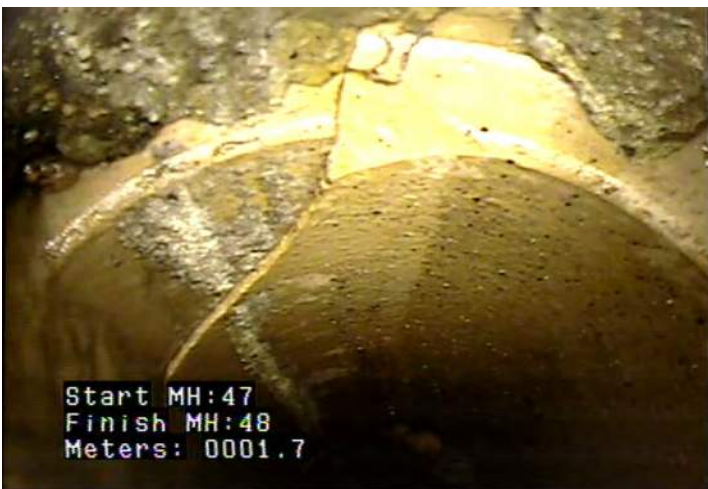
B - Pipe Broken @ 0.5 m.
