Appendix F CCTV Assessment

Client: CIMA
 Project: Pre-Rehabilitation Survey
 Date: 12/18/2020
 File: 14257

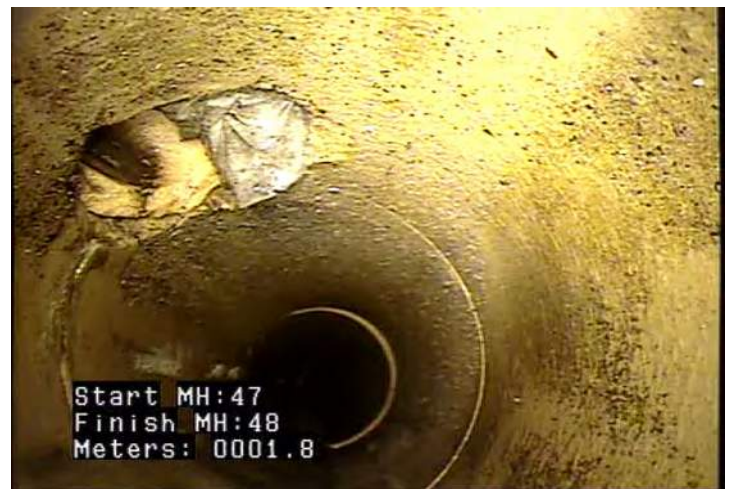
CC - Crack Circumferential @ 1.8 m.

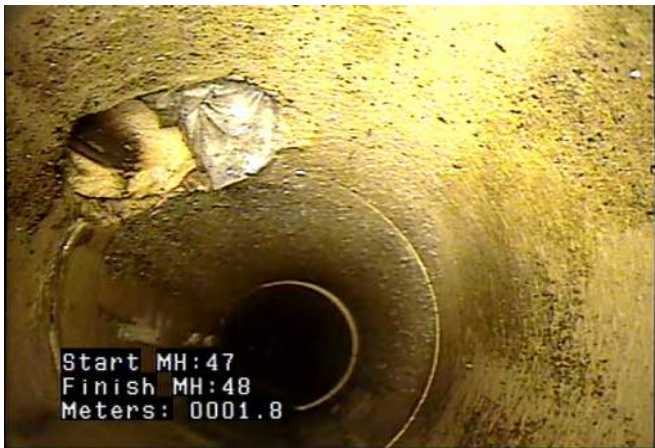
TBD - Tap, Break-in / Hammer: Defective @ 1.8 m. Plastic intruding from top of service.

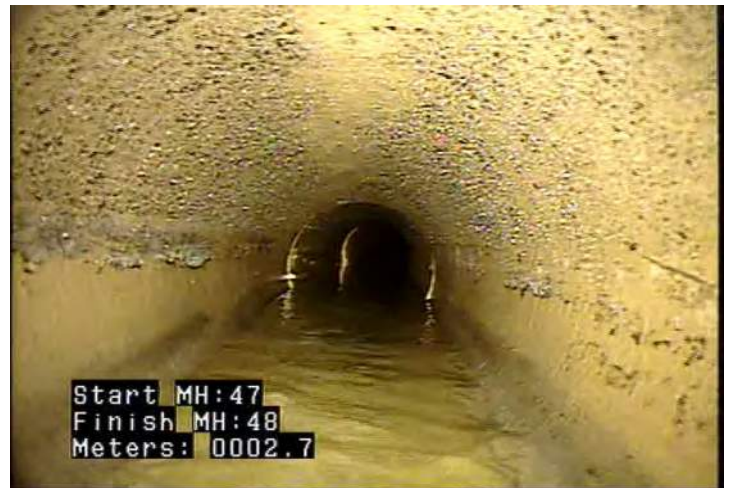
MWLS - Water Level: Sag @ 2.7 m.

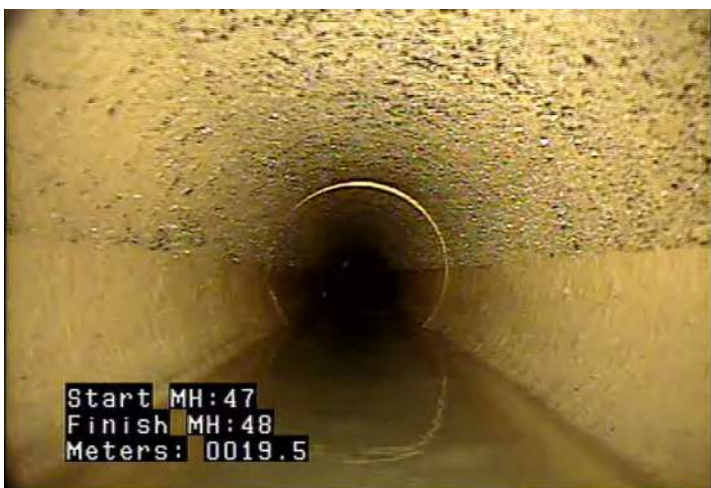
MWLS - Water Level: Sag @ 19.5 m.

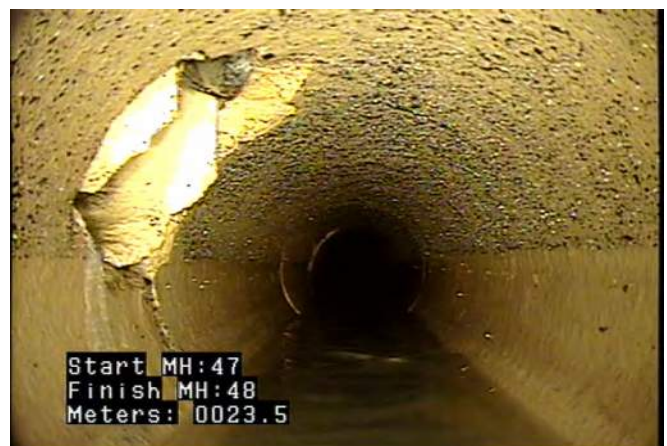
TBD - Tap, Break-in / Hammer: Defective @ 23.5 m. Plastic intruding from top of service.

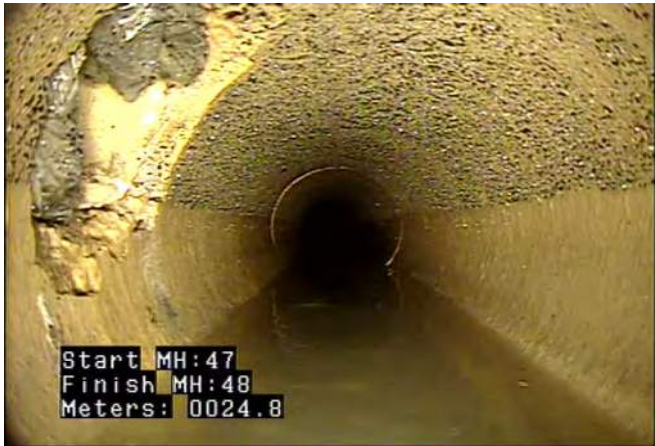
TBD - Tap, Break-in / Hammer: Defective @ 24.8 m. Plastic intruding from top of service.

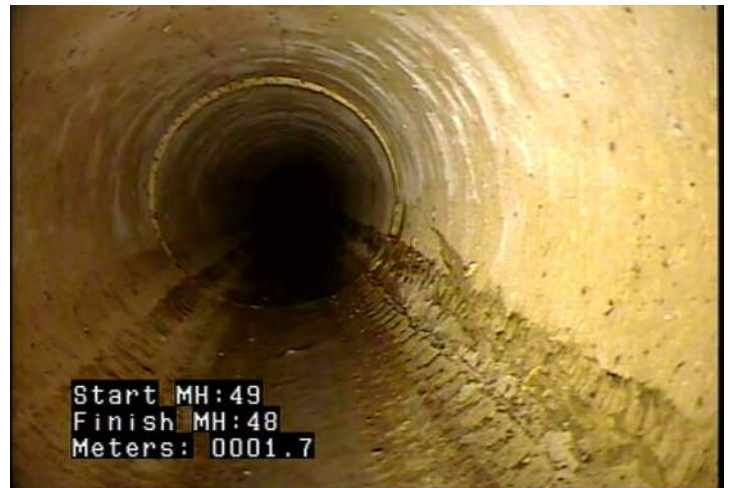
TBI - Tap, Break-in / Hammer: Intruding @ 10.1 m.

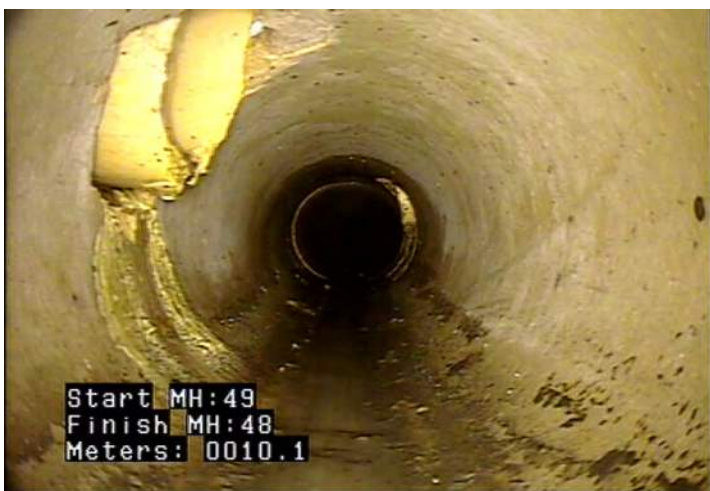
TB - Tap, Break-in / Hammer @ 10.9 m.

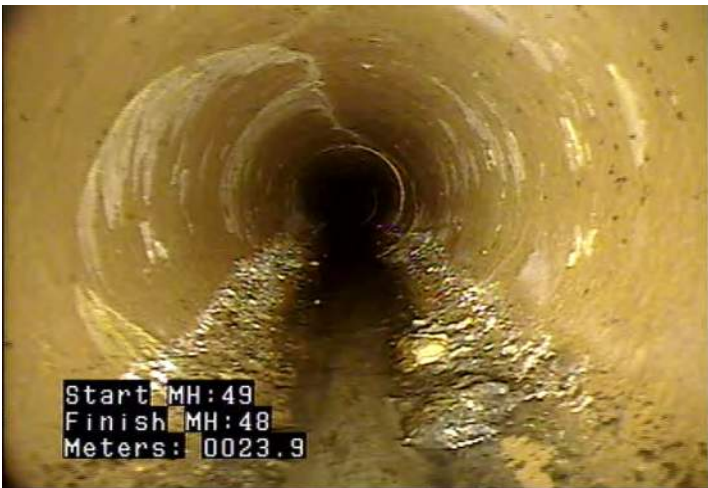
CS - Crack Spiral @ 23.9 m.

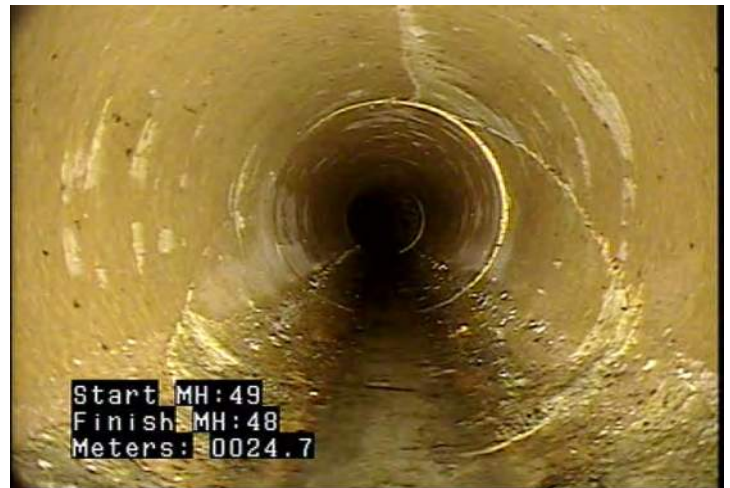
FS - Fracture Spiral @ 24.7 m.

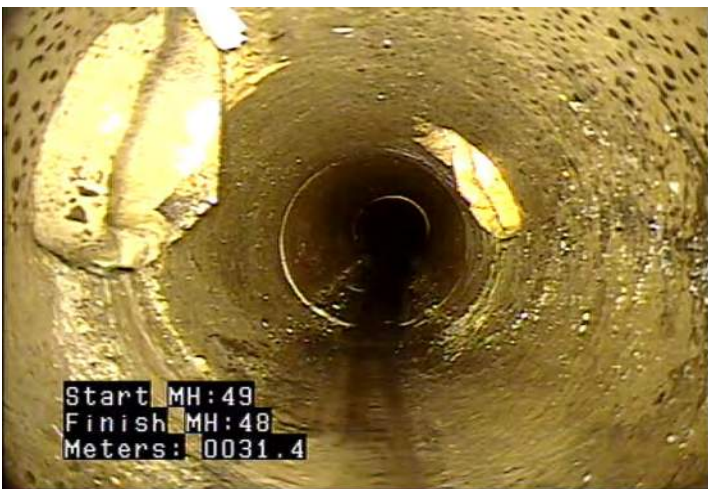
TBI - Tap, Break-in / Hammer: Intruding @ 31.4 m.

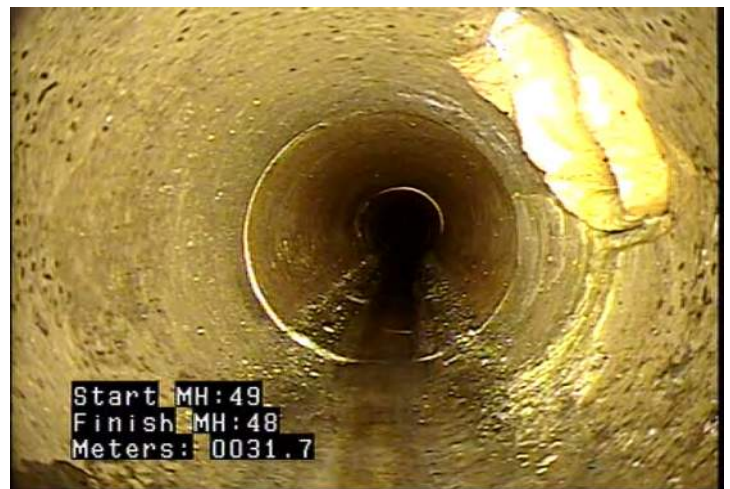
TBI - Tap, Break-in / Hammer: Intruding @ 31.7 m.

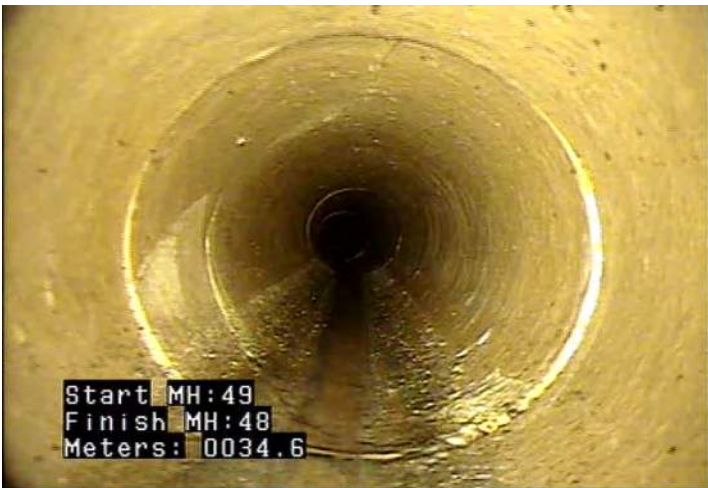
CS - Crack Spiral @ 34.8 m.

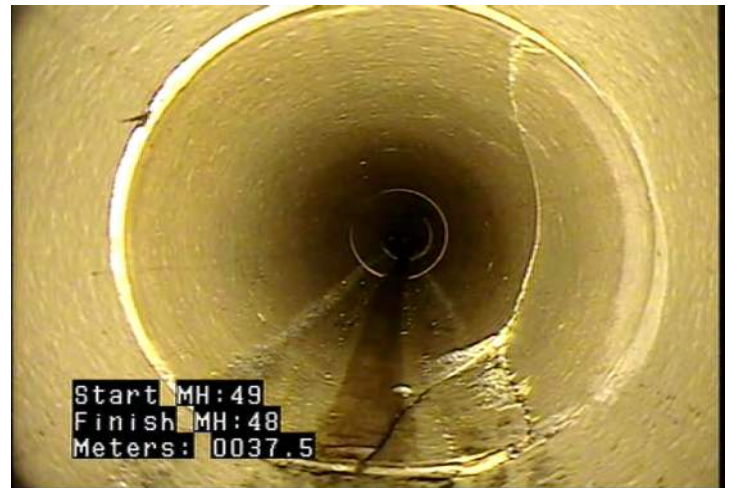
FM - Fracture Multiple @ 37.5 m.

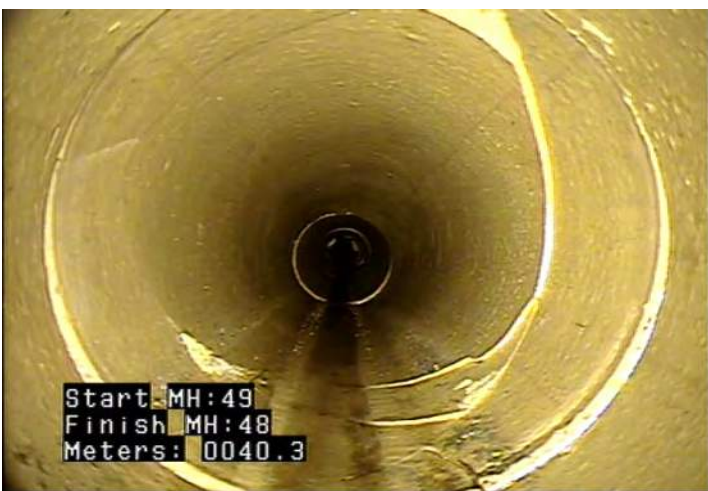
FM - Fracture Multiple @ 40.3 m.

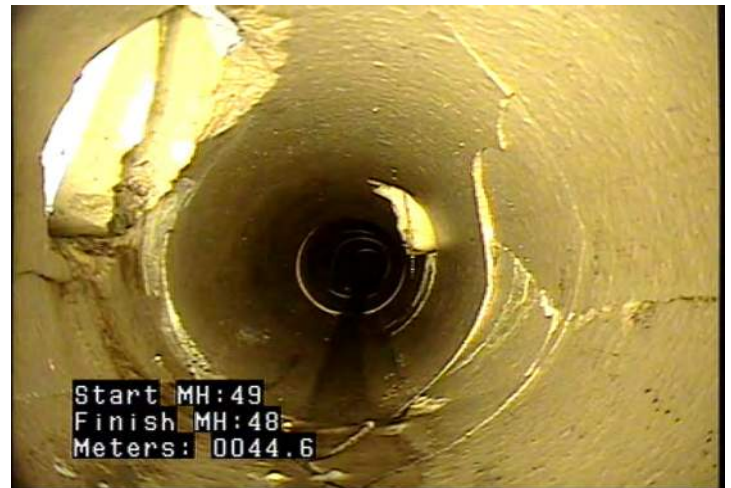
TB - Tap, Break-in / Hammer @ 44.6 m.

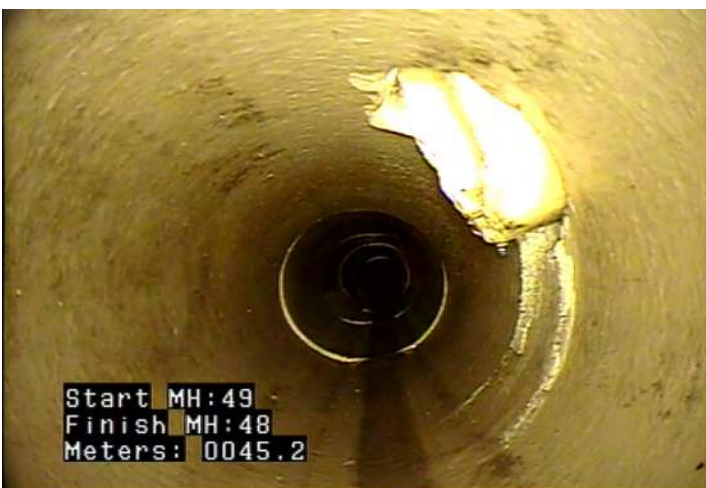
TBI - Tap, Break-in / Hammer: Intruding @ 45.2 m.

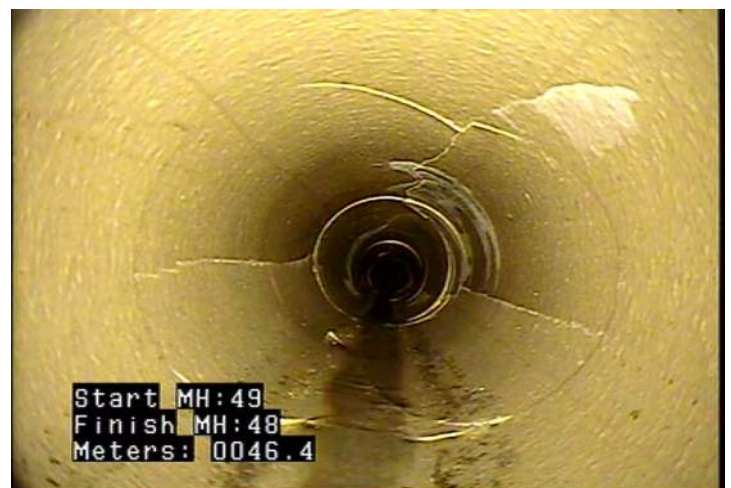
FM - Fracture Multiple @ 46.4 m.

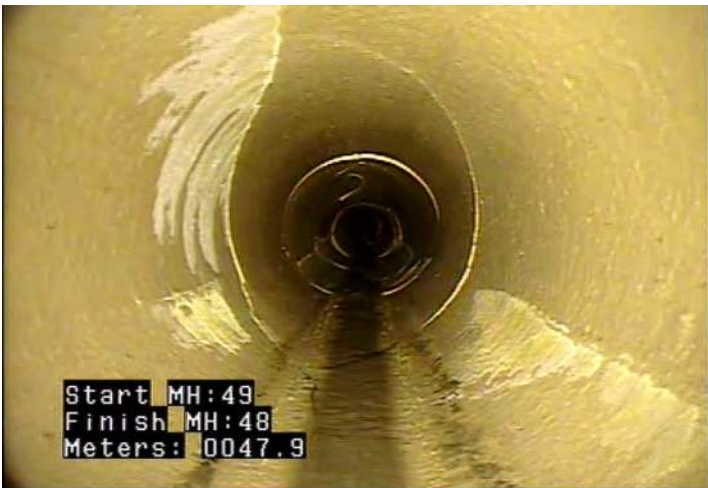
FM - Fracture Multiple @ 47.9 m.

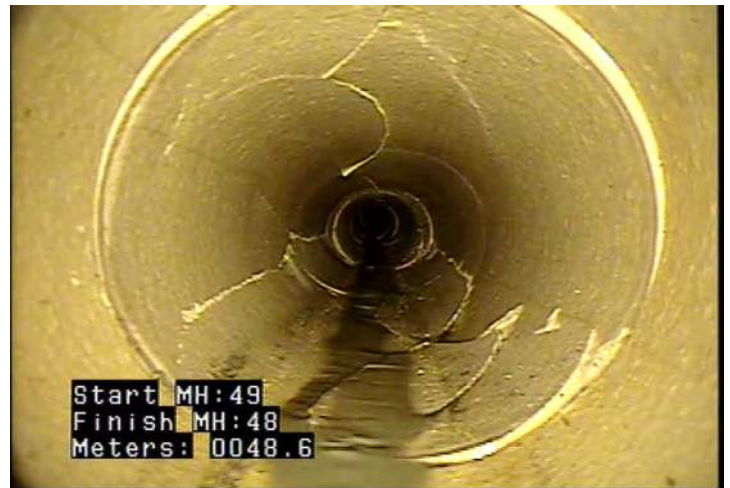
B - Pipe Broken @ 48.6 m.

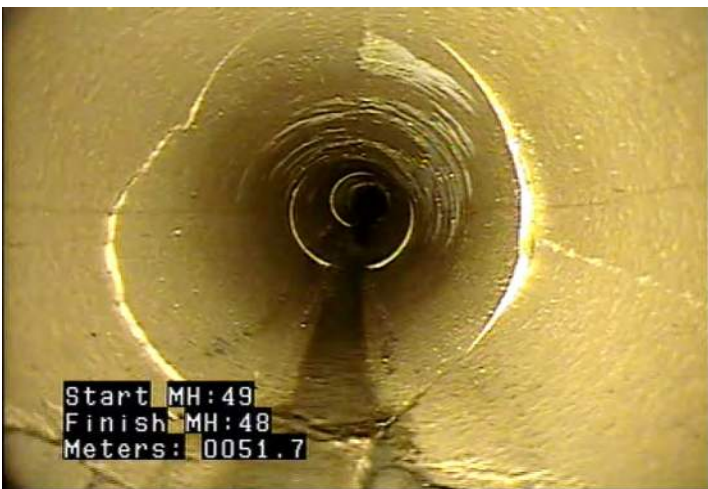
B - Pipe Broken @ 51.7 m.

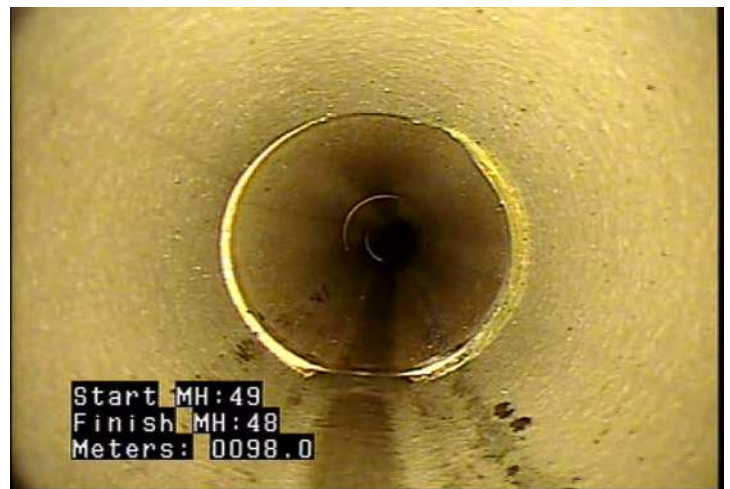
DAE - Deposits Attached: Encrustation @ 98.0 m.

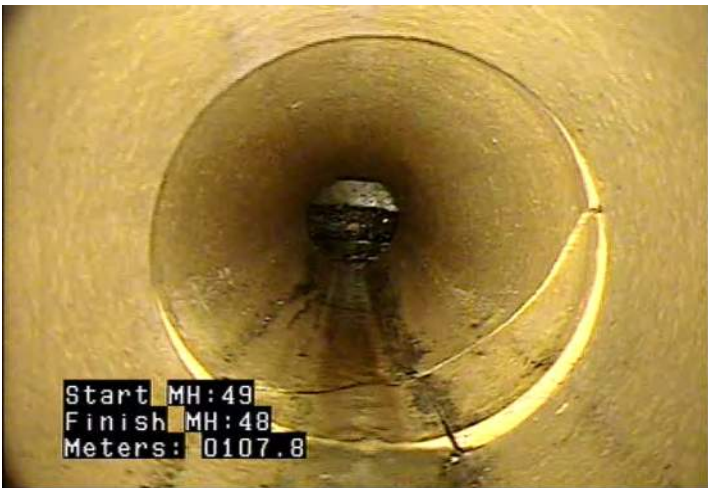
FM - Fracture Multiple @ 107.8 m.

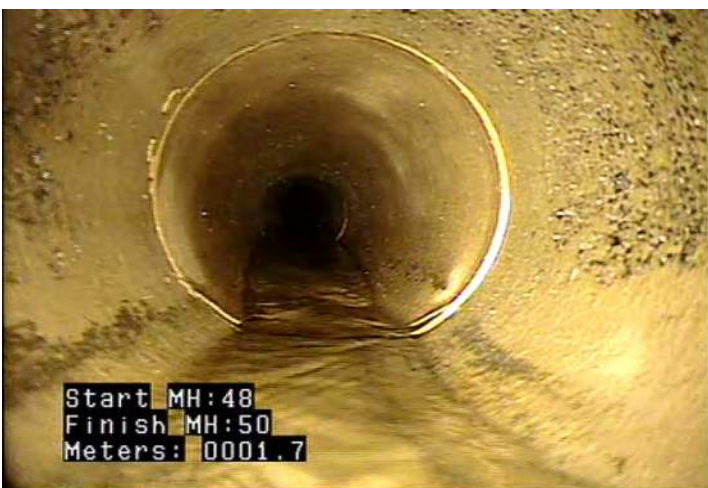
FS - Fracture Spiral @ 1.7 m.

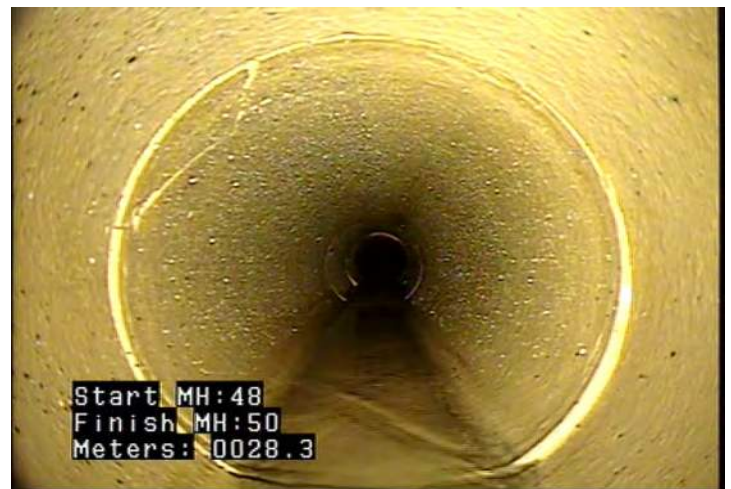
HVV - Hole in Pipe: Void Visible @ 30.6 m.

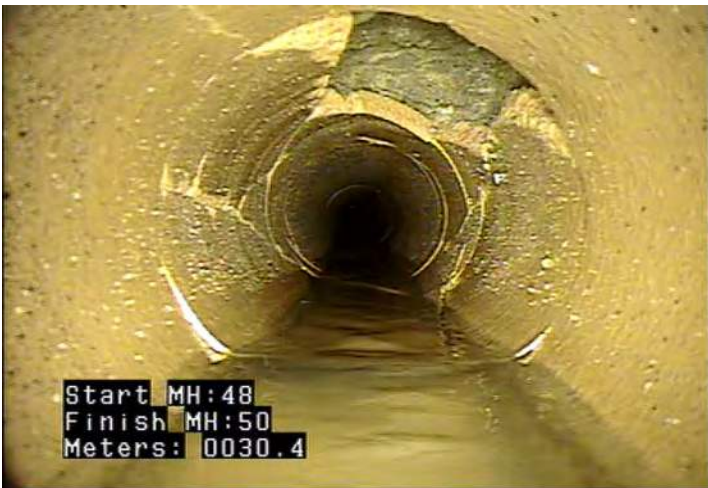
FM - Fracture Multiple @ 31.4 m.

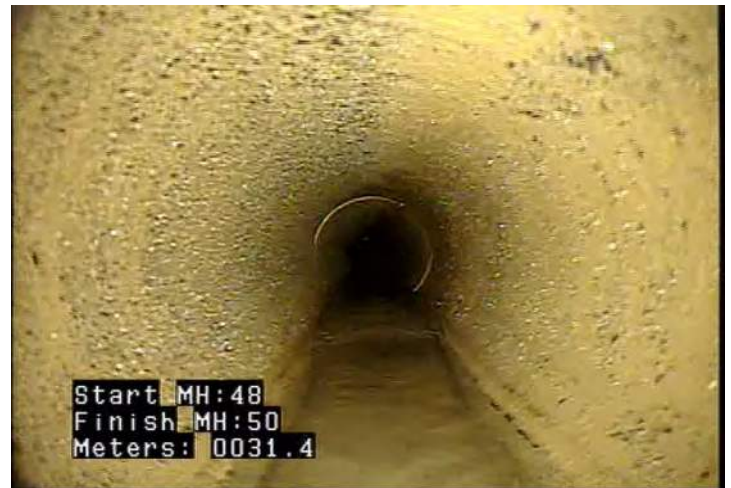
B - Pipe Broken @ 36.2 m.

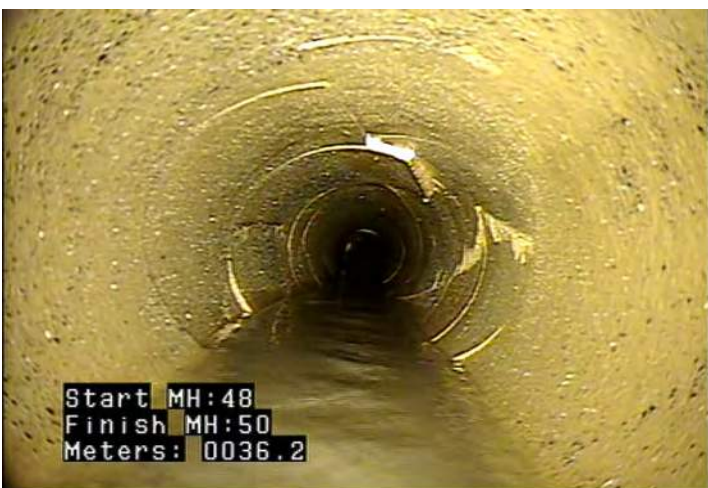
B - Pipe Broken @ 37.4 m.

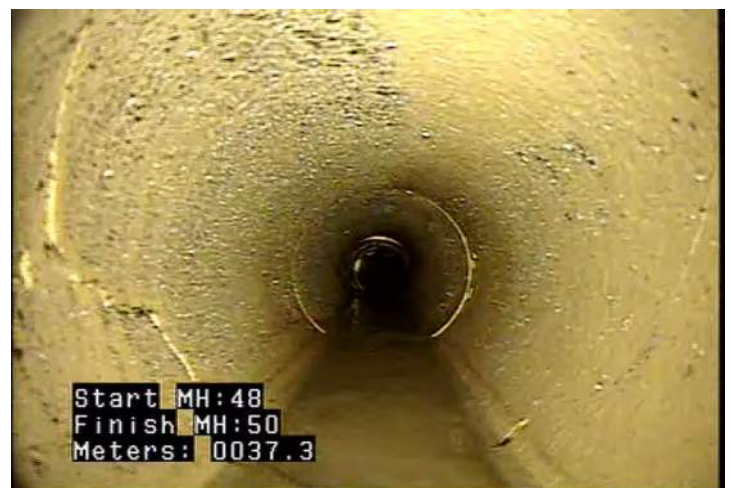
B - Pipe Broken @ 39.3 m.

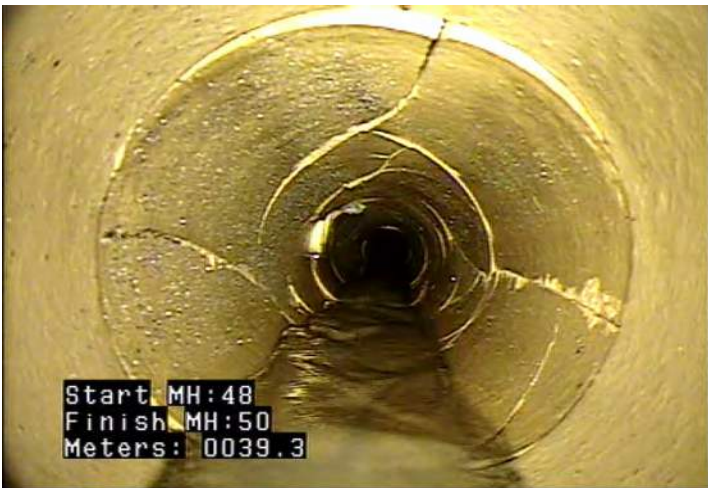
TBD - Tap, Break-in / Hammer: Defective @ 40.2 m. Plastic intruding from top of service.

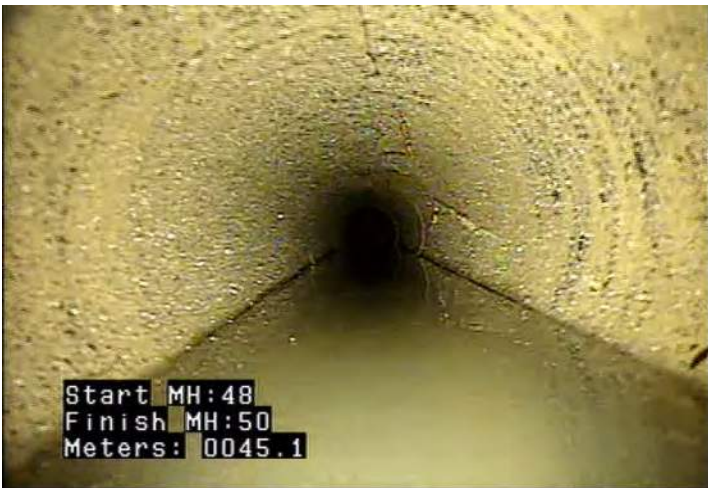
CM - Crack Multiple @ 45.1 m.

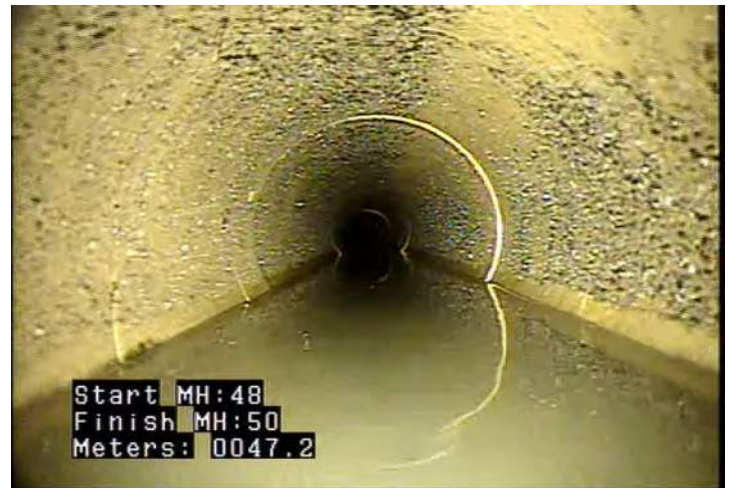
CM - Crack Multiple @ 47.2 m.

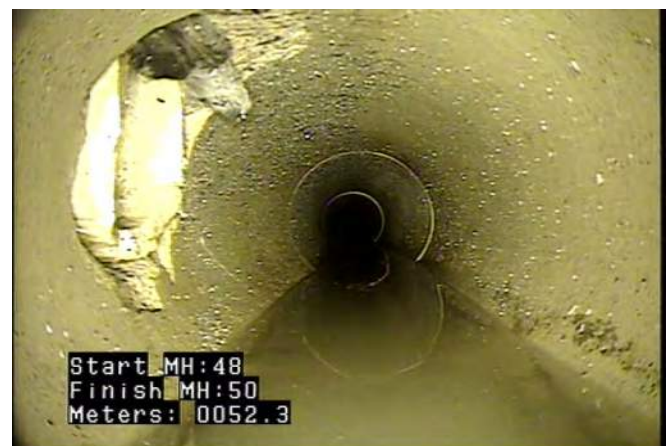
TBD - Tap, Break-in / Hammer: Defective @ 52.3 m. Plastic intruding from top of service.

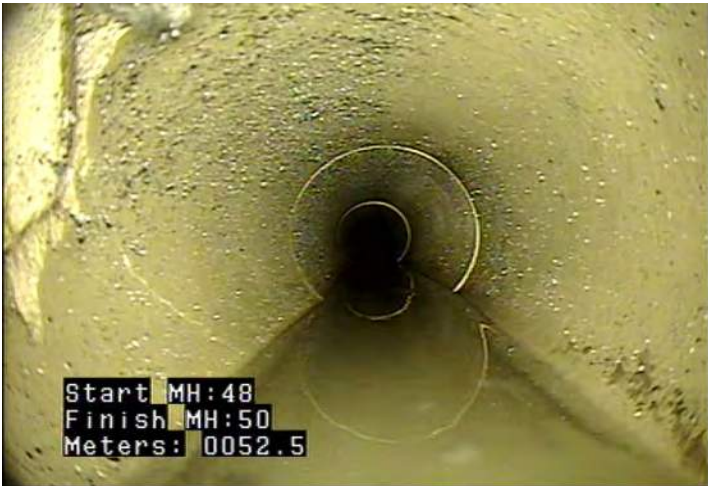
CS - Crack Spiral @ 52.5 m.

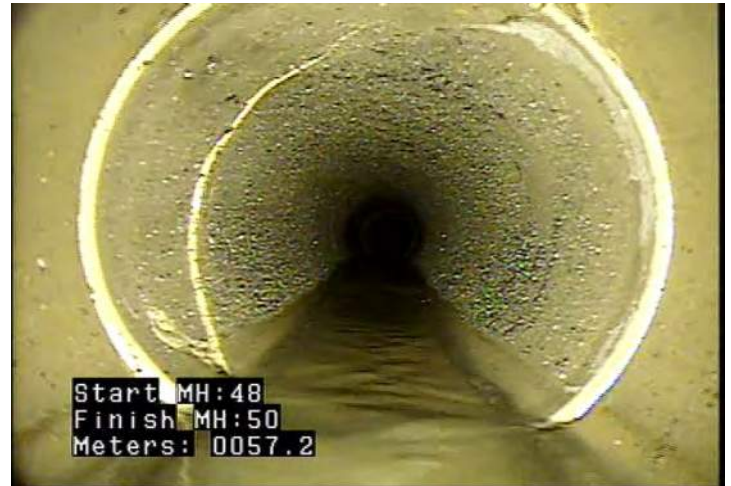
FS - Fracture Spiral @ 57.2 m.

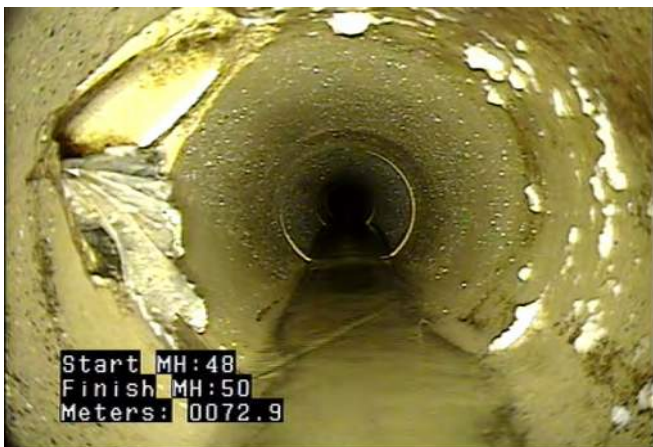
TBD - Tap, Break-in / Hammer: Defective @ 72.9 m. Plastic intruding from bottom of service.

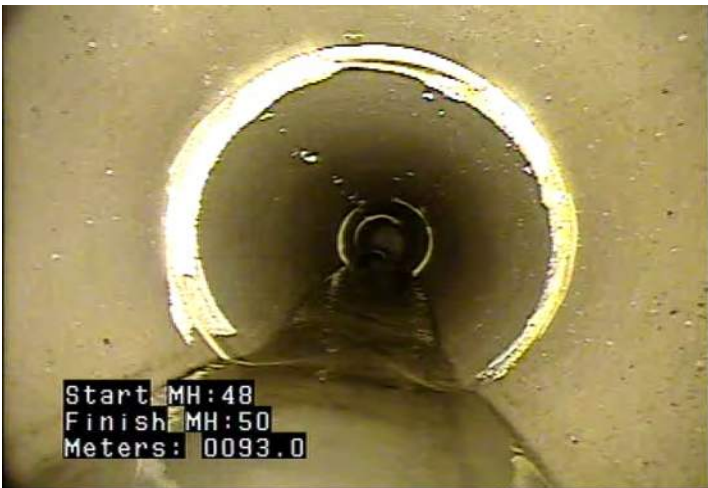
FS - Fracture Spiral @ 93.0 m.

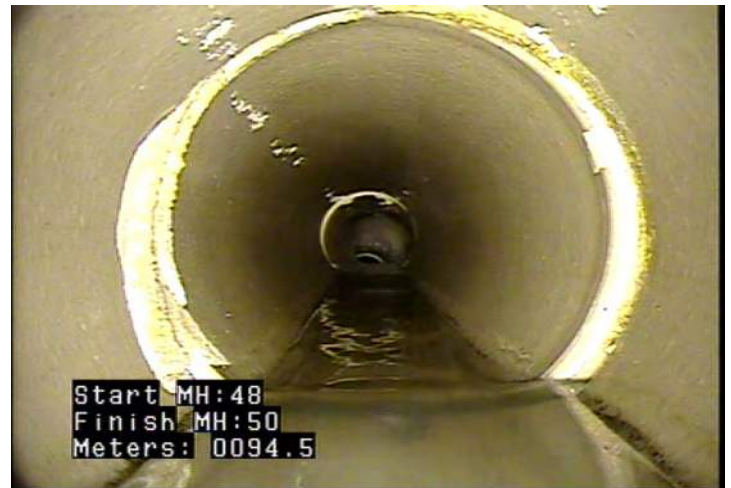
DAE - Deposits Attached: Encrustation @ 94.5 m.

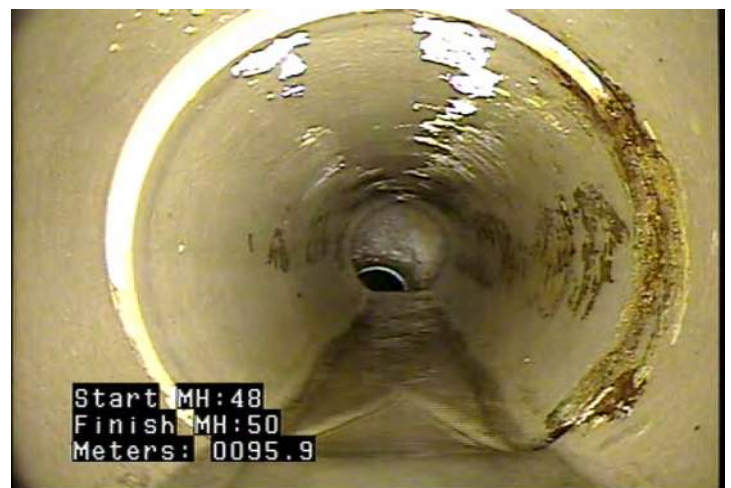
DAE - Deposits Attached: Encrustation @ 95.9 m.

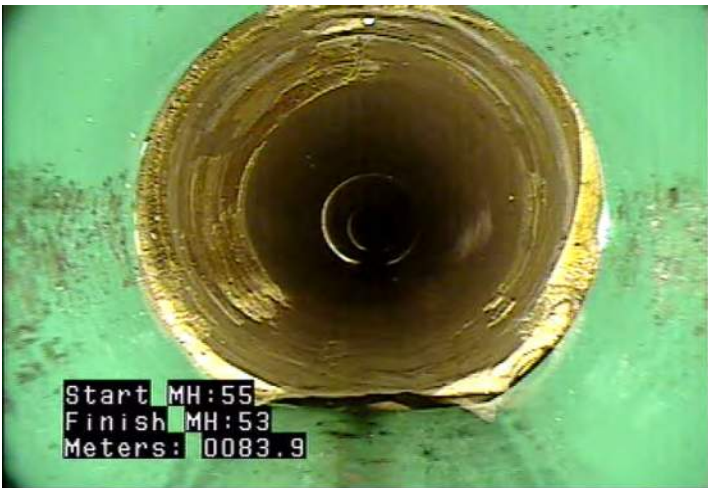
FS - Fracture Spiral @ 84.0 m.

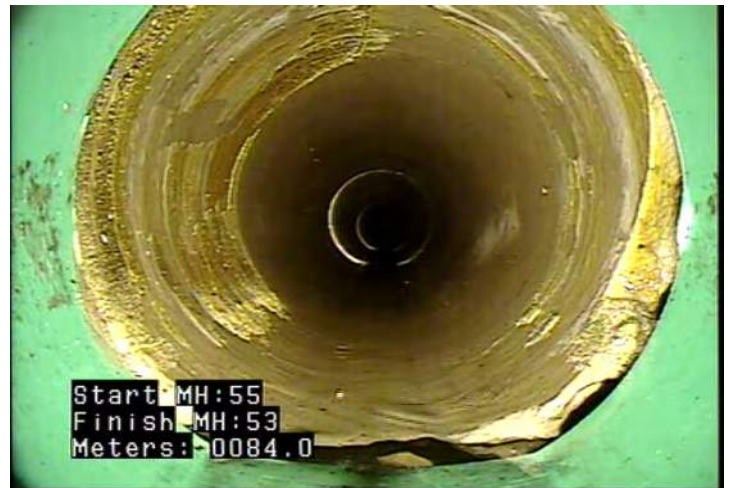
H - Hole in Pipe @ 84.0 m.

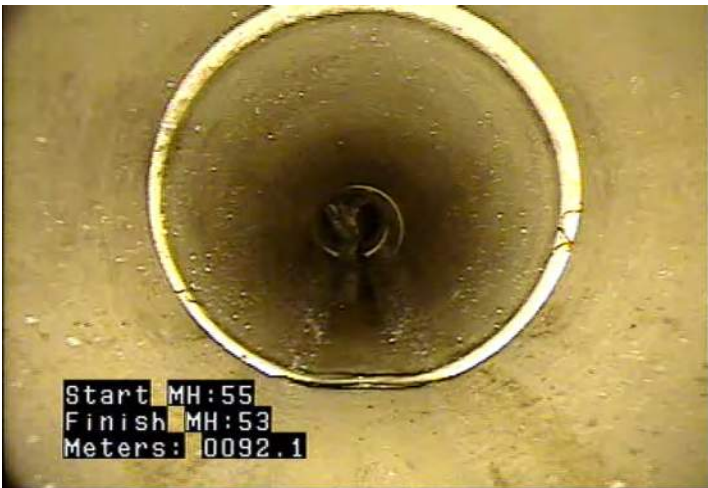
RFJ - Roots, Fine: Joint @ 92.1 m.

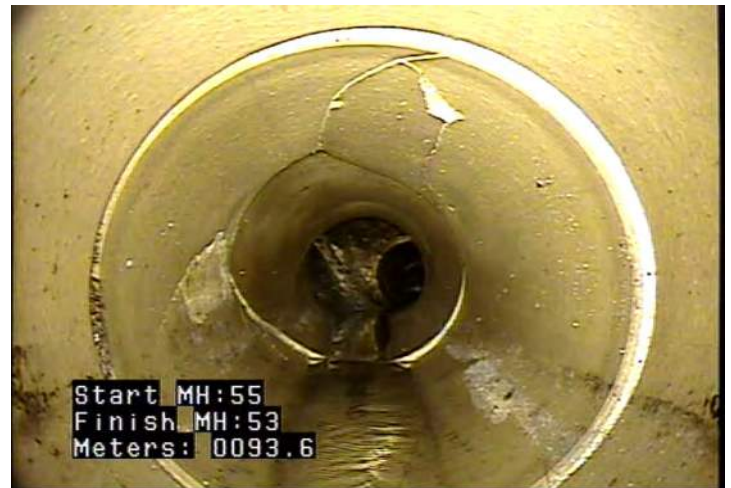
B - Pipe Broken @ 93.6 m.

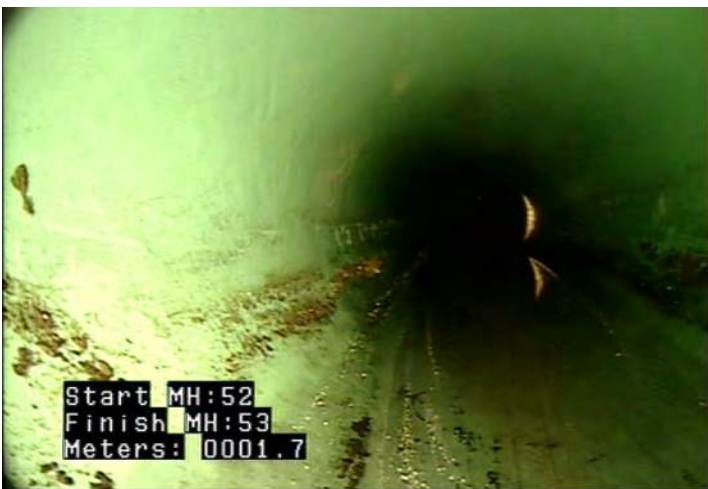
MWLS - Water Level: Sag @ 1.7 m.

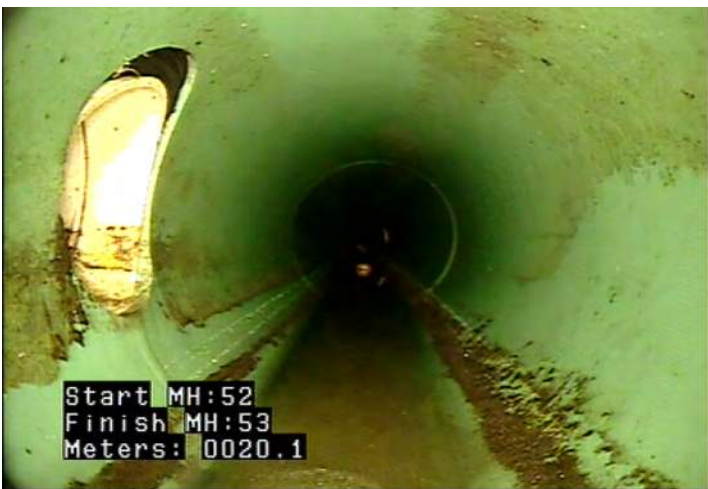
TSD - Tap, Saddle: Defective @ 20.1 m.
Hole for service overcut.

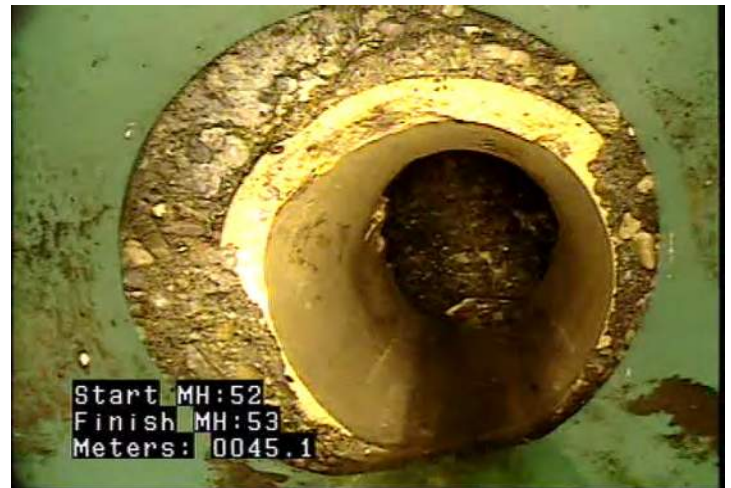
MMC - Material Change @ 45.1 m. PVC to Clay tile

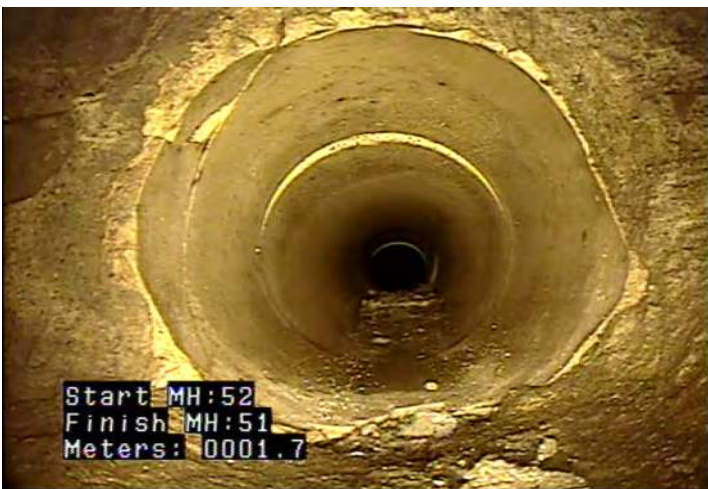
CC - Crack Circumferential @ 0.5 m. At
MH opening

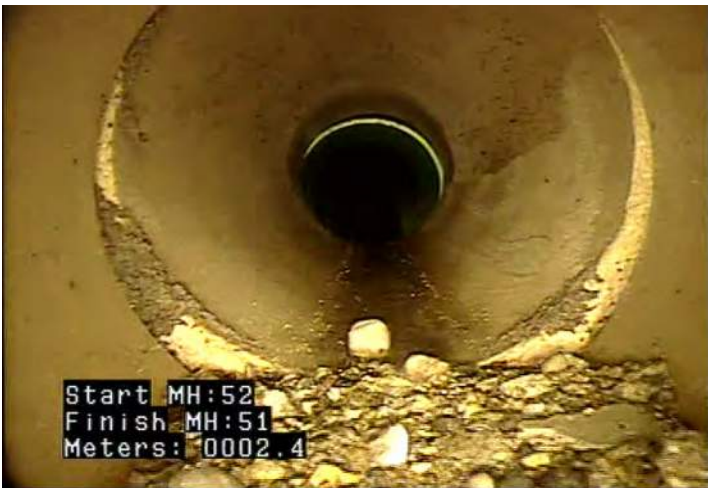
JOM - Joint Offset (displaced): Medium @ 2.4 m.

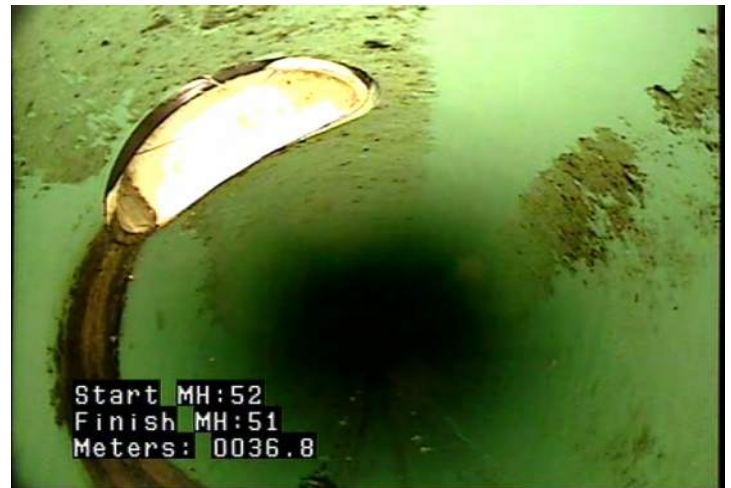
TSD - Tap, Saddle: Defective @ 36.8 m.
Gasket visible around service.

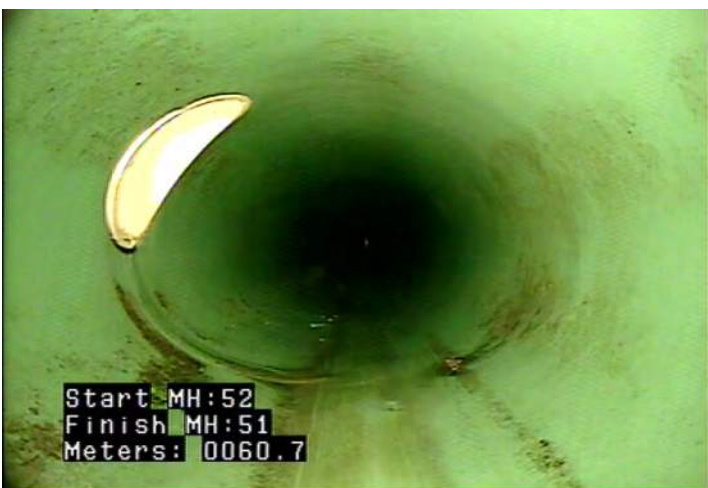
D - Pipe Deformed @ 60.7 m.

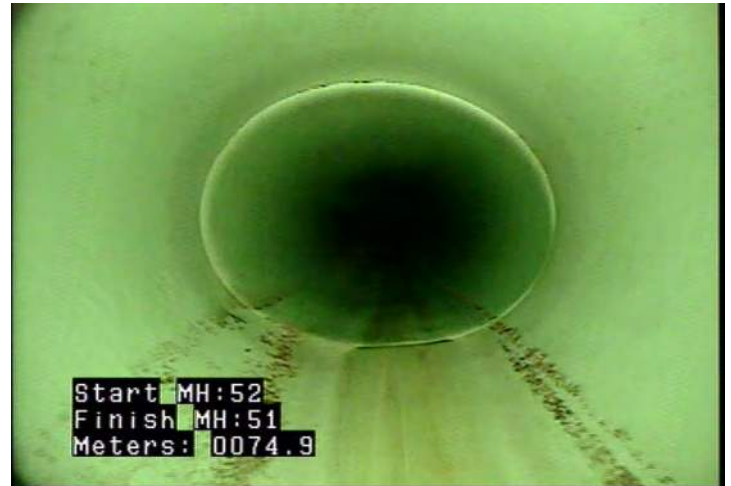
D - Pipe Deformed @ 74.9 m.

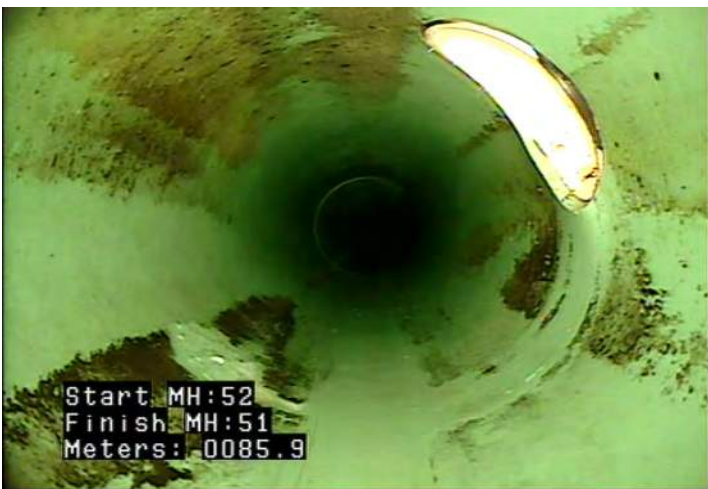
TSD - Tap, Saddle: Defective @ 85.9 m.
Gasket visible around service.

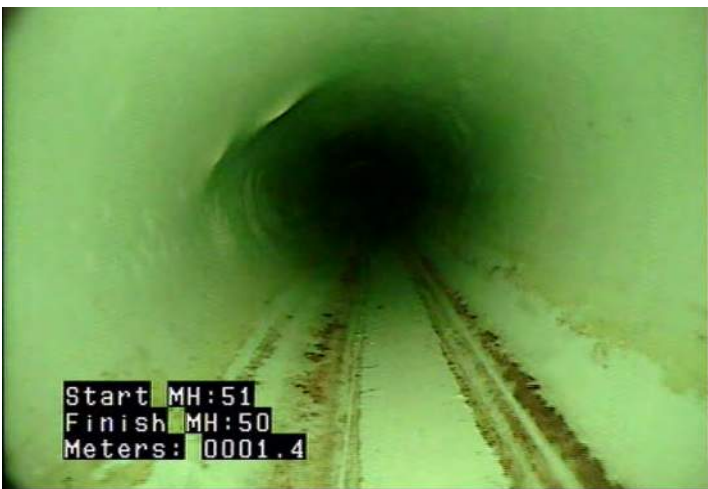
KD - Buckling Dimpling @ 1.4 m.

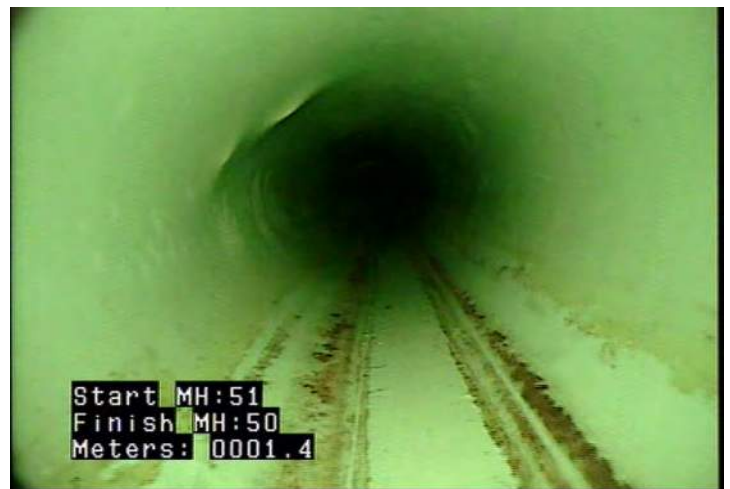
MWLS - Water Level: Sag @ 54.9 m.

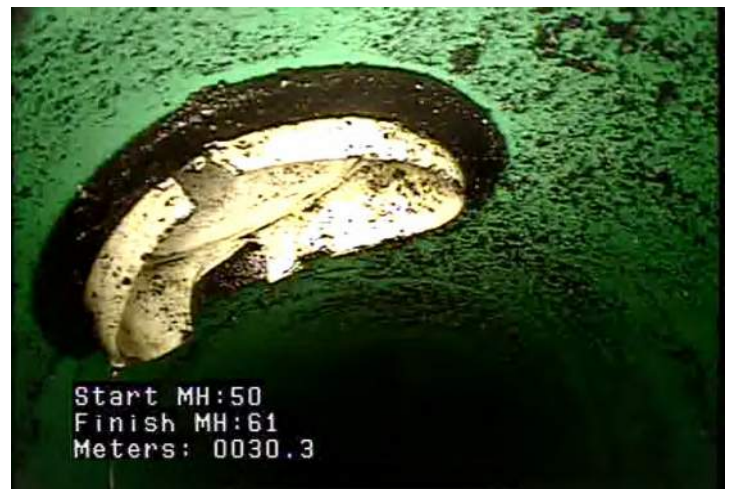
TSD - Tap, Saddle: Defective @ 30.3 m.
Chipped

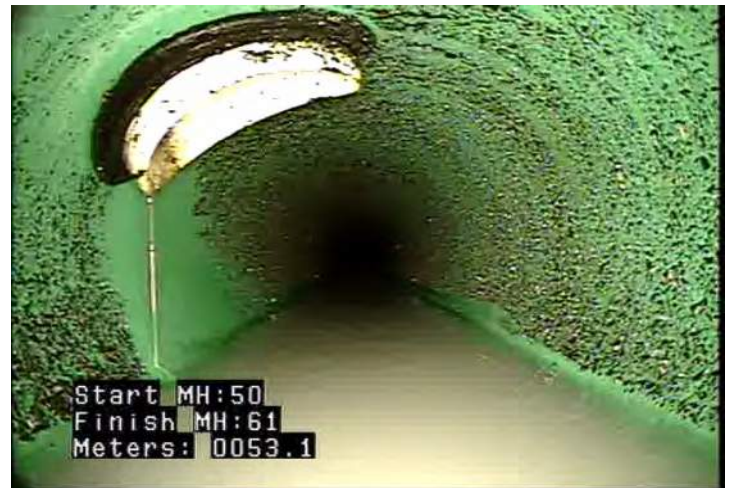
TSI - Tap, Saddle: Intruding @ 53.1 m.

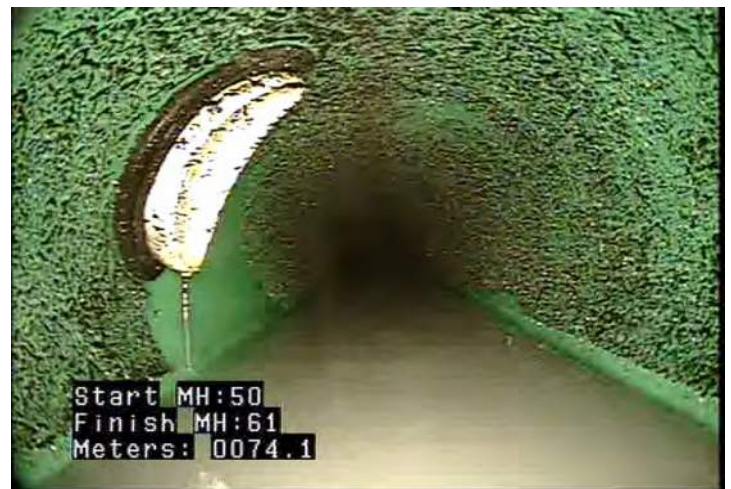
TSI - Tap, Saddle: Intruding @ 74.1 m.

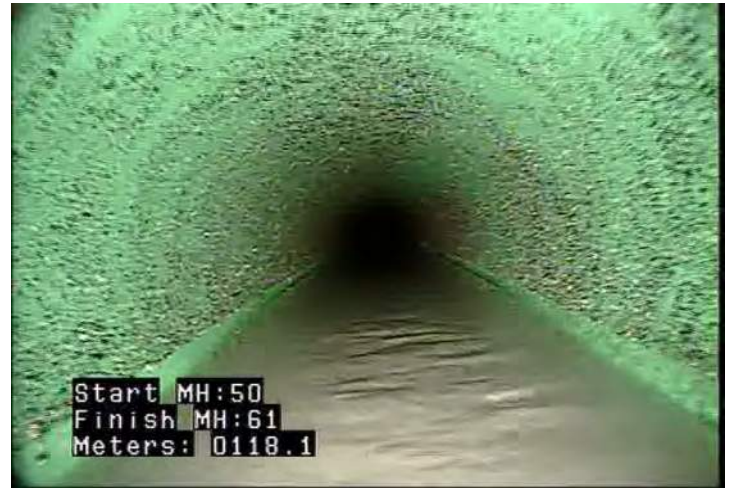
MWL - Water Level @ 118.1 m.

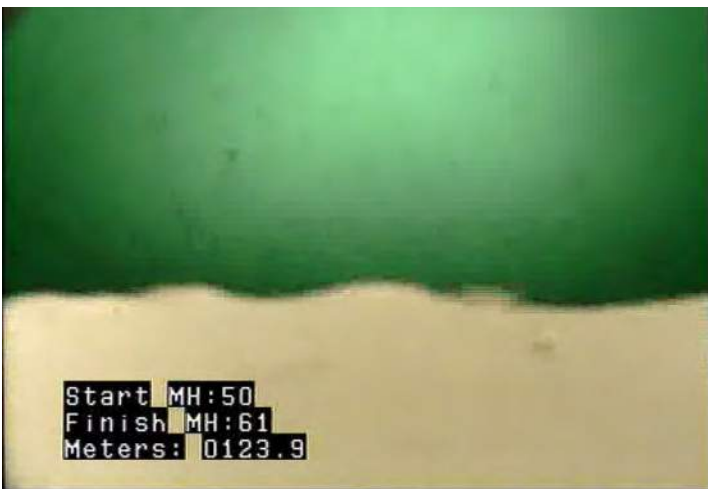
MWL - Water Level @ 123.9 m.

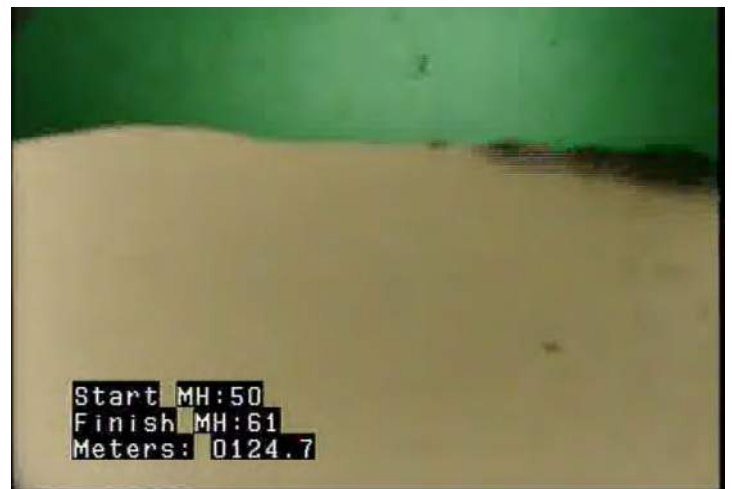
MCU - Camera Underwater @ 124.7 m.

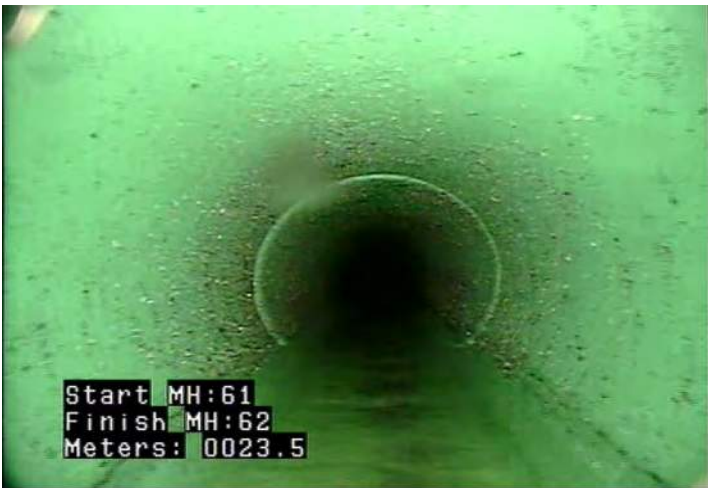
MWLS - Water Level: Sag @ 23.5 m.

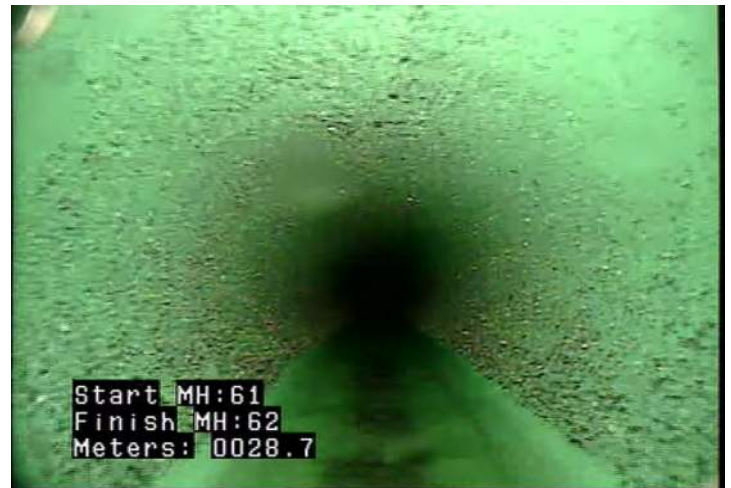
MWLS - Water Level: Sag @ 28.7 m.

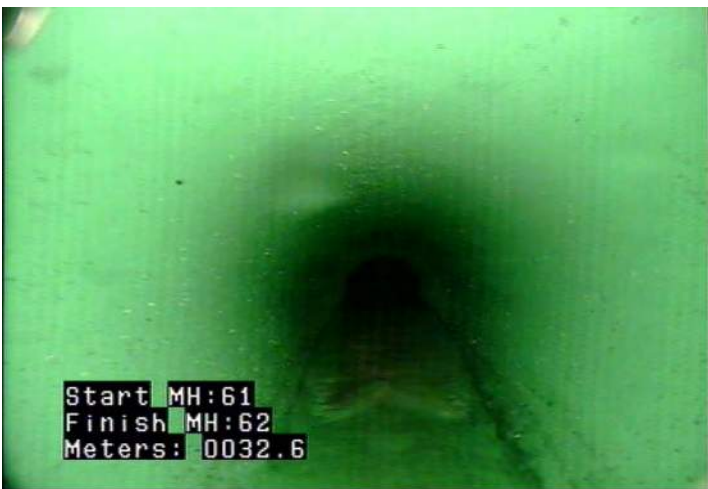
MWLS - Water Level: Sag @ 32.6 m.

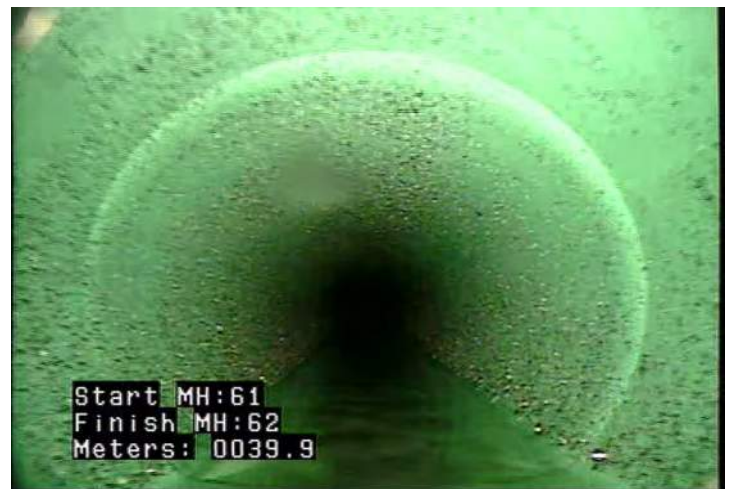
MWLS - Water Level: Sag @ 39.9 m.

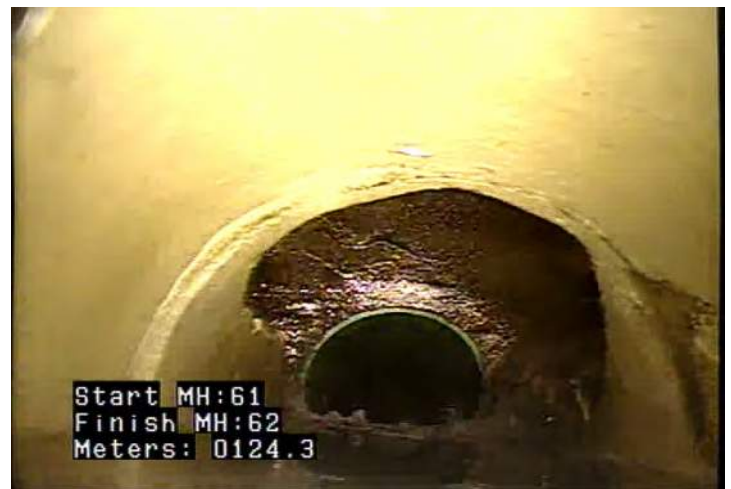
FC - Fracture Circumferential @ 124.3 m.
