Appendix F CCTV Assessment

Client: CIMA
 Project: Pre-Rehabilitation Survey
 Date: 12/18/2020
 File: 14257

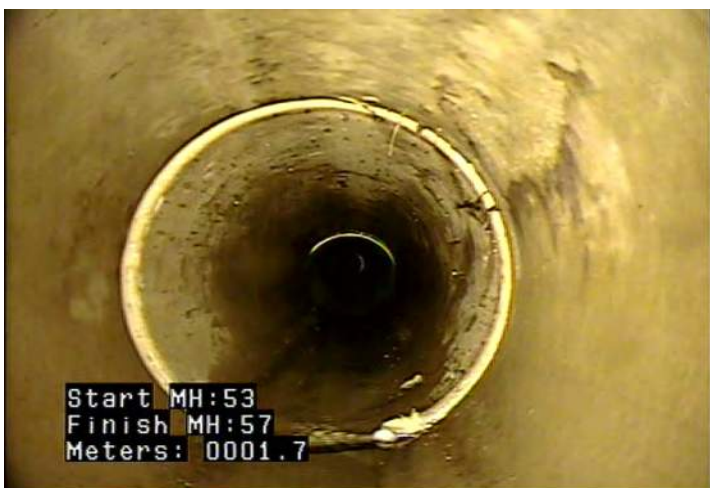
RFJ - Roots, Fine: Joint @ 1.7 m.

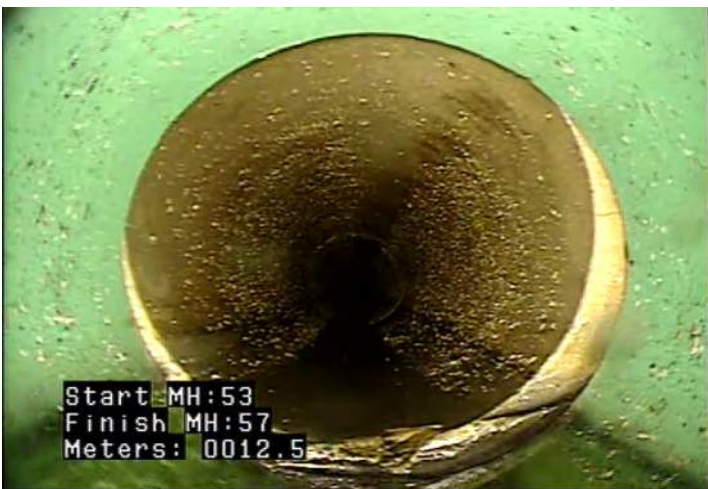
JOM - Joint Offset (displaced): Medium @ 12.5 m.

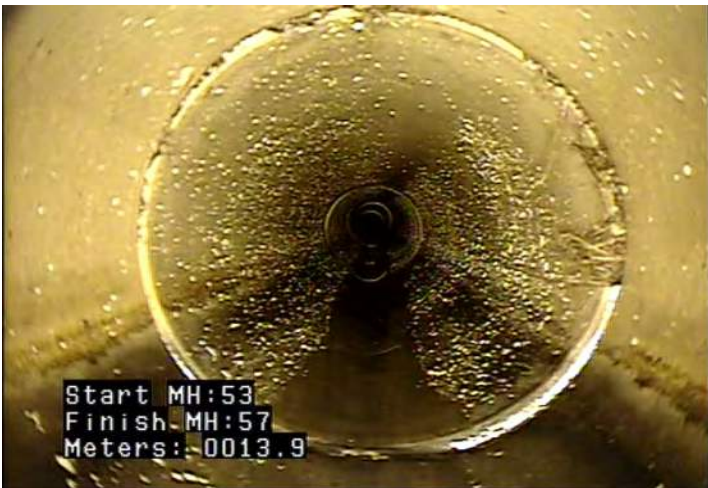
RFJ - Roots, Fine: Joint @ 13.9 m.

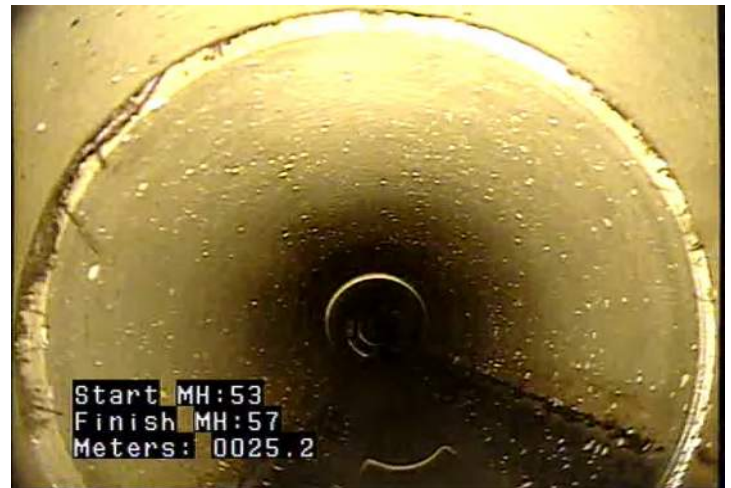
RFJ - Roots, Fine: Joint @ 25.2 m.

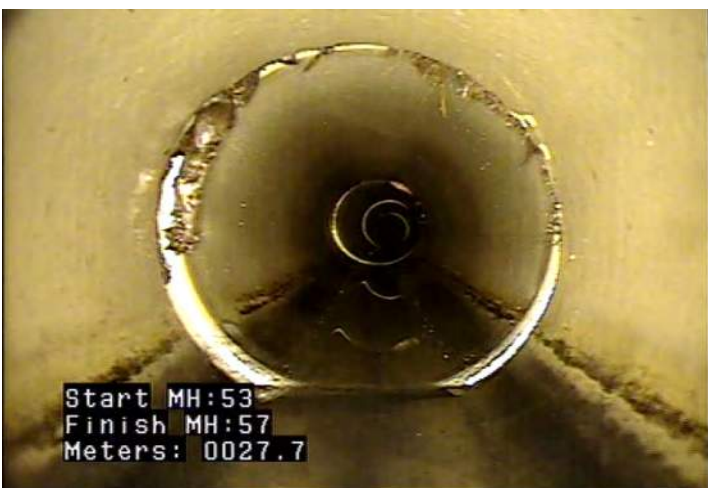
RTJ - Roots, Tap: Joint @ 27.7 m.

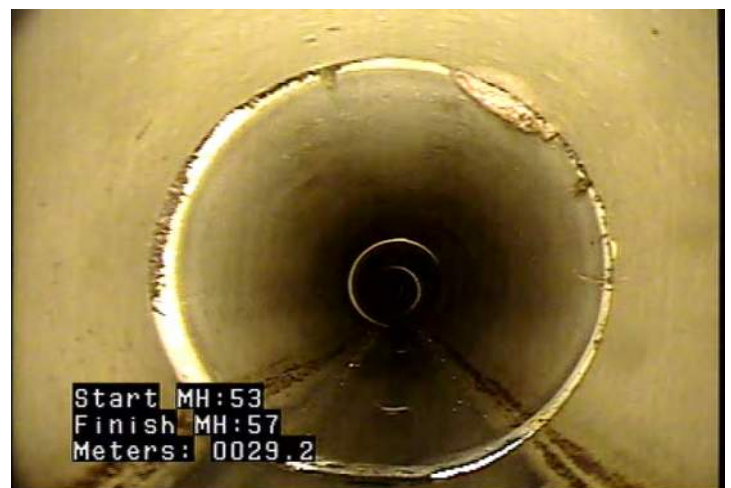
RFJ - Roots, Fine: Joint @ 29.2 m.

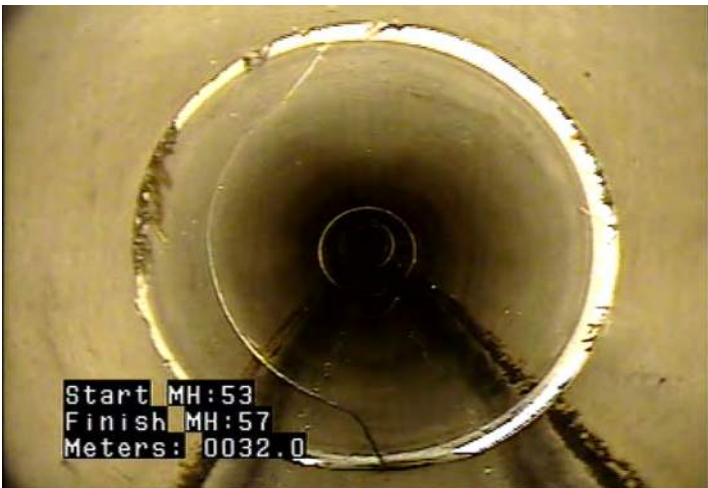
25.2		RFJ	Roots, Fine: Joint	8 to 11				
	27.7		RTJ	Roots, Tap: Joint	10	10		J	
	29.2		RFJ	Roots, Fine: Joint	8 to 4				
	32.0		FS	Fracture Spiral	6 to 12			J	
	32.0		RFJ	Roots, Fine: Joint	8 to 10

FS - Fracture Spiral @ 32.0 m.

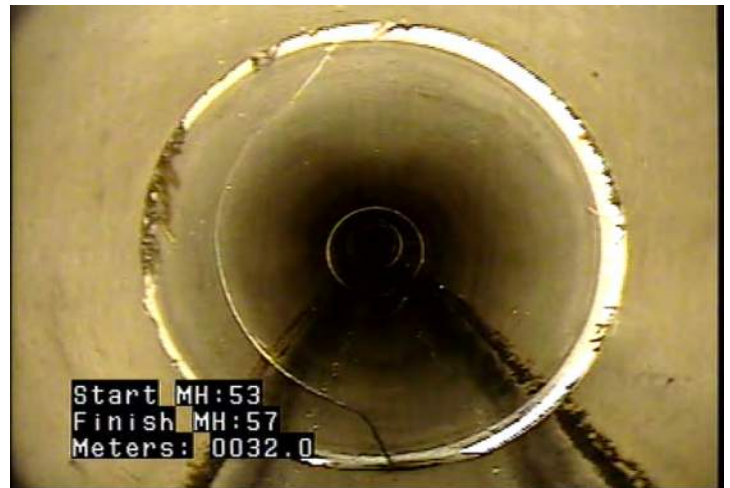
RFJ - Roots, Fine: Joint @ 32.0 m.

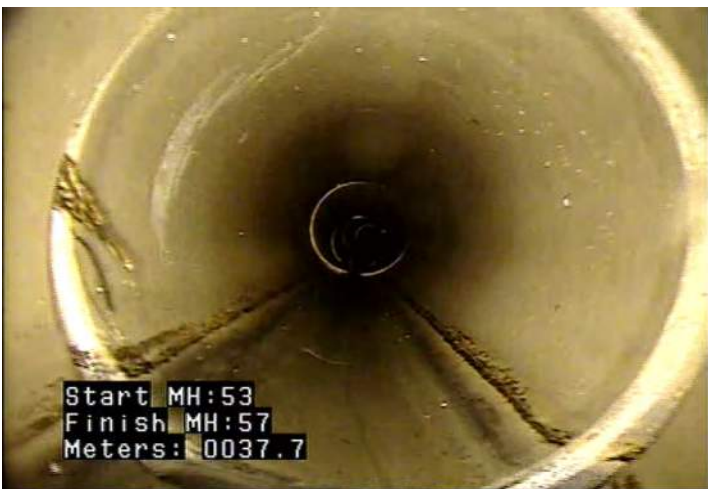
RFJ - Roots, Fine: Joint @ 37.7 m.

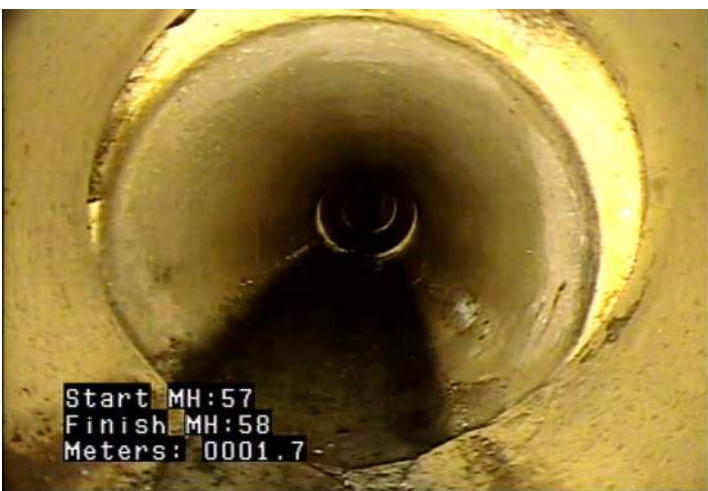
JOL - Joint Offset (displaced): Large @ 1.7 m.

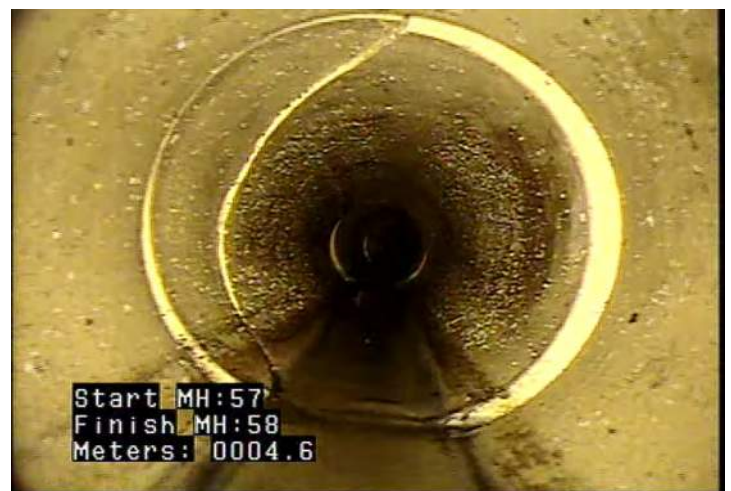
FS - Fracture Spiral @ 4.6 m.

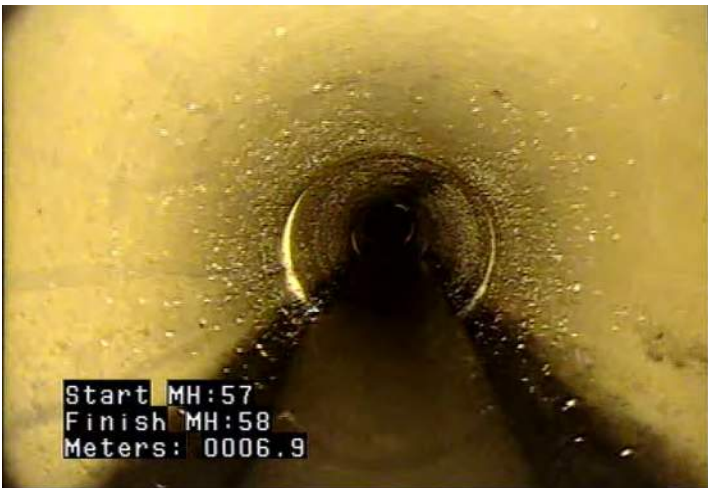
MWLS - Water Level: Sag @ 6.9 m.

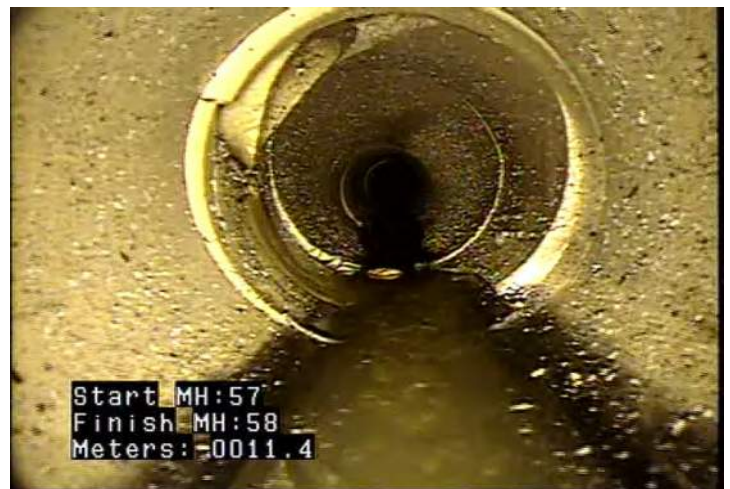
B - Pipe Broken @ 11.4 m.

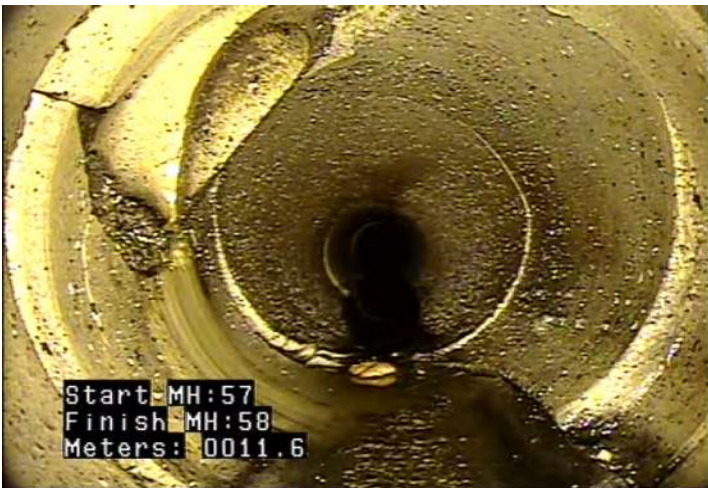
TB - Tap, Break-in / Hammer @ 11.6 m.

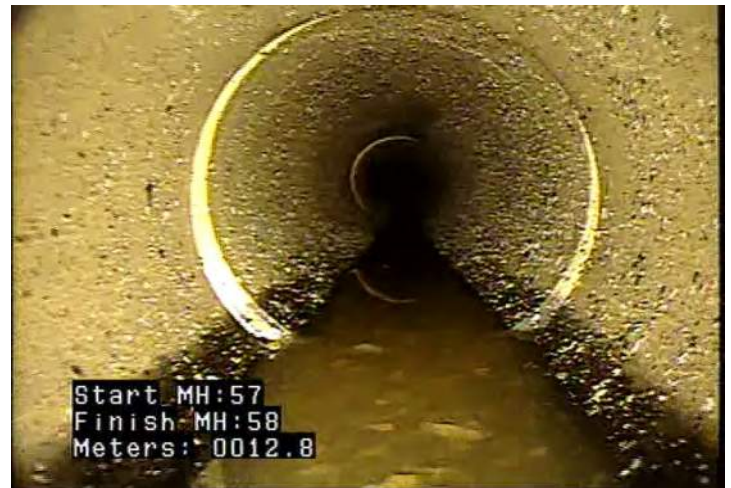
CM - Crack Multiple @ 12.8 m.

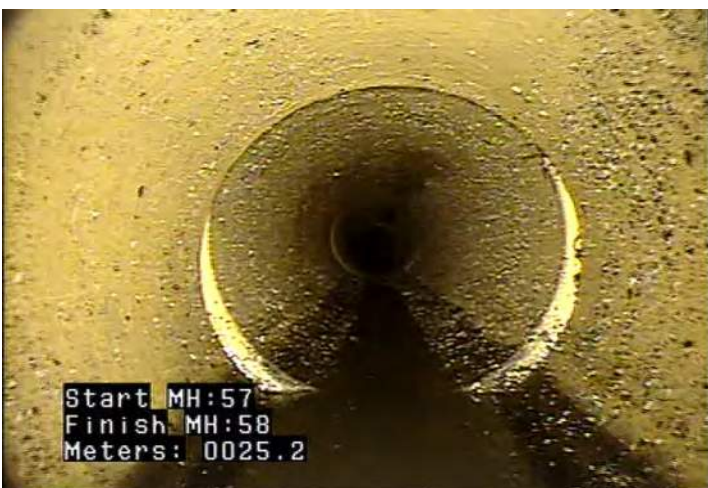
RFJ - Roots, Fine: Joint @ 25.2 m.

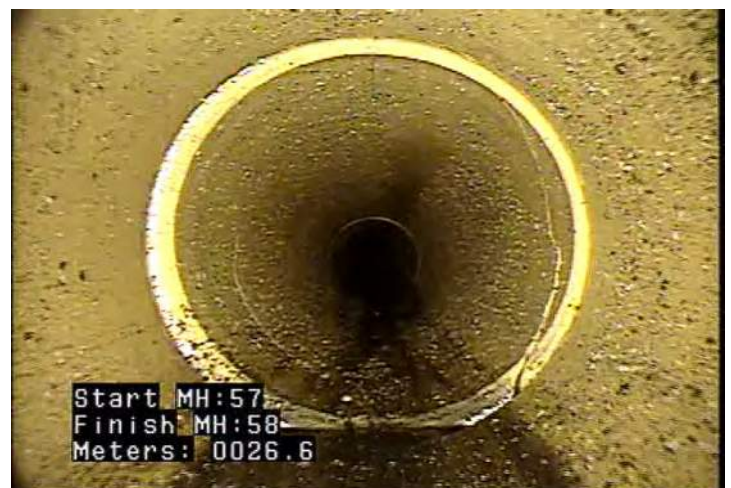
FM - Fracture Multiple @ 26.6 m.

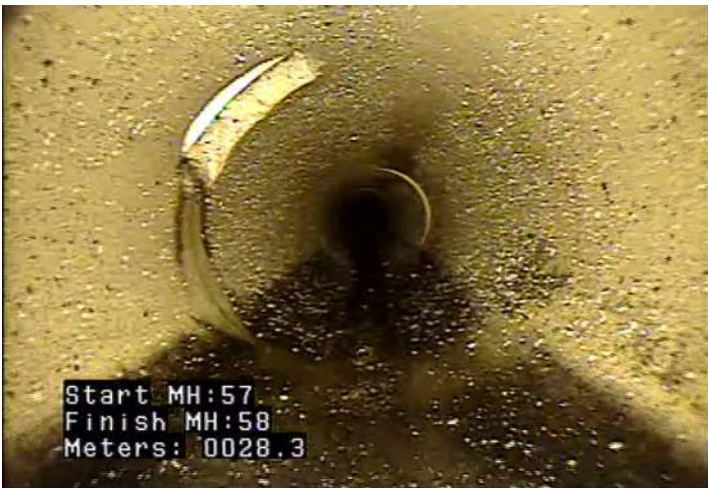
TB - Tap, Break-in / Hammer @ 28.3 m.

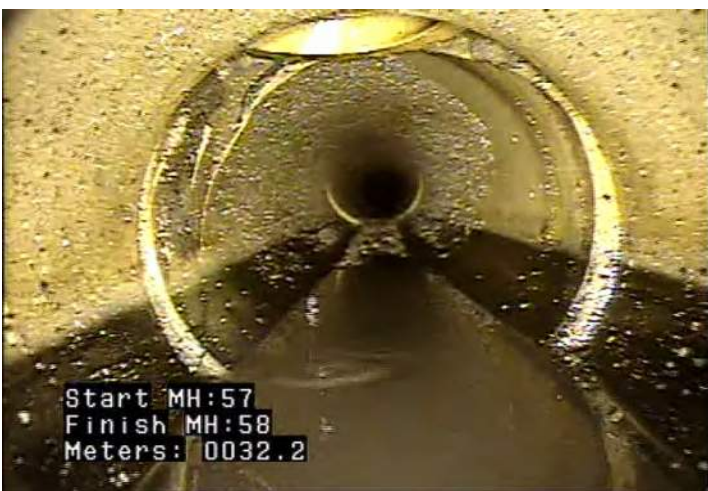
FM - Fracture Multiple @ 32.2 m.

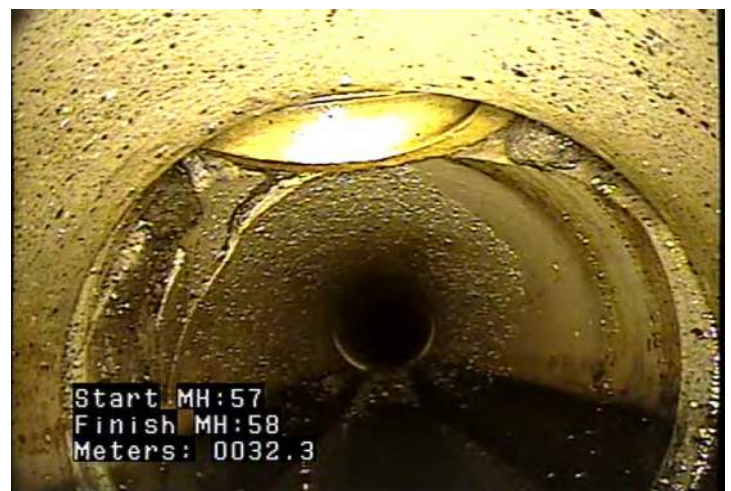
TB - Tap, Break-in / Hammer @ 32.3 m.

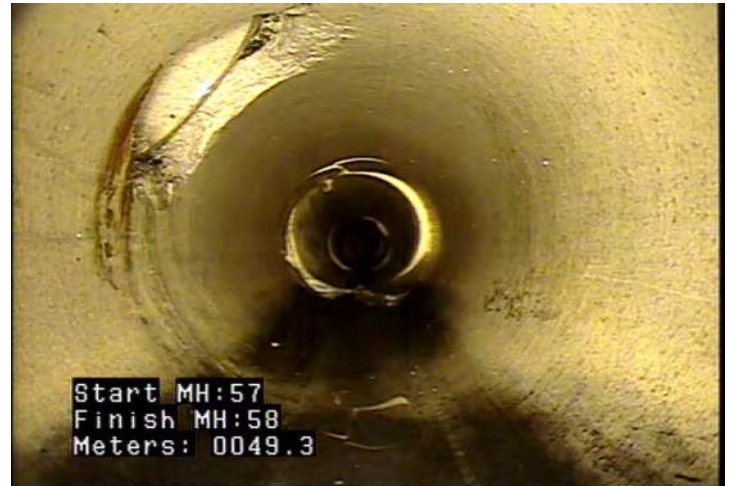
TB - Tap, Break-in / Hammer @ 49.3 m.

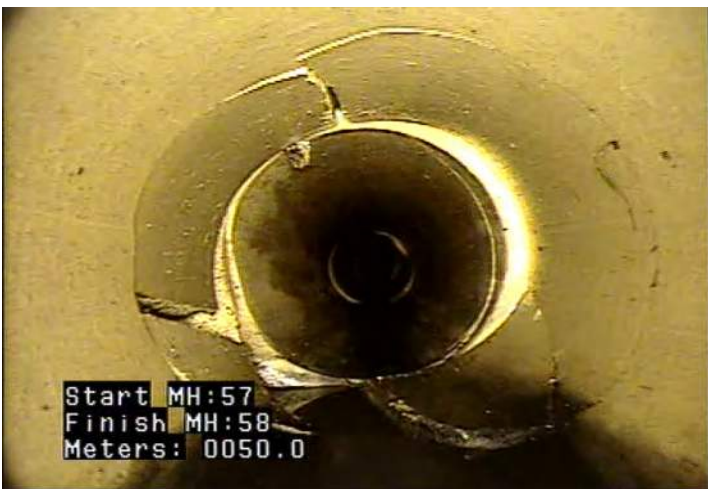
B - Pipe Broken @ 50.0 m.

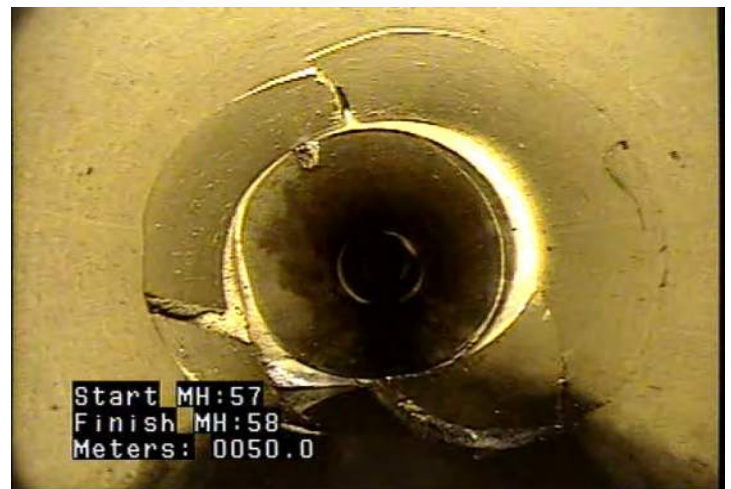
TB - Tap, Break-in / Hammer @ 51.9 m.

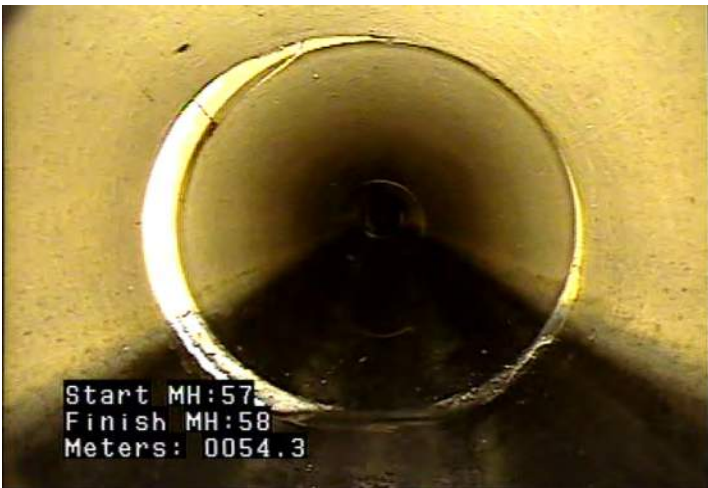
FS - Fracture Spiral @ 54.3 m.

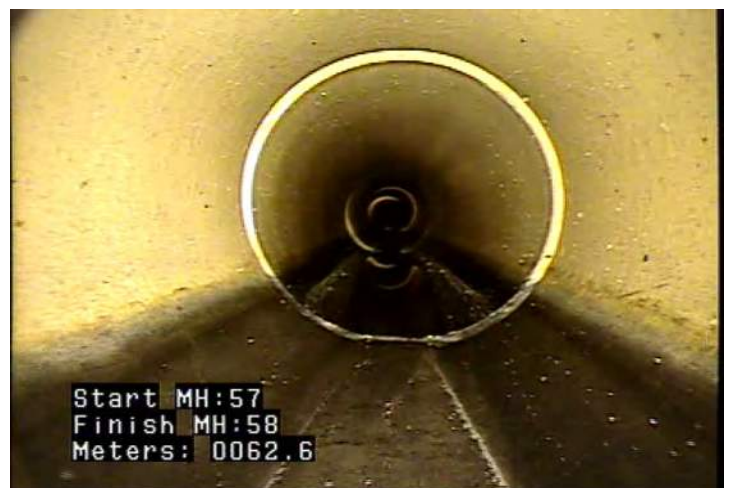
FS - Fracture Spiral @ 66.9 m.

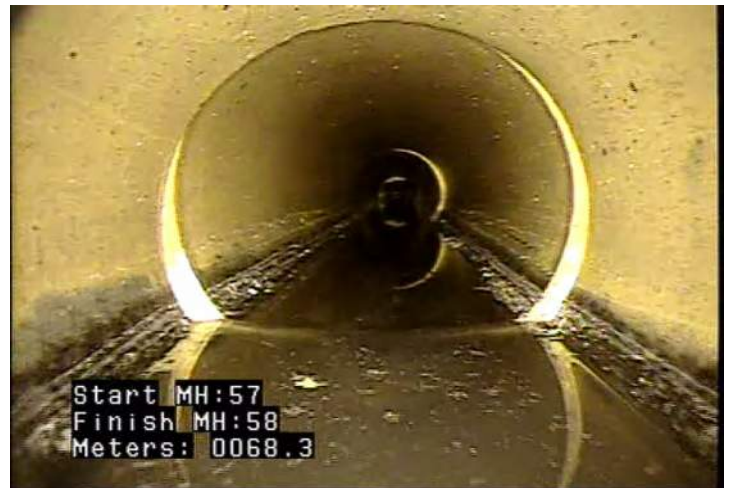
JOM - Joint Offset (displaced): Medium @ 68.3 m.

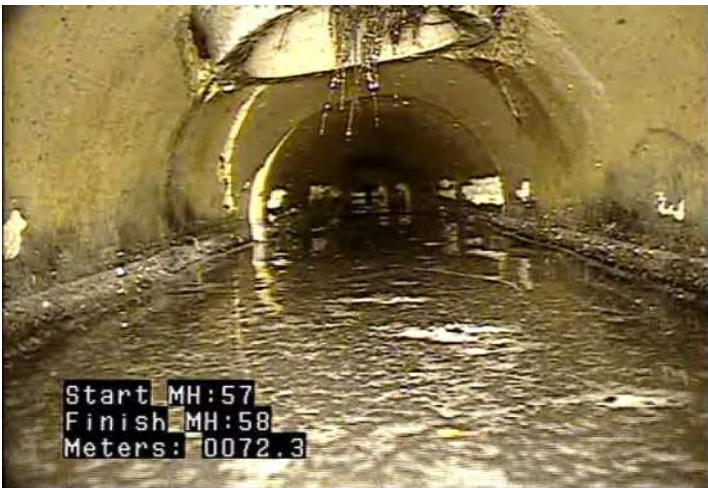
B - Pipe Broken @ 72.4 m. After tap

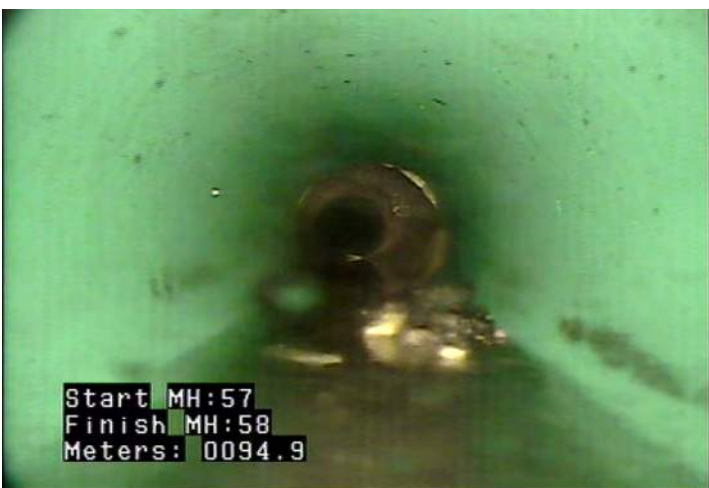
DSGV - Deposits Settled: Gravel @ 94.9 m.

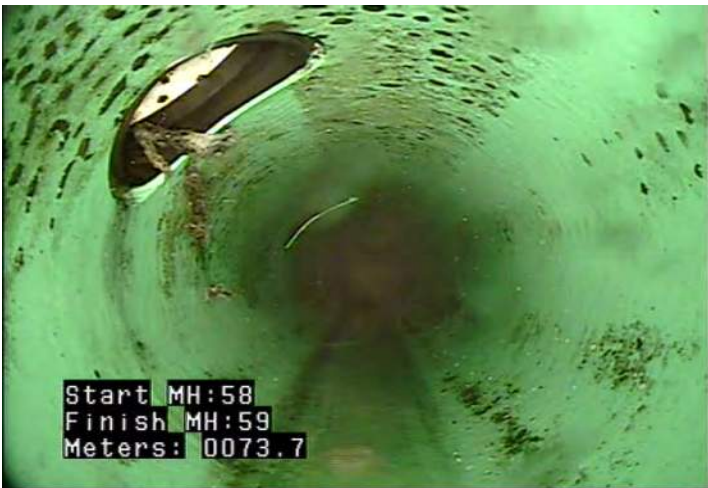
RFC - Roots, Fine: Connection @ 73.7 m.

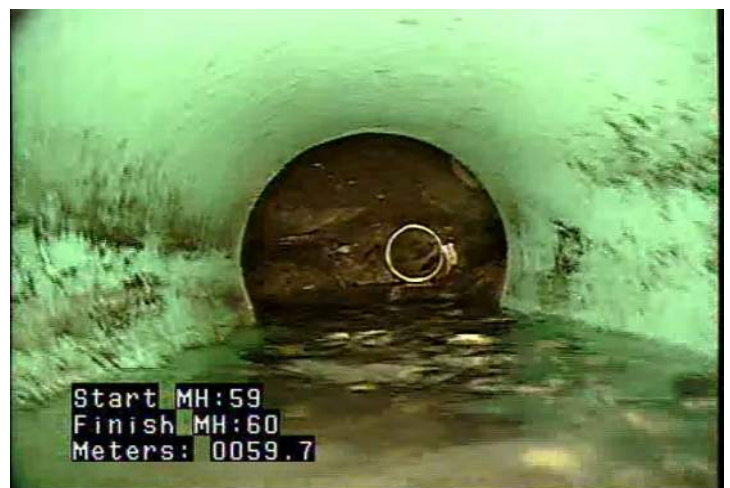
DSGV - Deposits Settled: Gravel @ 59.7 m.

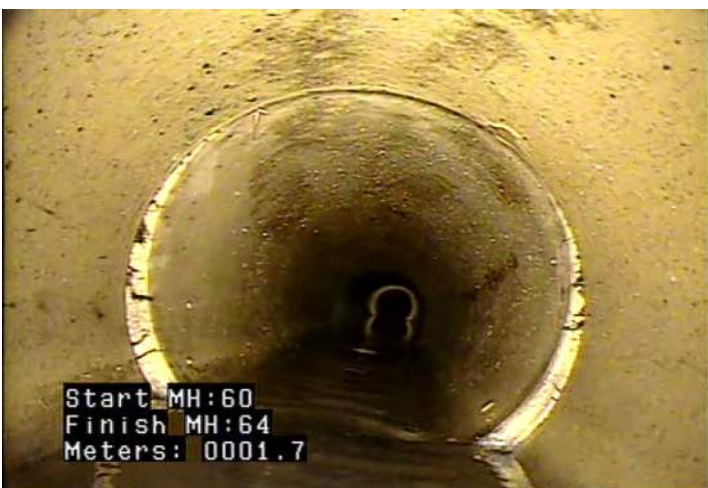
RFJ - Roots, Fine: Joint @ 1.2 m.

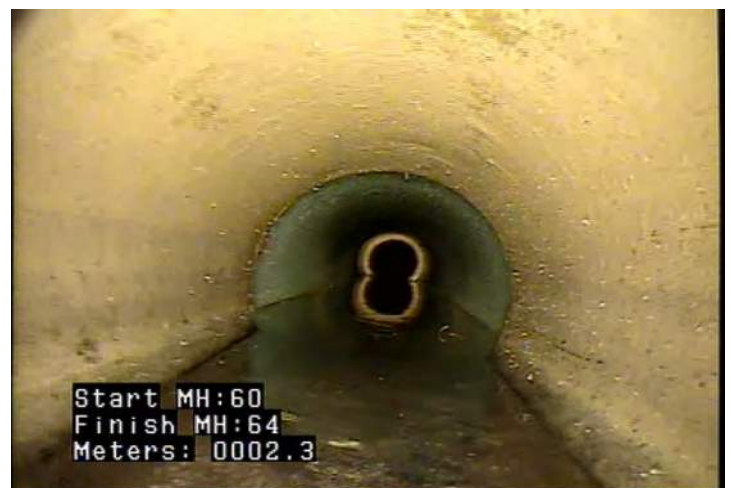
MWLS - Water Level: Sag @ 2.3 m.

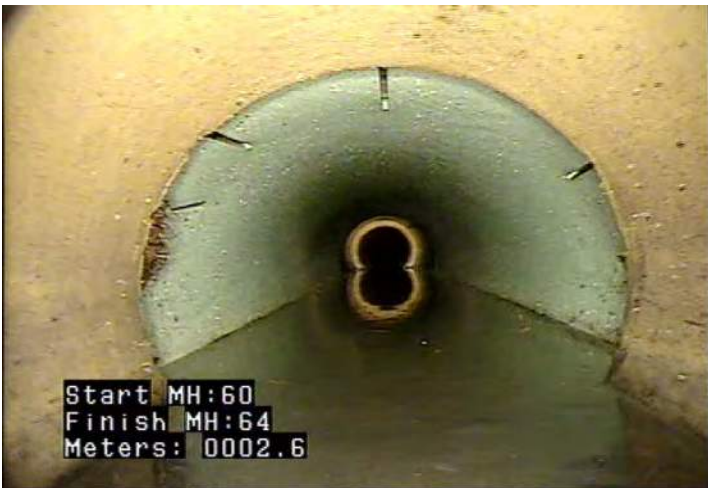
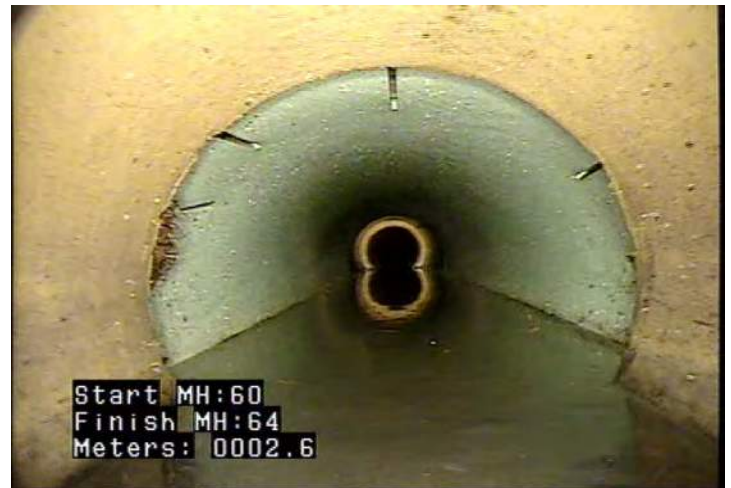
MSC - Dimension/Shape Change @ 2.6 m. RFJ - Roots, Fine: Joint @ 2.6 m.

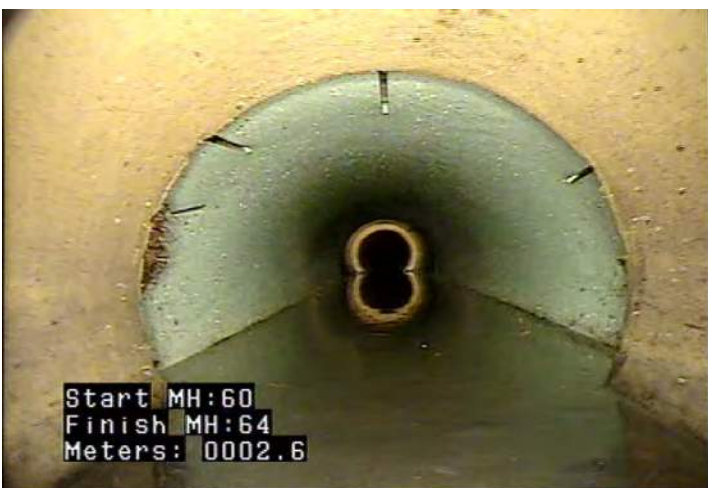
RPR - Point Repair - Pipe Replaced @ 2.6 m. PVC MSC - Dimension/Shape Change @ 5.3 m.

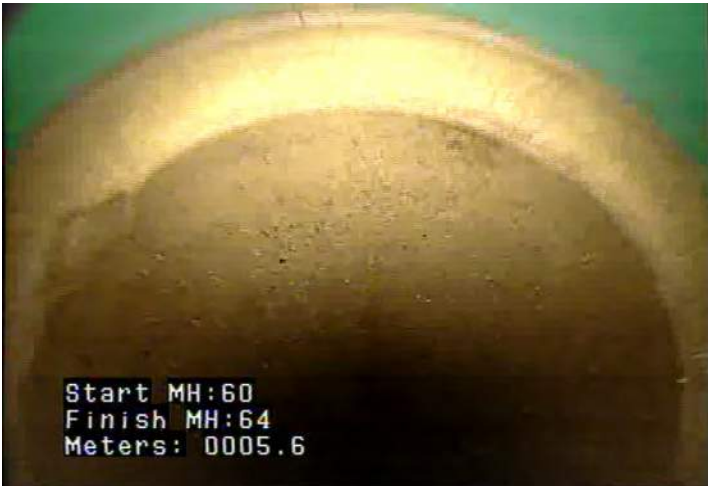
RPR - Point Repair - Pipe Replaced @ 5.6 m. PVC Ends

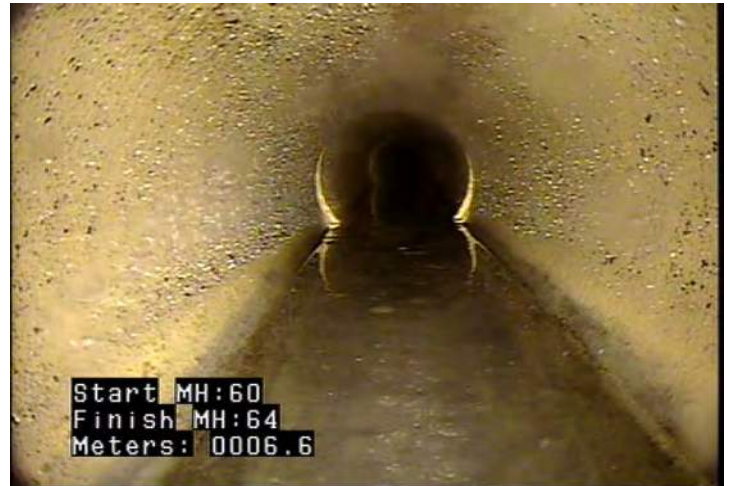
MSA - Survey Abandoned @ 6.6 m. Unable to pass diameter change

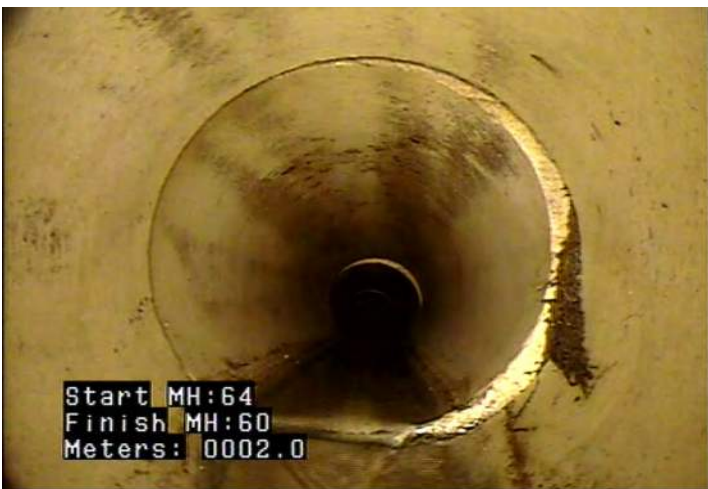
RFJ - Roots, Fine: Joint @ 2.0 m.

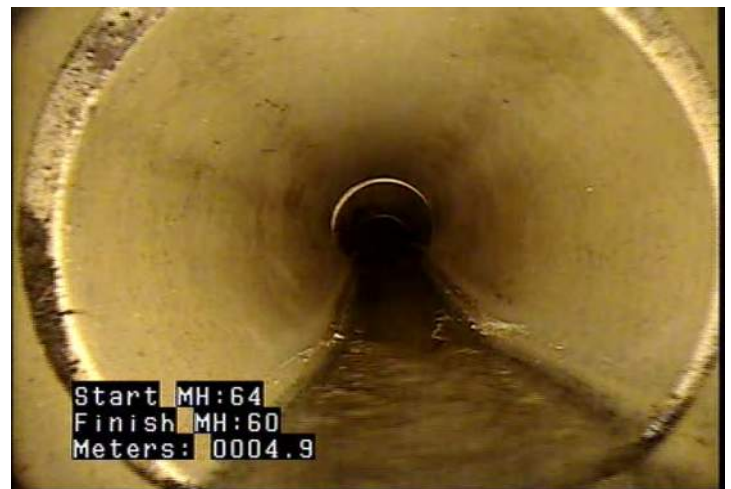
RFJ - Roots, Fine: Joint @ 4.9 m.

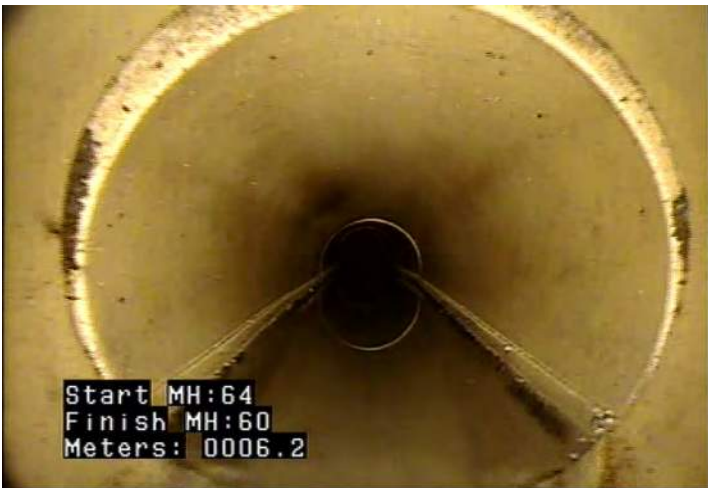
MWLS - Water Level: Sag @ 6.2 m.

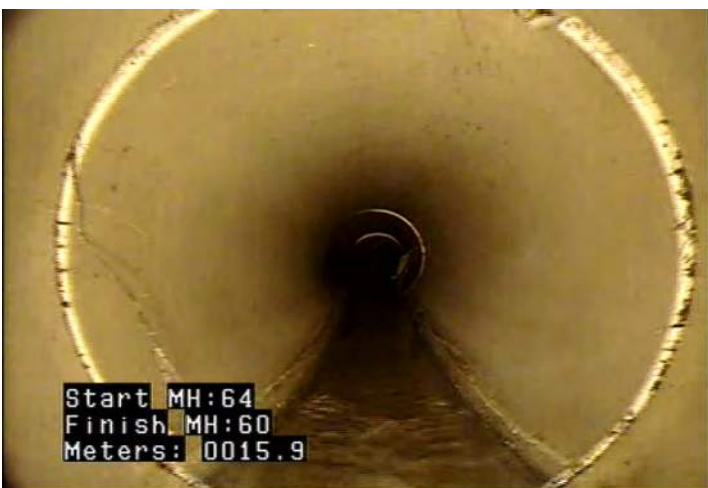
RFJ - Roots, Fine: Joint @ 15.9 m.

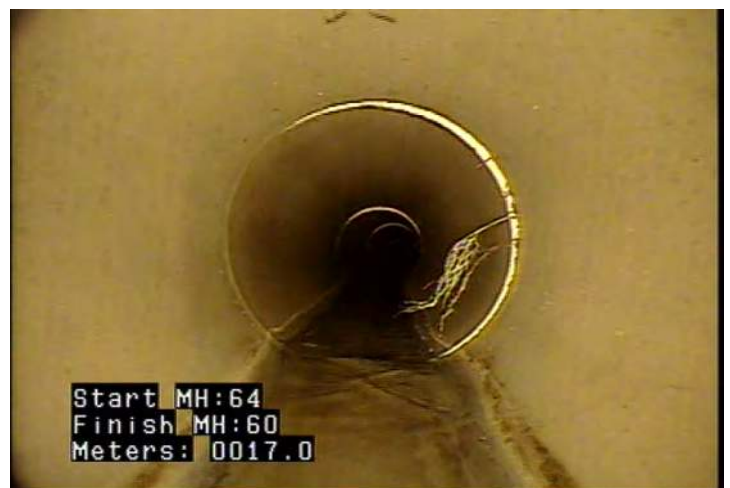
RFJ - Roots, Fine: Joint @ 17.0 m.

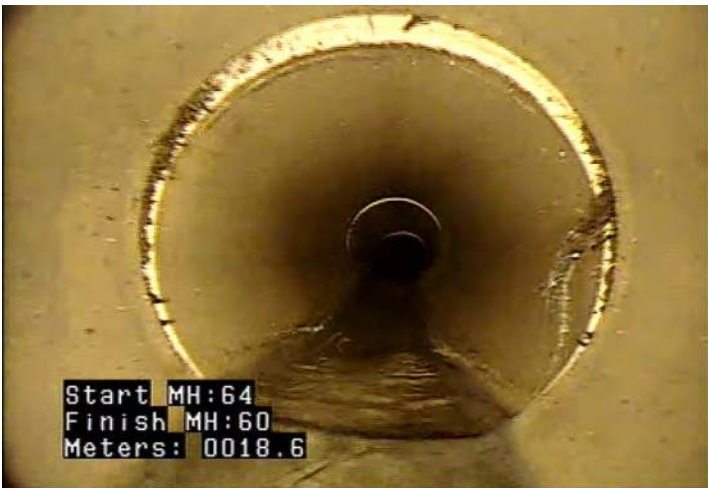
RFJ - Roots, Fine: Joint @ 18.6 m.

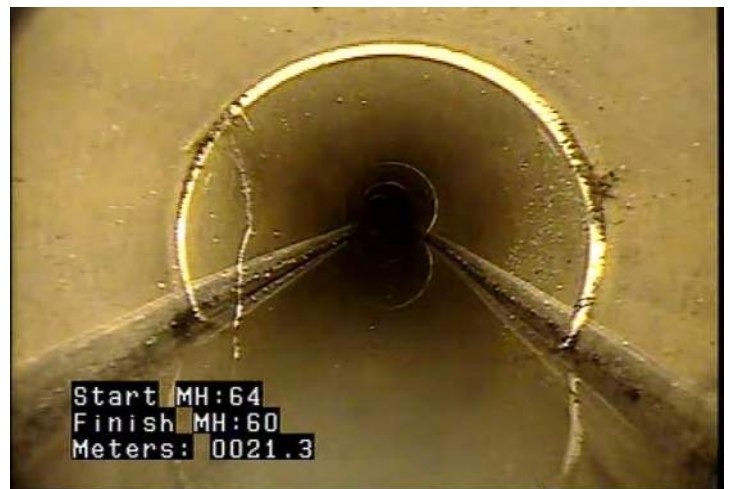
RFJ - Roots, Fine: Joint @ 21.3 m.

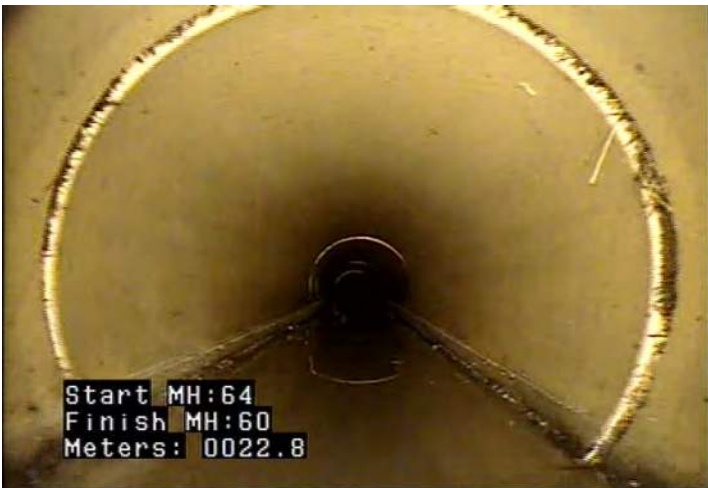
RFJ - Roots, Fine: Joint @ 22.8 m.

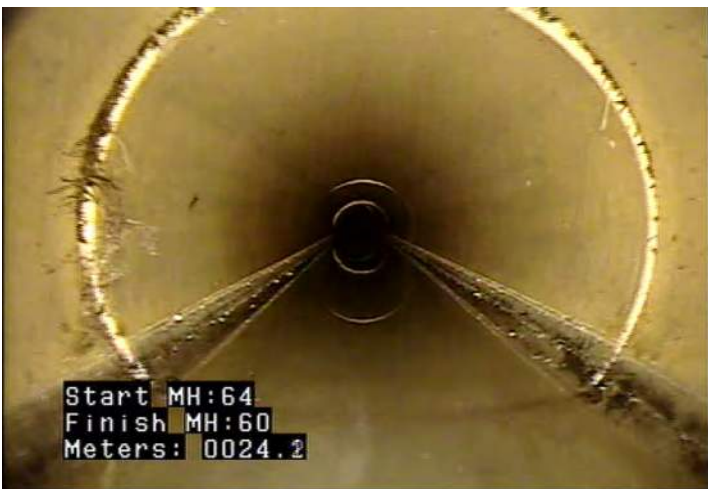
RFJ - Roots, Fine: Joint @ 24.2 m.

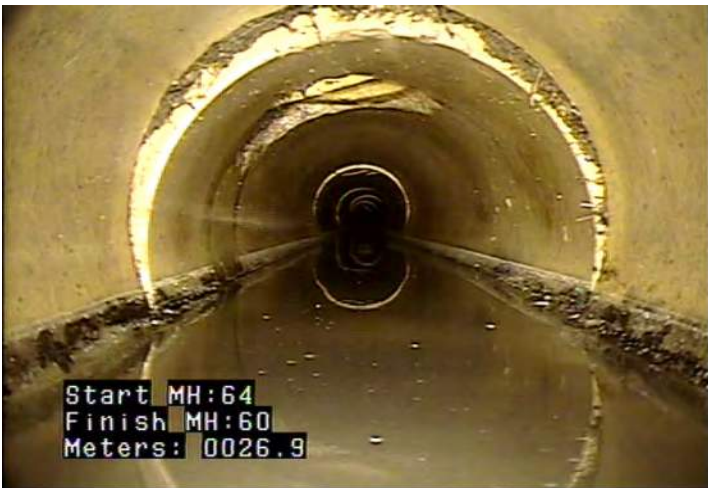
RFJ - Roots, Fine: Joint @ 26.9 m.

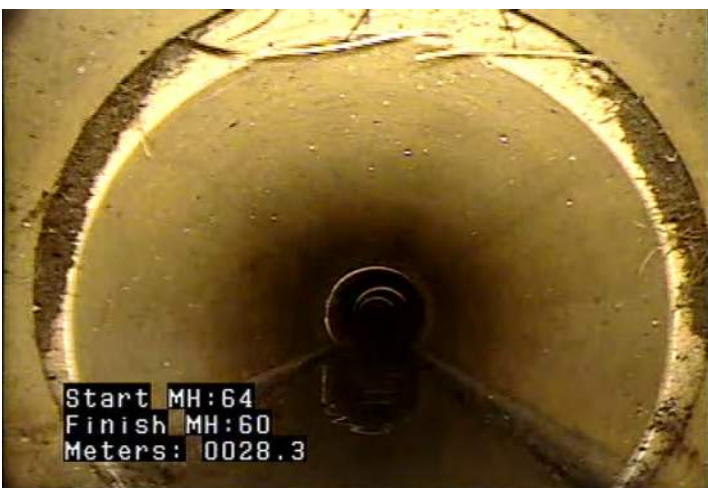
RFJ - Roots, Fine: Joint @ 28.3 m.

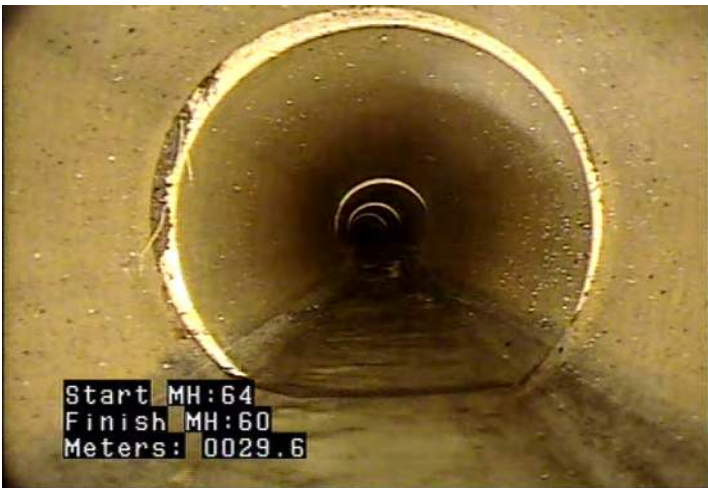
RFJ - Roots, Fine: Joint @ 29.6 m.

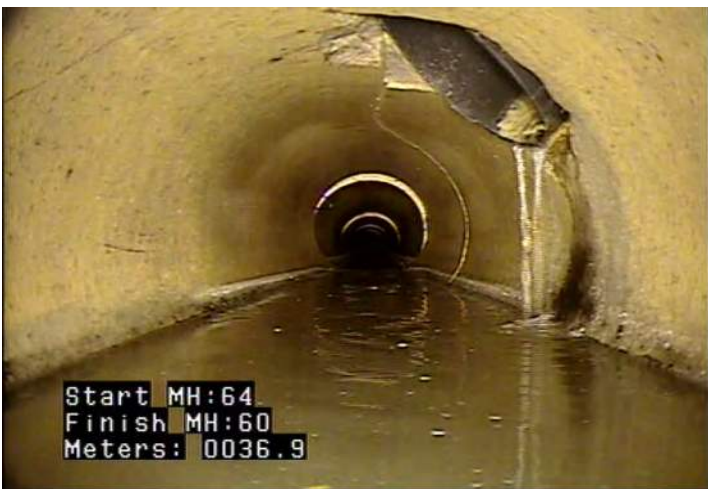
TBA - Tap, Break-in / Hammer: Active @ 36.9 m.

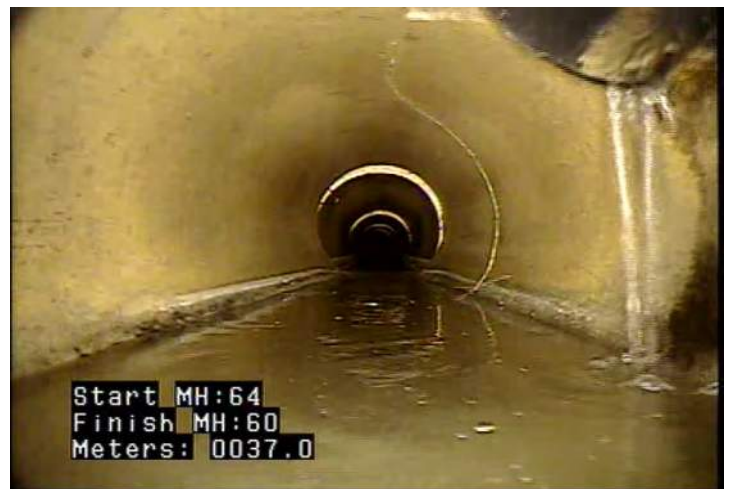
37.1		CS	Crack Spiral	2 to 5				
37.7		RFJ	Roots, Fine: Joint	9 to 5				
37.7		JOM	Joint Offset (displaced): Medium					
39.3		RFJ	Roots, Fine: Joint	9 to 4

CS - Crack Spiral @ 37.1 m.

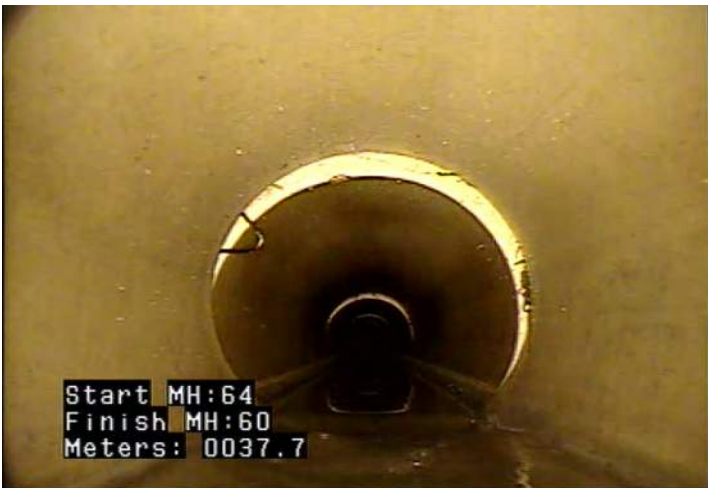
RFJ - Roots, Fine: Joint @ 37.7 m.

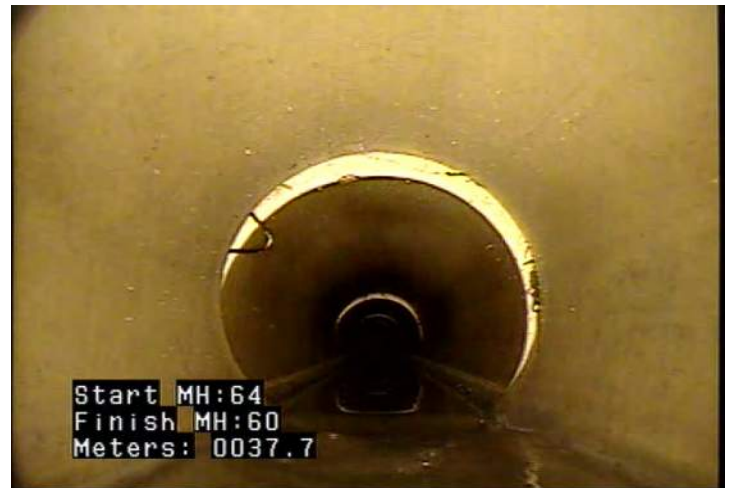
JOM - Joint Offset (displaced): Medium @ 37.7 m.

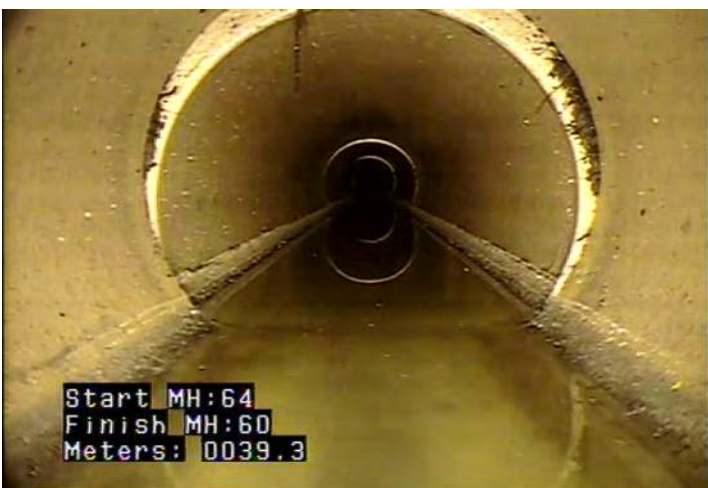
RFJ - Roots, Fine: Joint @ 39.3 m.

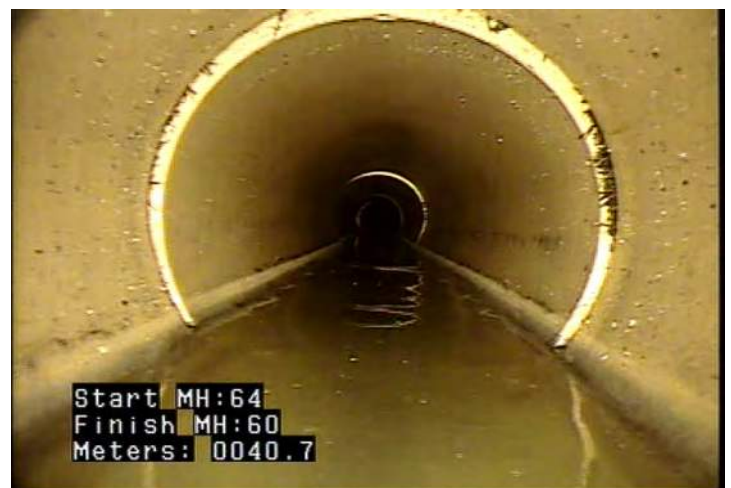
RFJ - Roots, Fine: Joint @ 40.7 m.

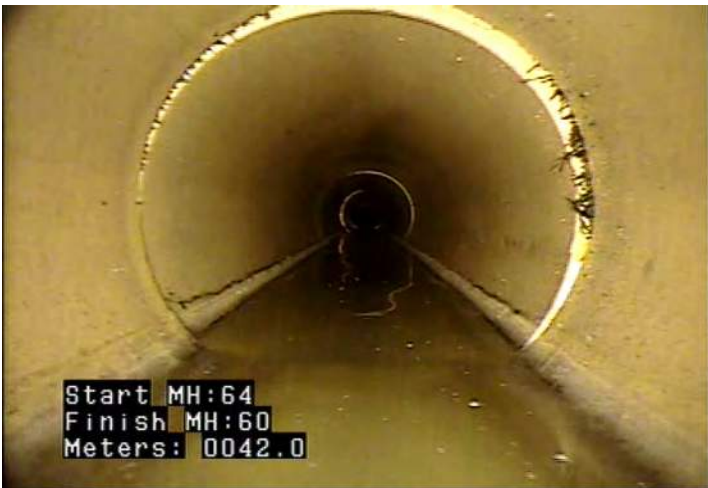
RFJ - Roots, Fine: Joint @ 42.0 m.

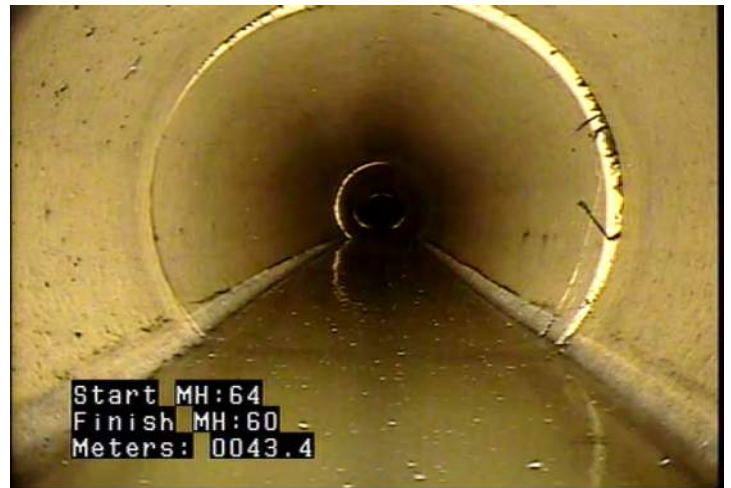
RFJ - Roots, Fine: Joint @ 43.4 m.

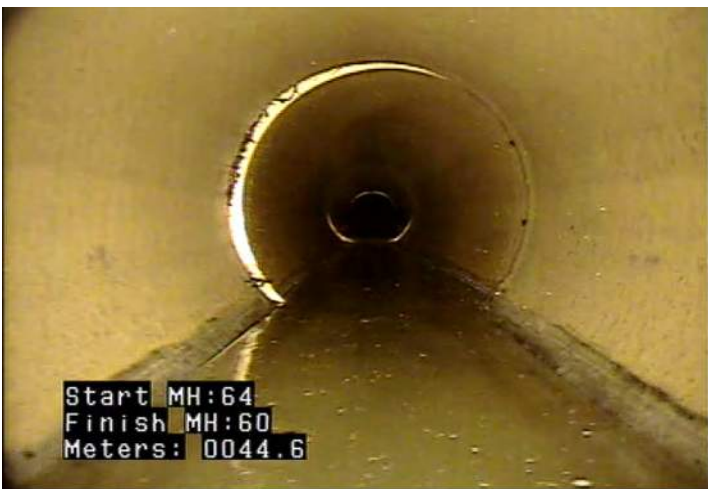
RFJ - Roots, Fine: Joint @ 44.6 m.

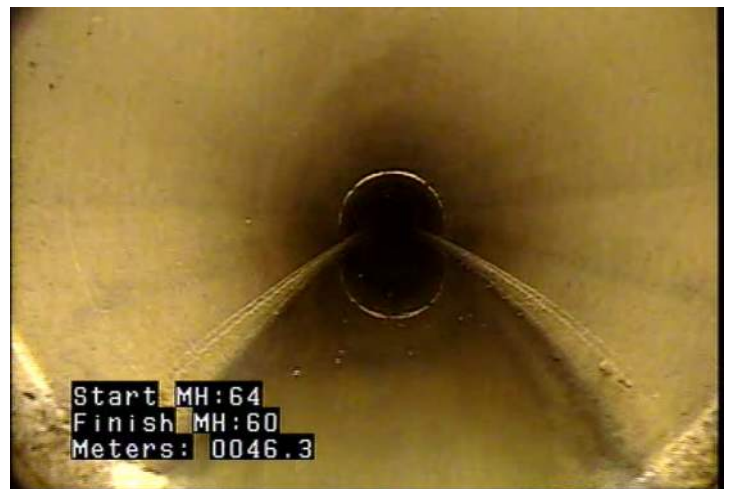
MWLS - Water Level: Sag @ 46.3 m.

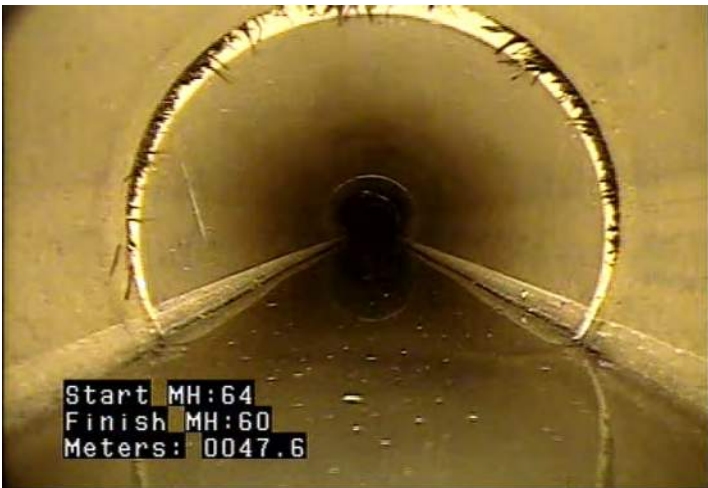
RFJ - Roots, Fine: Joint @ 47.6 m.

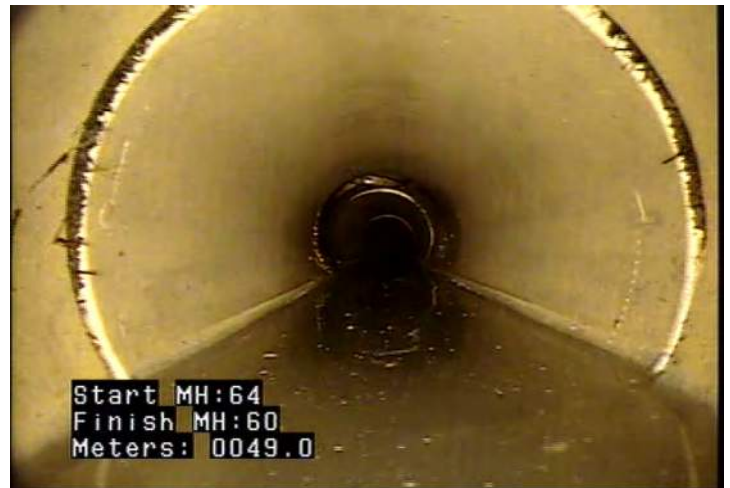
RFJ - Roots, Fine: Joint @ 49.0 m.

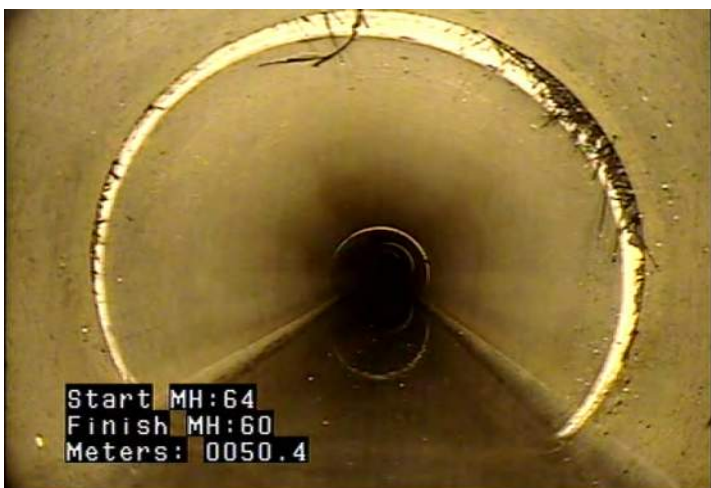
RFJ - Roots, Fine: Joint @ 50.4 m.

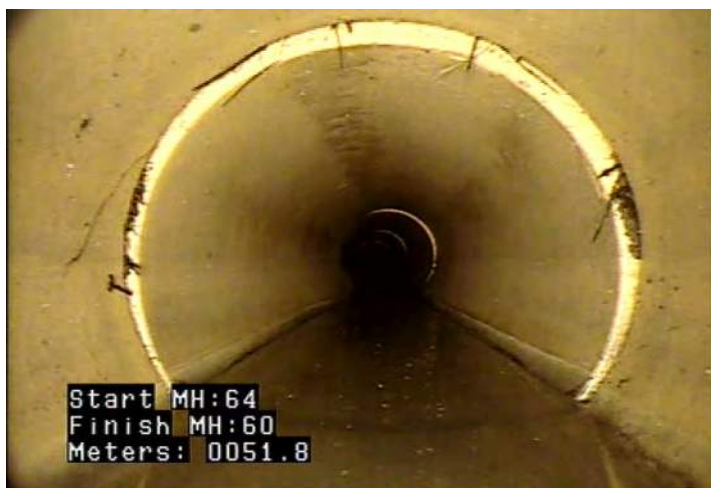
RFJ - Roots, Fine: Joint @ 51.8 m.

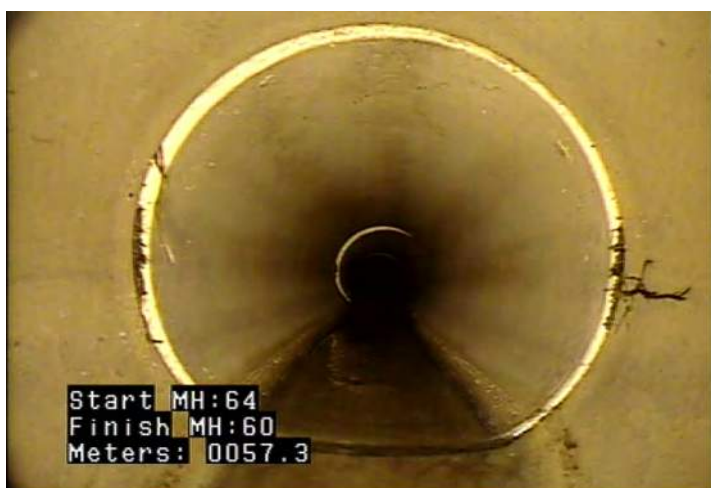
RFJ - Roots, Fine: Joint @ 57.3 m.
