Appendix F CCTV Assessment

Client: CIMA
 Project: Pre-Rehabilitation Survey
 Date: 12/18/2020
 File: 14257

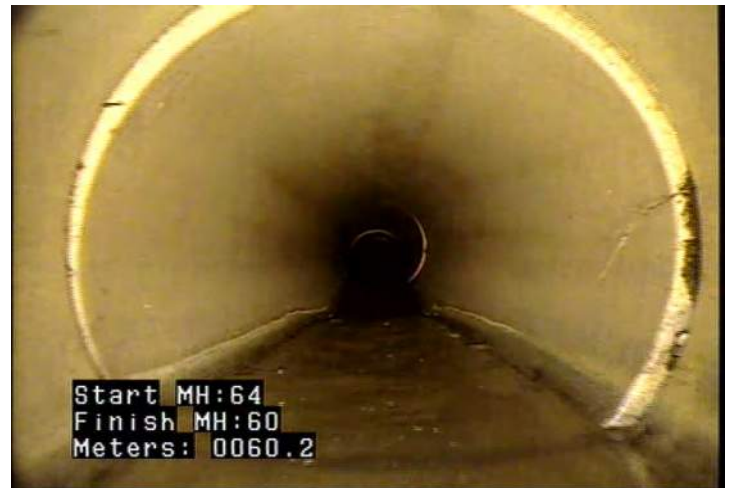
RFJ - Roots, Fine: Joint @ 60.2 m.

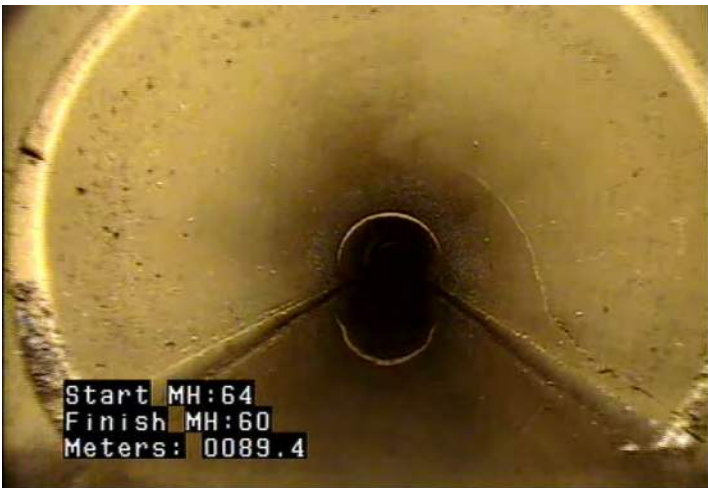
60.2		RFJ	Roots, Fine: Joint	2 to 4				
63.7		MWL	Water Level		5			
65.8		MWL	Water Level		10			
89.4		CS	Crack Spiral	2 to 4				
94.8		MMC	Material Change					Clay tile to PVC

CS - Crack Spiral @ 89.4 m.

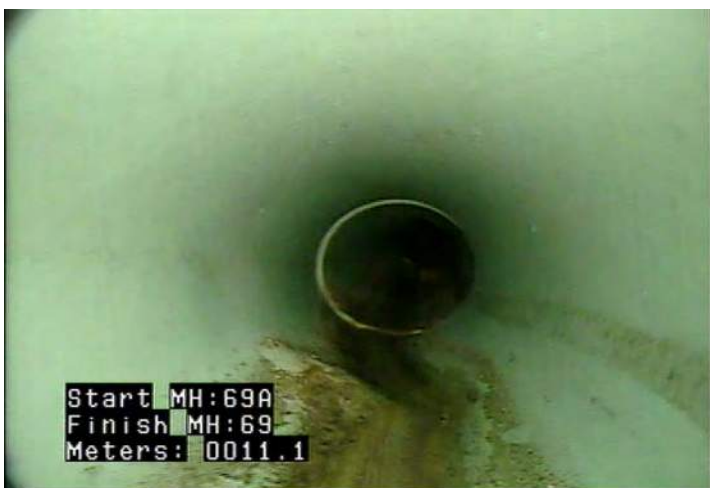
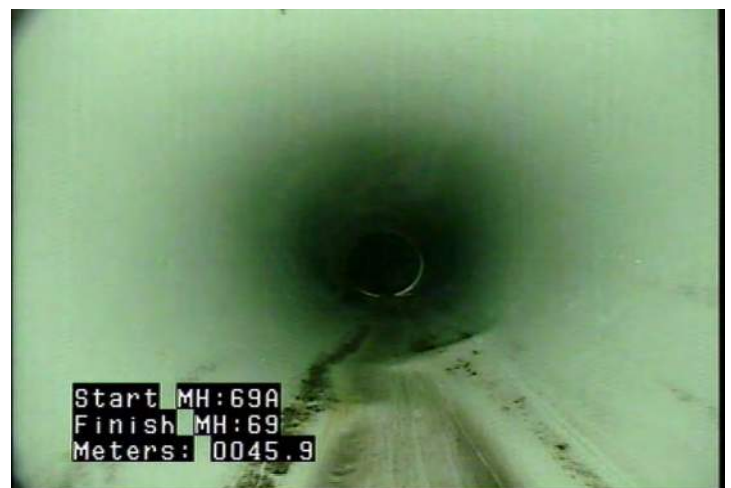
D - Pipe Deformed @ 11.1 m.

D - Pipe Deformed @ 45.9 m.

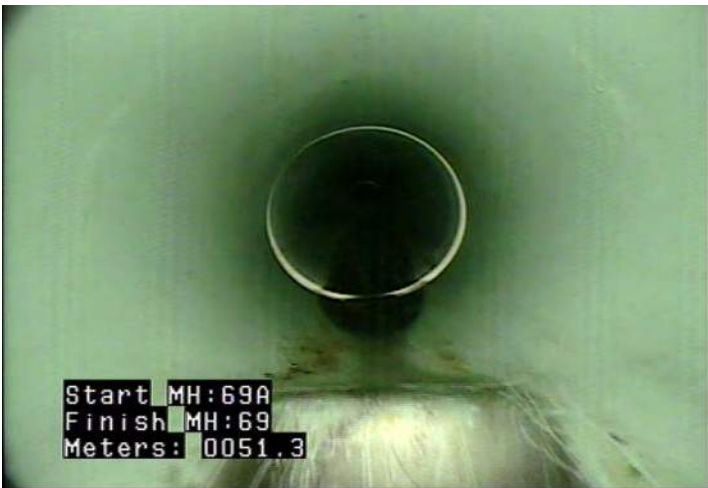
D - Pipe Deformed @ 51.3 m.

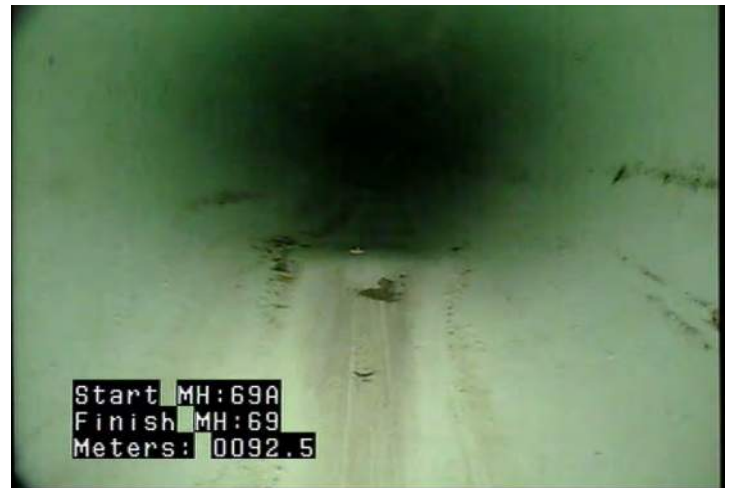
D - Pipe Deformed @ 92.5 m.

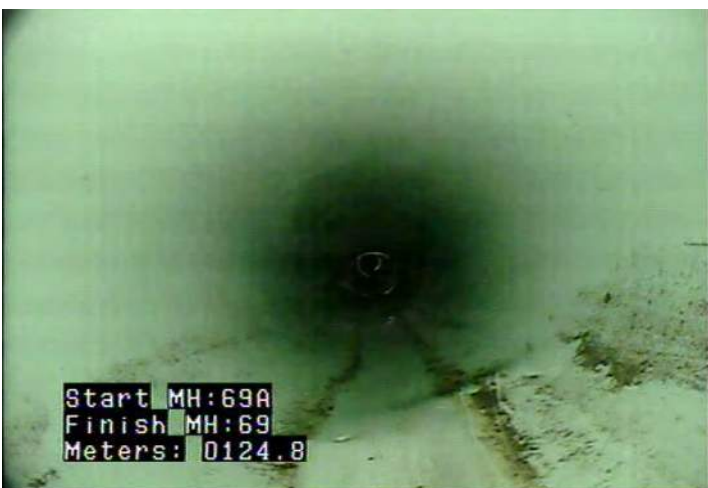
D - Pipe Deformed @ 124.8 m.

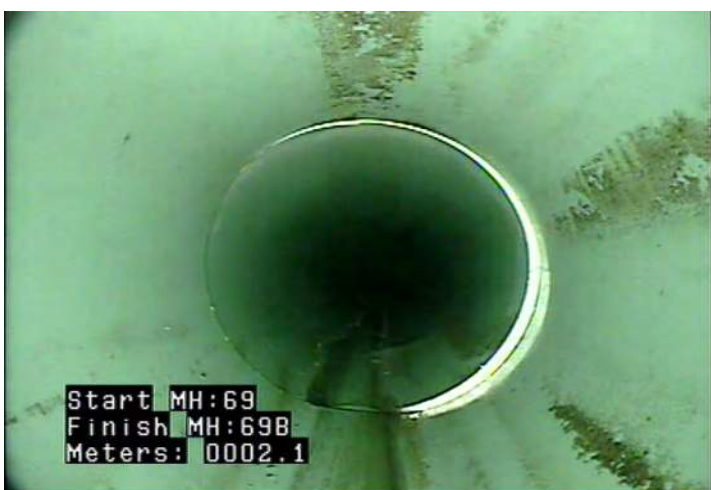
JOM - Joint Offset (displaced): Medium @
2.1 m.

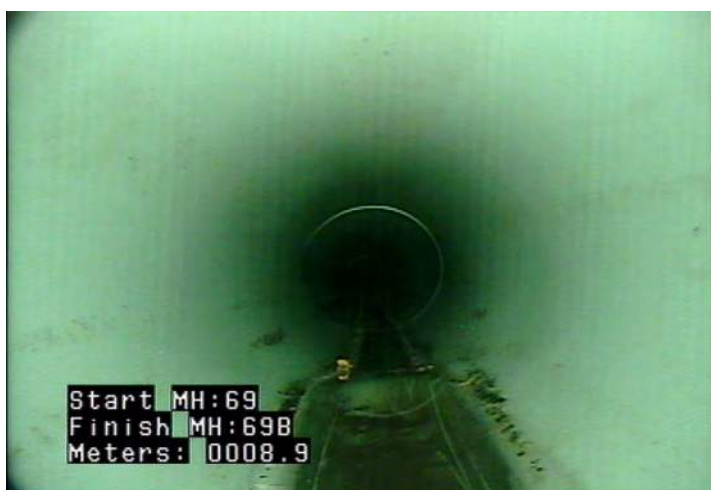
D - Pipe Deformed @ 8.9 m.

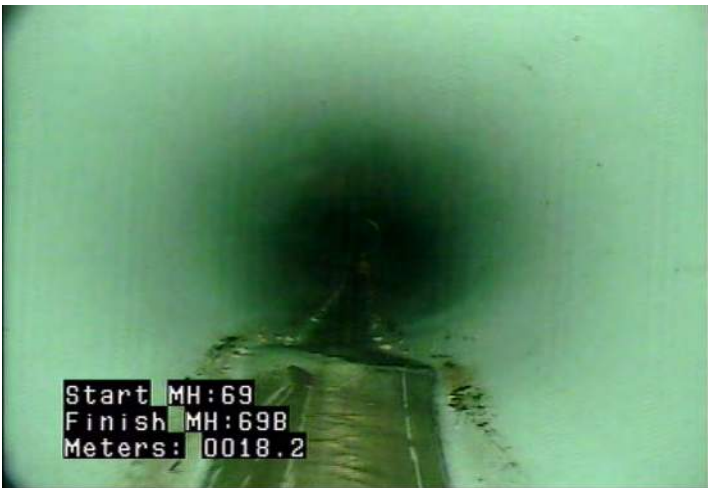
D - Pipe Deformed @ 18.2 m.

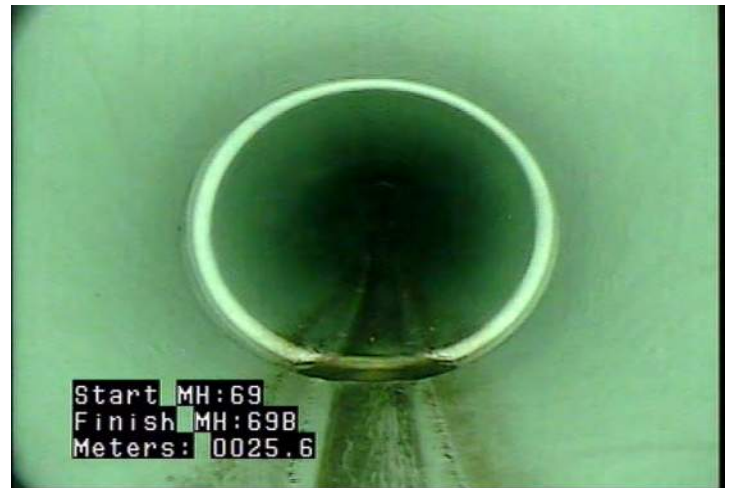
D - Pipe Deformed @ 25.6 m. Oval

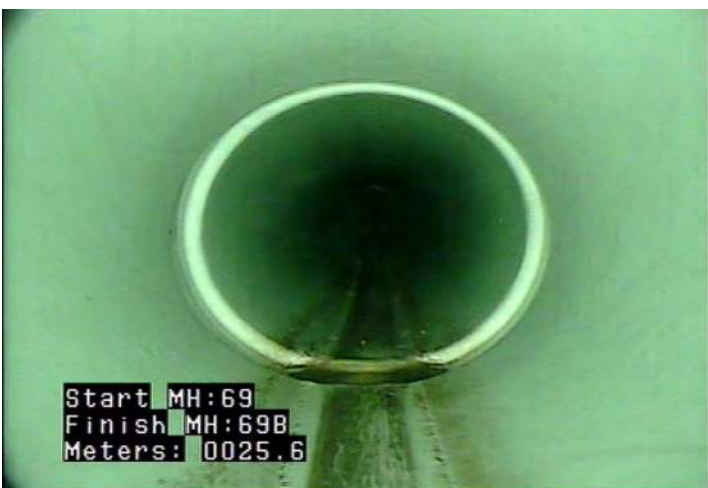
JSM - Joint Separated (open): Medium @ 25.6 m.

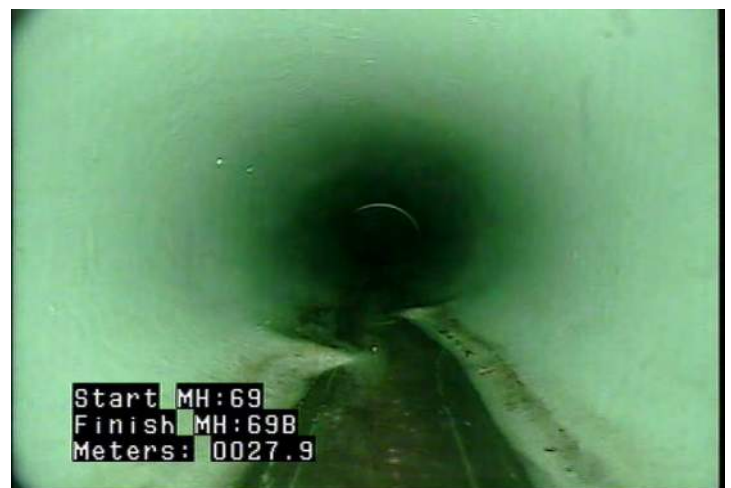
D - Pipe Deformed @ 27.9 m.

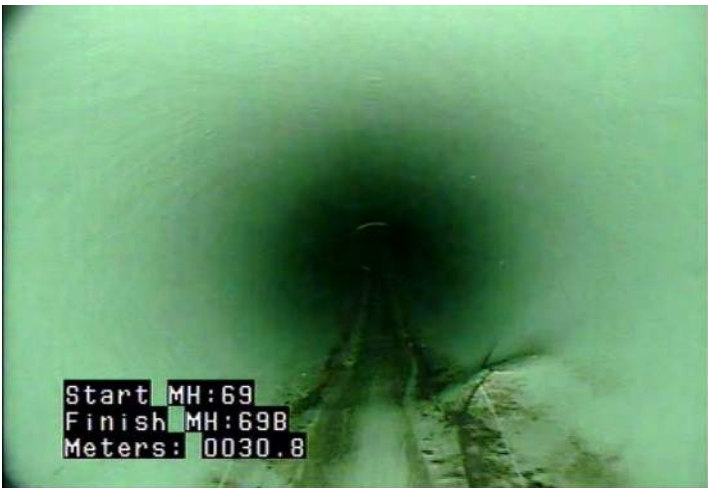
D - Pipe Deformed @ 30.8 m.

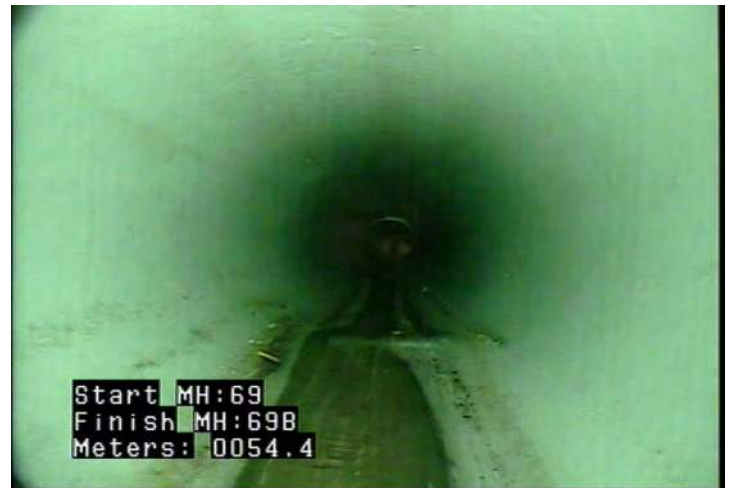
D - Pipe Deformed @ 54.5 m.

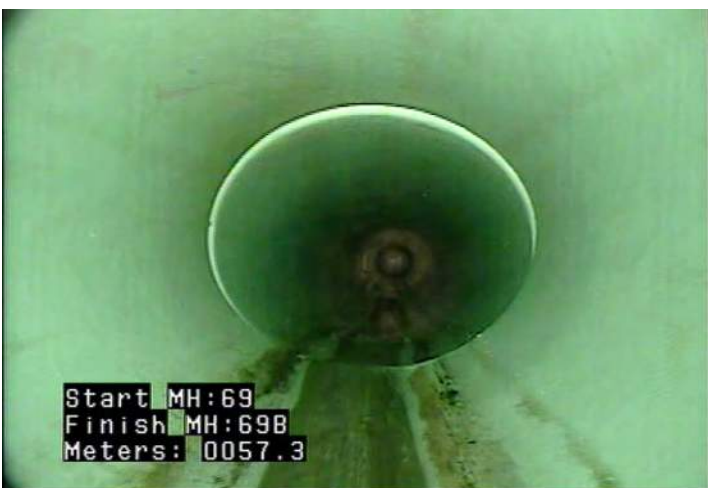
D - Pipe Deformed @ 57.3 m. Oval

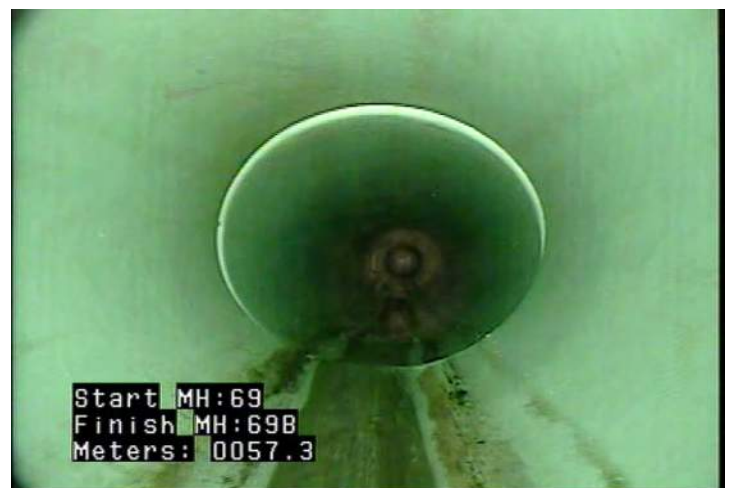
JAM - Joint Angular: Medium @ 57.3 m.

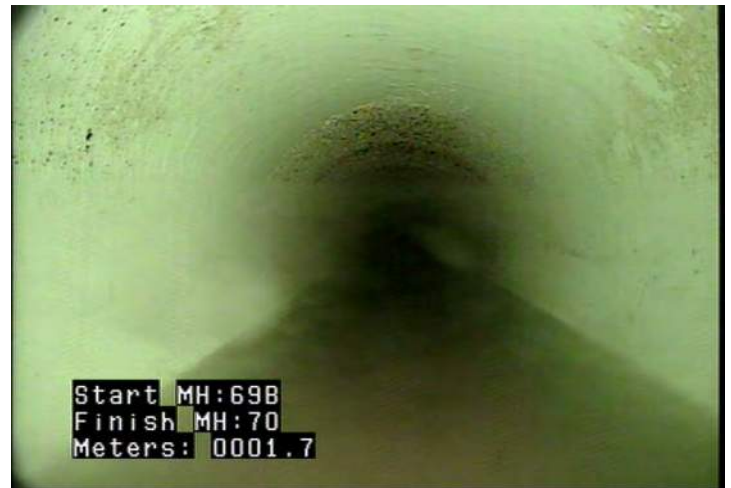
MWLS - Water Level: Sag @ 0.0 m.

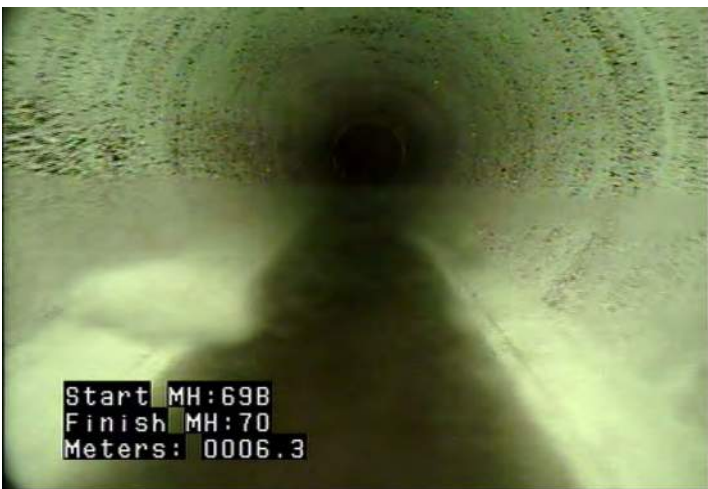
MWLS - Water Level: Sag @ 6.3 m.

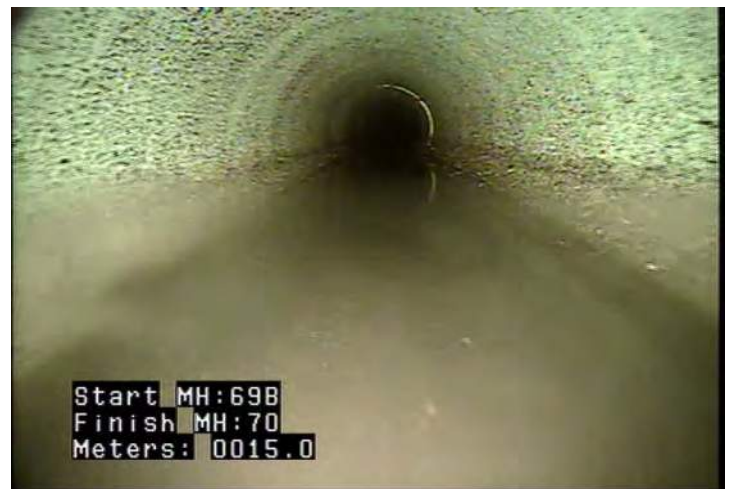
MWLS - Water Level: Sag @ 15.0 m.

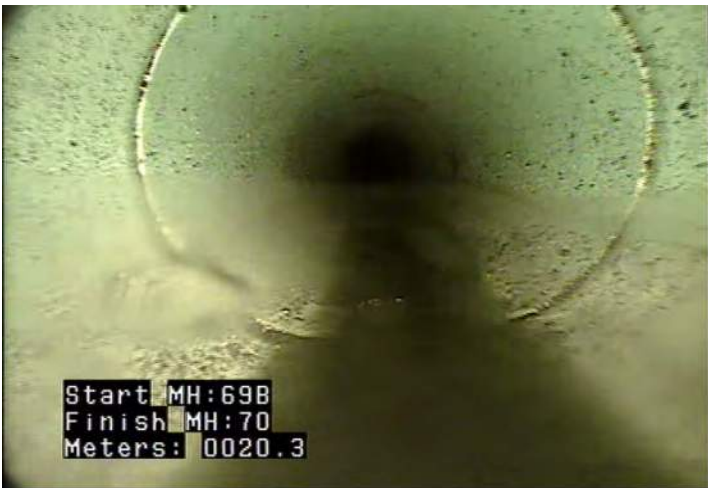
MWLS - Water Level: Sag @ 20.3 m.

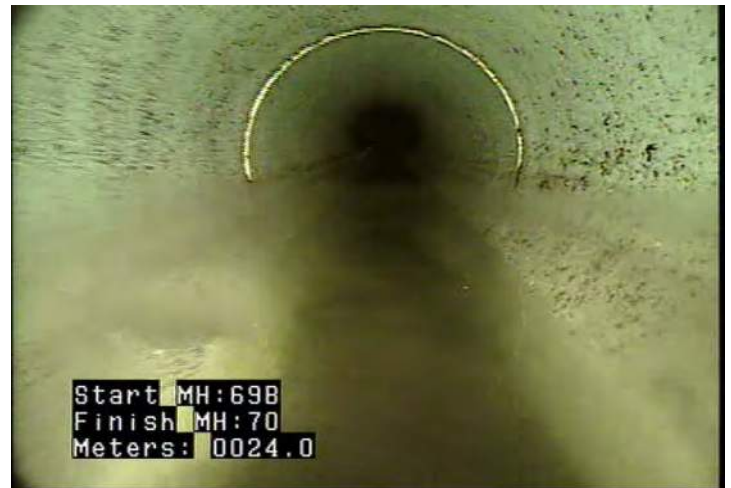
MWLS - Water Level: Sag @ 24.0 m.

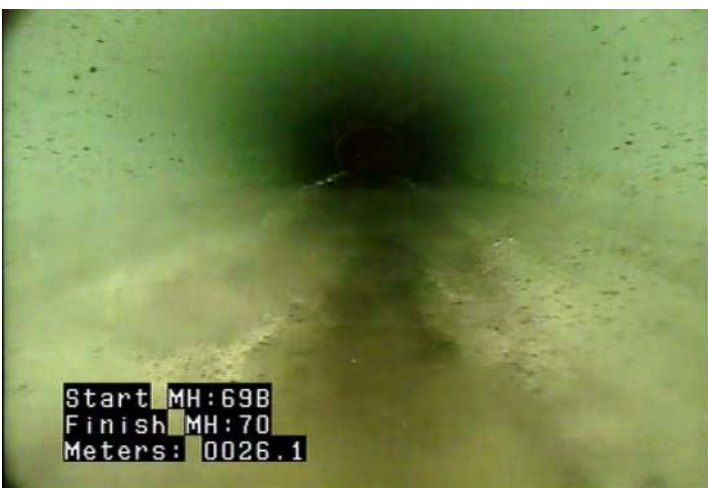
MWLS - Water Level: Sag @ 26.1 m.

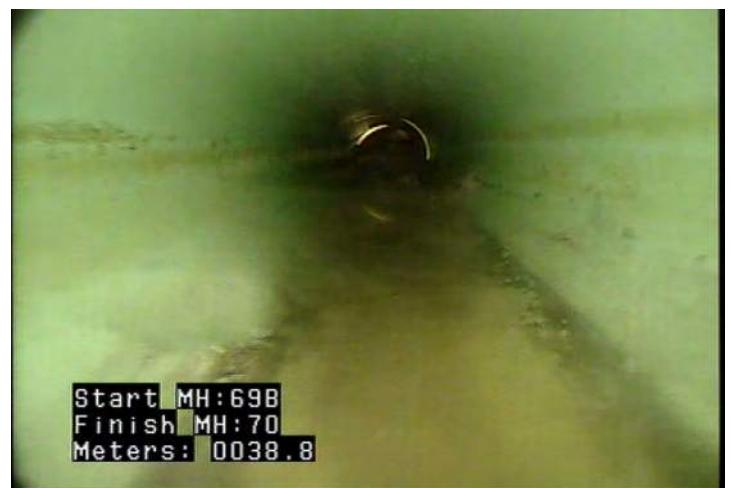
MWLS - Water Level: Sag @ 38.8 m.

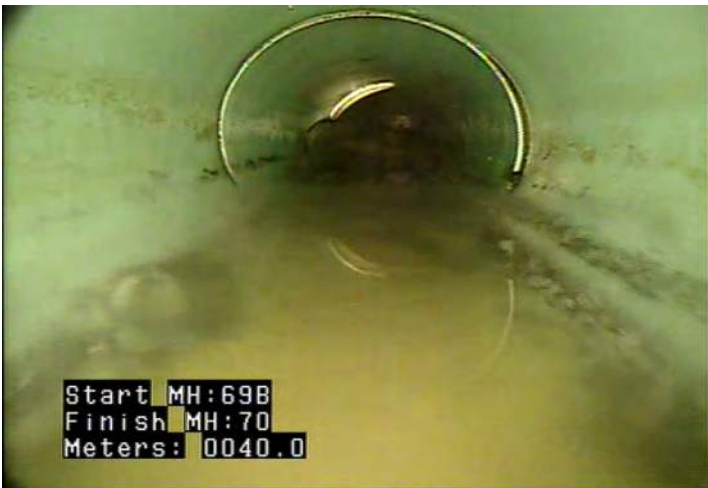
D - Pipe Deformed @ 40.0 m. Oval

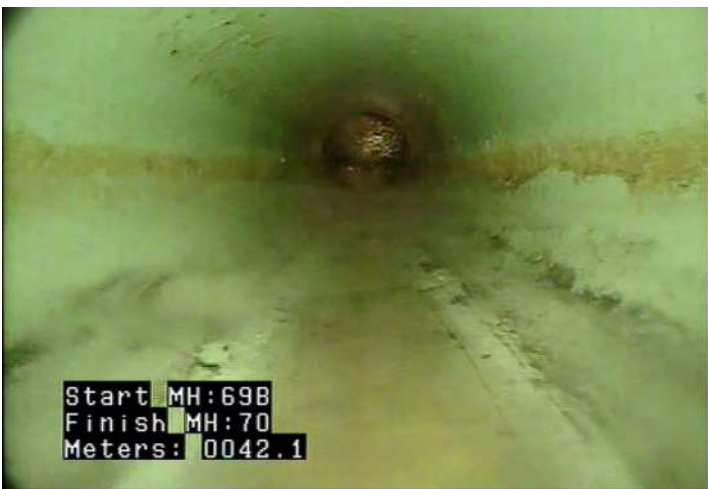
MWLS - Water Level: Sag @ 42.1 m.

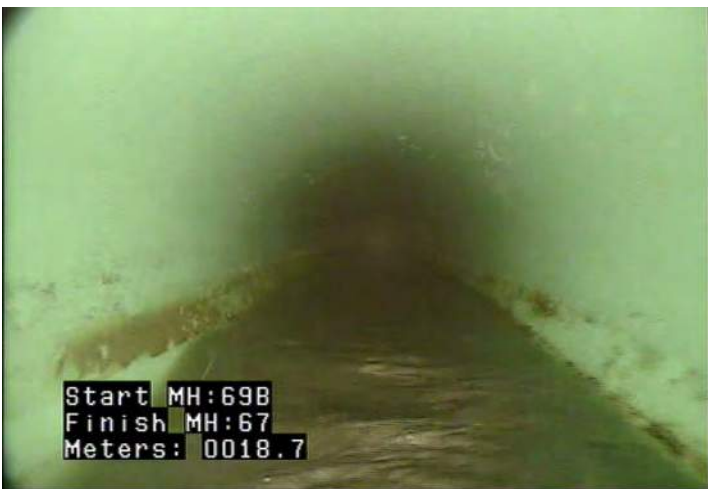
MWLS - Water Level: Sag @ 18.7 m.

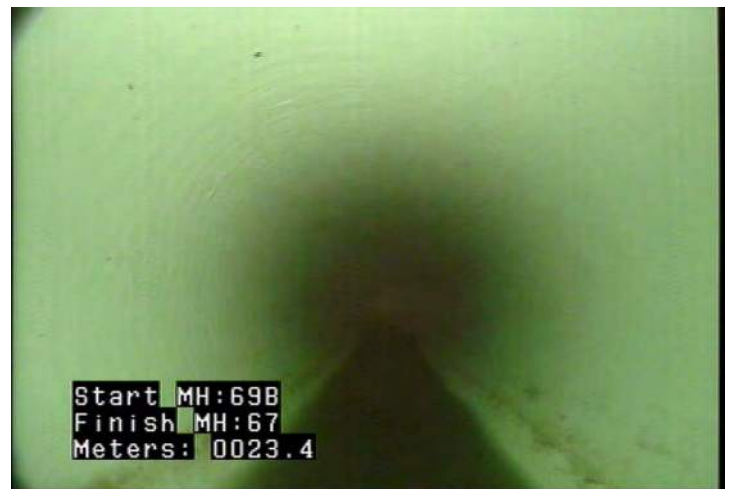
MWLS - Water Level: Sag @ 23.4 m.

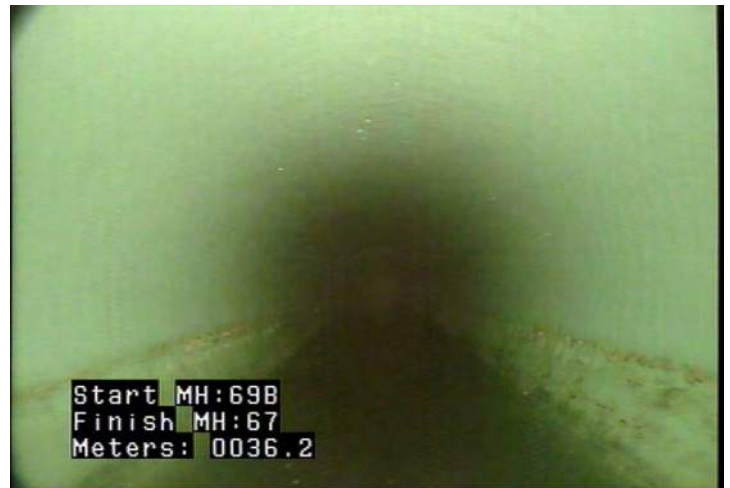
MWLS - Water Level: Sag @ 36.2 m.

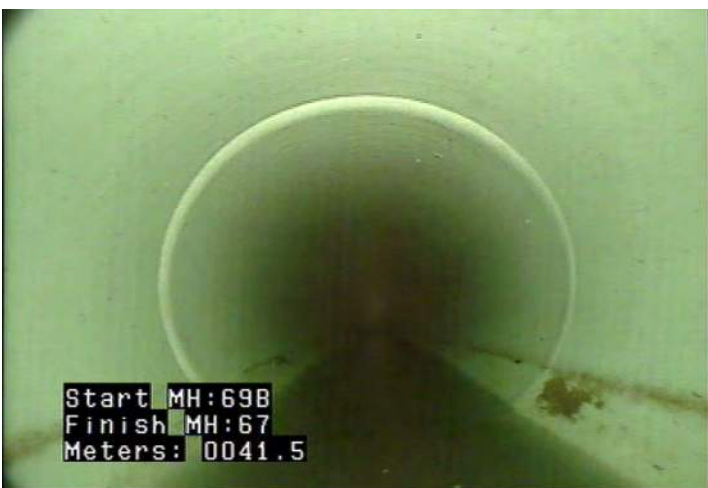
MWLS - Water Level: Sag @ 41.5 m.

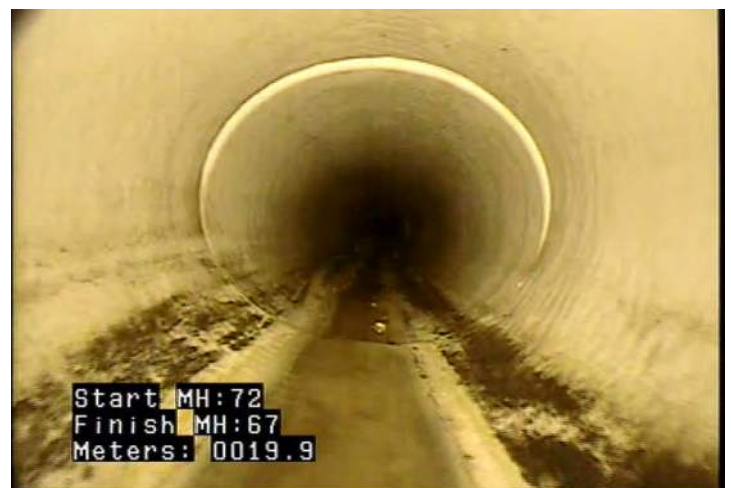
D - Pipe Deformed @ 19.9 m.

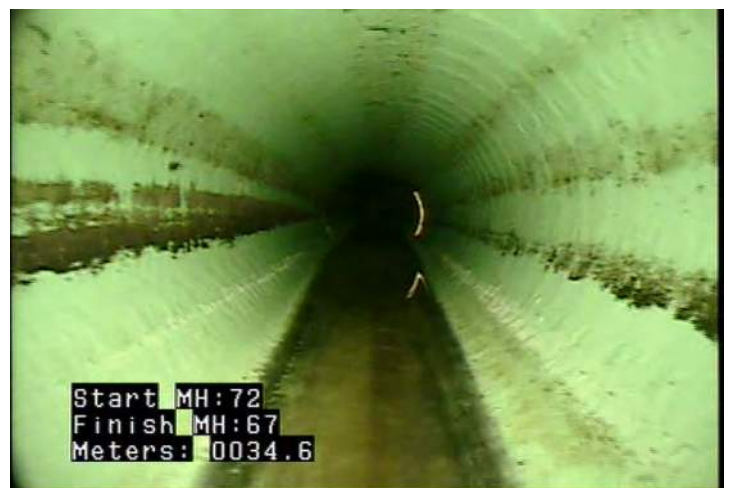
MWLS - Water Level: Sag @ 34.6 m.

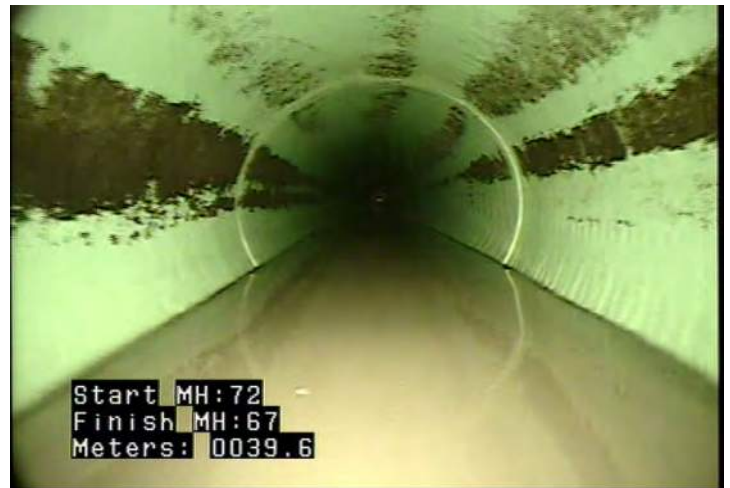
39.6		CL	Crack Longitudinal	11				Closer view of crack
	39.9		MGP	General Photograph

CL - Crack Longitudinal @ 39.6 m.

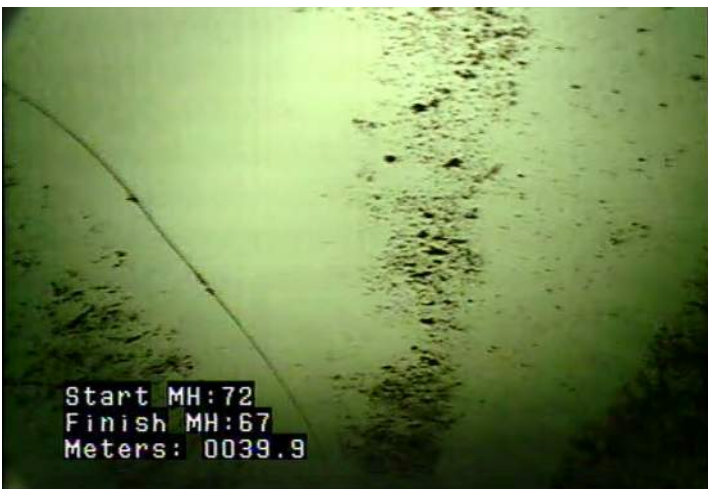
MGP - General Photograph @ 39.9 m.
Closer view of crack

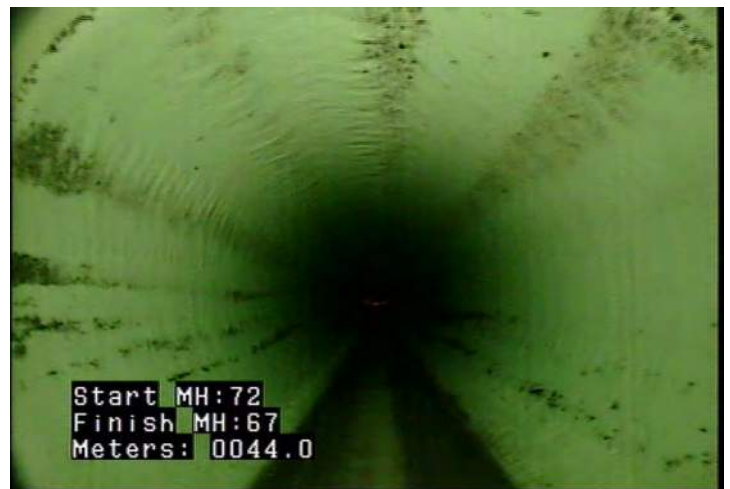
MWLS - Water Level: Sag @ 44.0 m.

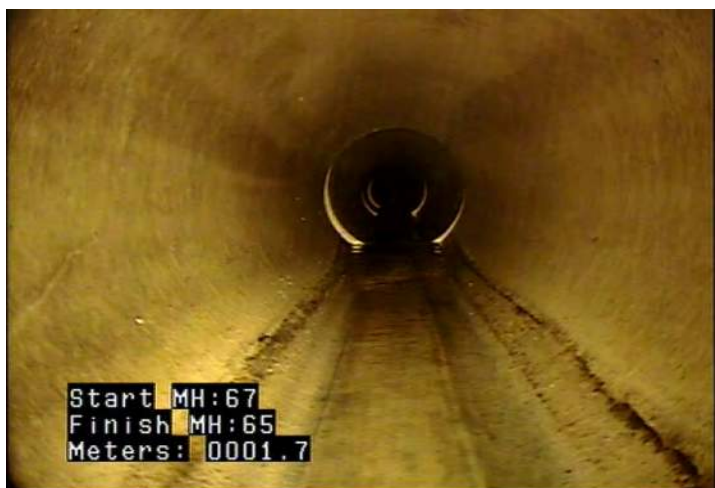
CS - Crack Spiral @ 0.5 m.

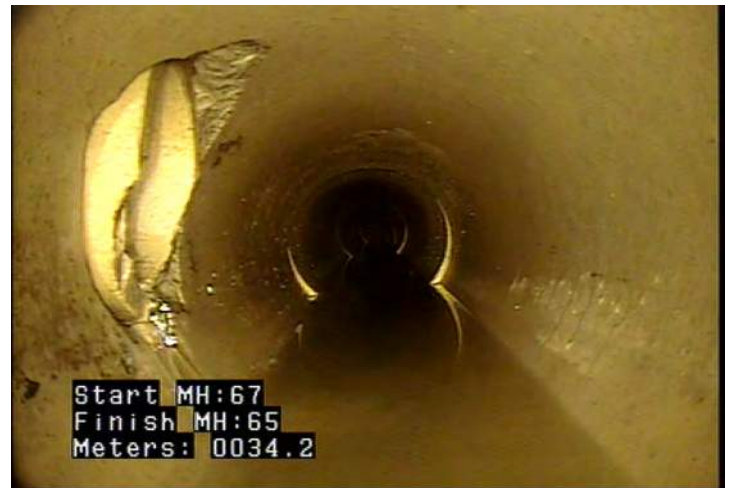
TBA - Tap, Break-in / Hammer: Active @ 34.2 m.

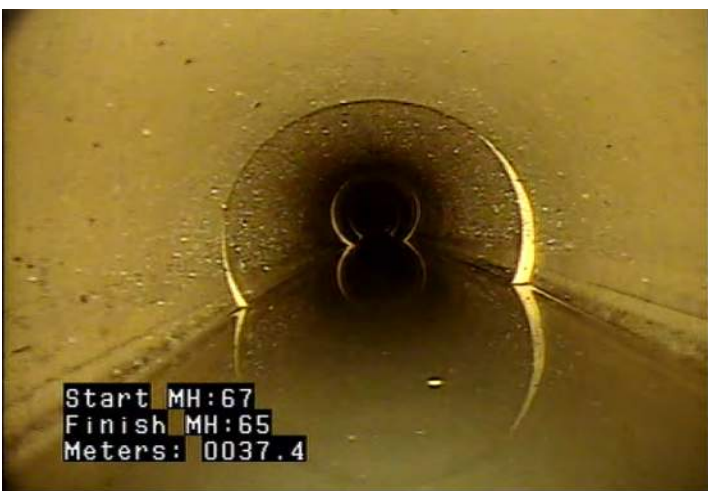
MGP - General Photograph @ 37.4 m.
Deepest point of sag 30%

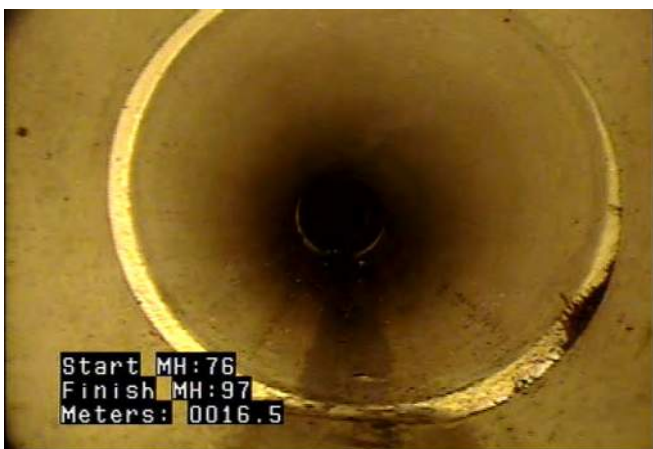
RFJ - Roots, Fine: Joint @ 16.5 m. Fine roots at most joints throughout ipe from 16.5 - 52.4

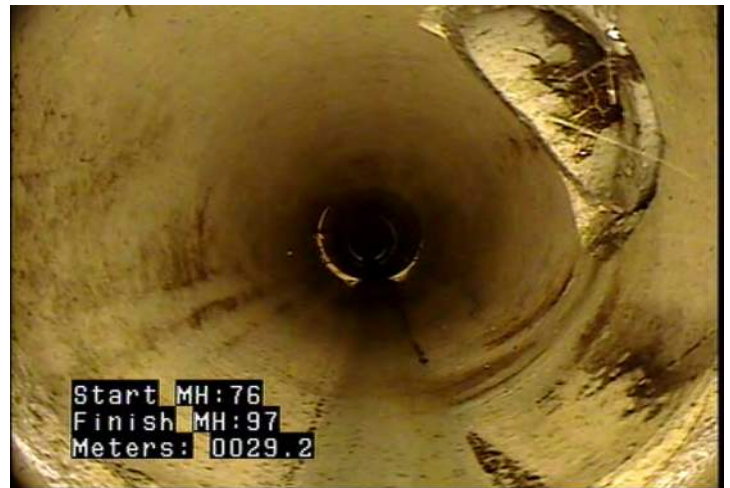
TBD - Tap, Break-in / Hammer: Defective @ 29.2 m. Roots in service

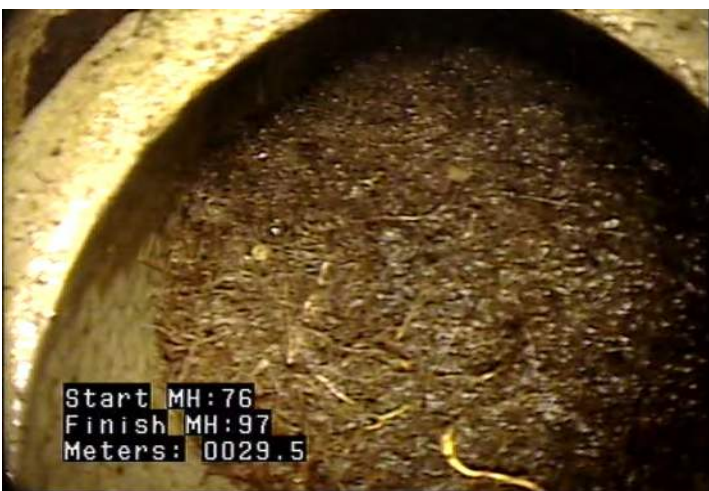
MGP - General Photograph @ 29.2 m.
View of root ball inside service

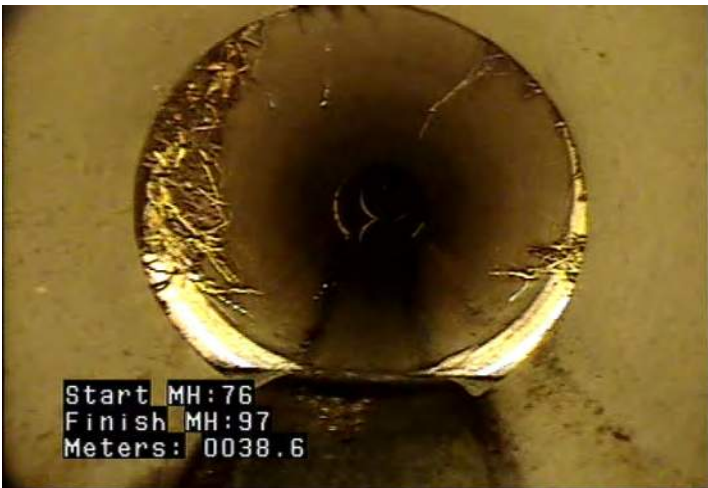
JOM - Joint Offset (displaced): Medium @ 38.6 m.

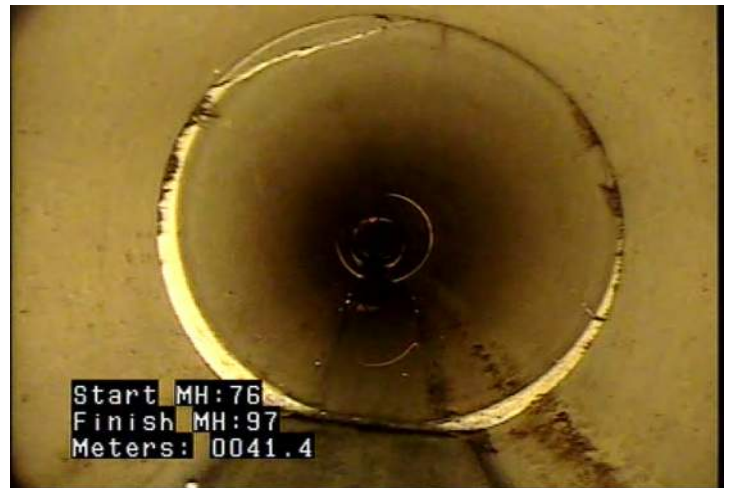
FS - Fracture Spiral @ 41.4 m.

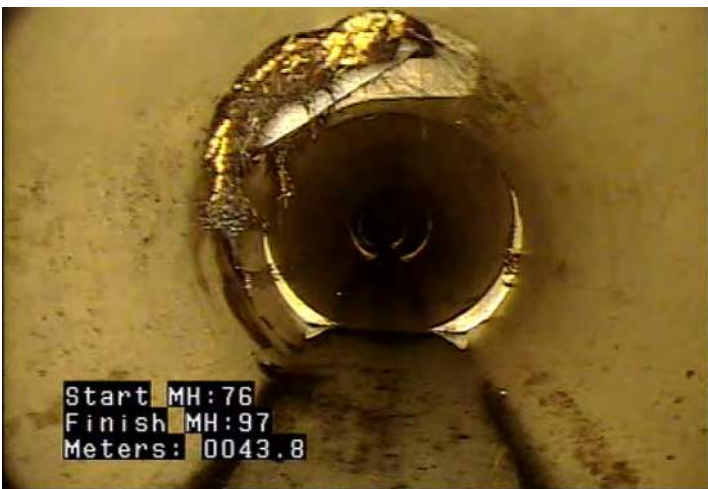
RMC - Roots, Medium: Connection @ 43.8 m.

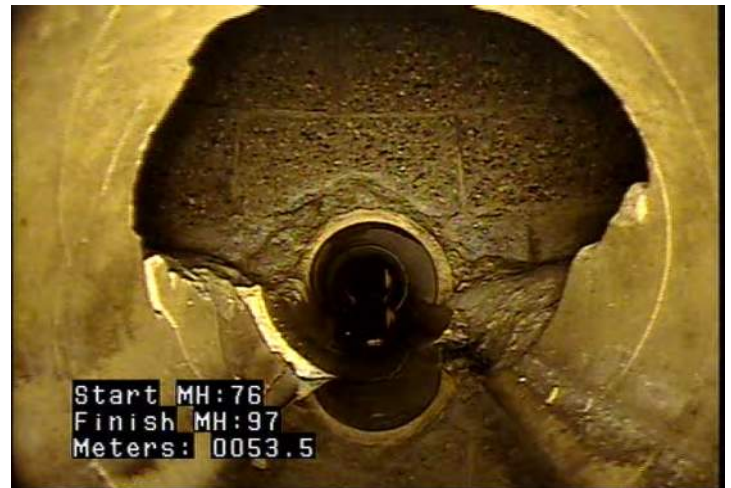
CC - Crack Circumferential @ 53.5 m.

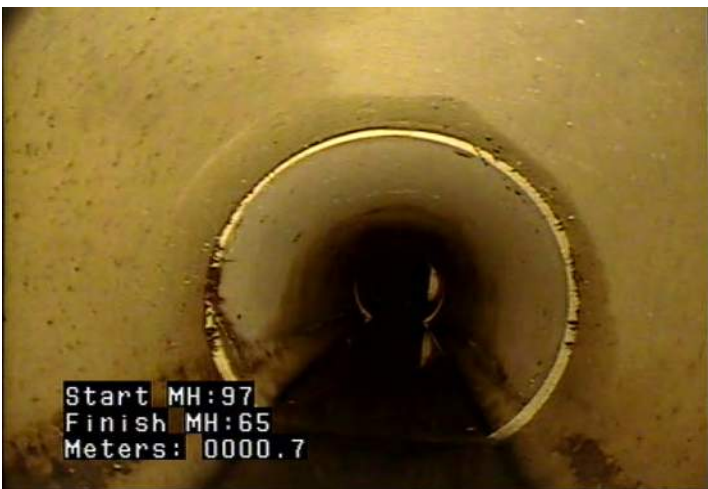
RFJ - Roots, Fine: Joint @ 0.7 m. Fine roots at most joints throughout pipe

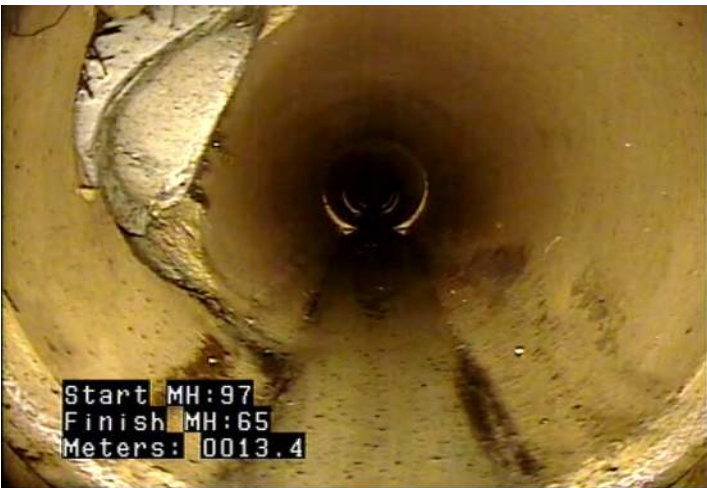
TB - Tap, Break-in / Hammer @ 13.4 m.

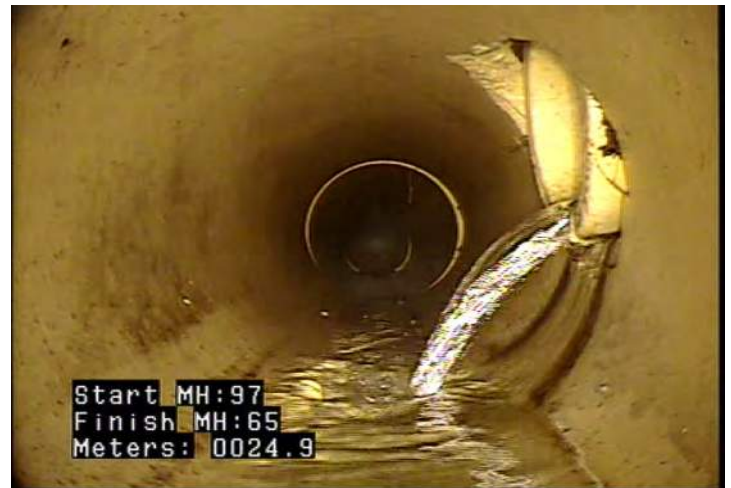
TBA - Tap, Break-in / Hammer: Active @ 24.9 m.

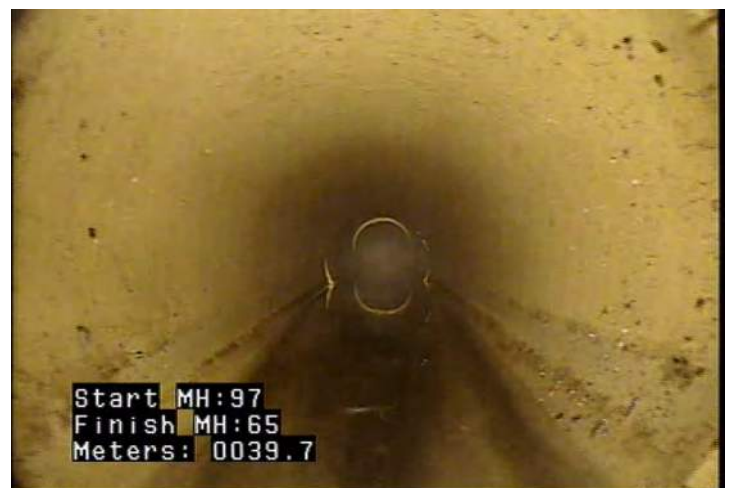
MWLS - Water Level: Sag @ 39.7 m.

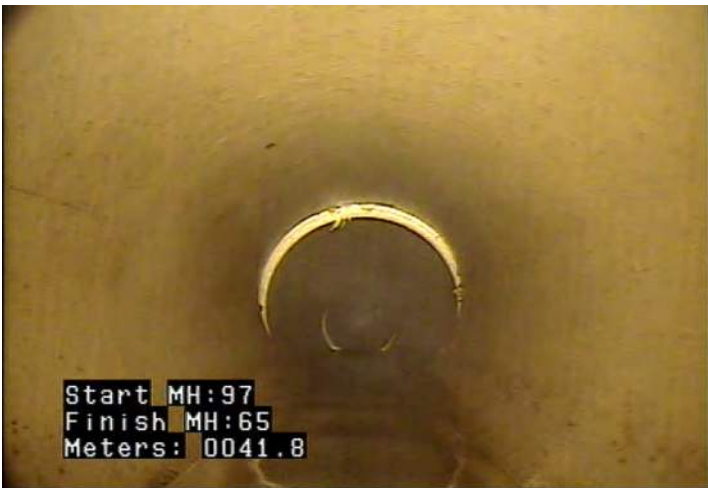
MWLS - Water Level: Sag @ 41.8 m.

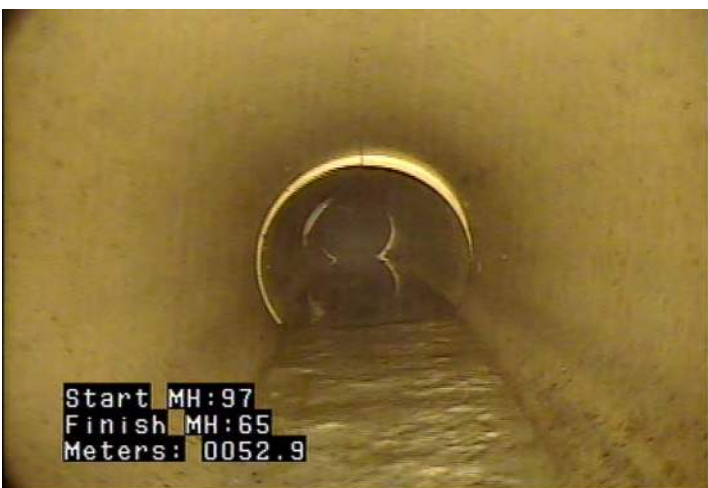
MWLS - Water Level: Sag @ 52.9 m.

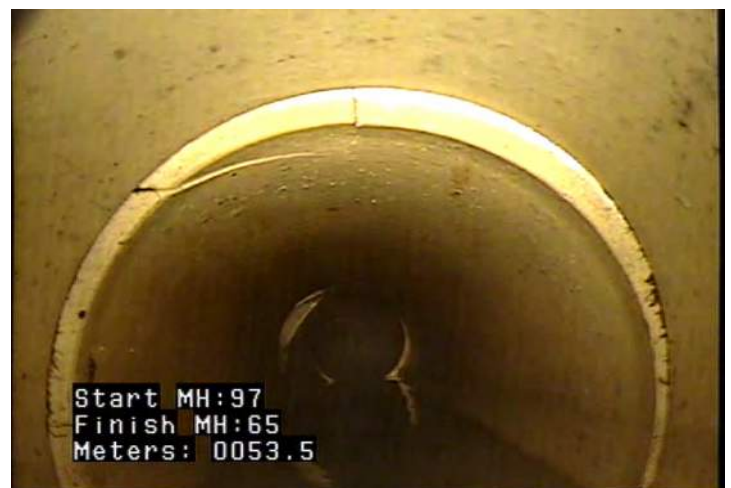
FS - Fracture Spiral @ 53.5 m.

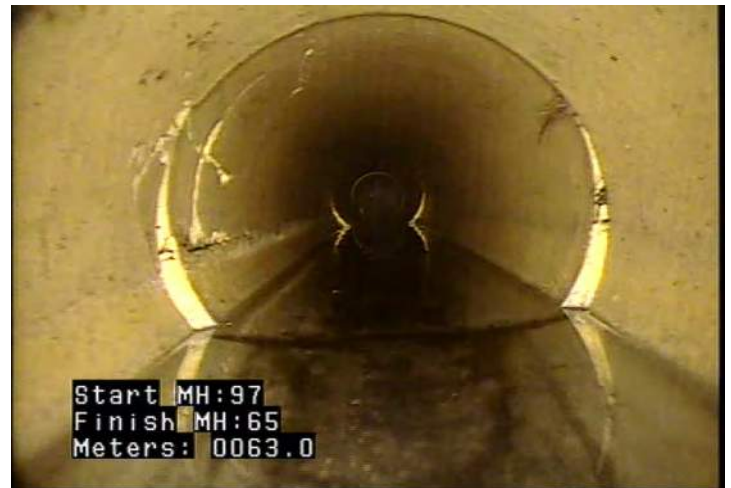
FM - Fracture Multiple @ 63.0 m.

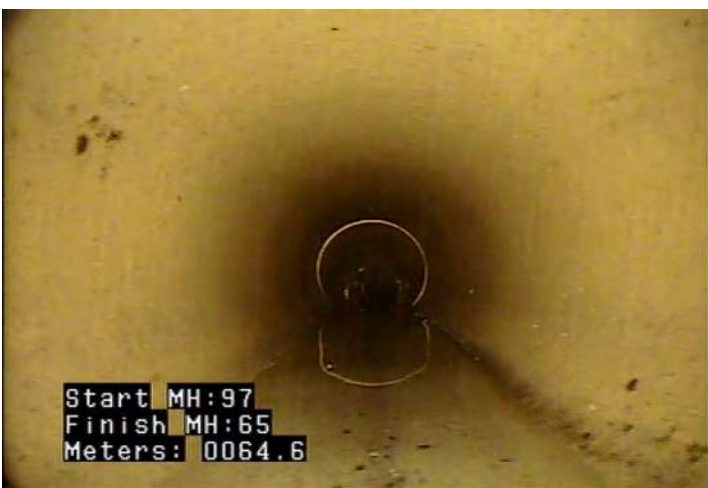
MWLS - Water Level: Sag @ 64.6 m.

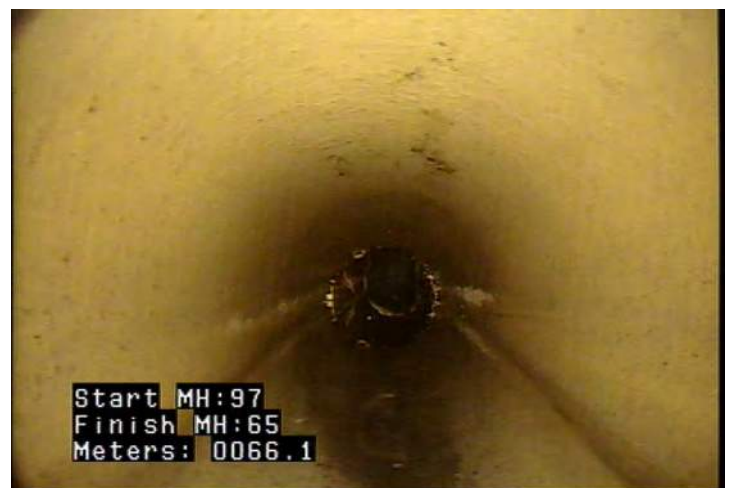
MWLS - Water Level: Sag @ 66.1 m.

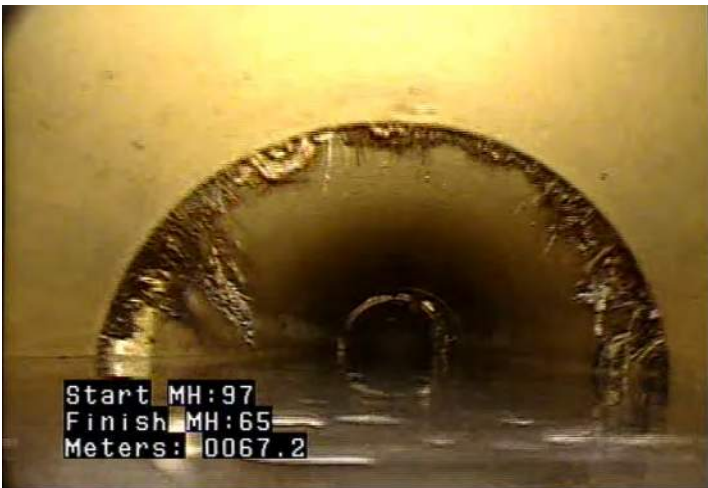
RMJ - Roots, Medium, Joint @ 67.2 m.

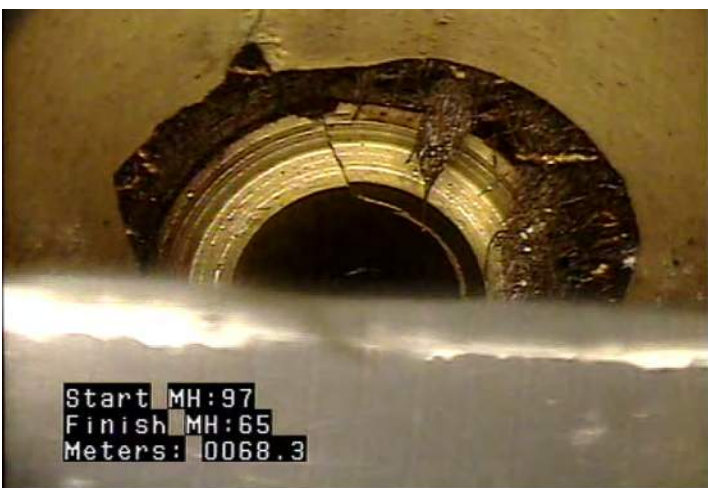
RMJ - Roots, Medium, Joint @ 68.3 m.

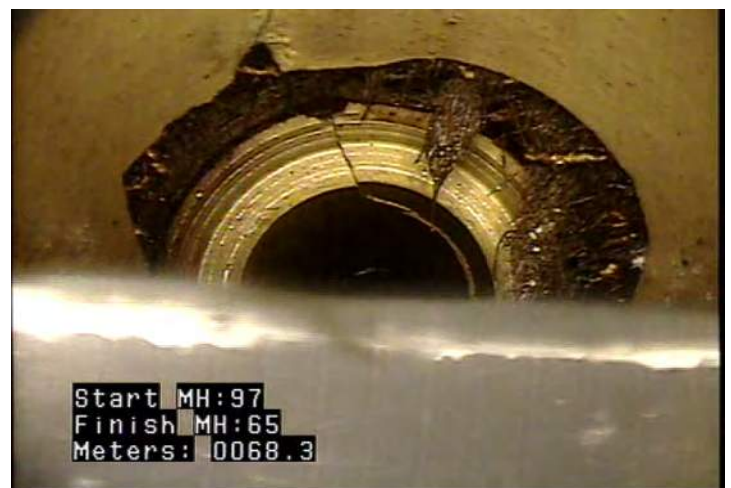
67.6		MCU	Camera Underwater					
68.3		RMJ	Roots, Medium, Joint	9 to 3	20			
68.3		H	Hole in Pipe	9 to 3				Pipe missing at joint
68.5		FS	Fracture Spiral	12 to 3				Fracture visible in pipesegment after hole

H - Hole in Pipe @ 68.3 m. Pipe missing at joint

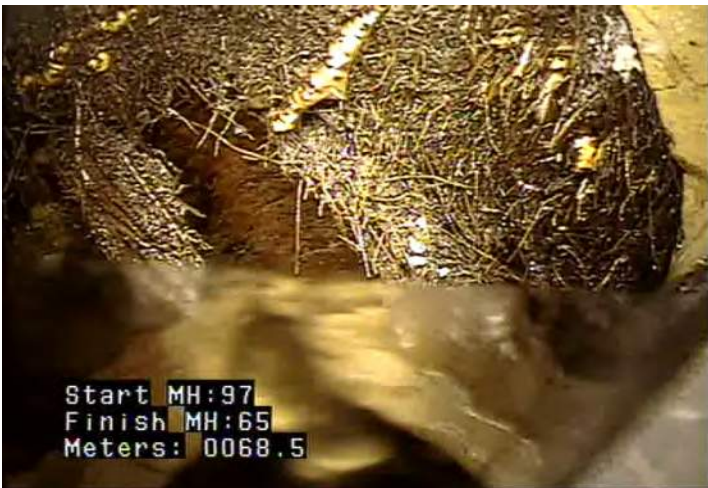
FS - Fracture Spiral @ 68.5 m. Fracture visible in pipesegment after hole

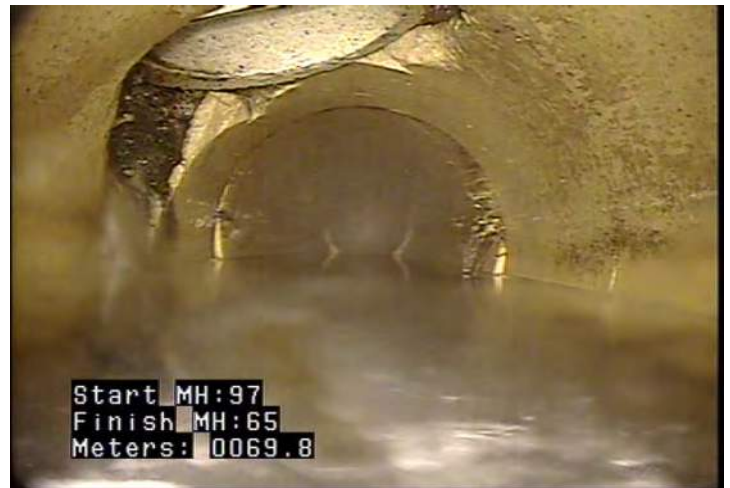
69.8		H	Hole in Pipe	7 to 9				Under service.
69.8		TB	Tap, Break-in / Hammer	11				
71.9		MWL	Water Level		5			
72.7		H	Hole in Pipe	8 to 9			J	Piece missing at joint

H - Hole in Pipe @ 69.8 m. Under service.

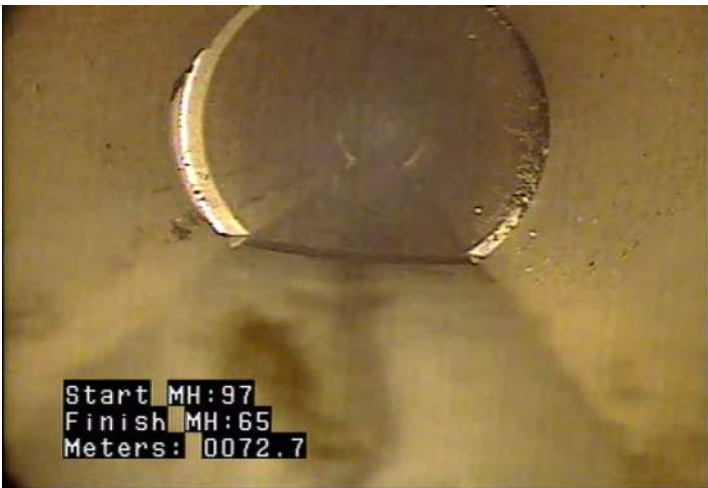
H - Hole in Pipe @ 72.7 m. Piece missing at joint

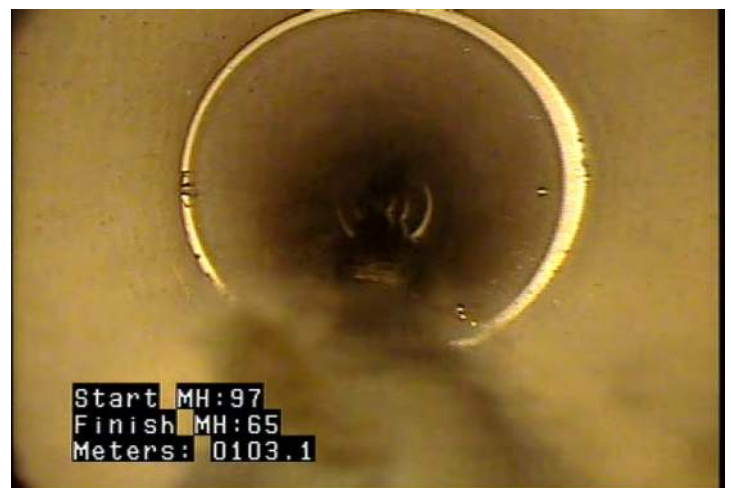
RFJ - Roots, Fine: Joint @ 103.1 m.

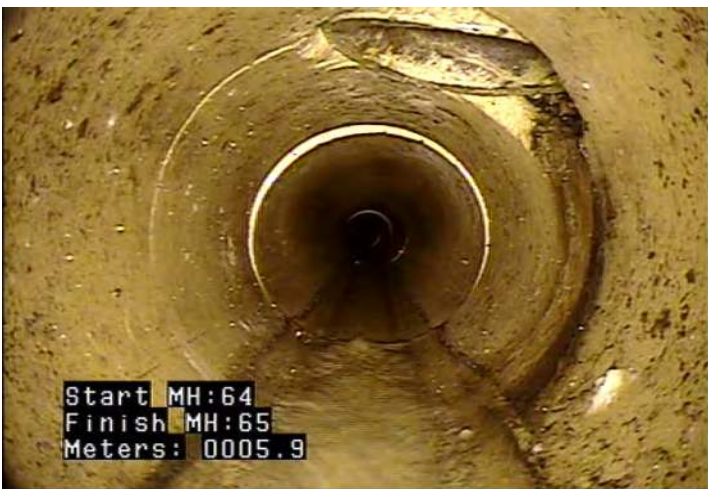
CC - Crack Circumferential @ 5.9 m.

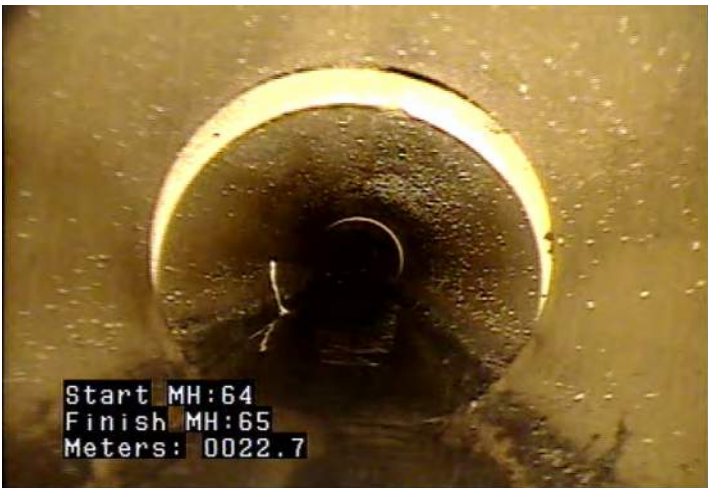
JOL - Joint Offset (displaced): Large @ 22.7 m.
