Appendix F CCTV Assessment

Client: CIMA
 Project: Pre-Rehabilitation Survey
 Date: 12/18/2020
 File: 14257

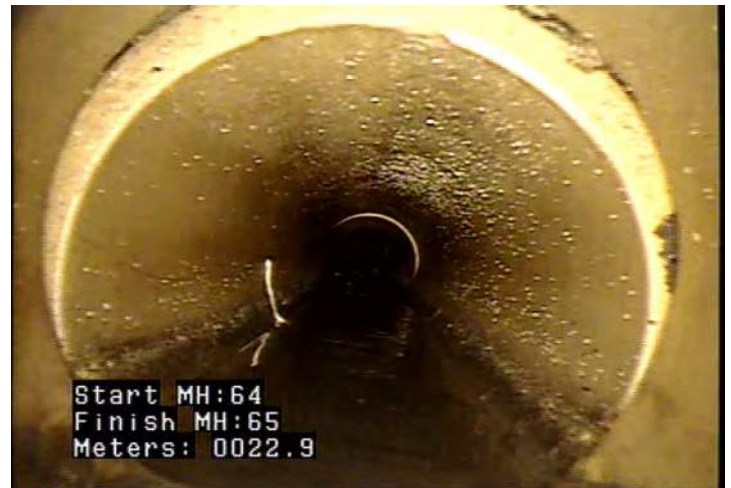
MWLS - Water Level: Sag @ 22.9 m.

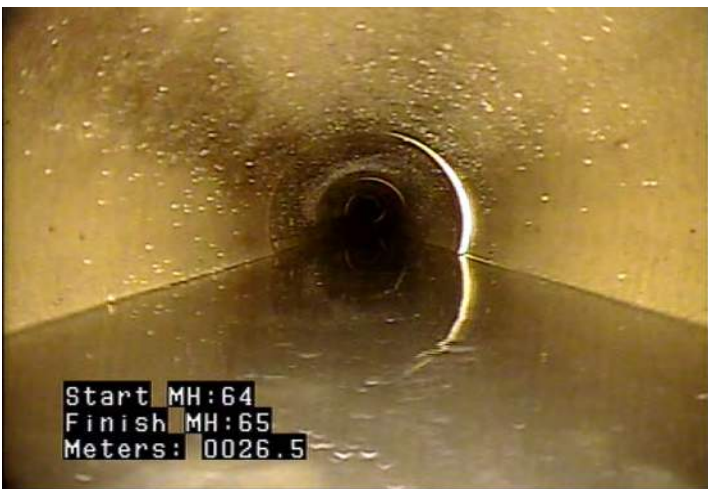
MGP - General Photograph @ 26.5 m.
Deepest point of sag

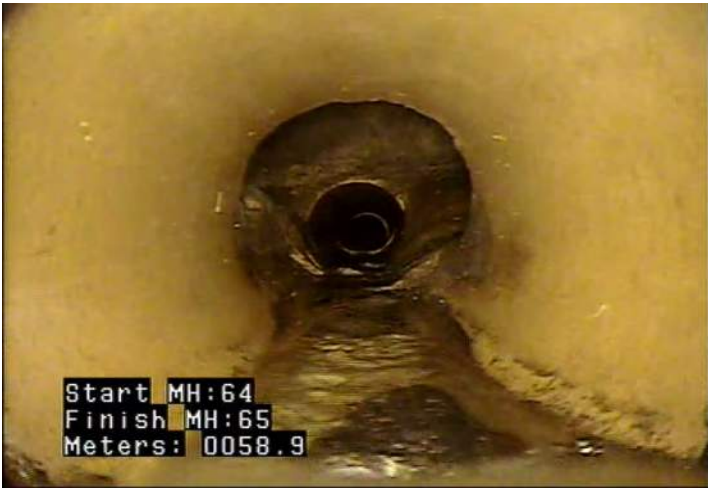
DSGV - Deposits Settled: Gravel @ 58.9 m.

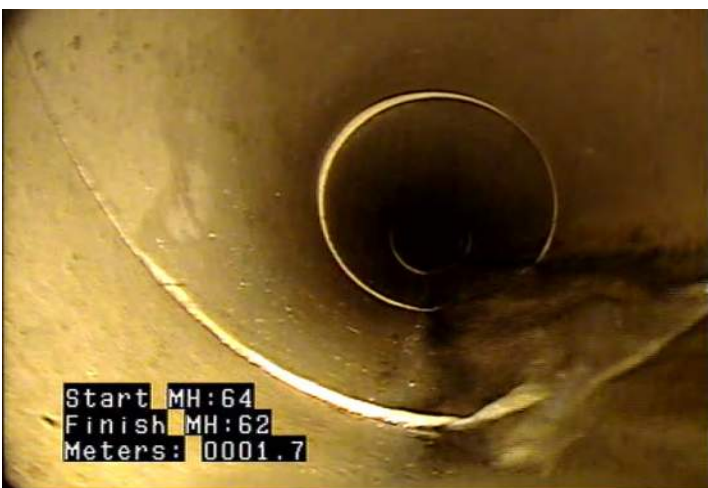
Dist.	Cont.	Code	Defect Description	Clock	%	mm	Joint	Remark
0.0		AMH	Access Point - Manhole					S MH 64
0.0		MWL	Water Level		5			
0.5		FC	Fracture Circumferential	4 to 10

FC - Fracture Circumferential @ 0.5 m.

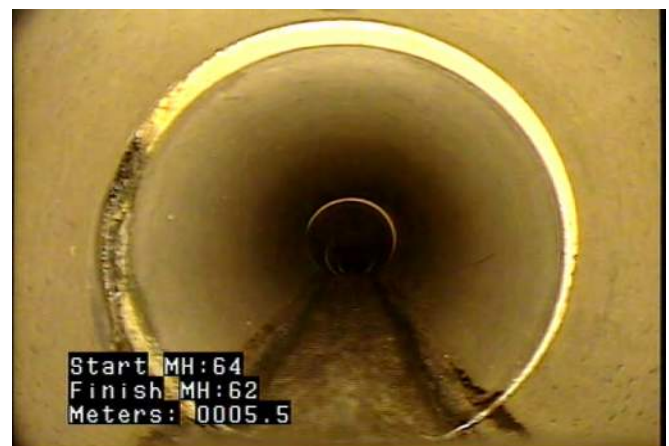
DAE - Deposits Attached: Encrustation @ 5.6 m. Deposits/Encrustation at most joints throughout pipe

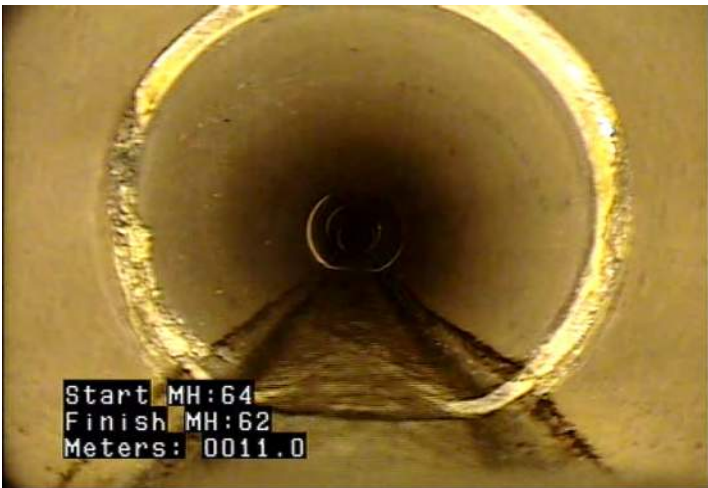
DAE - Deposits Attached: Encrustation @ 11.0 m.

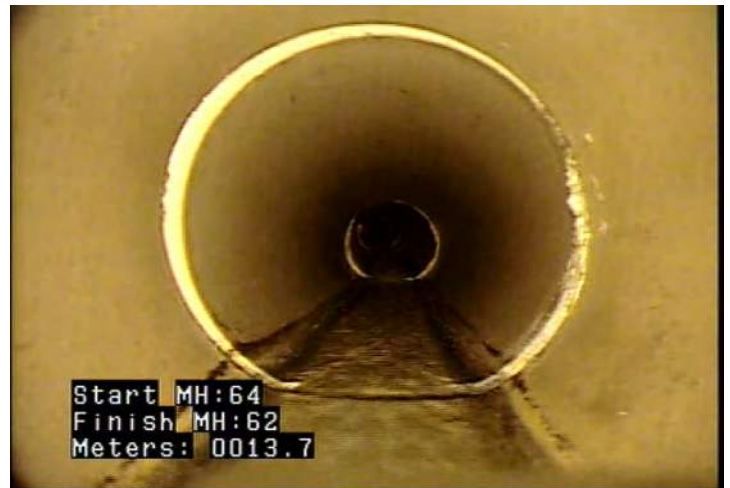
DAE - Deposits Attached: Encrustation @ 13.7 m.

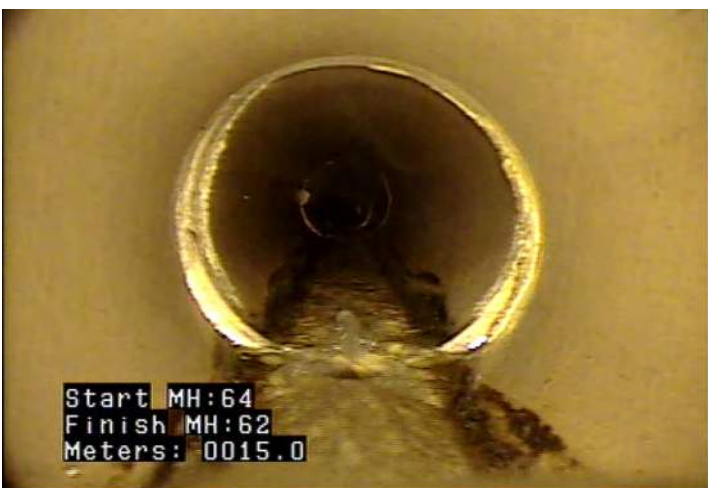
DAE - Deposits Attached: Encrustation @ 15.0 m.

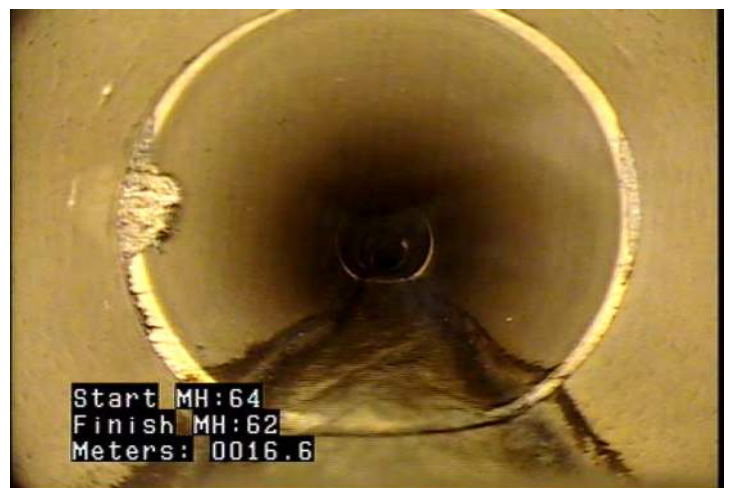
RFJ - Roots, Fine: Joint @ 16.6 m.

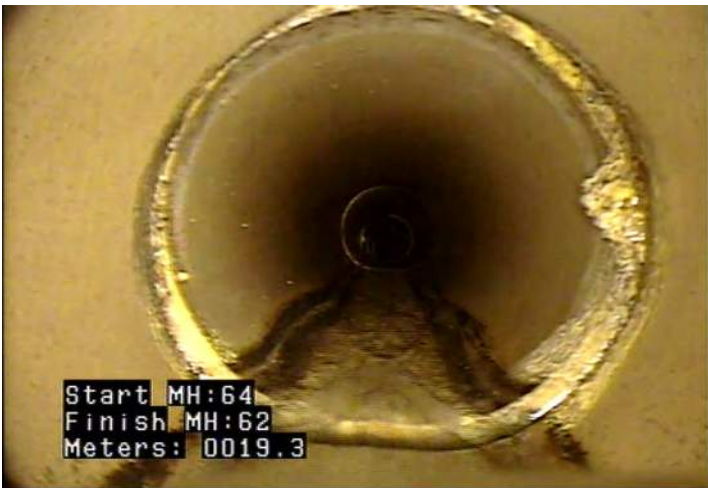
DAE - Deposits Attached: Encrustation @ 19.3 m.

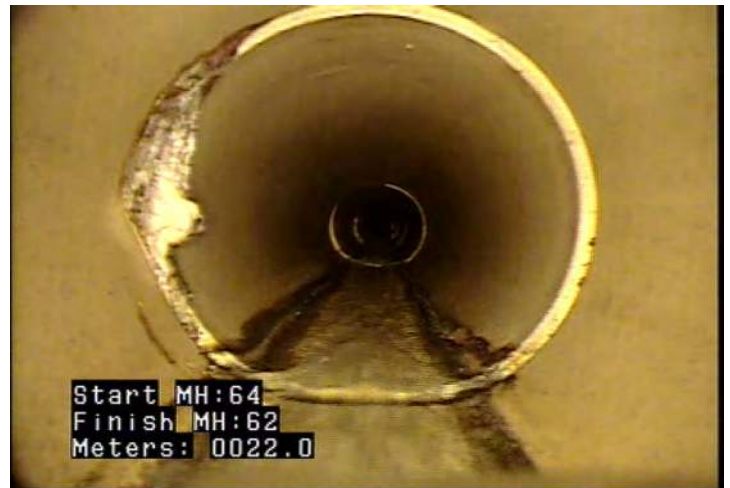
DAE - Deposits Attached: Encrustation @ 22.0 m.

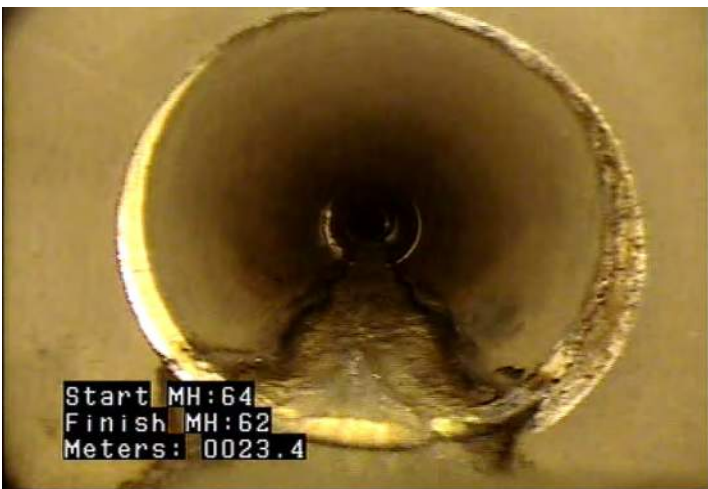
DAE - Deposits Attached: Encrustation @ 23.4 m.

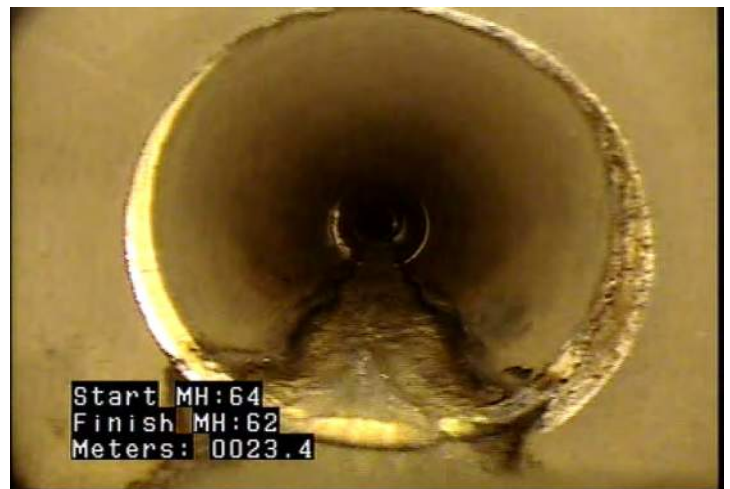
DAE - Deposits Attached: Encrustation @ 24.8 m.

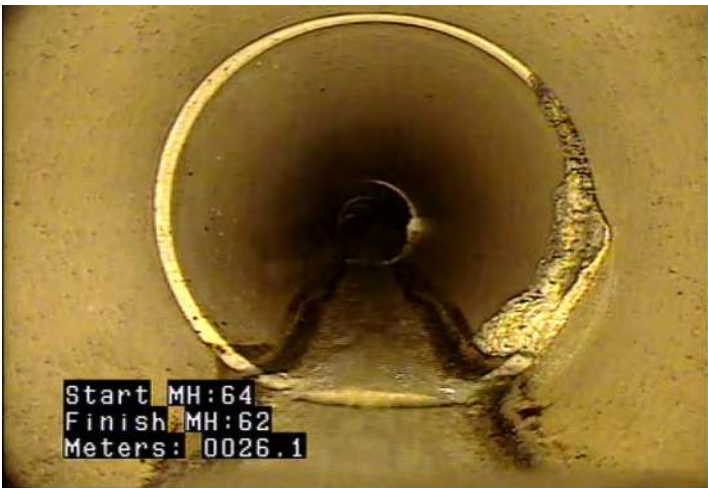
DAE - Deposits Attached: Encrustation @ 26.1 m.

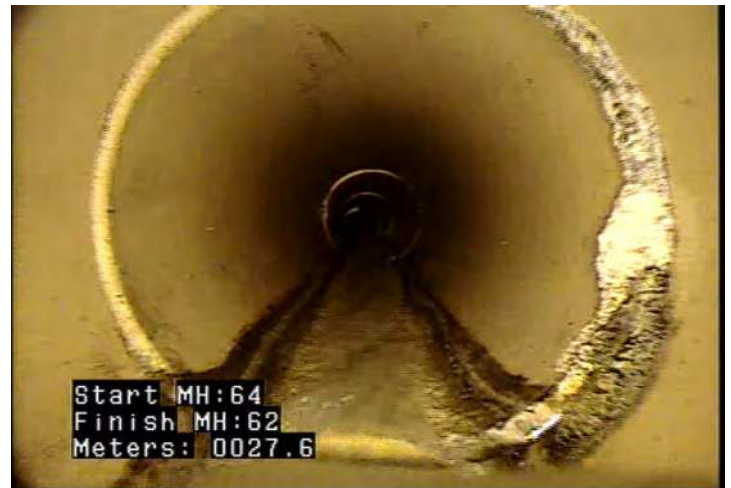
DAE - Deposits Attached: Encrustation @ 27.6 m.

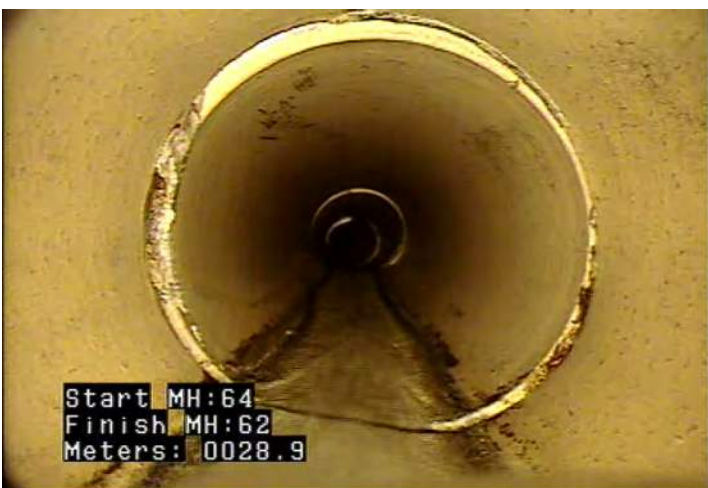
DAE - Deposits Attached: Encrustation @ 28.9 m.

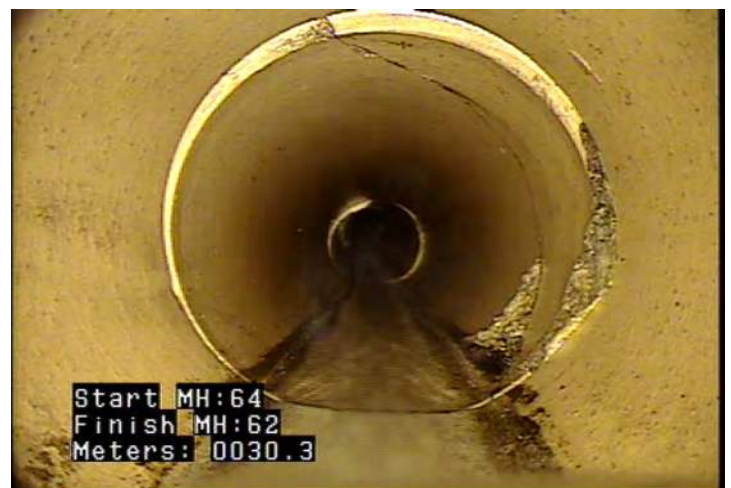
30.3		FC	Fracture Circumferential	11 to 5			J	
30.3		DAE	Deposits Attached: Encrustation	2 to 4	5		J	
31.7		DAE	Deposits Attached: Encrustation	8 to 4	10		J

FC - Fracture Circumferential @ 30.3 m.

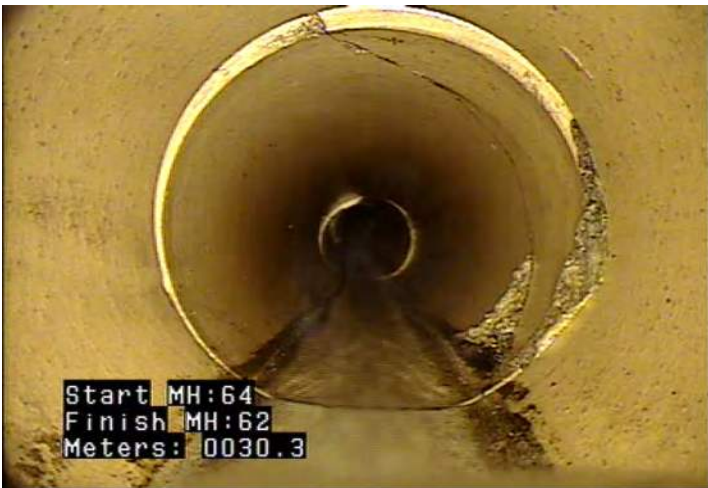
DAE - Deposits Attached: Encrustation @ 30.3 m.

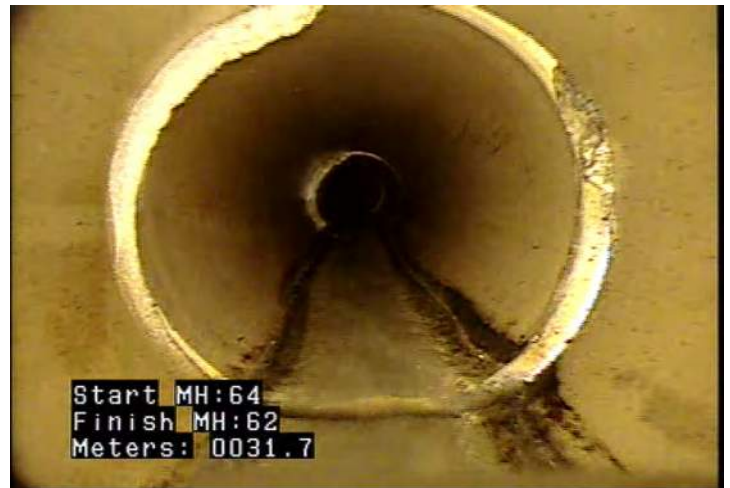
DAE - Deposits Attached: Encrustation @ 31.7 m.

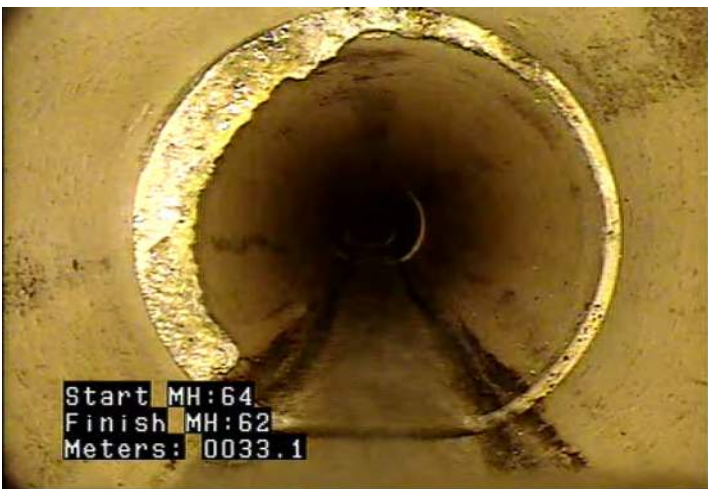
DAE - Deposits Attached: Encrustation @ 33.1 m.

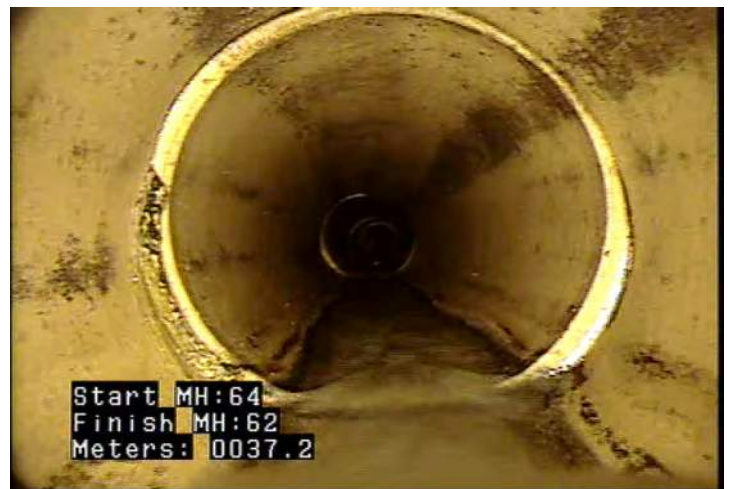
DAE - Deposits Attached: Encrustation @ 37.2 m.

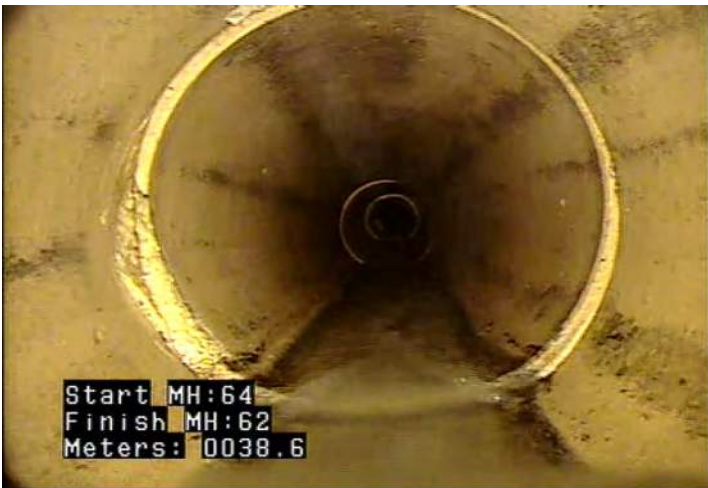
DAE - Deposits Attached: Encrustation @ 38.6 m.

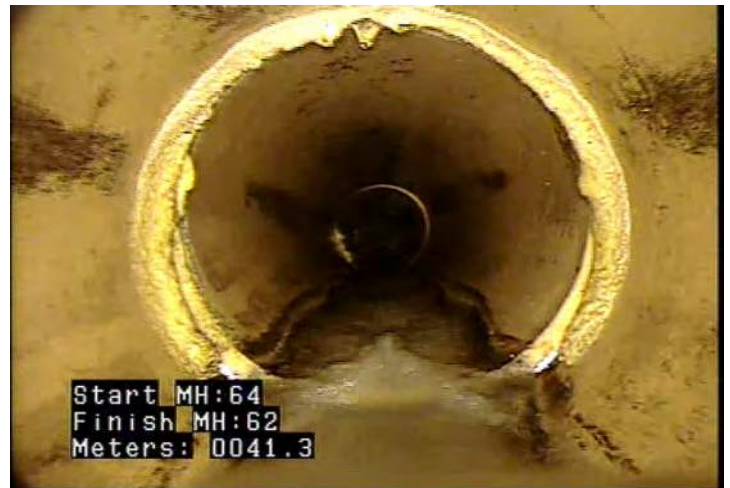
DAE - Deposits Attached: Encrustation @ 41.3 m.

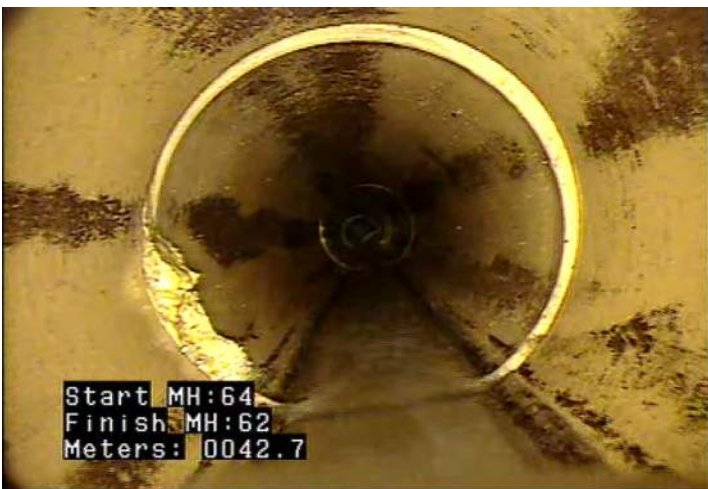
DAE - Deposits Attached: Encrustation @ 42.7 m.

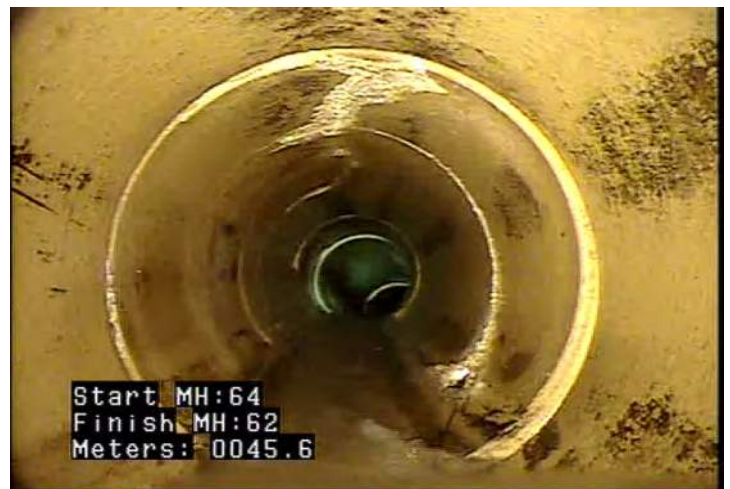
41.3		DAE	Deposits Attached: Encrustation	8 to 4	10		J	
42.7		DAE	Deposits Attached: Encrustation	7 to 9	5		J	
45.6		CM	Crack Multiple	11 to 5			J	
46.5	F01	DAE	Deposits Attached: Encrustation	12 to 12	5

CM - Crack Multiple @ 45.6 m.

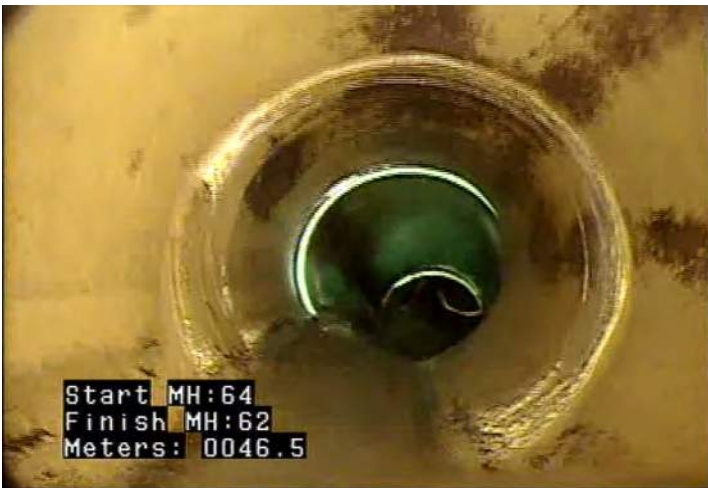
DAE - Deposits Attached: Encrustation @ 46.5 m.

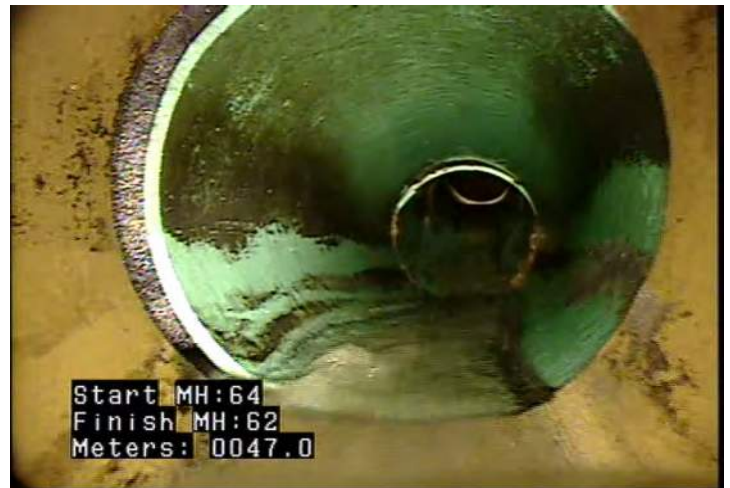
MMC - Material Change @ 47.0 m. Clay tile to PVC

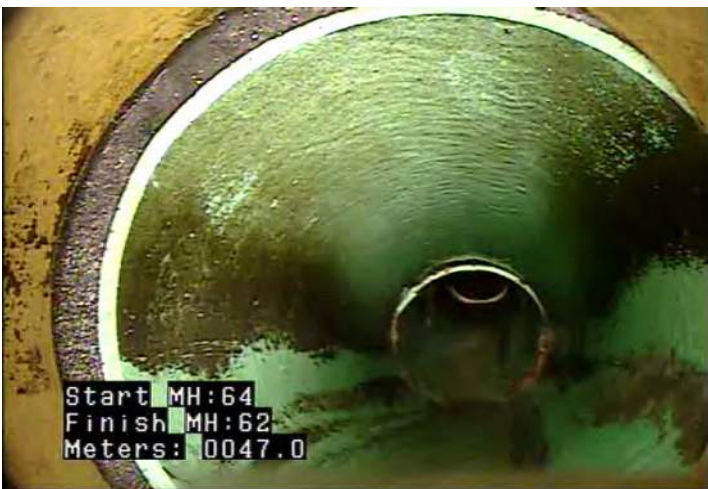
LD - Line - Down @ 47.0 m.

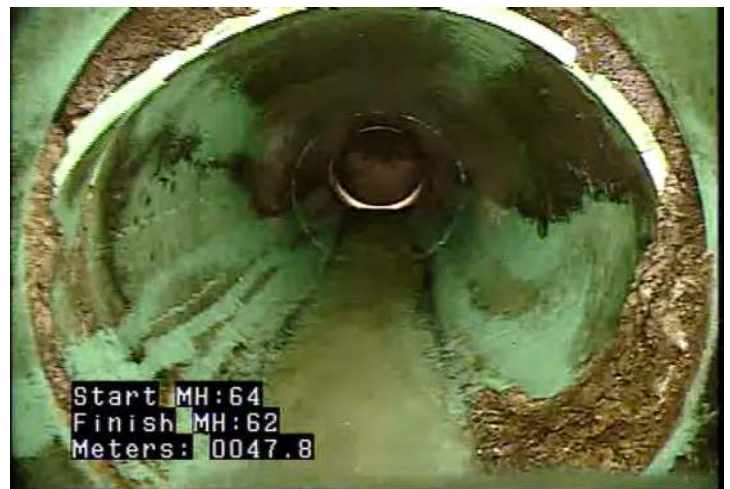
JSM - Joint Separated (open): Medium @ 47.8 m.

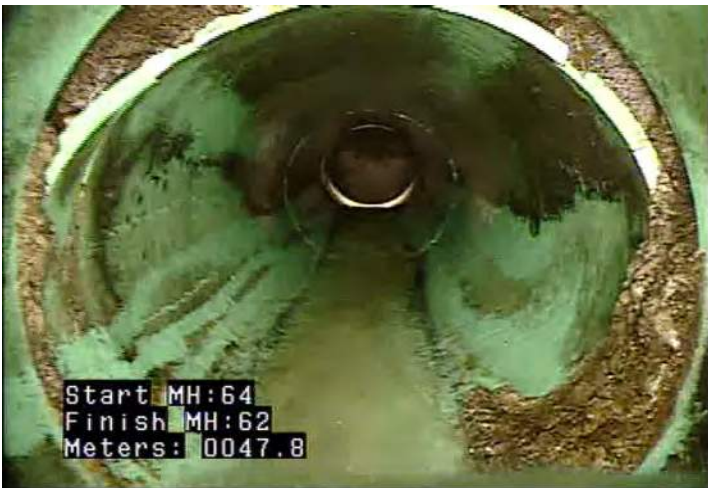
D - Pipe Deformed @ 47.8 m.

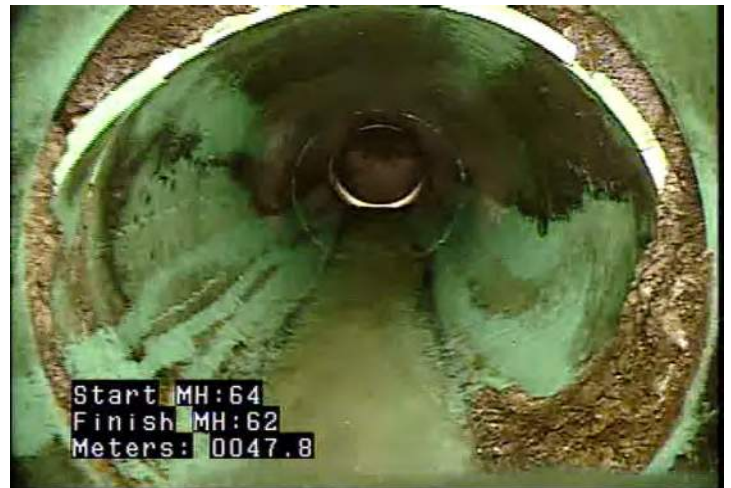
LU - Line - Up @ 47.8 m. Return to horizontal

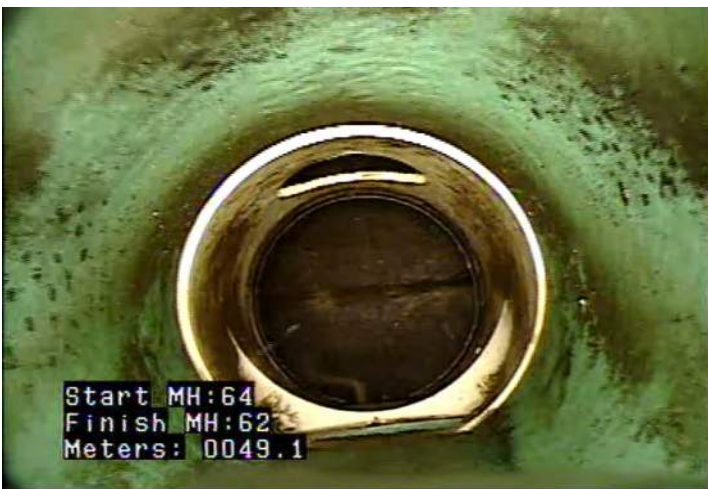
TF - Tap, Factory Made @ 49.1 m. Drop Structure

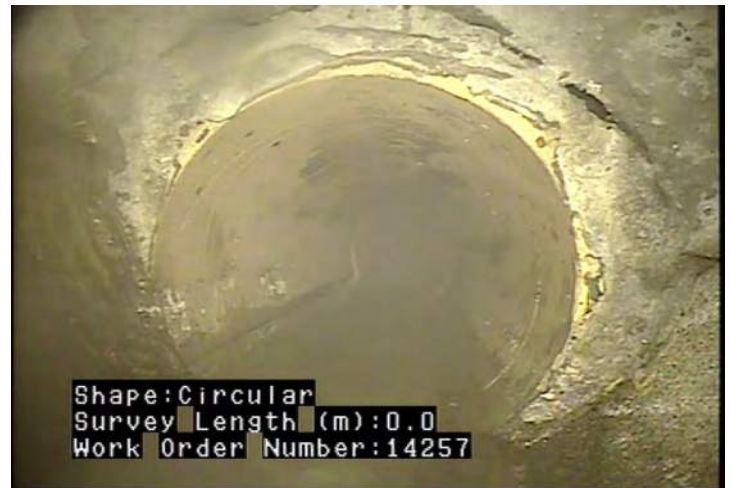
MWL - Water Level @ 0.0 m.

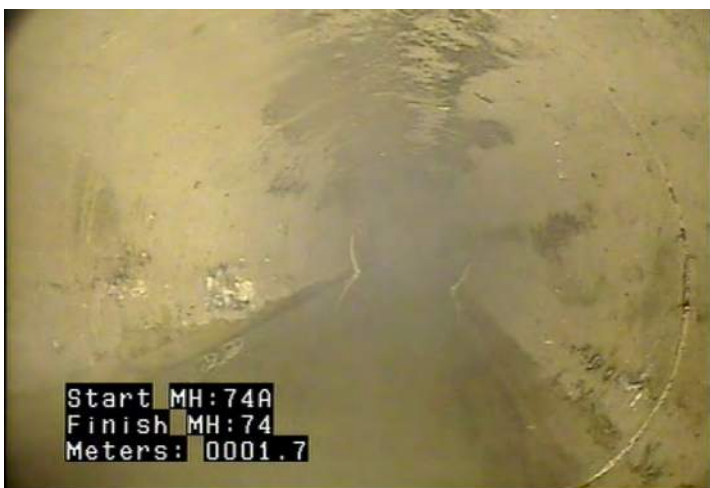
Dist.	Cont.	Code	Defect Description	Clock	%	mm	Joint	Remark
0.0		AMH	Access Point - Manhole					S MH 74A
0.0		MWL	Water Level		10			
1.0		CC	Crack Circumferential	2 to 5

CC - Crack Circumferential @ 1.0 m.

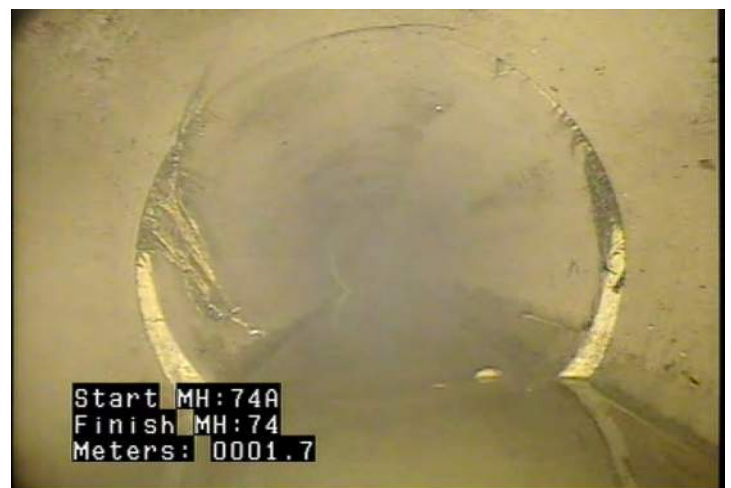
RFJ - Roots, Fine: Joint @ 1.7 m. Fine roots at most joints

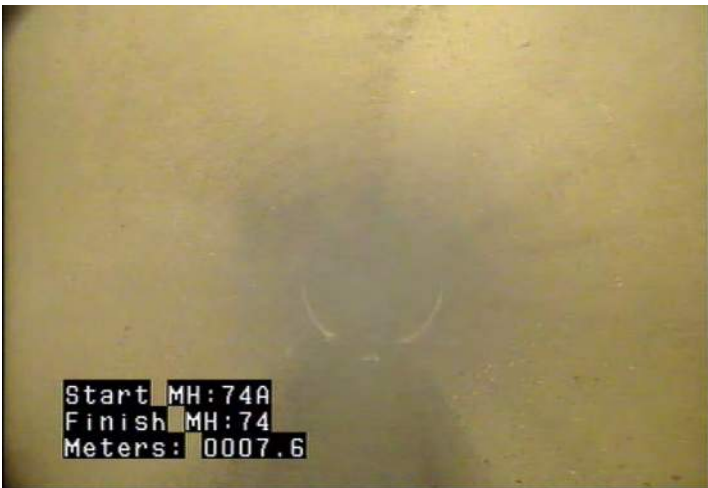
MWL - Water Level @ 7.6 m.

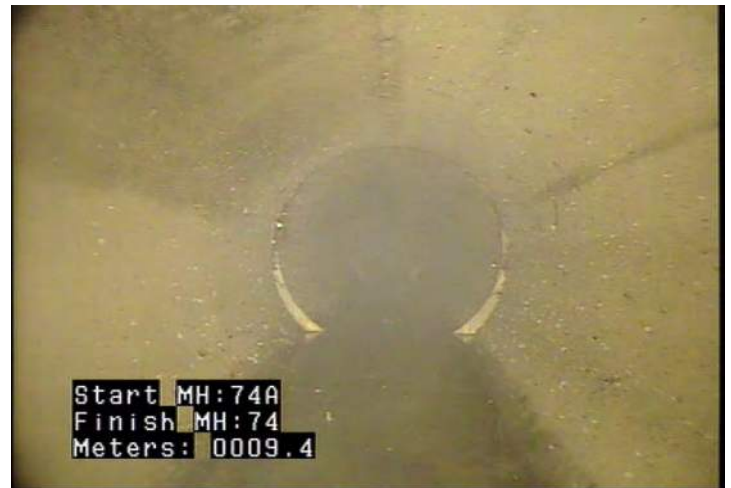
MWL - Water Level @ 9.4 m.

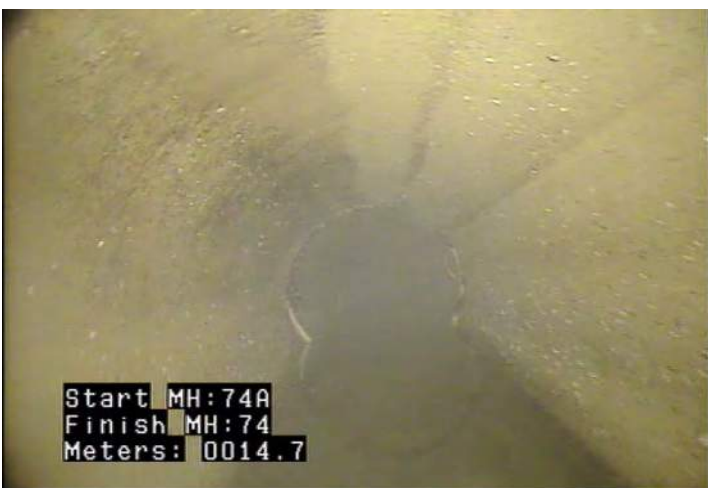
MWL - Water Level @ 14.7 m.

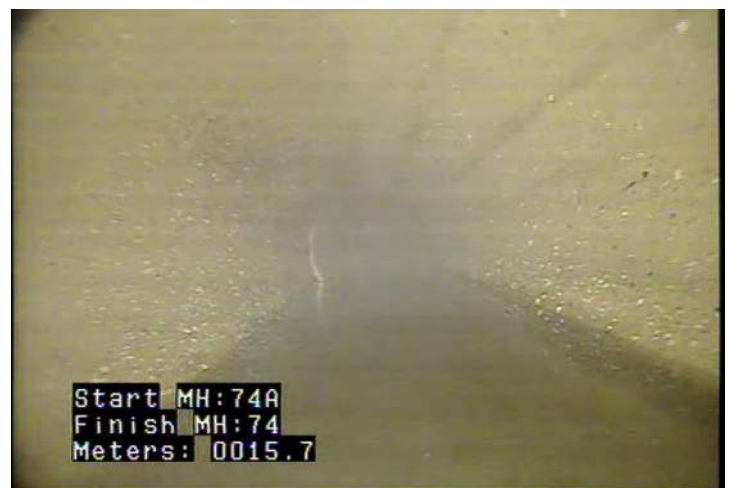
MWL - Water Level @ 15.7 m.

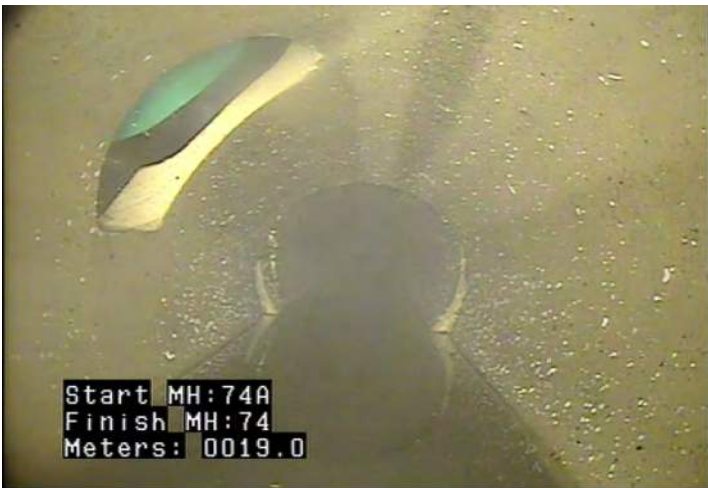
TB - Tap, Break-in / Hammer @ 19.0 m.

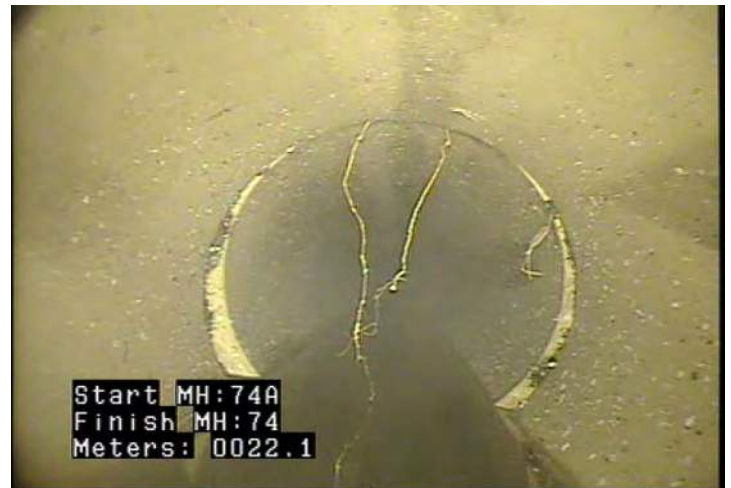
RFJ - Roots, Fine: Joint @ 22.1 m.

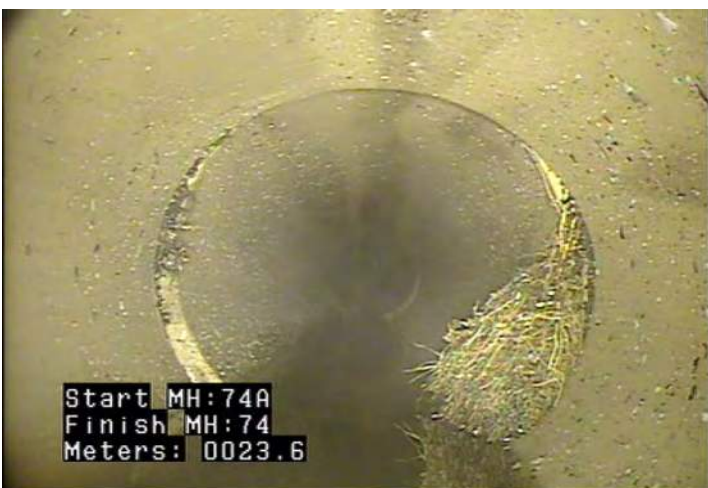
RMJ - Roots, Medium, Joint @ 23.6 m.
Moderate roots at most joints

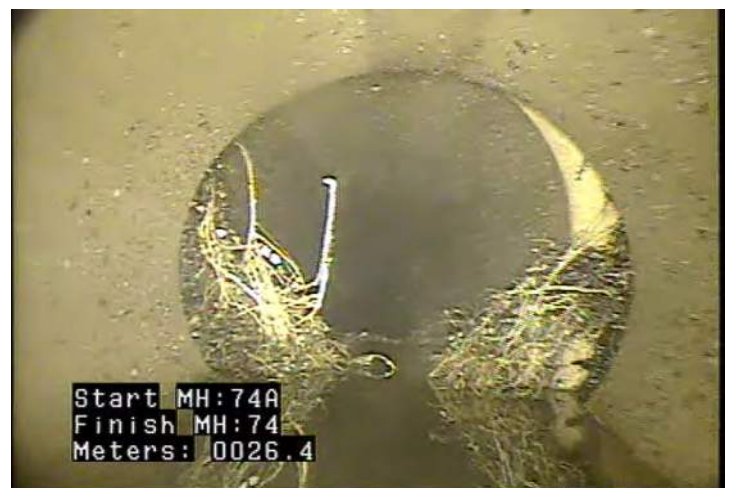
JOL - Joint Offset (displaced): Large @ 26.5 m.

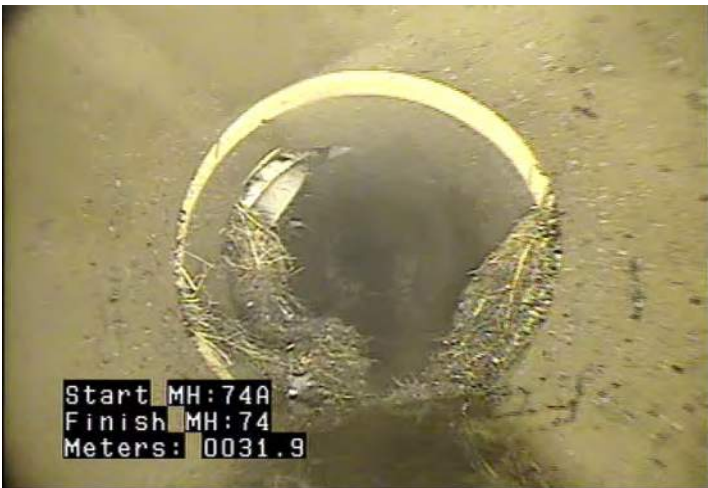
RMJ - Roots, Medium, Joint @ 31.9 m.

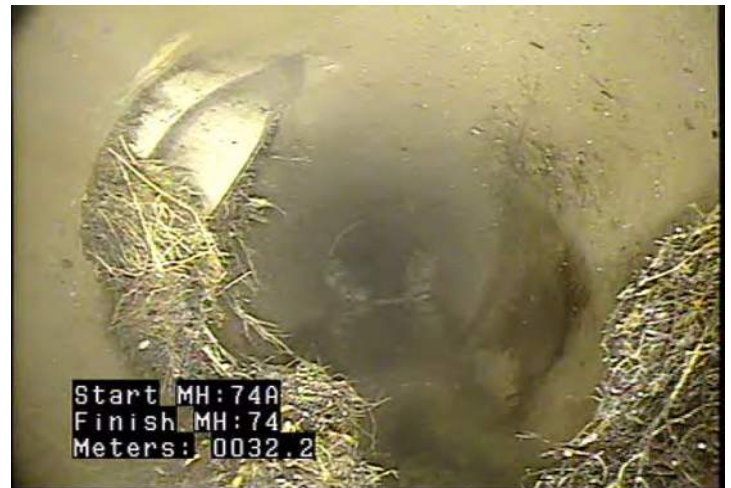
RMC - Roots, Medium: Connection @ 32.2 m.

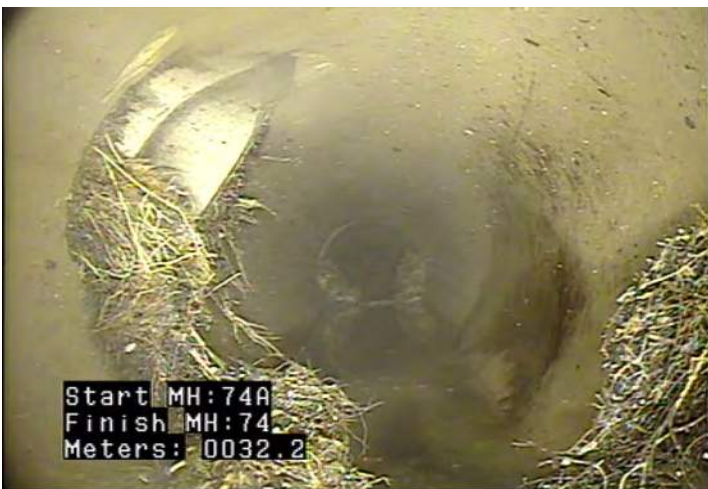
TB - Tap, Break-in / Hammer @ 32.2 m.

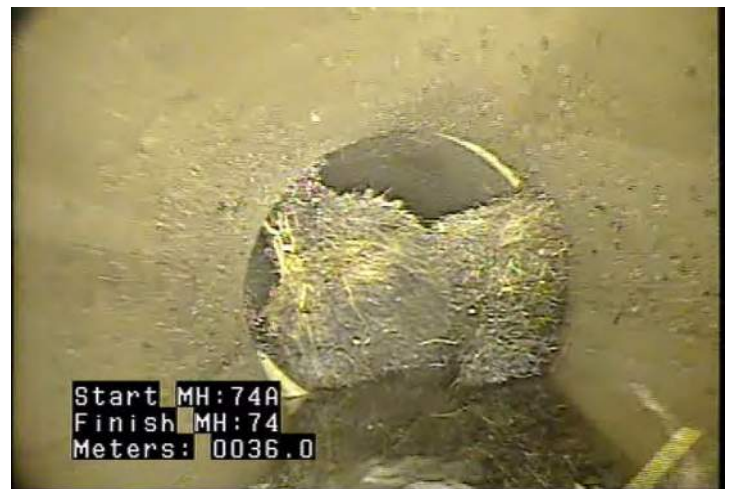
36.0		RBJ	Roots, Ball, Joint	2 to 10	80		J	
51.0		TB	Tap, Break-in / Hammer	10				
51.2		FL	Fracture Longitudinal	8			J	
63.6		B	Pipe Broken	12 to 10				
63.7		MGP	General Photograph					Additional view of break

RBJ - Roots, Ball, Joint @ 36.0 m.

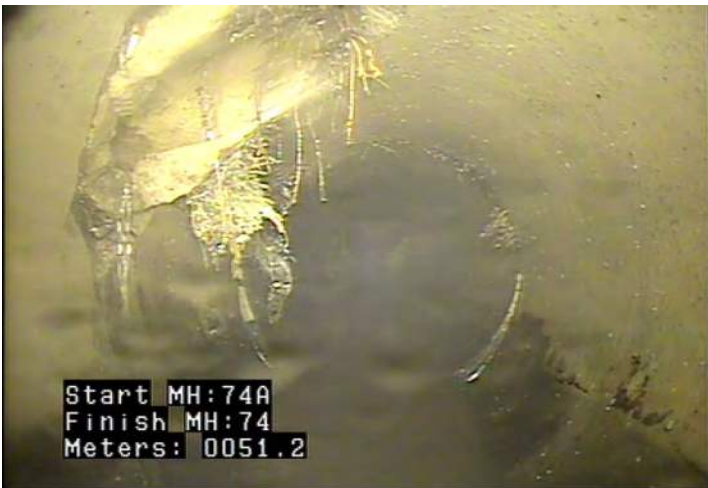
TB - Tap, Break-in / Hammer @ 51.0 m.

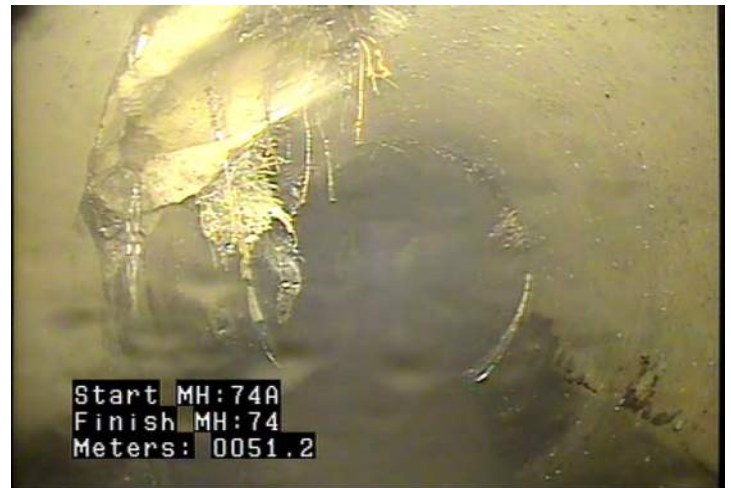
FL - Fracture Longitudinal @ 51.2 m.

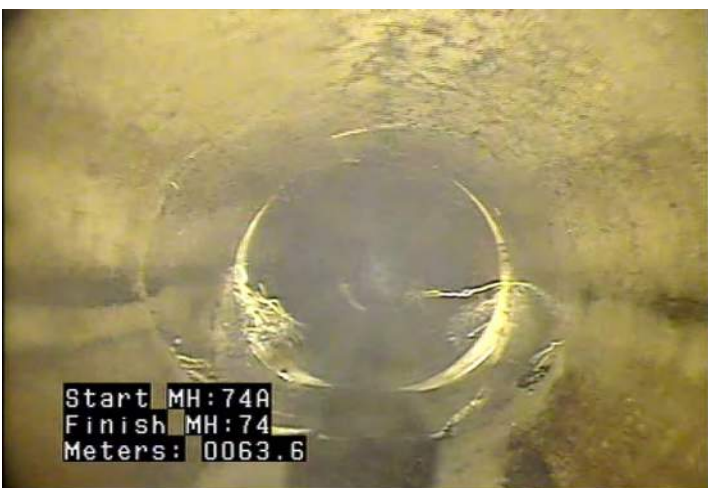
B - Pipe Broken @ 63.6 m.

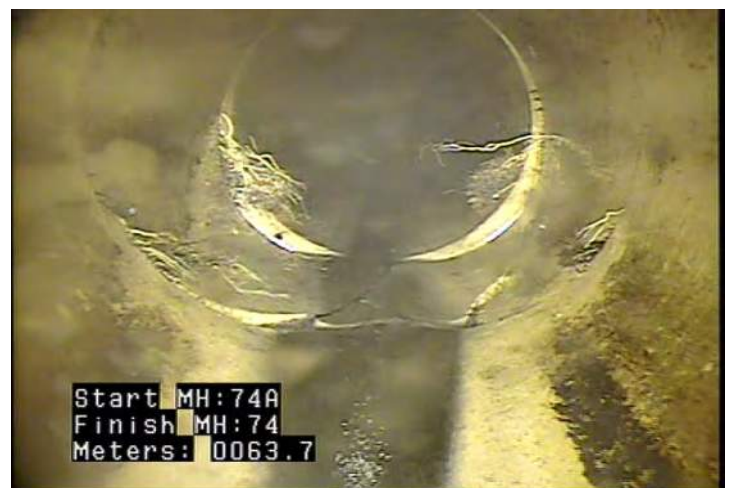
MGP - General Photograph @ 63.7 m.
Additional view of break

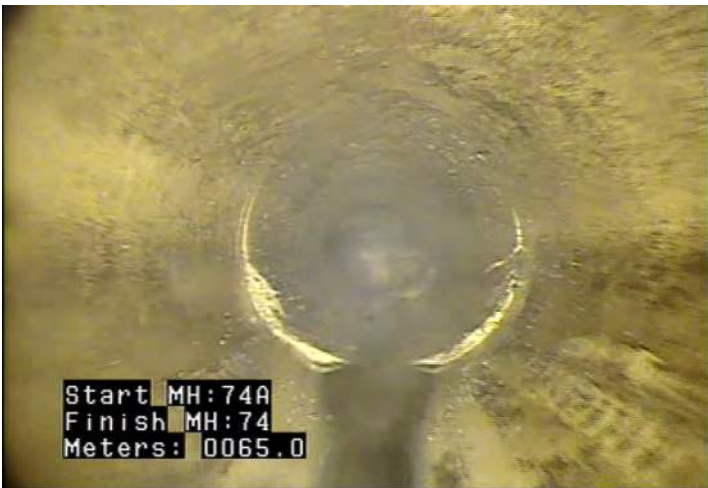
RMJ - Roots, Medium, Joint @ 65.0 m.

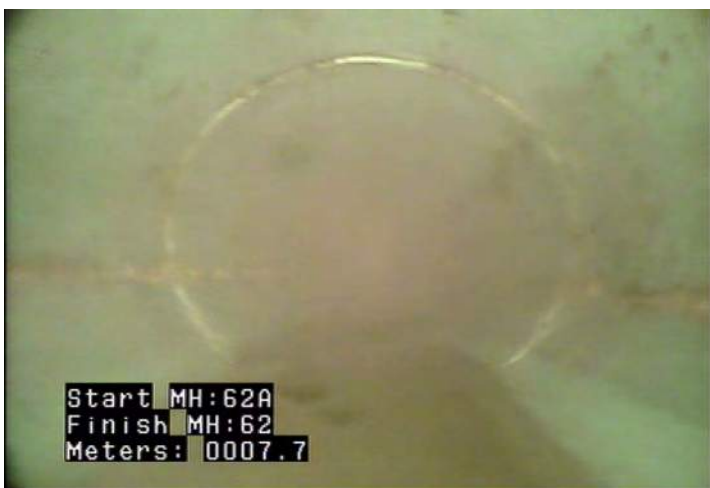
MWL - Water Level @ 7.7 m.

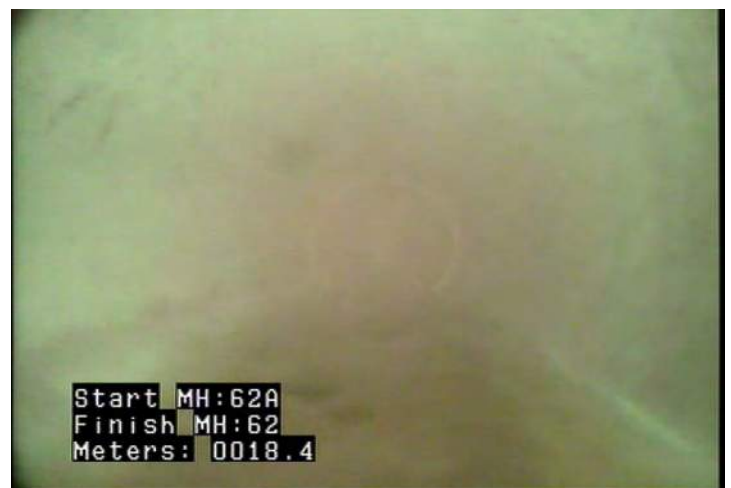
MWLS - Water Level: Sag @ 18.4 m.

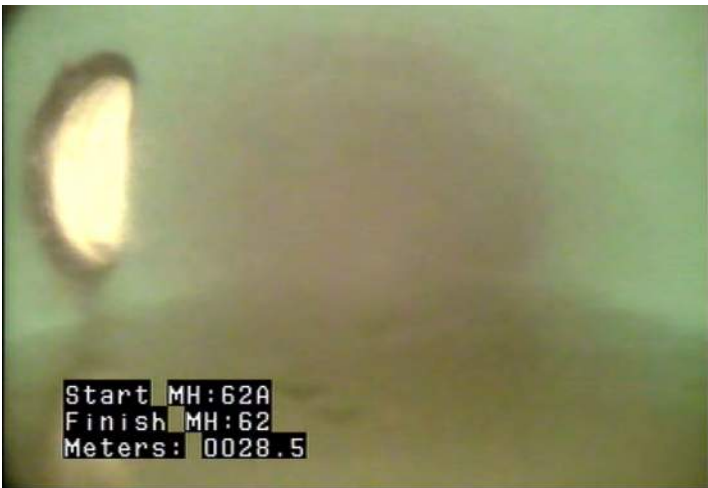
TS - Tap, Saddle @ 28.5 m.

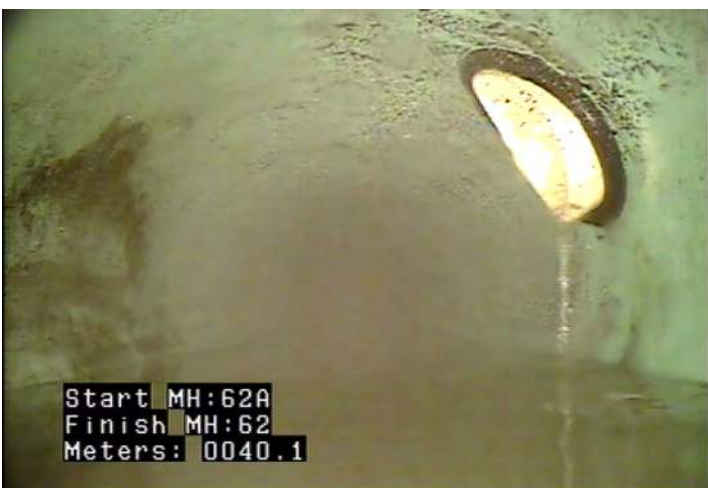
40.1		TSI	Tap, Saddle: Intruding	2				
	48.3		TS	Tap, Saddle	11				
	52.5	F01	MWLS	Water Level: Sag		10			
	64.6		AMH	Access Point - Manhole					S MH 62

TSI - Tap, Saddle: Intruding @ 40.1 m.

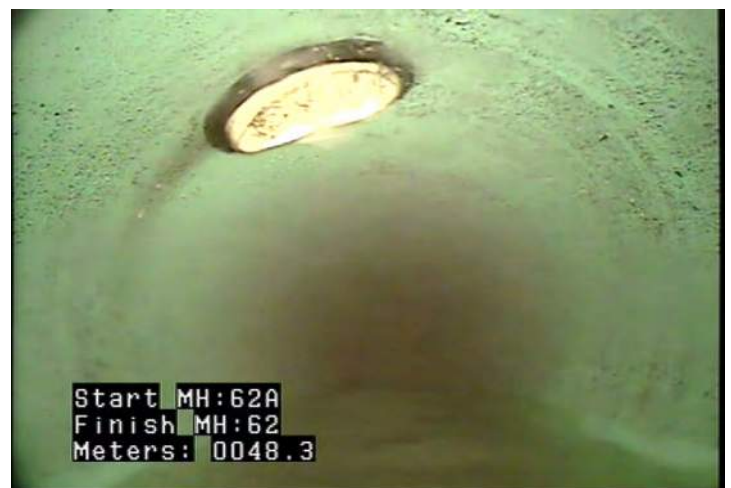
TS - Tap, Saddle @ 48.3 m.

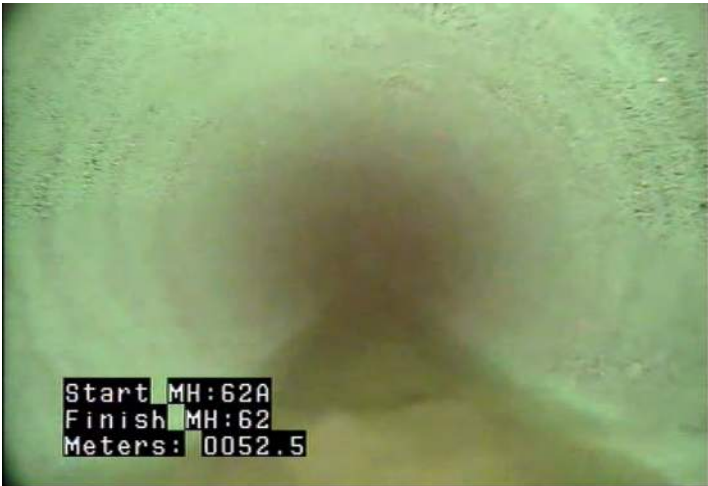
MWLS - Water Level: Sag @ 52.5 m.

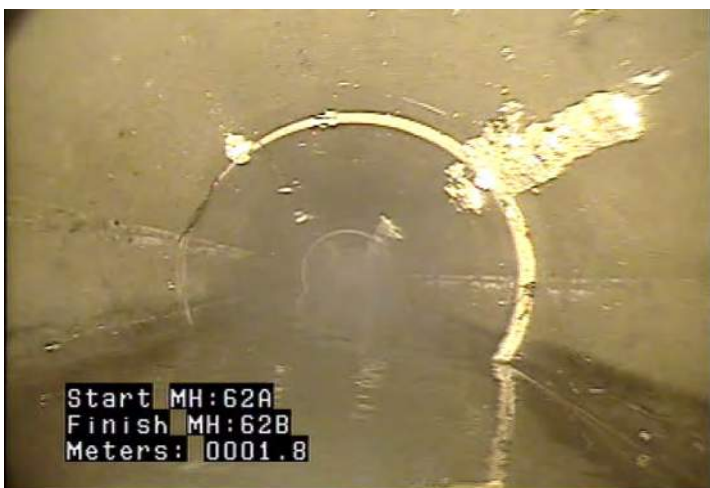
Dist.	Cont.	Code	Defect Description	Clock	%	mm	Joint	Remark
0.0		AMH	Access Point - Manhole					MH 62A
0.0		MWL	Water Level		25			
1.8	S01	DAGS	Deposits Attached: Grease	1 to 2	5

DAGS - Deposits Attached: Grease @ 1.8 m.

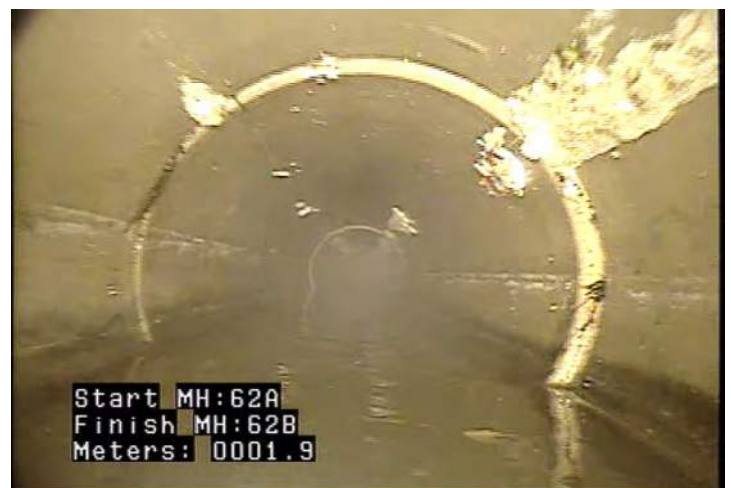
RFJ - Roots, Fine: Joint @ 1.9 m.

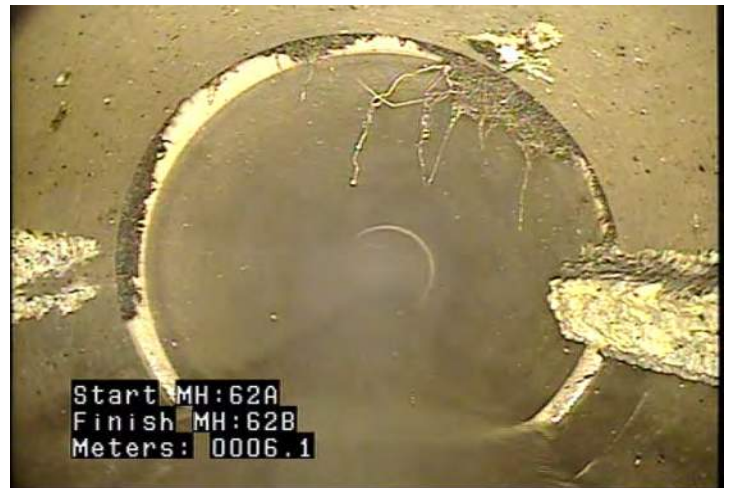
RFJ - Roots, Fine: Joint @ 6.1 m.

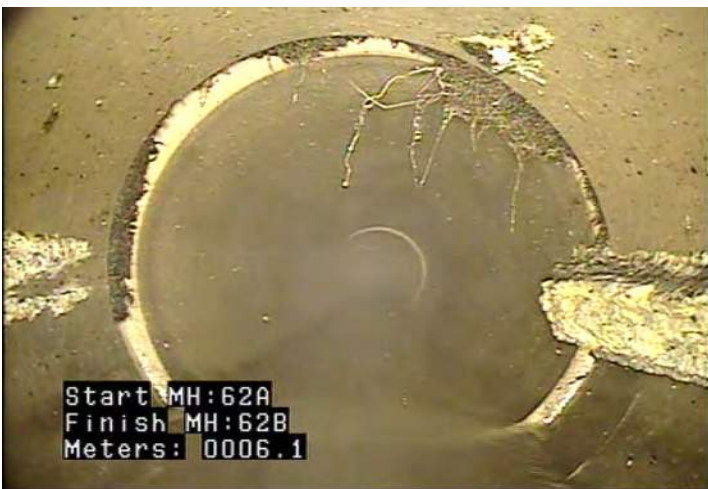
DAGS - Deposits Attached: Grease @ 6.1 m.

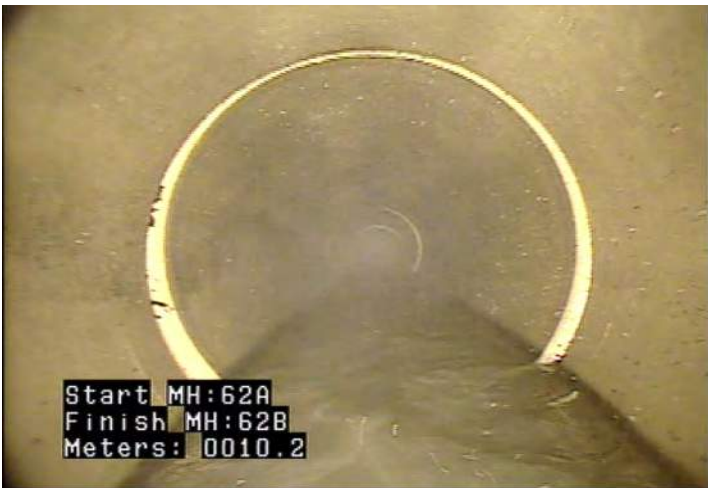
RFJ - Roots, Fine: Joint @ 10.2 m.
