Appendix F CCTV Assessment

Client: CIMA
 Project: Pre-Rehabilitation Survey
 Date: 12/18/2020
 File: 14257

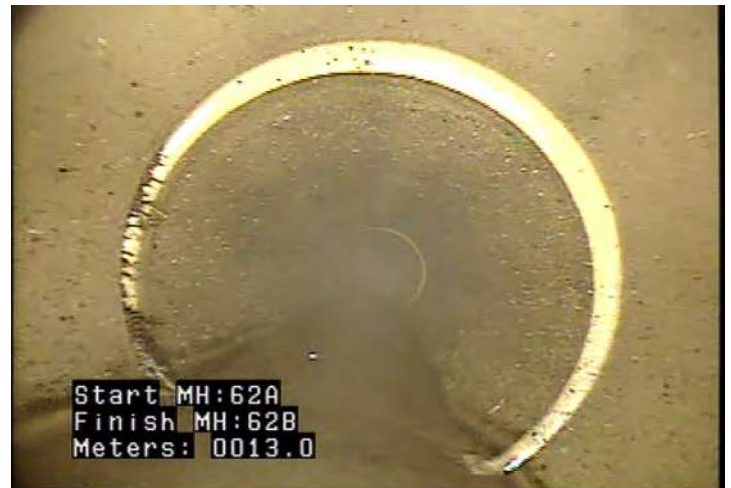
RFJ - Roots, Fine: Joint @ 13.0 m.

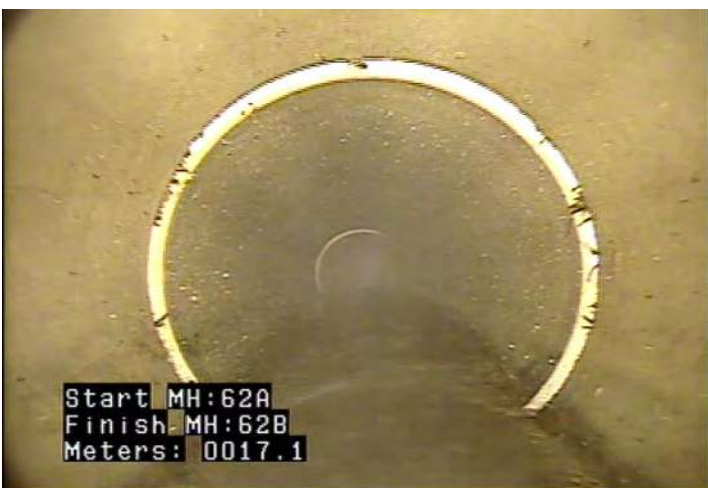
RFJ - Roots, Fine: Joint @ 17.1 m.

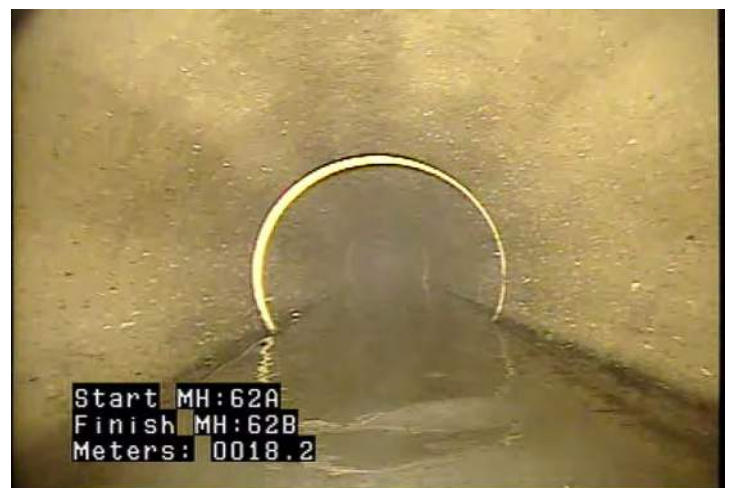
MWLS - Water Level: Sag @ 18.2 m.

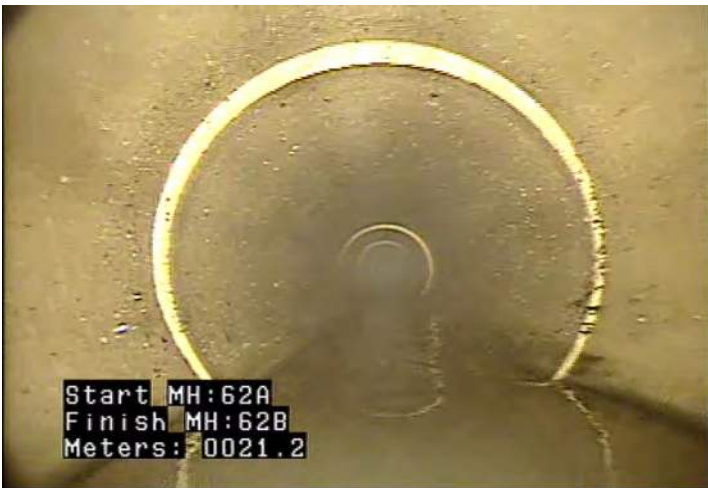
MWLS - Water Level: Sag @ 21.2 m.

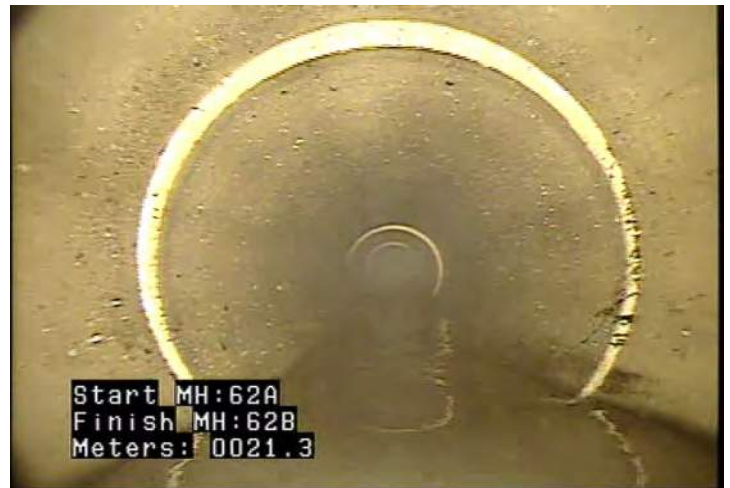
RFJ - Roots, Fine: Joint @ 21.3 m.

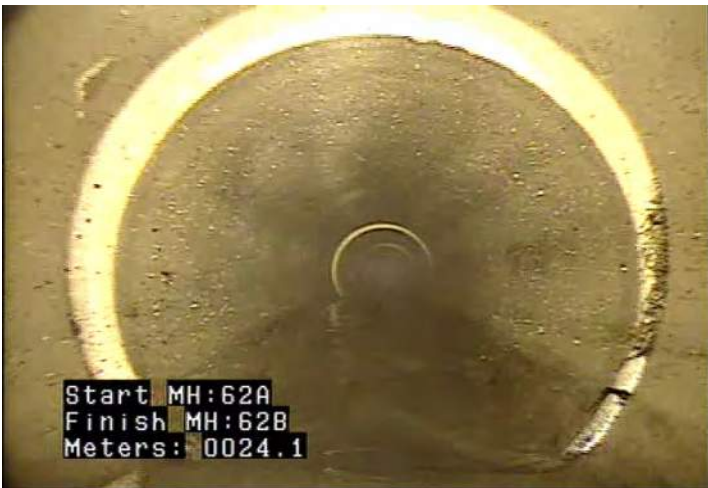
RFJ - Roots, Fine: Joint @ 24.1 m.

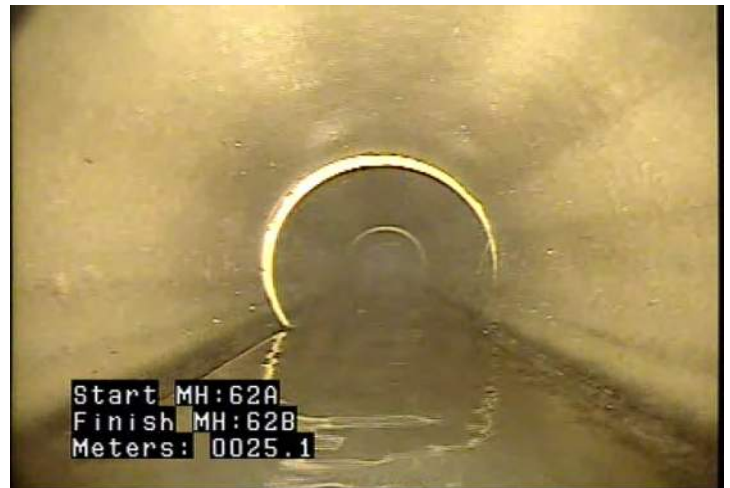
MWLS - Water Level: Sag @ 25.1 m.

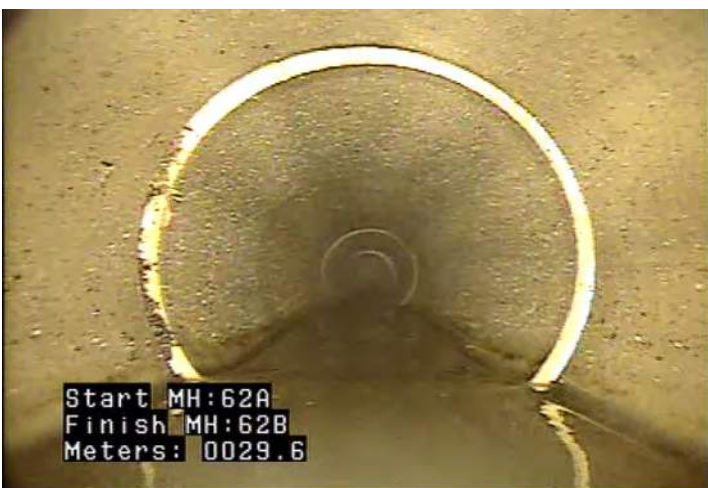
MWLS - Water Level: Sag @ 29.6 m.

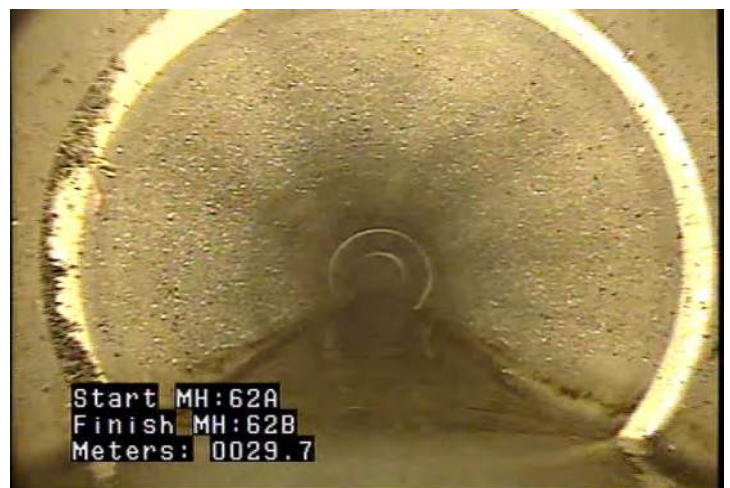
RFJ - Roots, Fine: Joint @ 29.7 m.

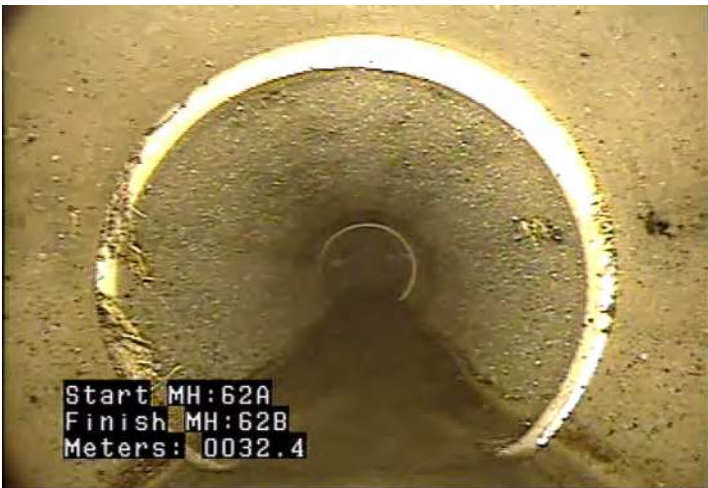
RFJ - Roots, Fine: Joint @ 32.4 m.

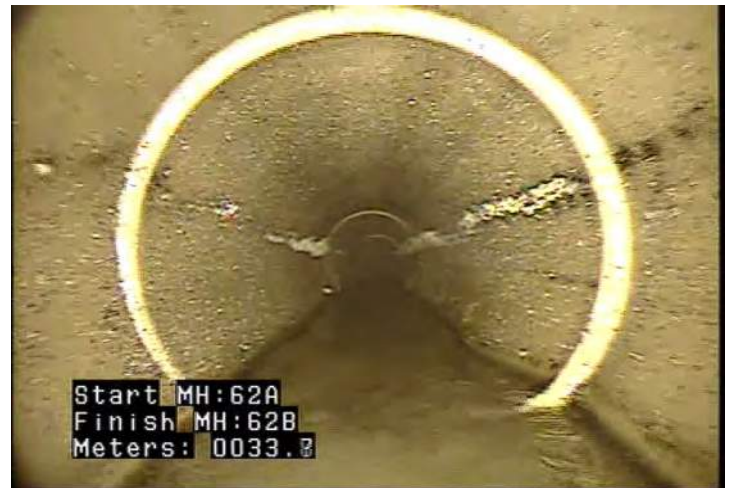
DAGS - Deposits Attached: Grease @ 33.8 m.

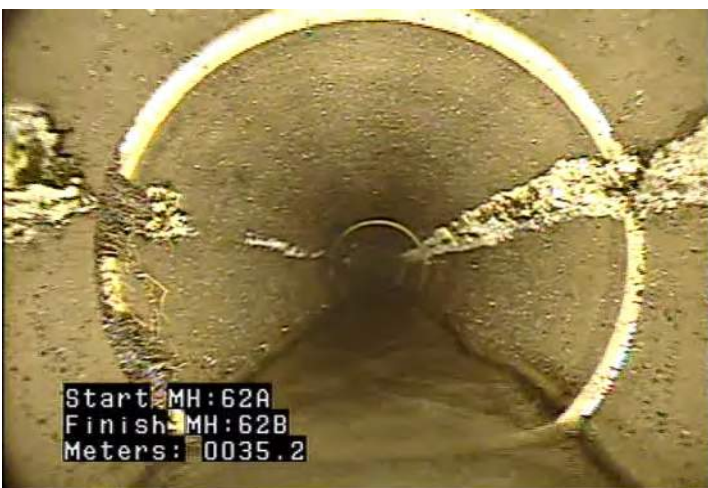
RFJ - Roots, Fine: Joint @ 35.2 m.

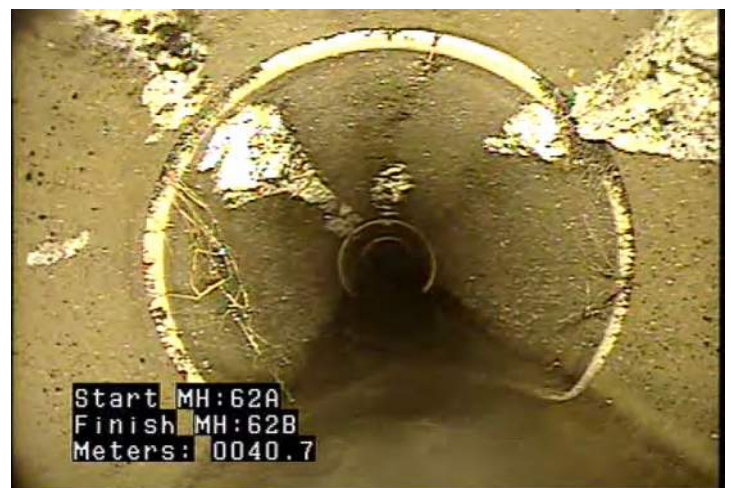
RFJ - Roots, Fine: Joint @ 40.7 m.

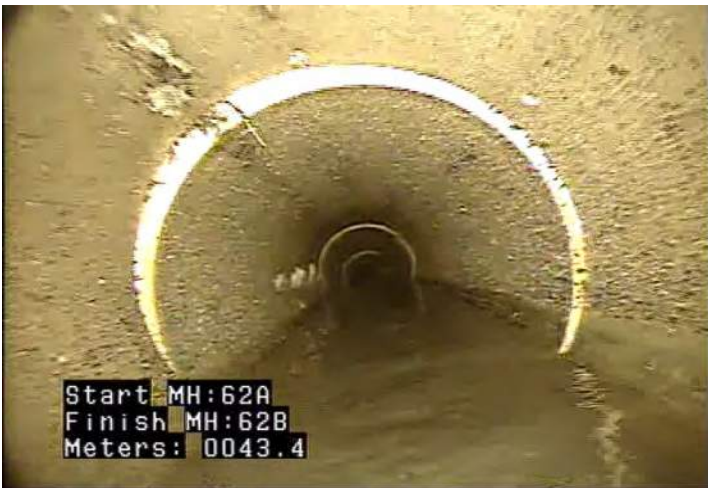
RFJ - Roots, Fine: Joint @ 43.4 m.

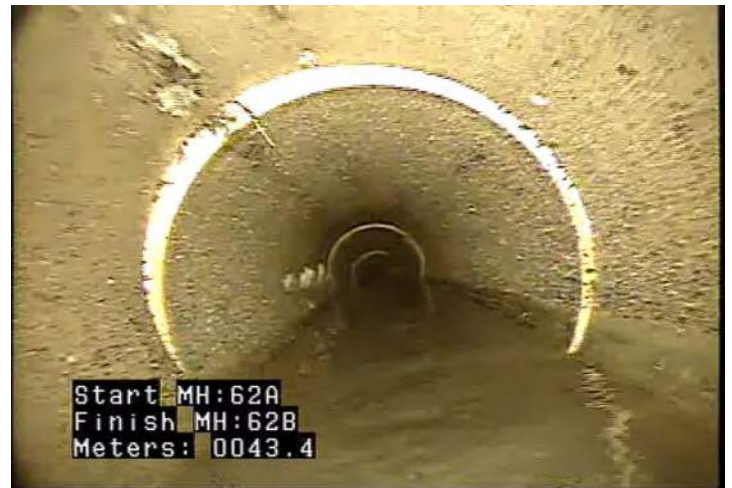
DAGS - Deposits Attached: Grease @ 43.4 m.

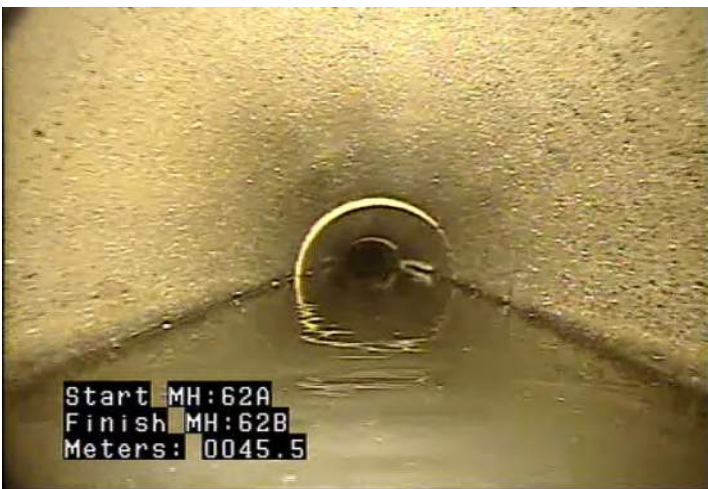
MWLS - Water Level: Sag @ 45.5 m.

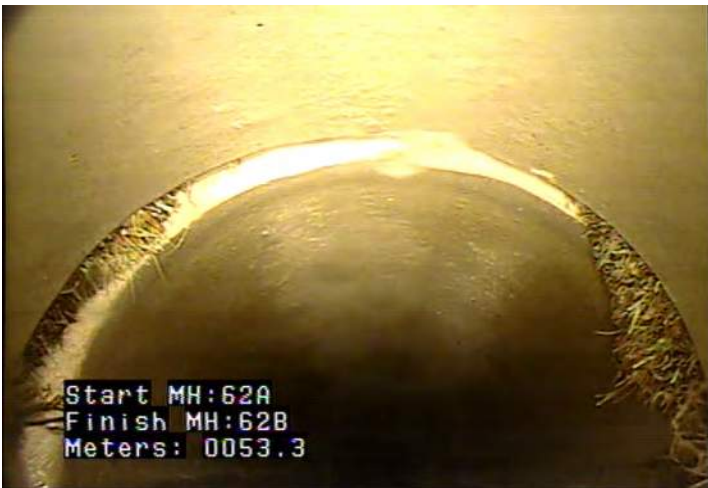
RFJ - Roots, Fine: Joint @ 53.3 m.

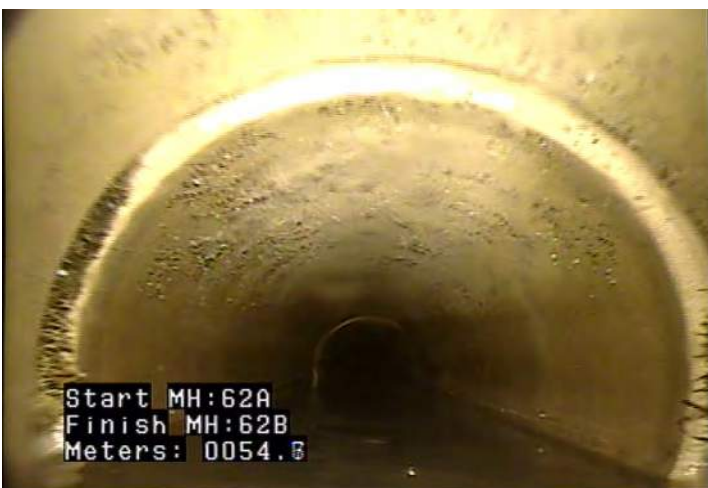
RFJ - Roots, Fine: Joint @ 54.7 m.

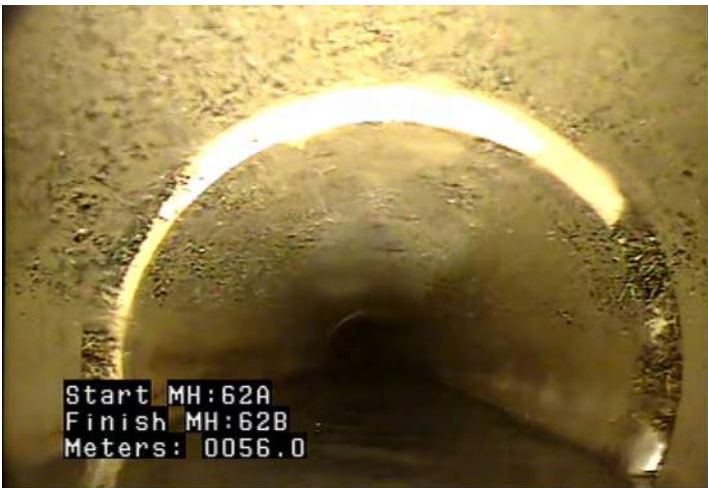
RFJ - Roots, Fine: Joint @ 56.0 m.

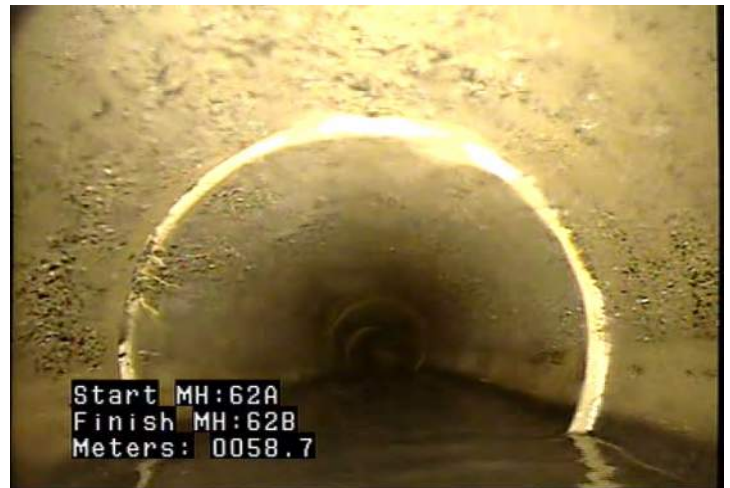
RFJ - Roots, Fine: Joint @ 58.7 m.

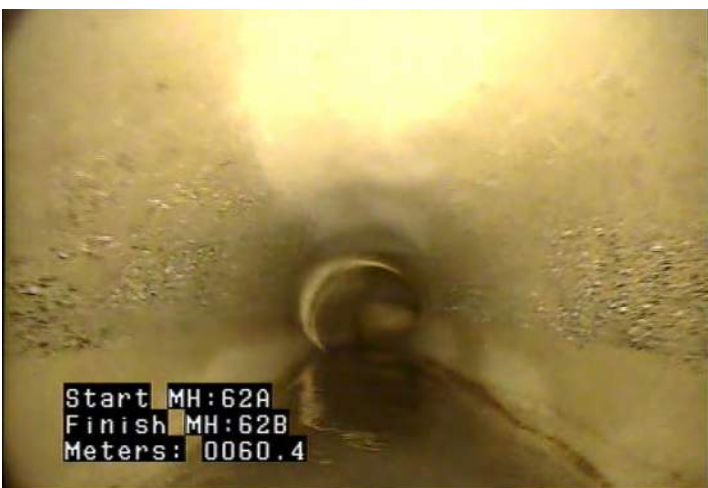
MWLS - Water Level: Sag @ 60.4 m.

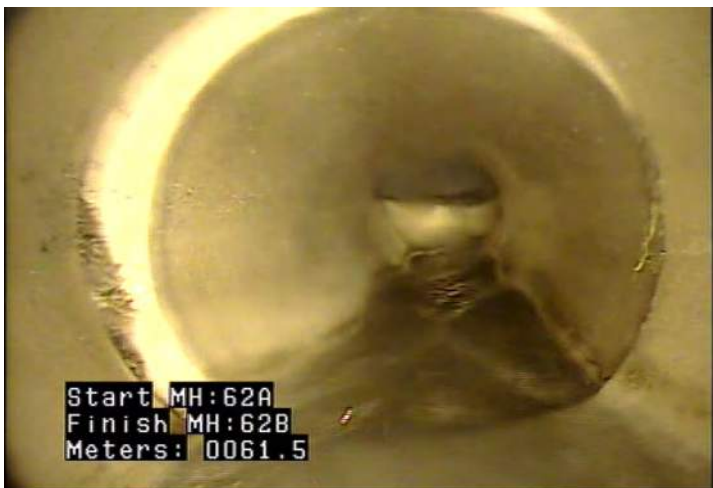
RFJ - Roots, Fine: Joint @ 61.5 m.

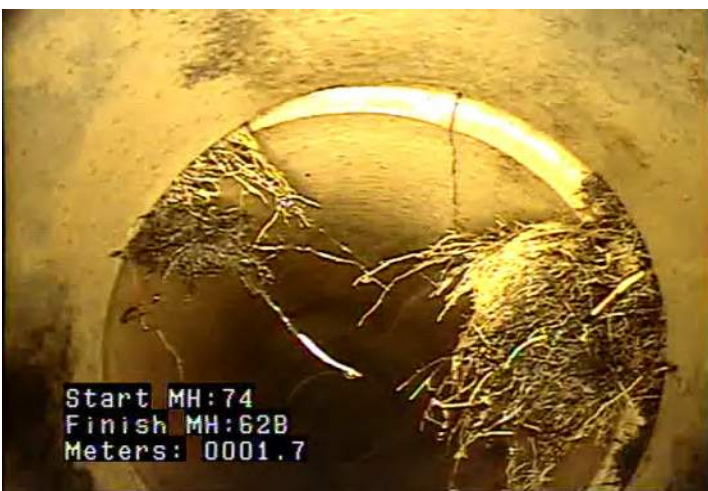
CL - Crack Longitudinal @ 1.7 m.

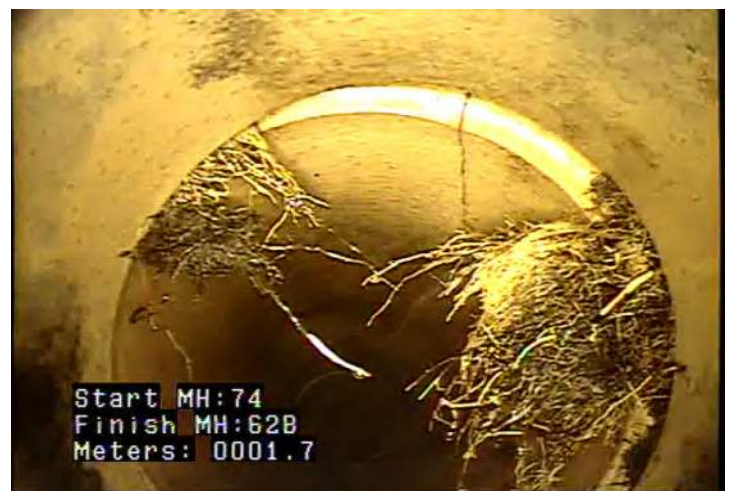
RMJ - Roots, Medium, Joint @ 1.7 m.

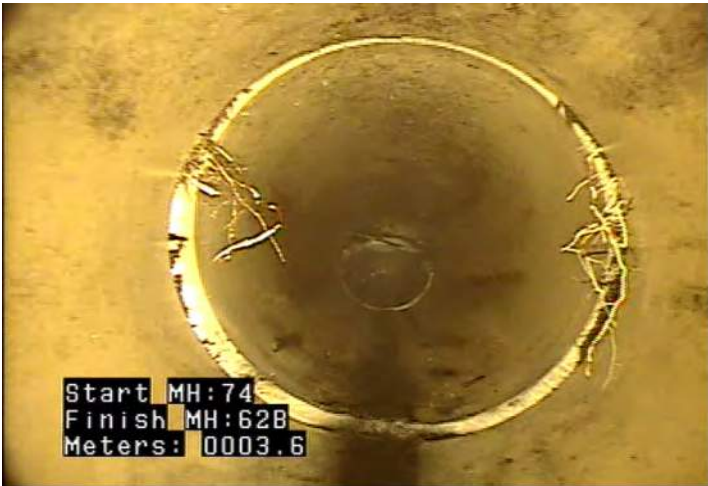
RFJ - Roots, Fine: Joint @ 3.6 m.

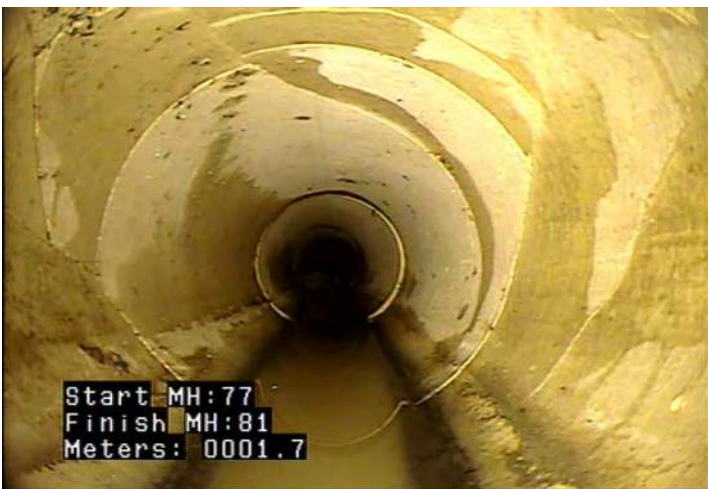
CM - Crack Multiple @ 0.5 m.

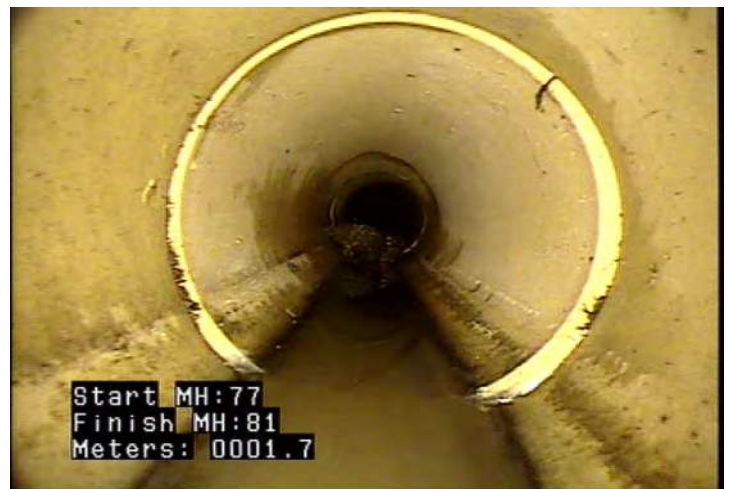
RFJ - Roots, Fine: Joint @ 1.7 m.

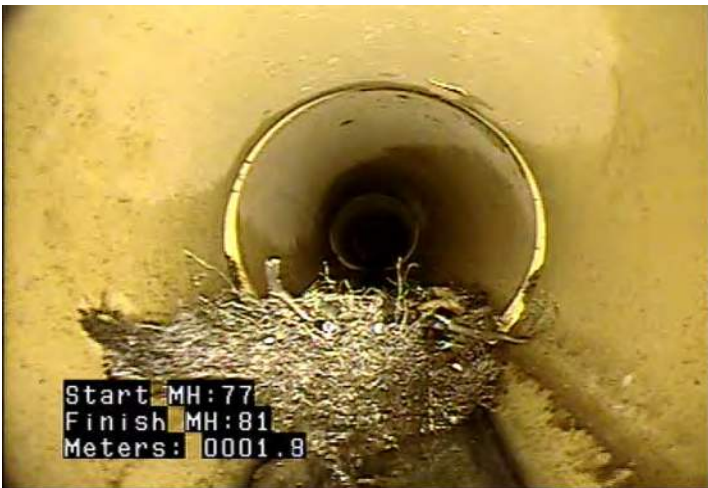
RMJ - Roots, Medium, Joint @ 1.8 m.

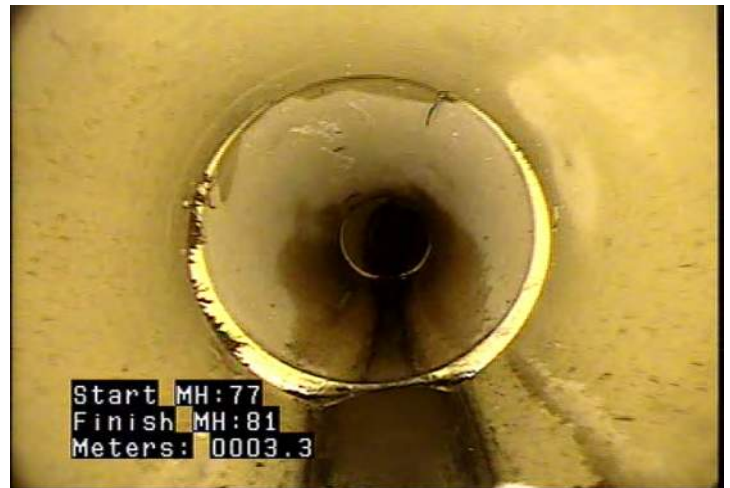
RFJ - Roots, Fine: Joint @ 3.3 m.

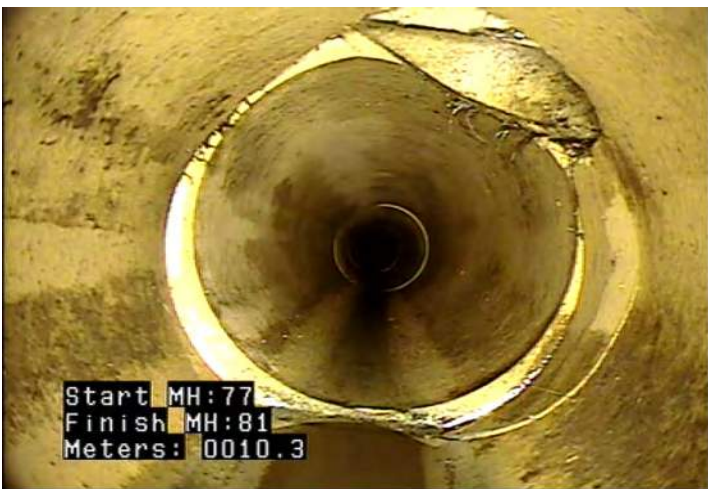
TB - Tap, Break-in / Hammer @ 10.3 m.

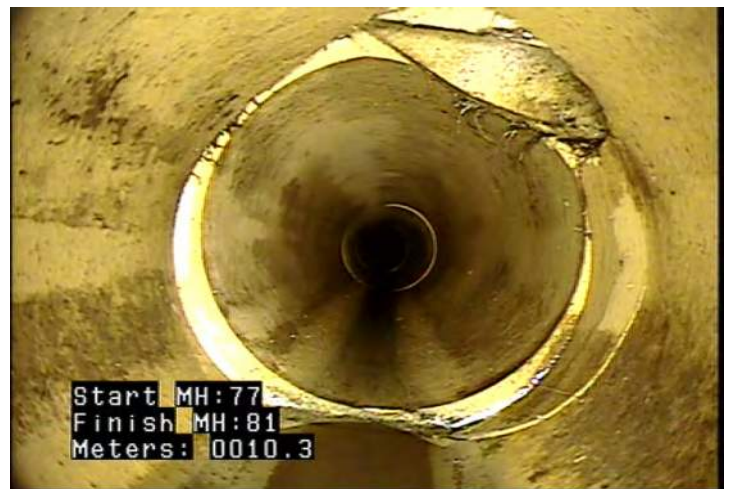
FS - Fracture Spiral @ 10.4 m.

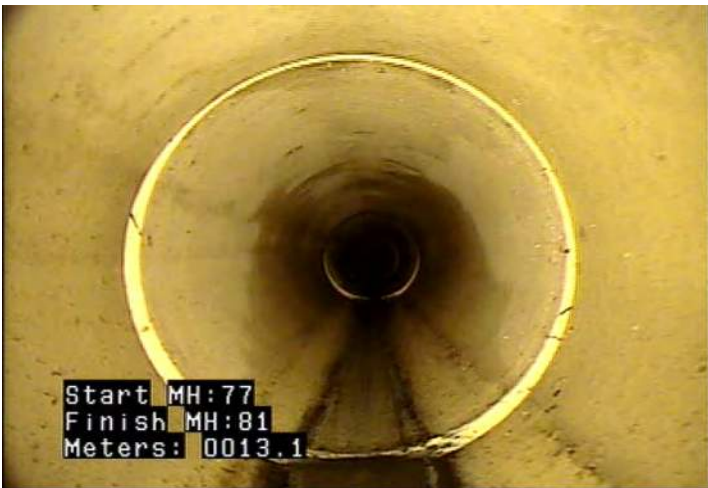
RFJ - Roots, Fine: Joint @ 13.1 m.

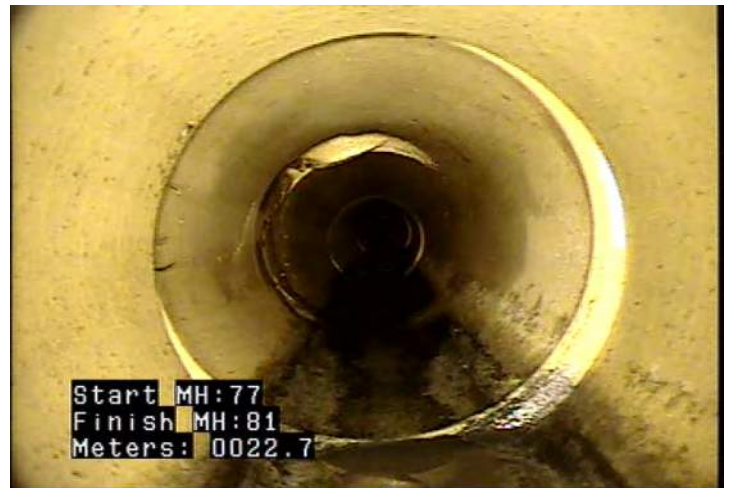
RFJ - Roots, Fine: Joint @ 22.7 m.

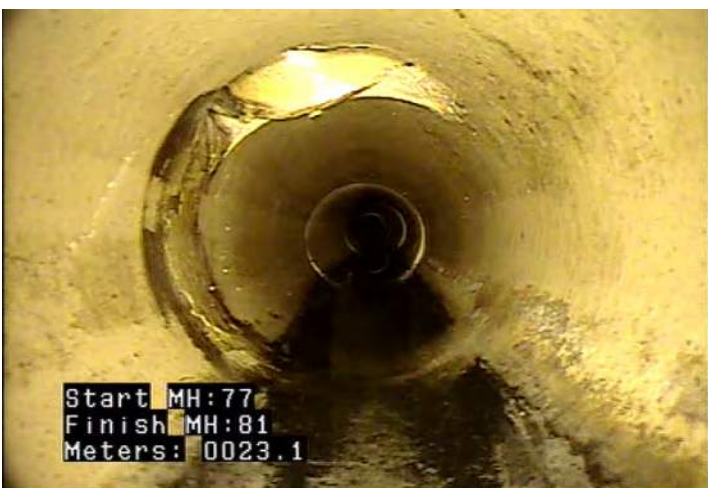
TB - Tap, Break-in / Hammer @ 23.1 m.

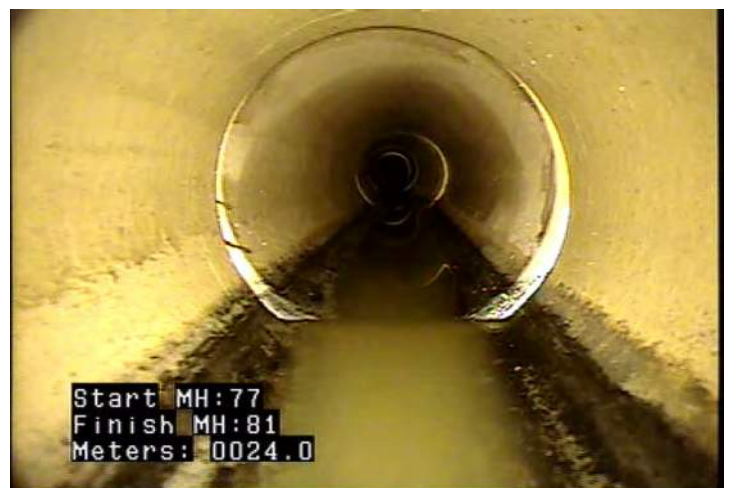
RFJ - Roots, Fine: Joint @ 24.0 m.

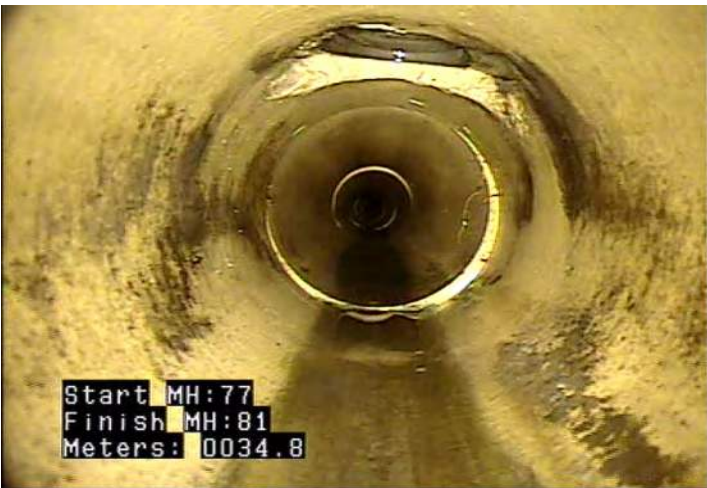
TB - Tap, Break-in / Hammer @ 34.8 m.

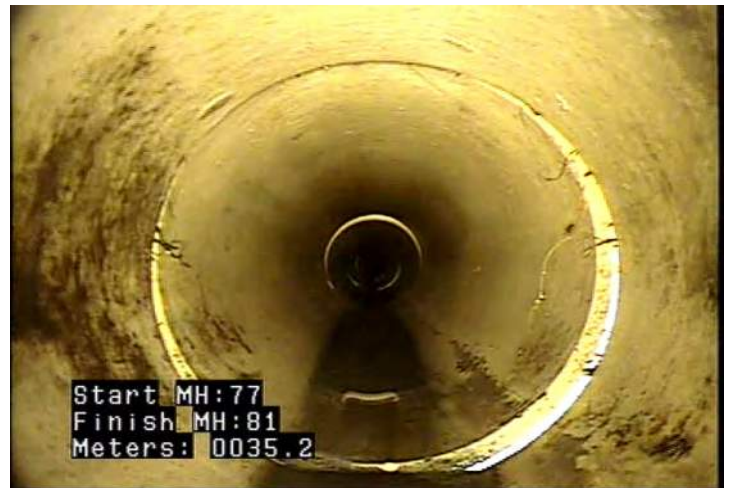
RFJ - Roots, Fine: Joint @ 35.2 m.

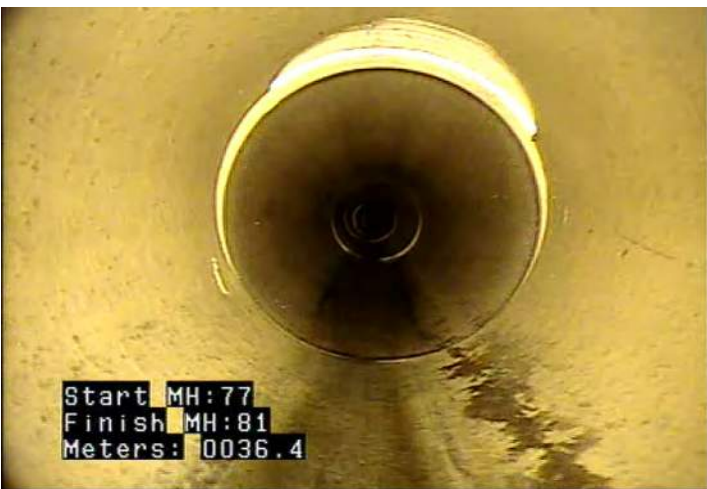
24.0		RFJ	Roots, Fine: Joint	7 to 8			J	
34.8		TB	Tap, Break-in / Hammer	12				
35.2		RFJ	Roots, Fine: Joint	7 to 5			J	
36.4		H	Hole in Pipe	11 to 1			J	Piece of pipe missing at joint, ground visible, roots

H - Hole in Pipe @ 36.4 m. Piece of pipe missing at joint, ground visible, roots

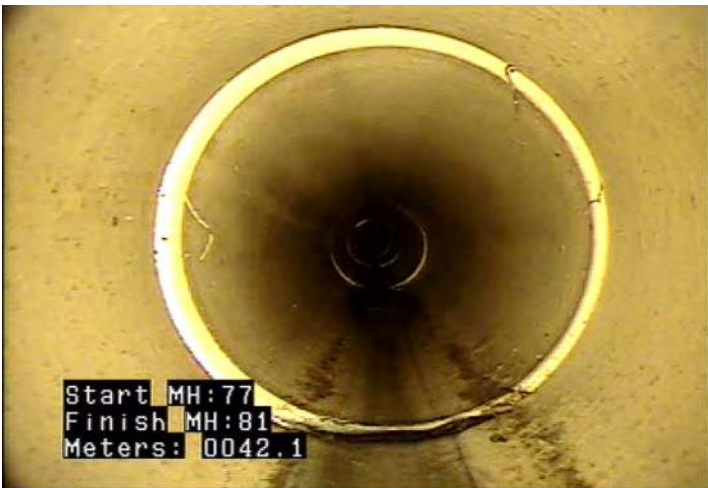
RFJ - Roots, Fine: Joint @ 42.1 m.

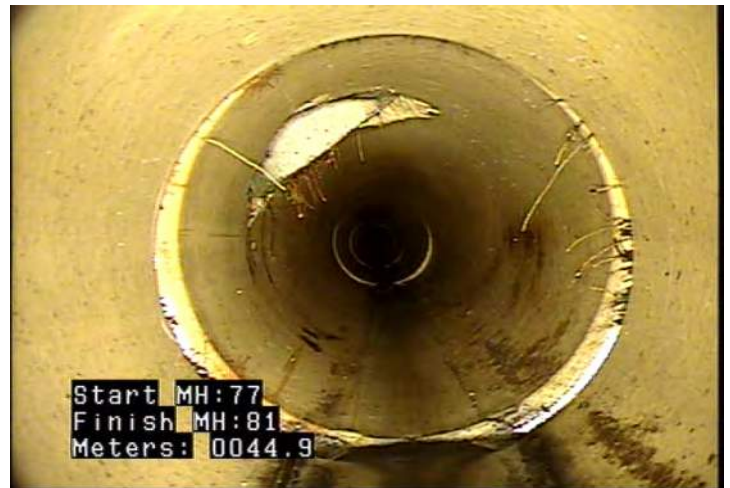
RFJ - Roots, Fine: Joint @ 44.9 m.

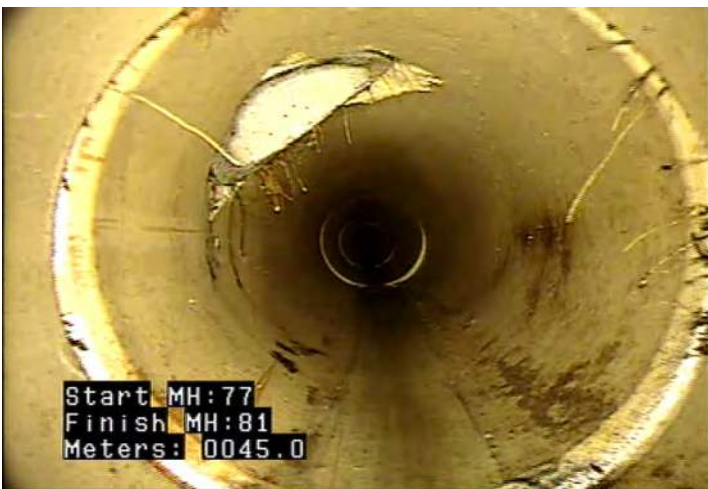
TB - Tap, Break-in / Hammer @ 45.1 m.

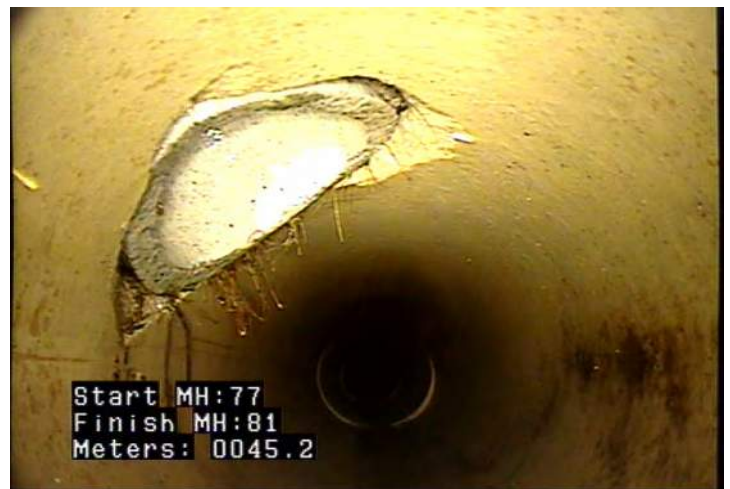
RFC - Roots, Fine: Connection @ 45.1 m.

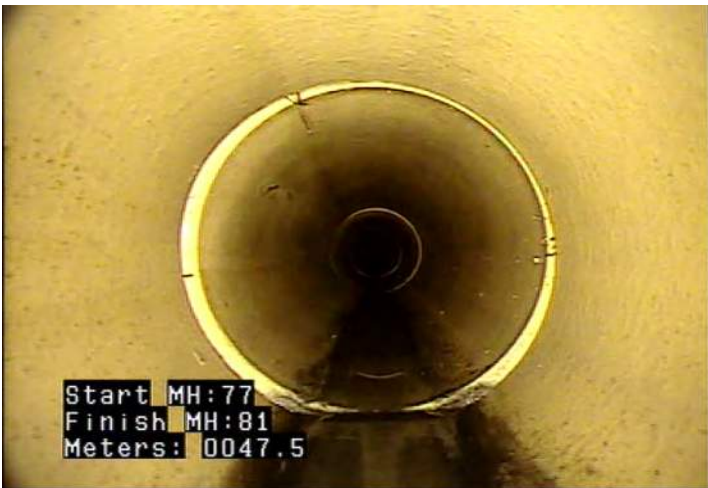
RFJ - Roots, Fine: Joint @ 47.5 m.

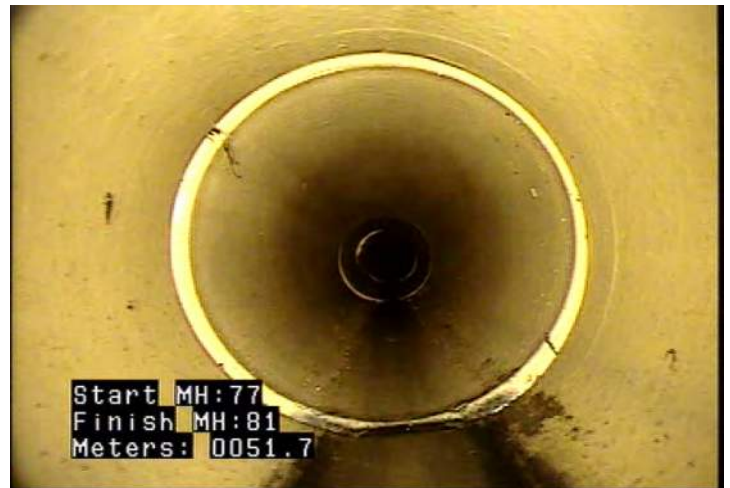
RFJ - Roots, Fine: Joint @ 51.7 m.

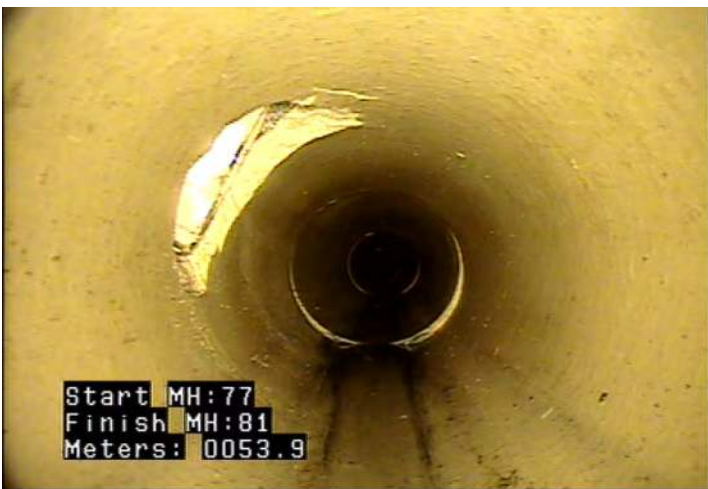
TB - Tap, Break-in / Hammer @ 53.9 m.

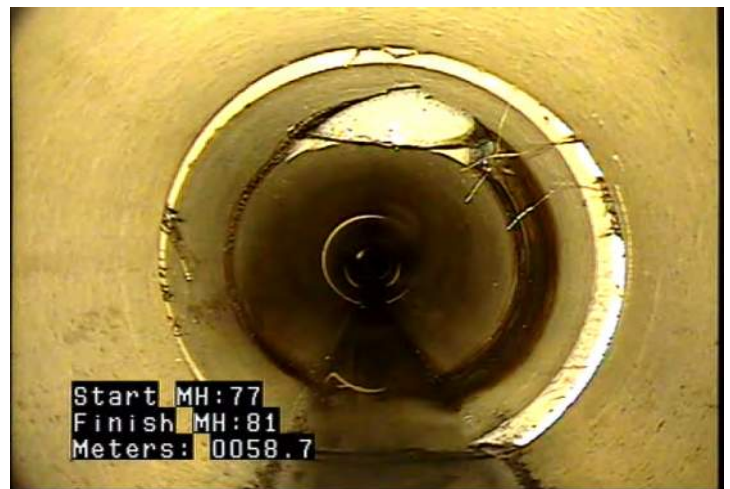
RFJ - Roots, Fine: Joint @ 58.7 m.

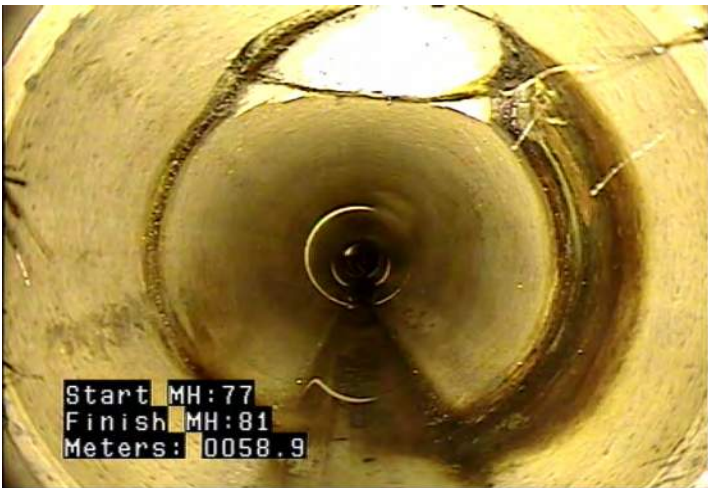
TB - Tap, Break-in / Hammer @ 58.9 m.

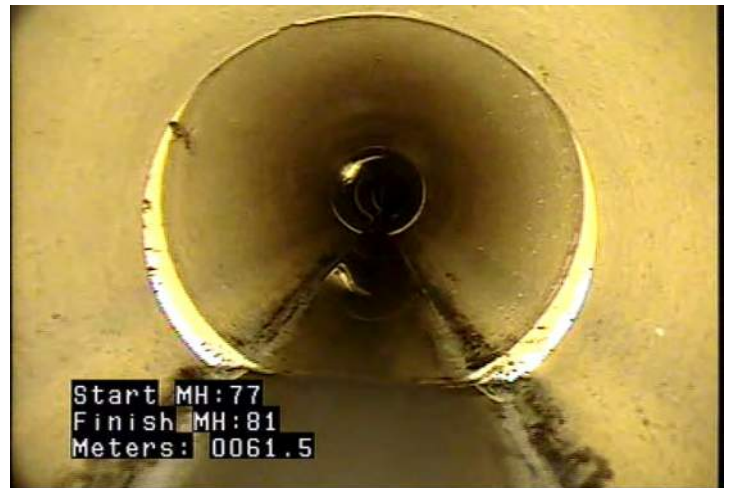
RFJ - Roots, Fine: Joint @ 61.5 m.

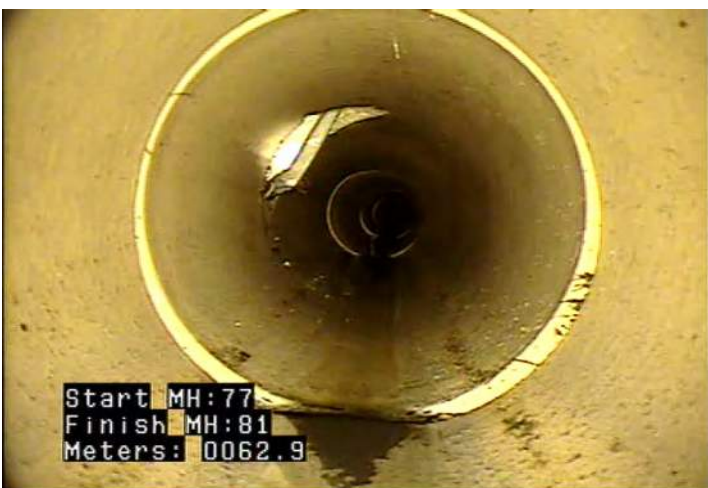
RFJ - Roots, Fine: Joint @ 62.9 m.

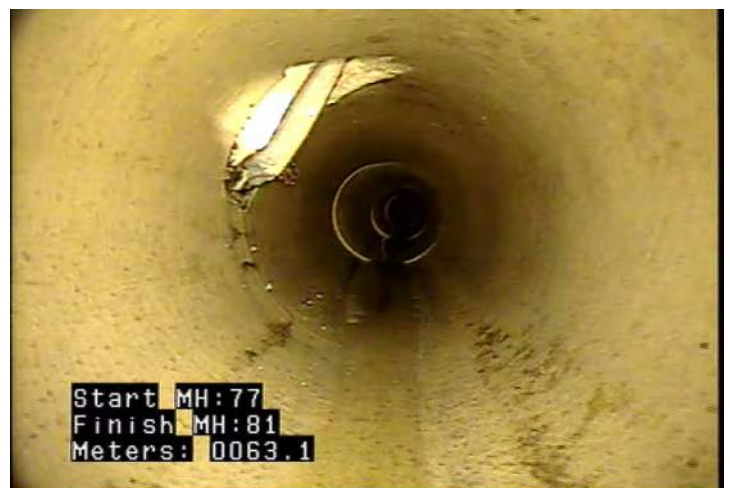
TBI - Tap, Break-in / Hammer: Intruding @ 63.1 m.

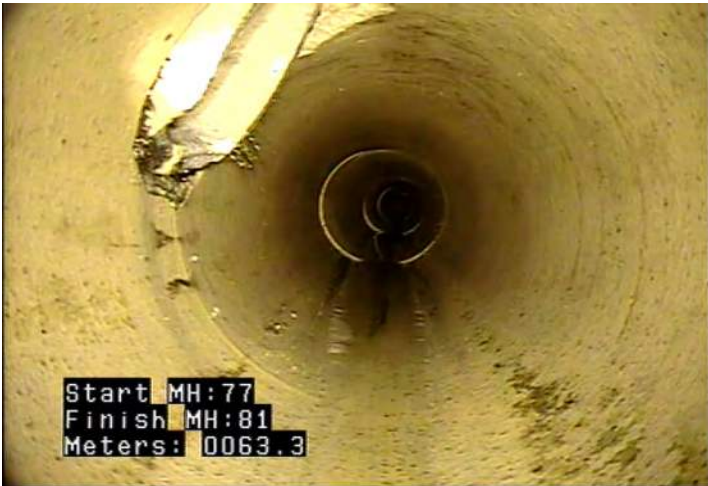
RFC - Roots, Fine: Connection @ 63.3 m.

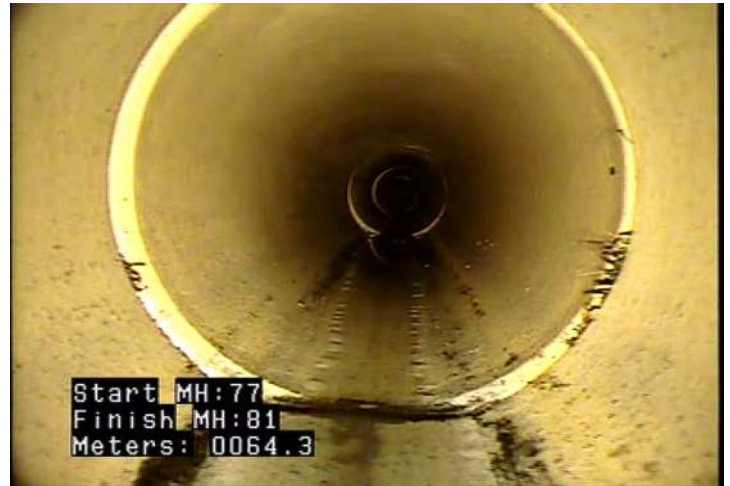
RFJ - Roots, Fine: Joint @ 64.3 m.

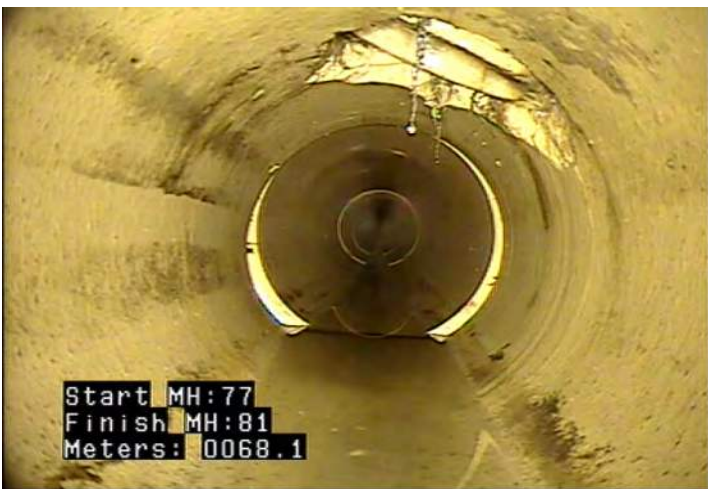
RFC - Roots, Fine: Connection @ 68.1 m.

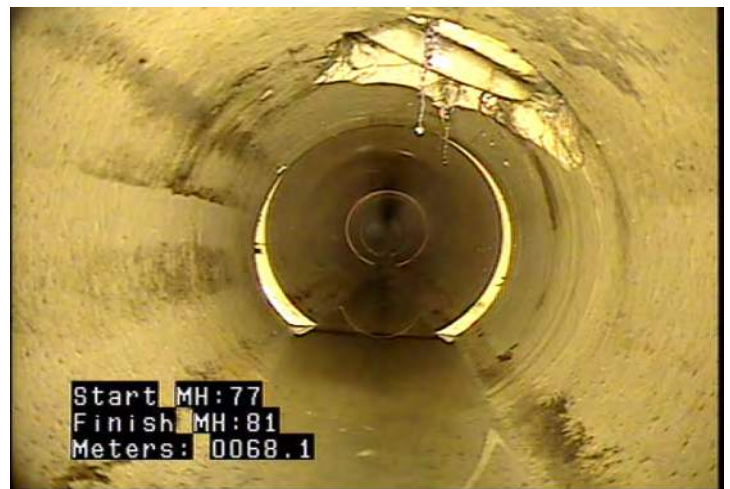
TB - Tap, Break-in / Hammer @ 68.1 m.

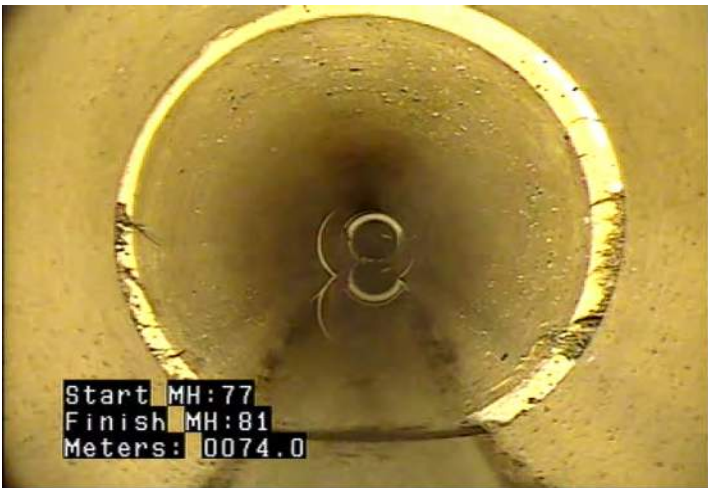
RFJ - Roots, Fine: Joint @ 74.0 m.

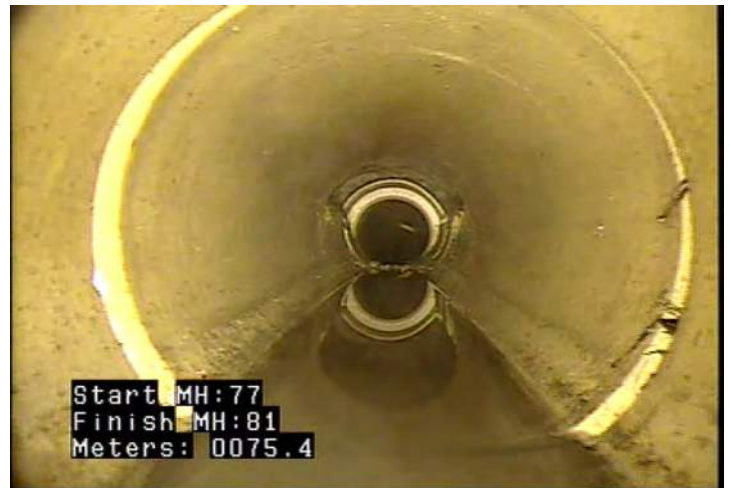
RFJ - Roots, Fine: Joint @ 75.4 m.

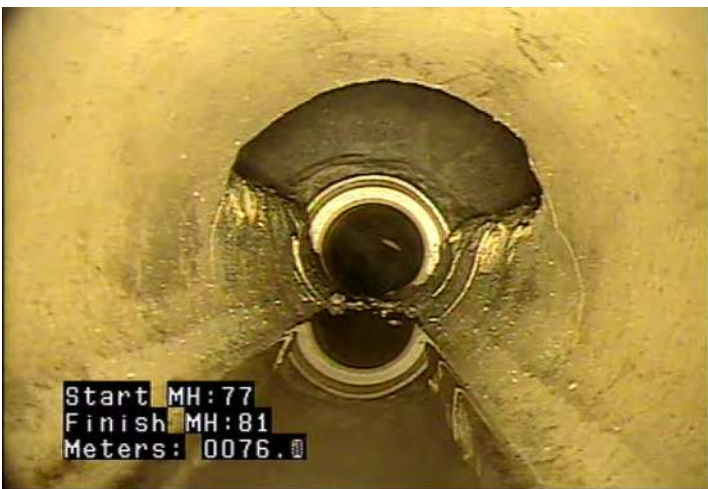
CS - Crack Spiral @ 76.0 m.

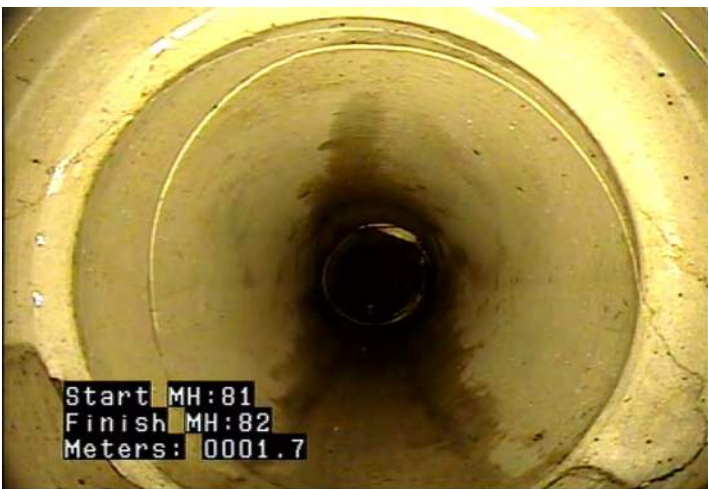
CS - Crack Spiral @ 0.5 m.

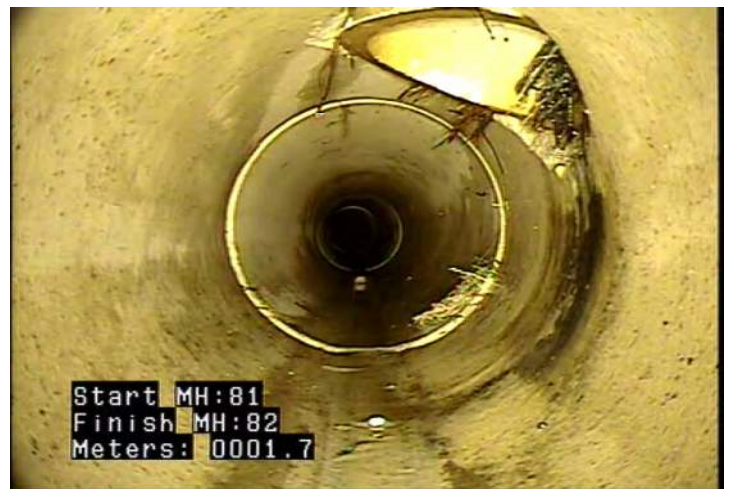
TB - Tap, Break-in / Hammer @ 1.7 m.

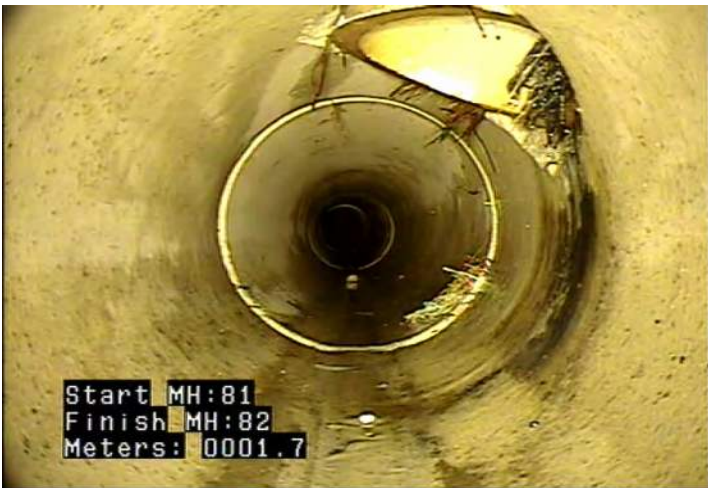
RFB - Roots, Fine: Barrel @ 1.7 m.

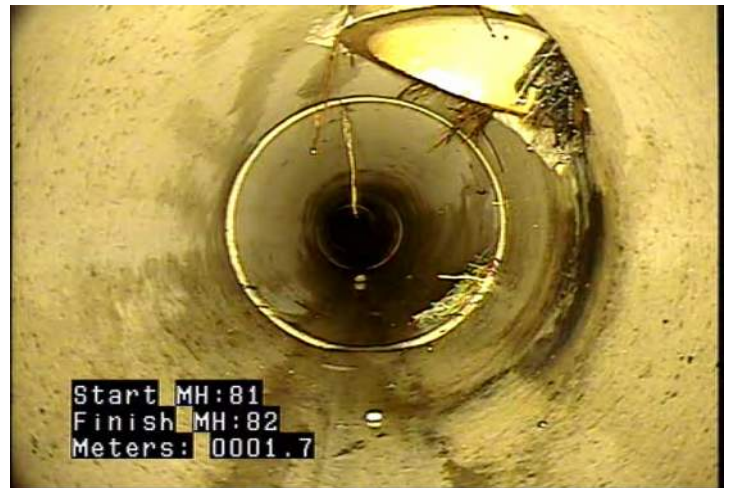
RFC - Roots, Fine: Connection @ 1.7 m.

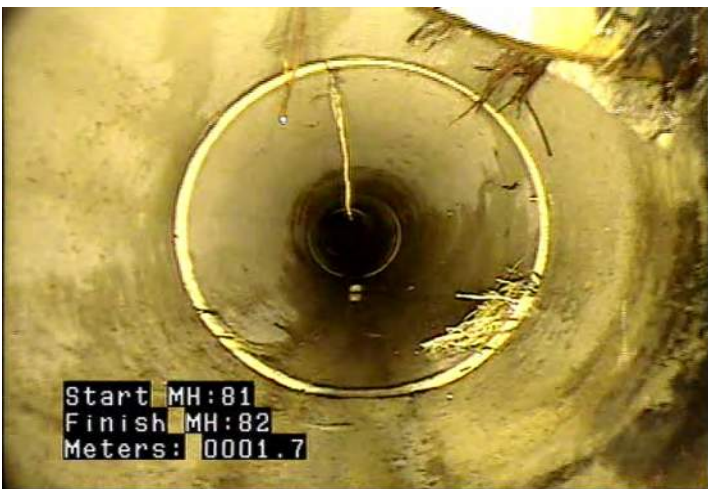
RFJ - Roots, Fine: Joint @ 1.8 m. Fine roots at most joints throughout pipe

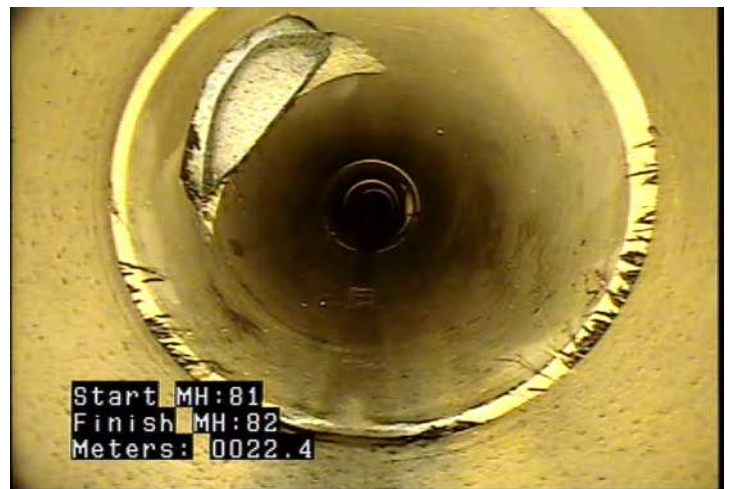
TB - Tap, Break-in / Hammer @ 22.4 m.

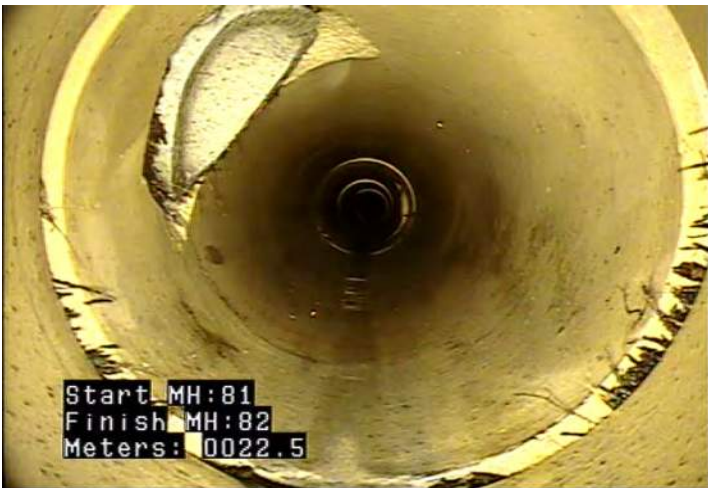
RFC - Roots, Fine: Connection @ 22.5 m.
