Appendix F CCTV Assessment

Client: CIMA
 Project: Pre-Rehabilitation Survey
 Date: 12/18/2020
 File: 14257

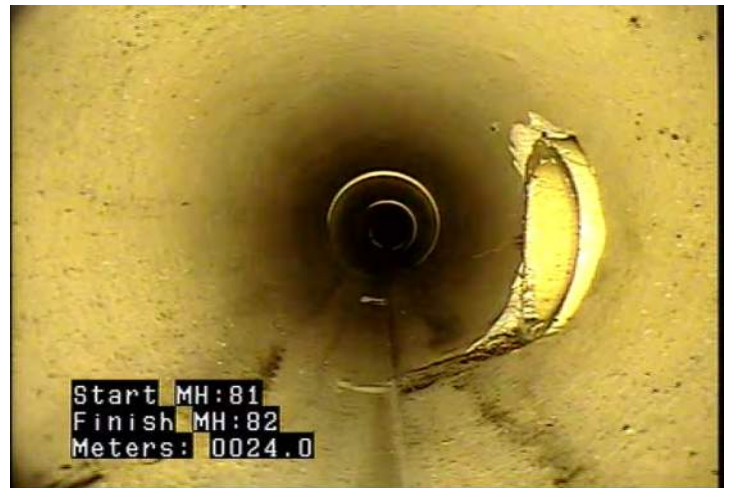
TB - Tap, Break-in / Hammer @ 24.0 m.

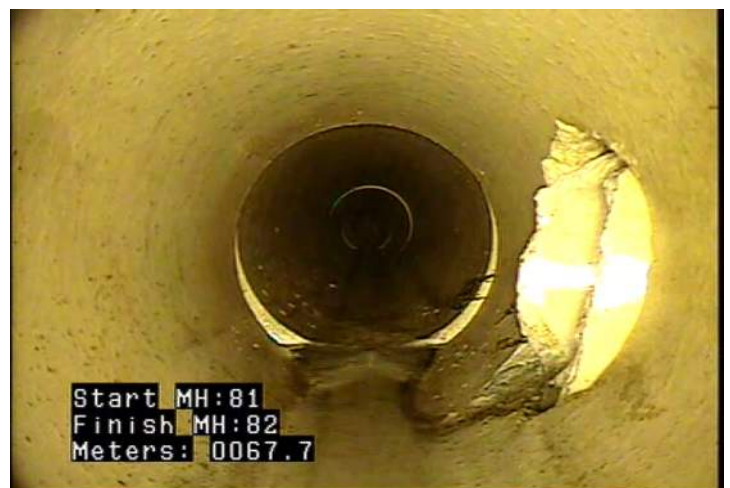
TBI - Tap, Break-in / Hammer: Intruding @ 67.7 m.

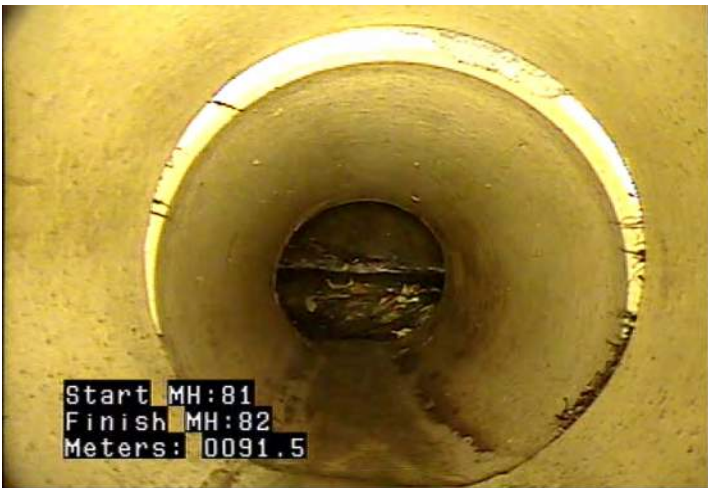
RFJ - Roots, Fine: Joint @ 91.5 m.

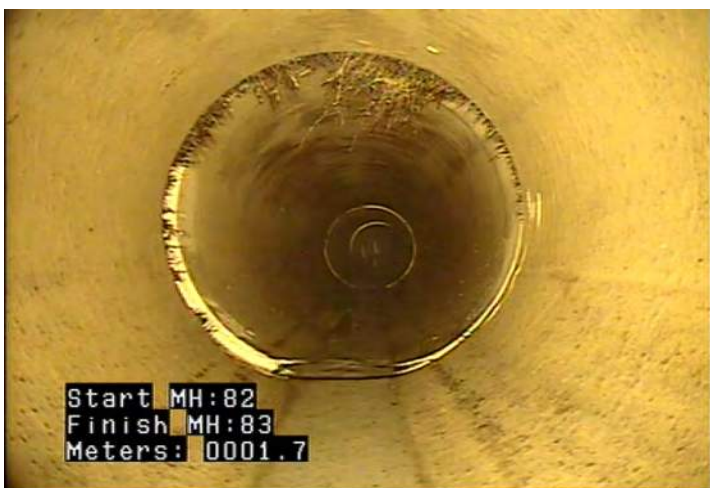
RFJ - Roots, Fine: Joint @ 0.5 m.

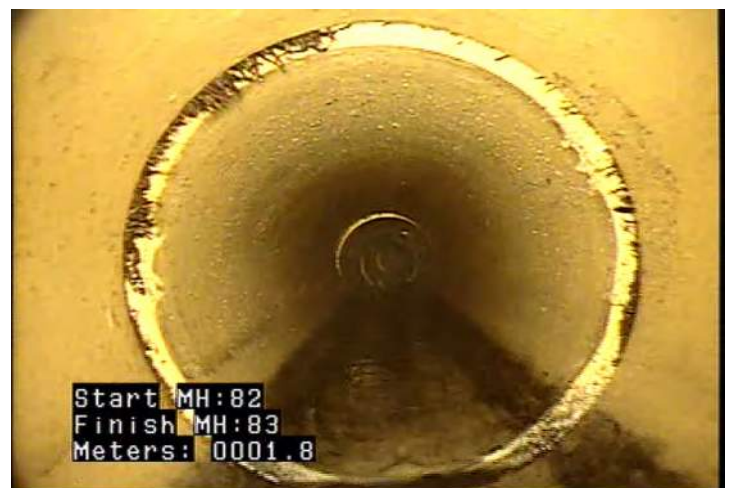
RFJ - Roots, Fine: Joint @ 1.8 m.

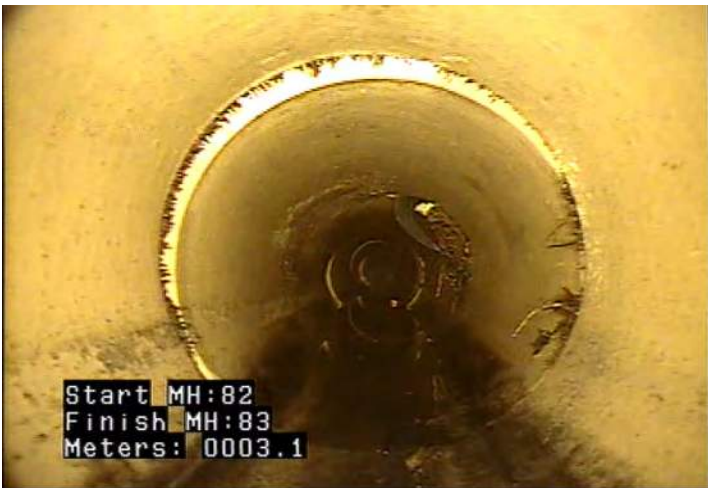
RFJ - Roots, Fine: Joint @ 3.1 m.

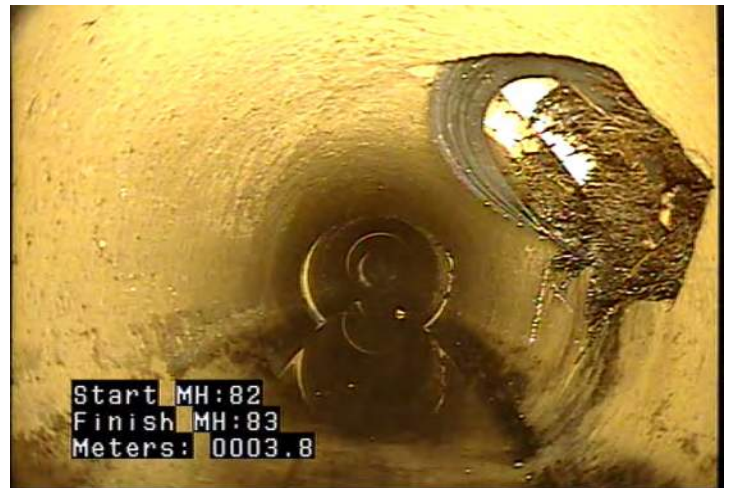
ISSRL - Intruding Seal Material - Sealing Ring: Loose/Poorly Fitting @ 3.8 m.

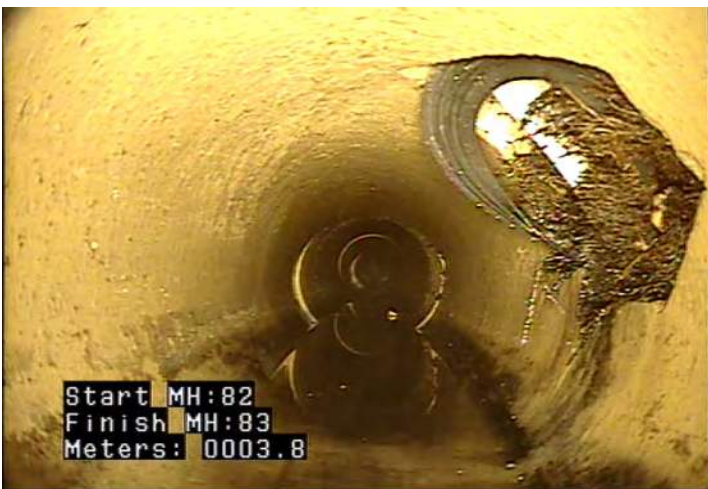
RMC - Roots, Medium: Connection @ 3.8 m.

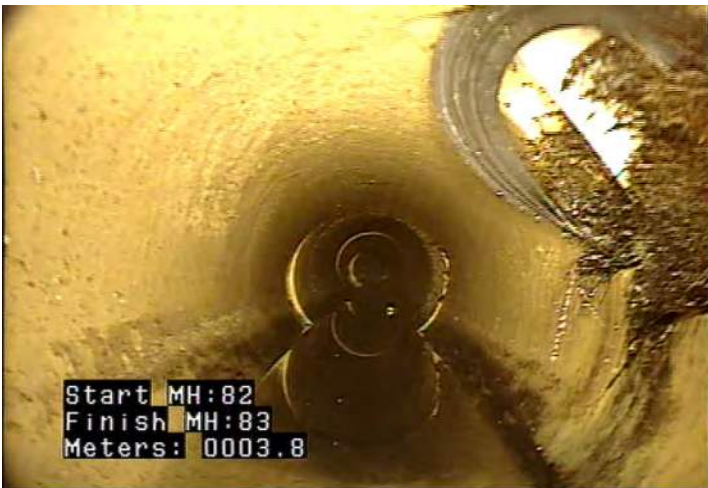
MWLS - Water Level: Sag @ 3.8 m.

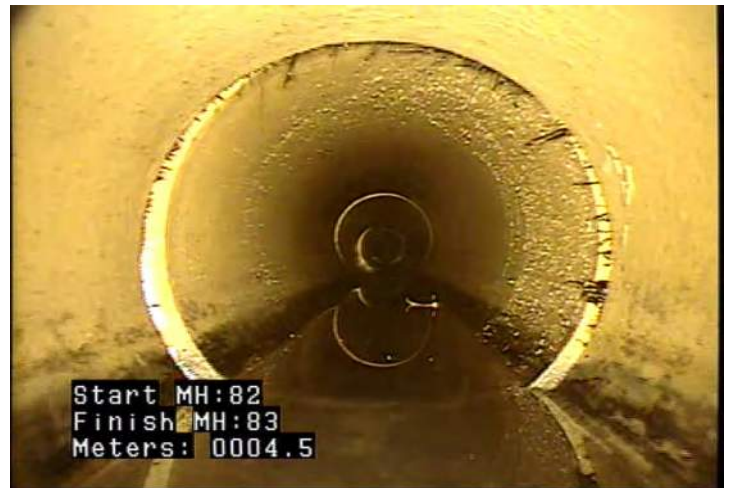
RFJ - Roots, Fine: Joint @ 4.6 m.

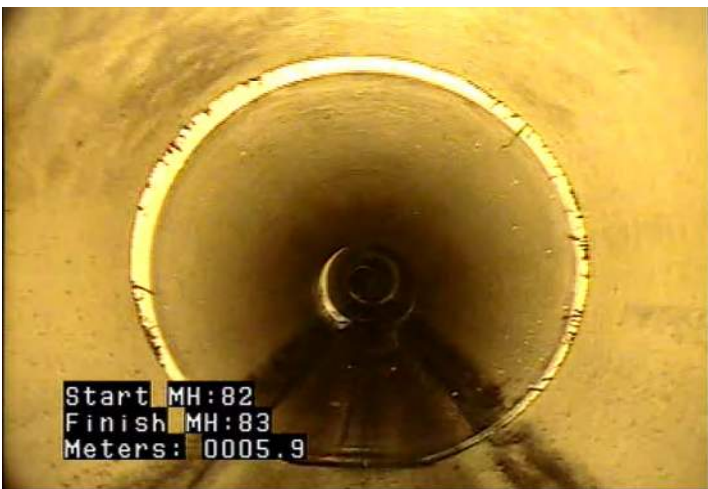
RFJ - Roots, Fine: Joint @ 5.9 m.

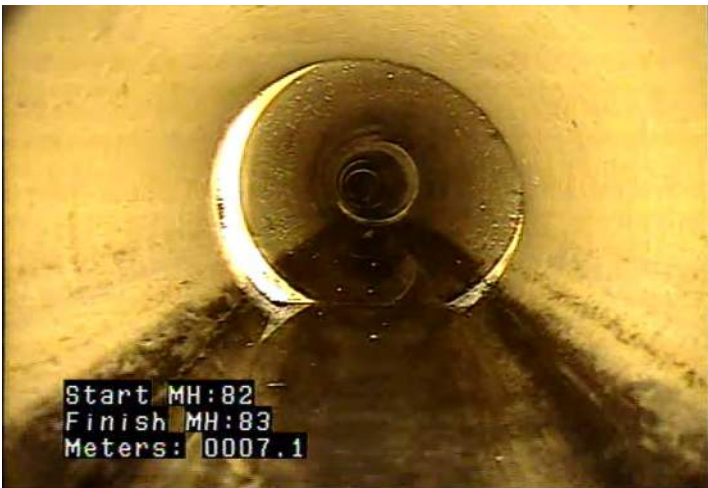
RFJ - Roots, Fine: Joint @ 7.1 m. Fine roots at most joints

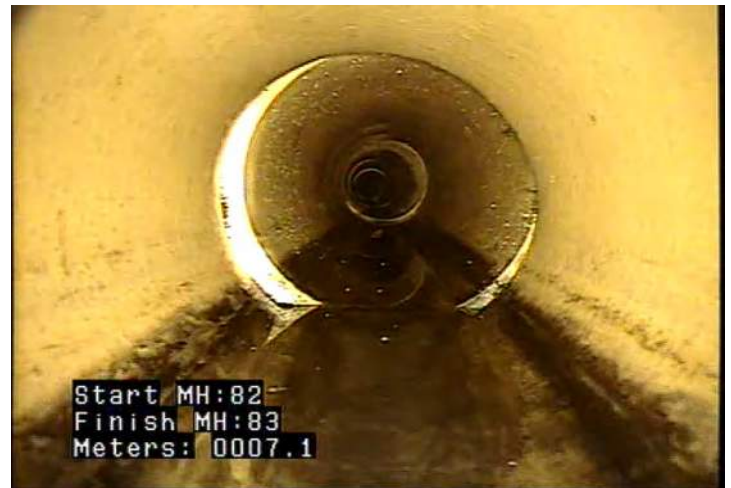
JOM - Joint Offset (displaced): Medium @ 7.1 m.

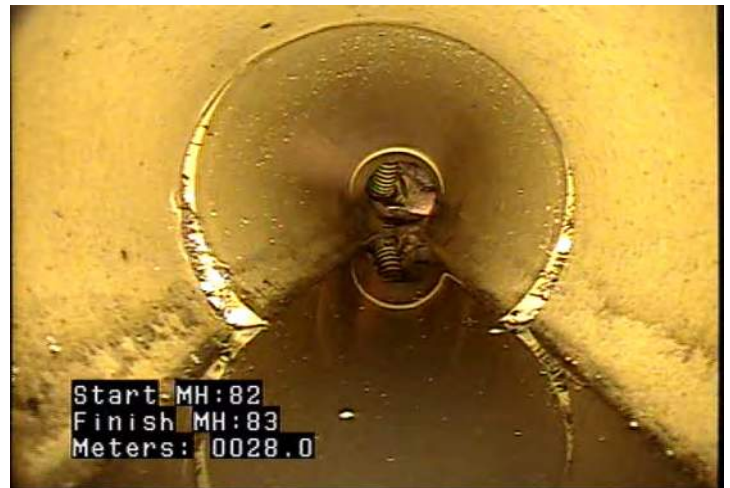
RFJ - Roots, Fine: Joint @ 28.0 m.

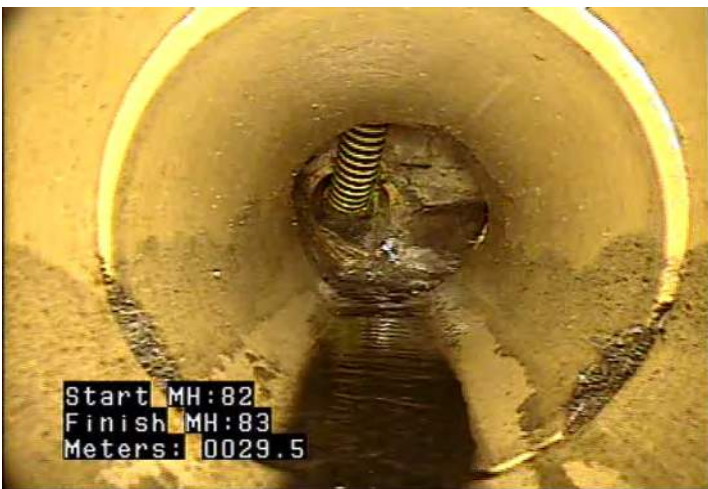
RFJ - Roots, Fine: Joint @ 29.5 m.

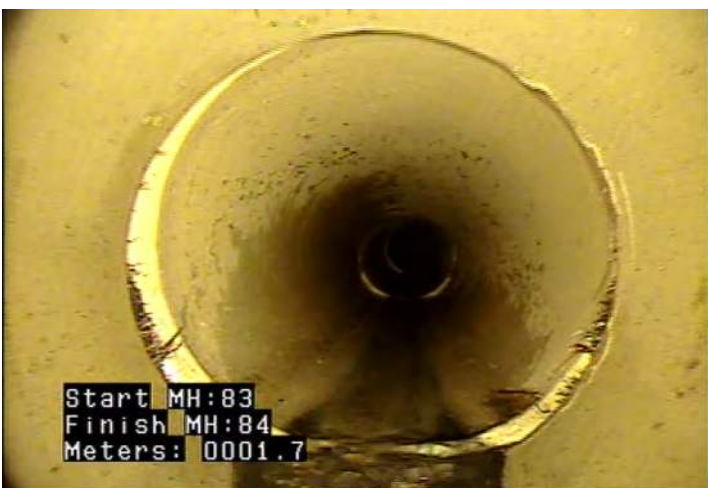
RFJ - Roots, Fine: Joint @ 1.7 m.

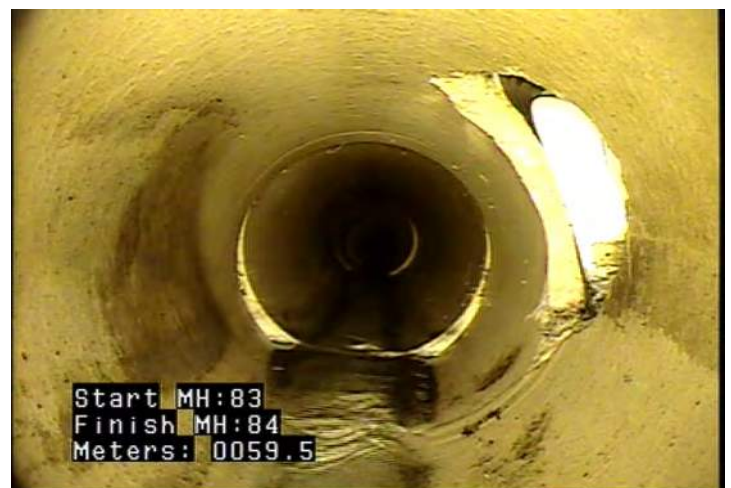
TBA - Tap, Break-in / Hammer: Active @ 59.5 m.

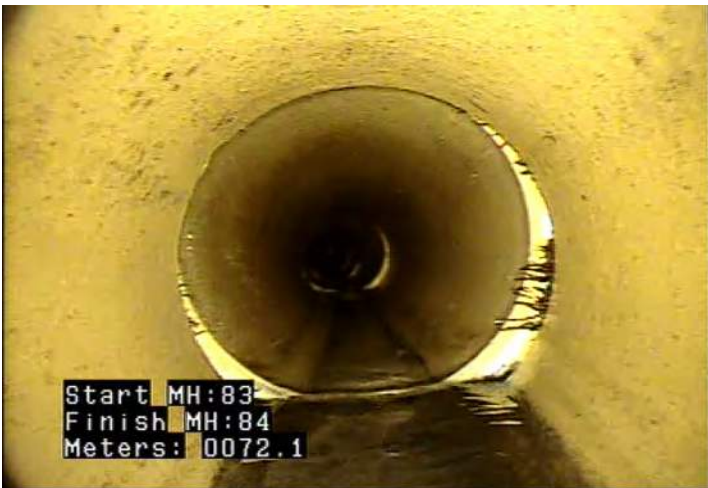
JOM - Joint Offset (displaced): Medium @ 72.1 m.

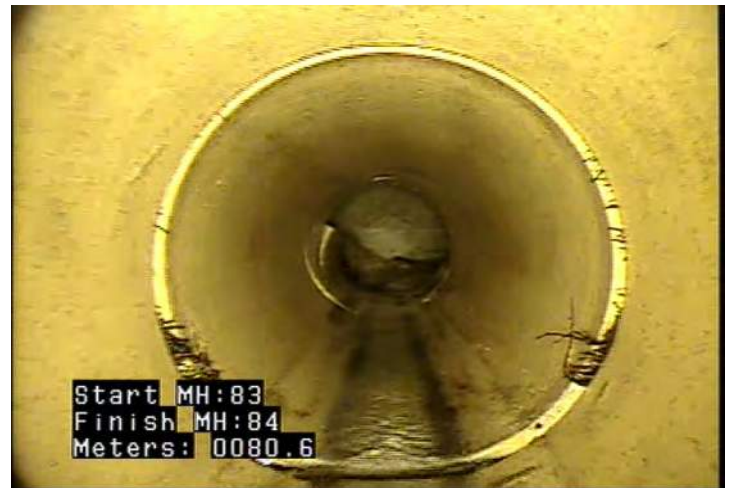
RFJ - Roots, Fine: Joint @ 80.6 m.

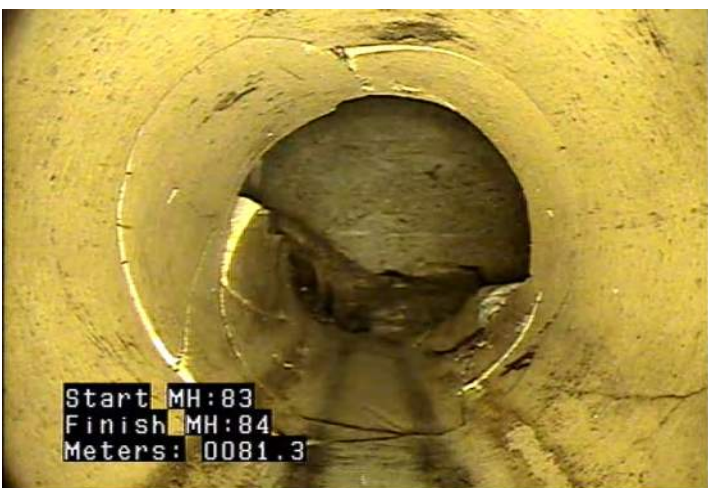
B - Pipe Broken @ 81.3 m.

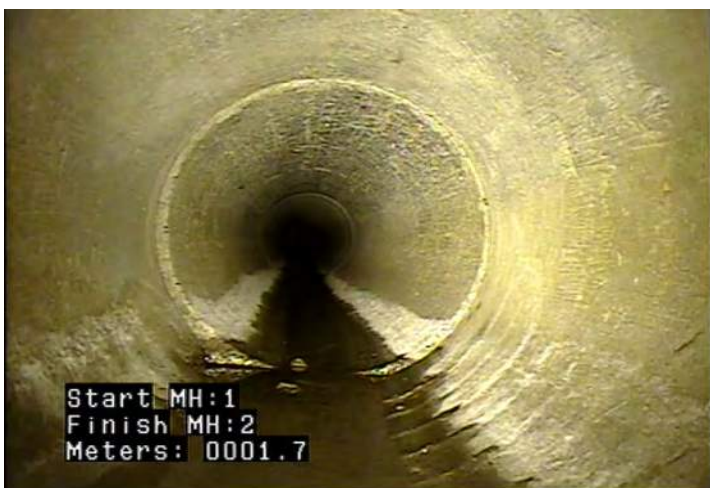
SRP - Surface: Reinforcement Projecting @ 1.7 m.

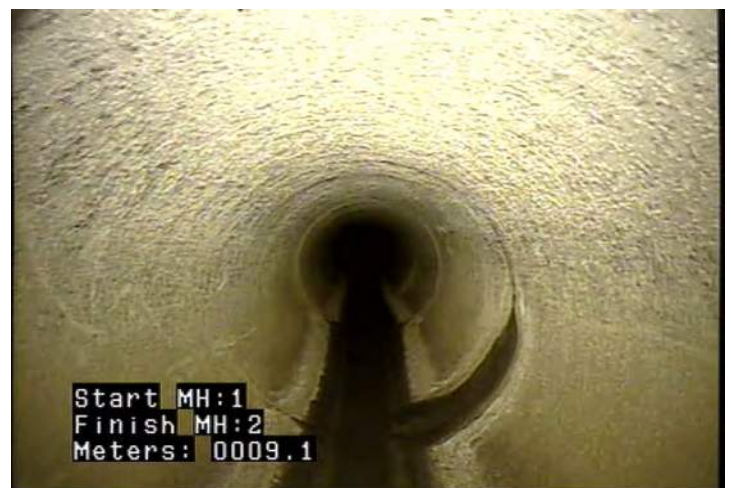
CC - Crack Circumferential @ 9.1 m.

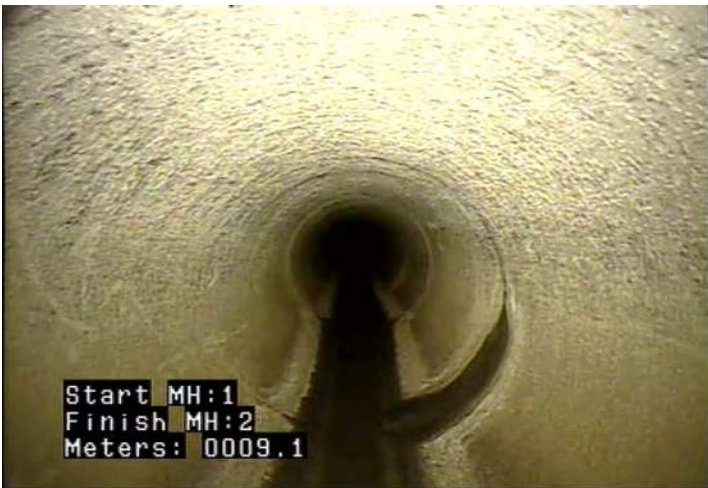
IS - Infiltration - Stain @ 9.1 m.

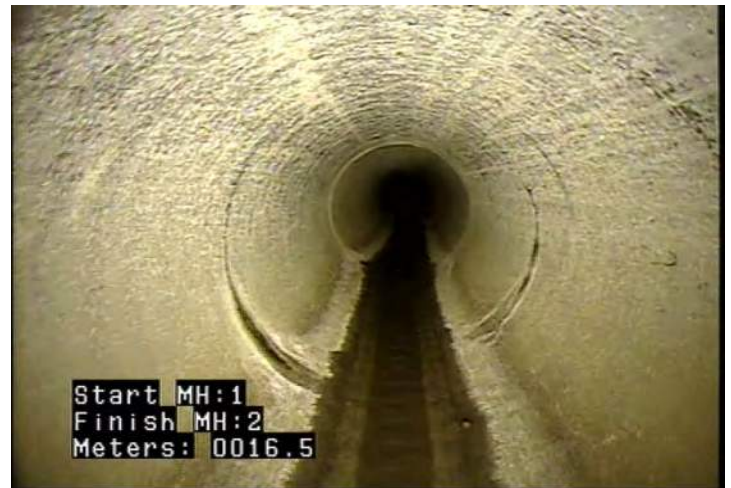
CS - Crack Spiral @ 16.5 m.

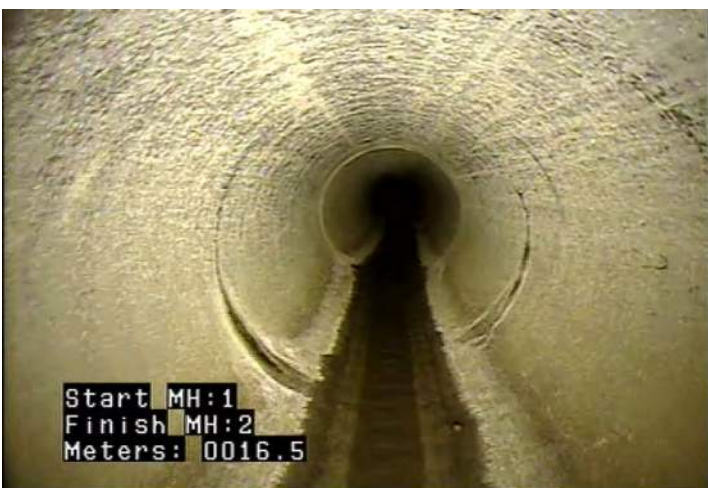
IS - Infiltration - Stain @ 16.7 m.

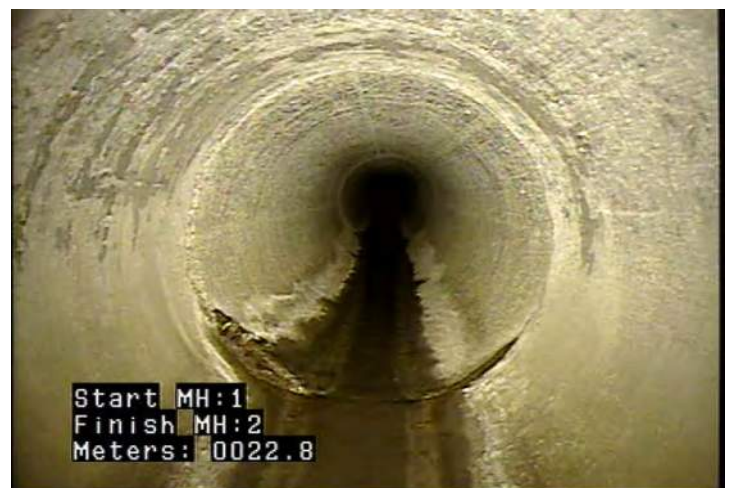
OBJ - Obstacle - Object Wedged in Joint @ 22.8 m. Branch

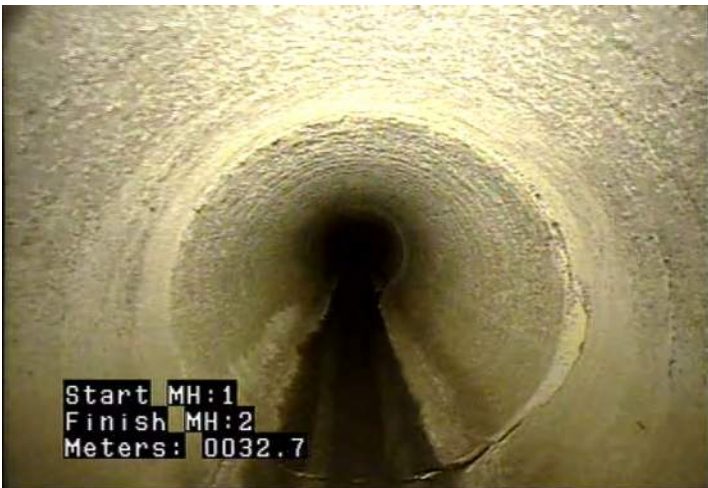
MGO - General Observation @ 32.7 m.
Chip at joint

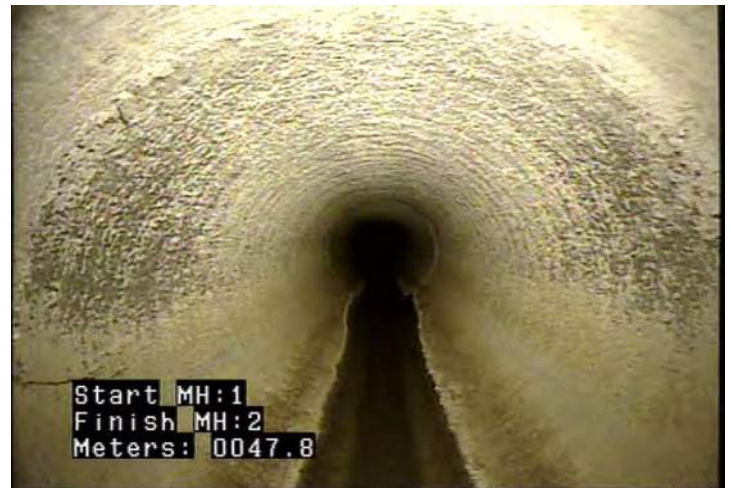
CL - Crack Longitudinal @ 47.8 m.

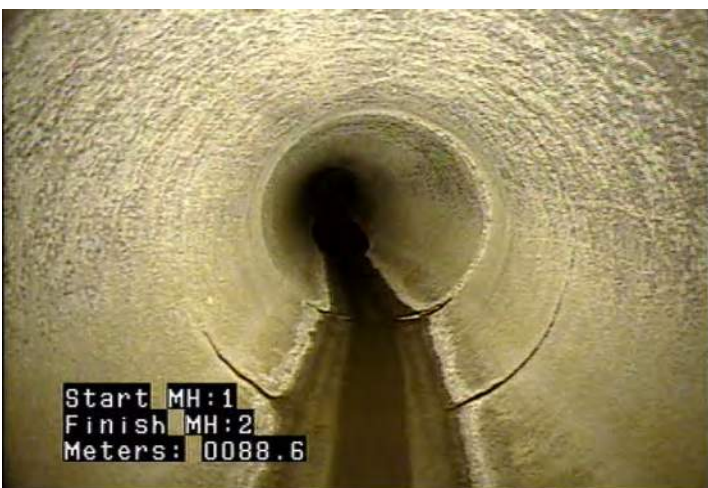
CC - Crack Circumferential @ 88.6 m.

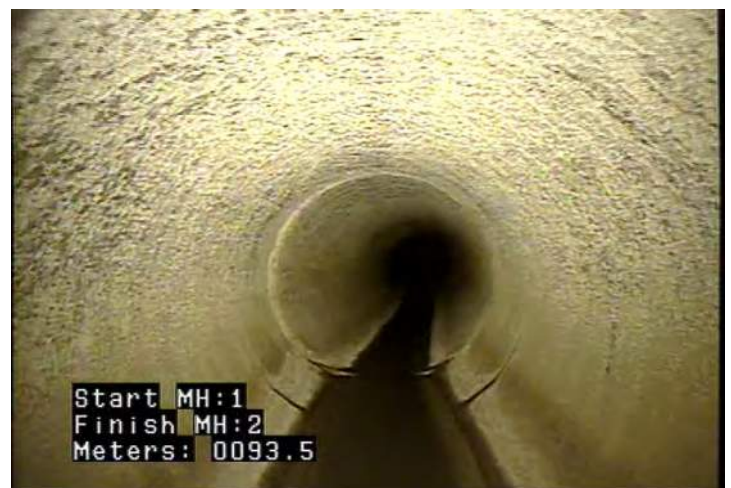
CC - Crack Circumferential @ 93.5 m.

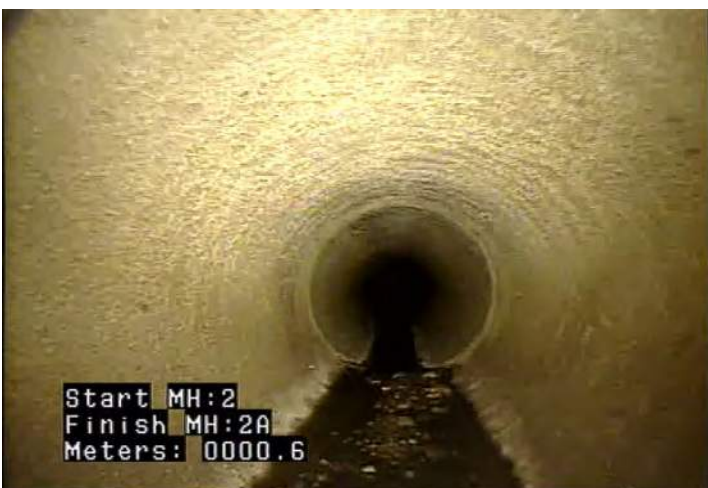
DSGV - Deposits Settled: Gravel @ 0.6 m.

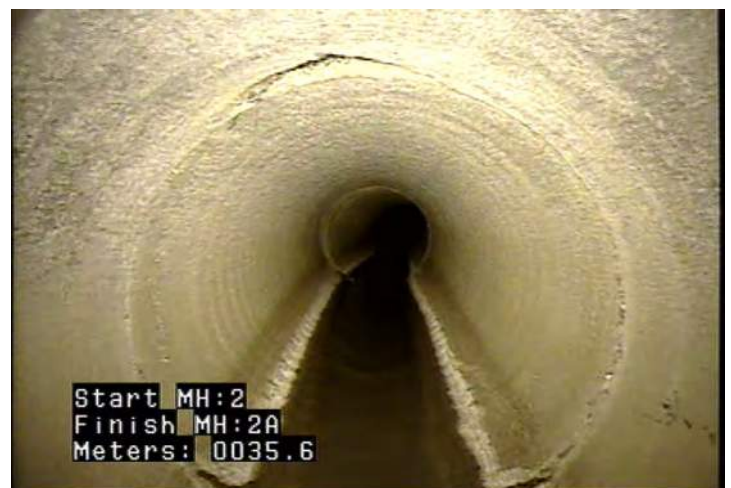
MGO - General Observation @ 35.6 m.
Chipped joint

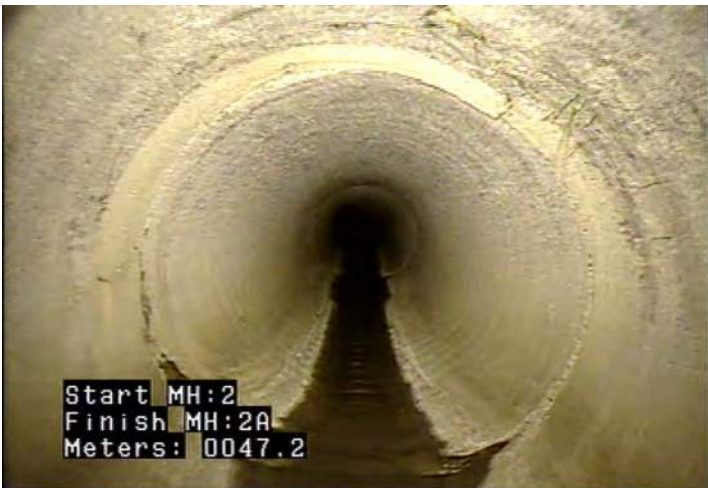
CS - Crack Spiral @ 47.3 m.

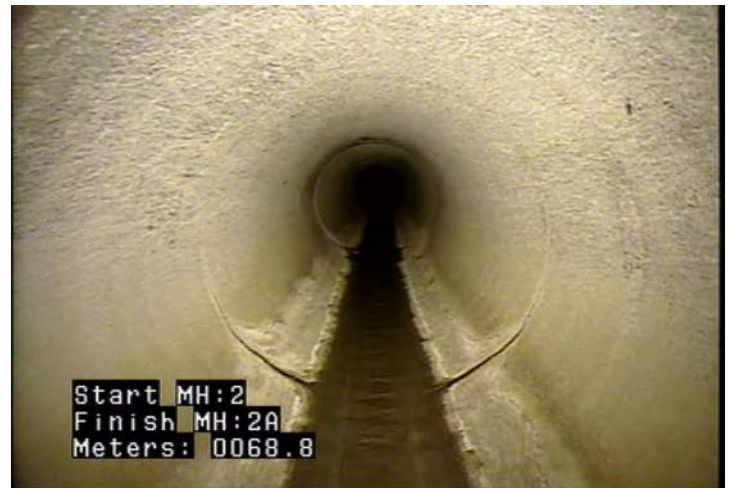
CC - Crack Circumferential @ 68.8 m.

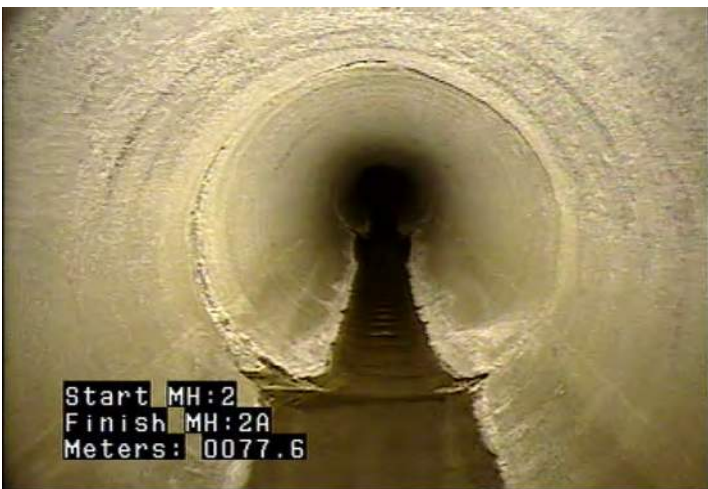
MGO - General Observation @ 77.6 m.
Chipped joint 12:00

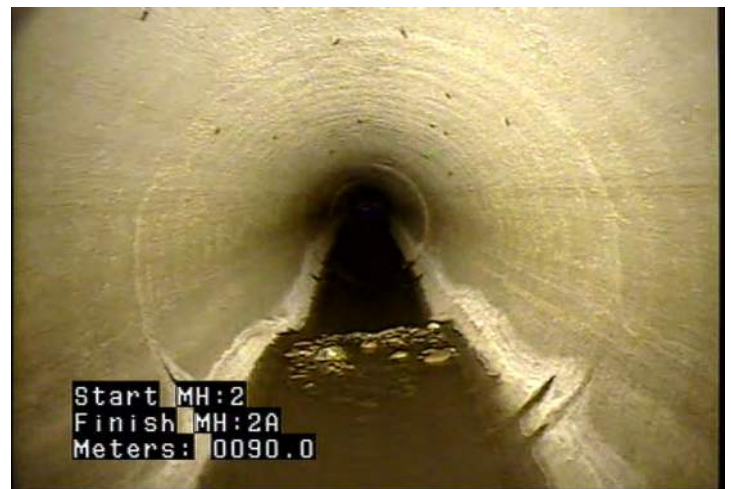
DSGV - Deposits Settled: Gravel @ 90.0 m.

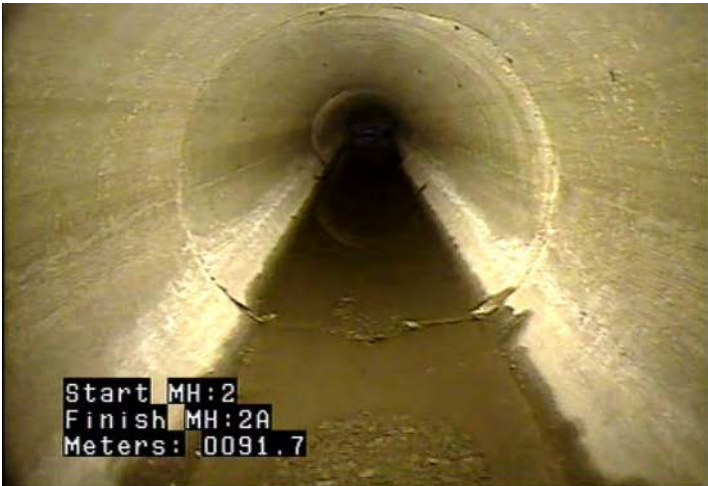
MWLS - Water Level: Sag @ 91.7 m.

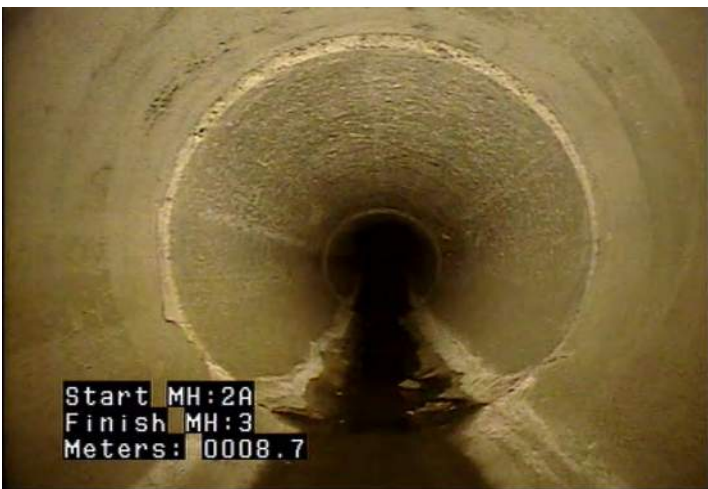
MGO - General Observation @ 8.9 m.
Chipped joint 9:00

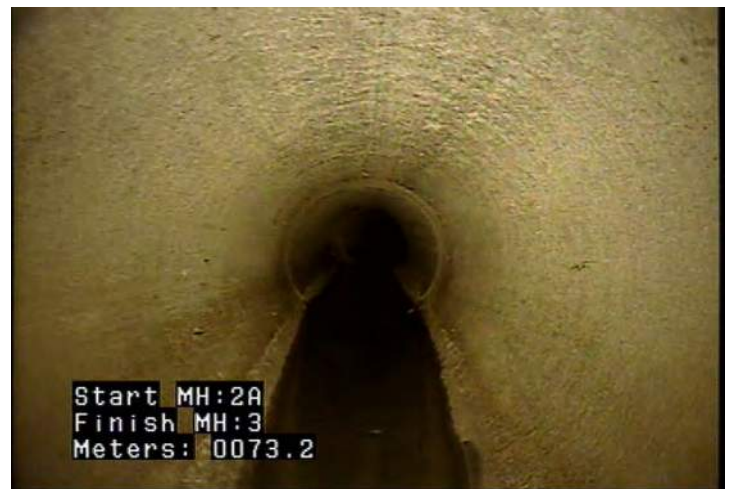
MWL - Water Level @ 73.2 m. Debris in manhole holding back water

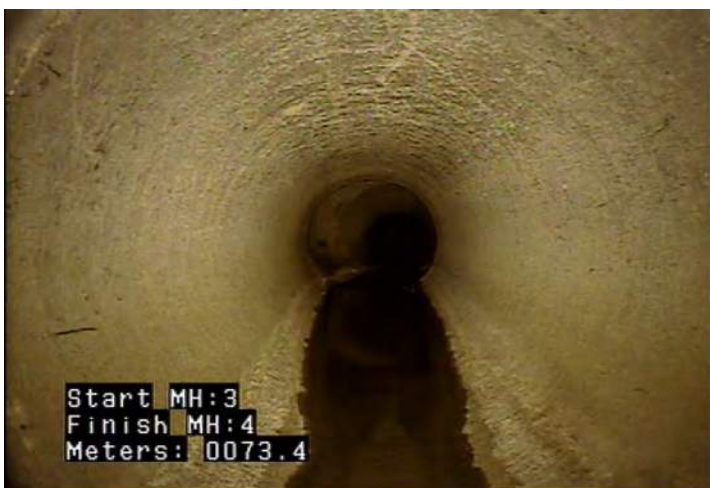
MWL - Water Level @ 73.4 m.

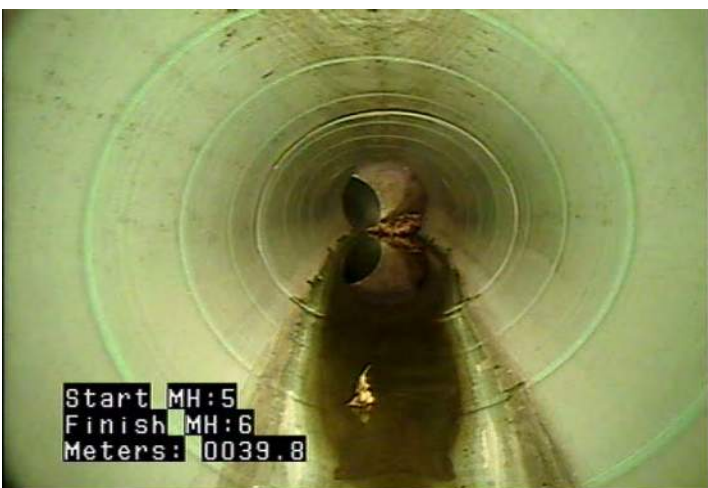
MWLS - Water Level: Sag @ 39.8 m.

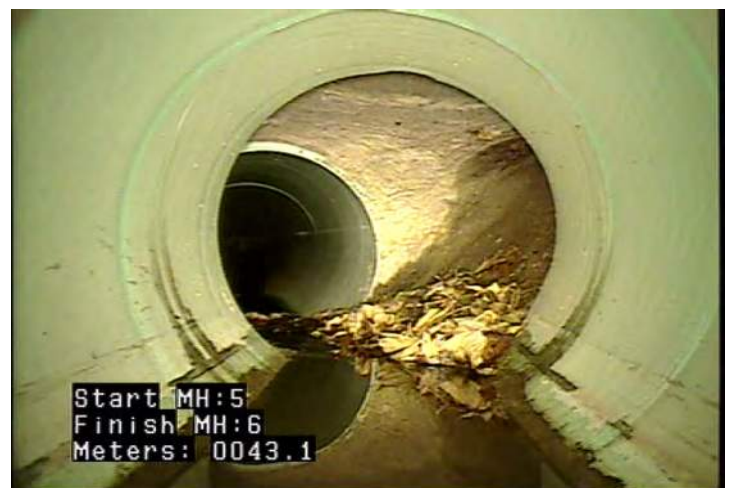
MWLS - Water Level: Sag @ 43.1 m.

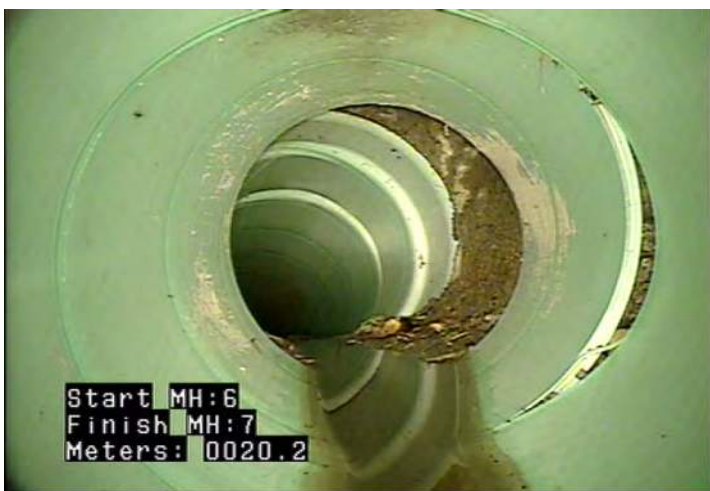
JOM - Joint Offset (displaced): Medium @ 20.2 m.

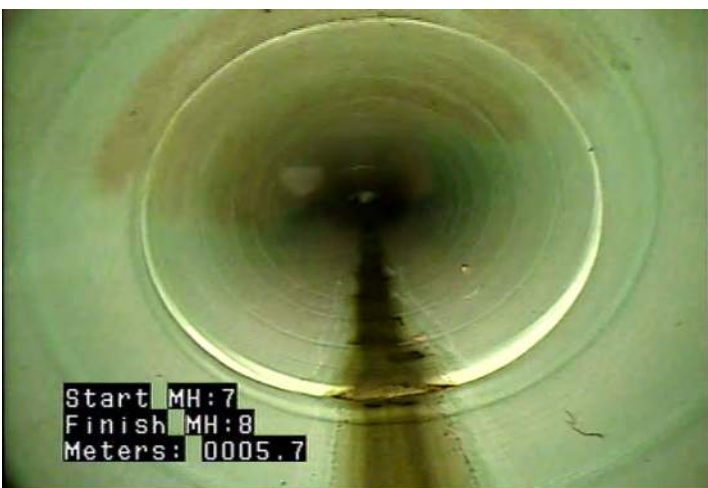
D - Pipe Deformed @ 5.7 m.

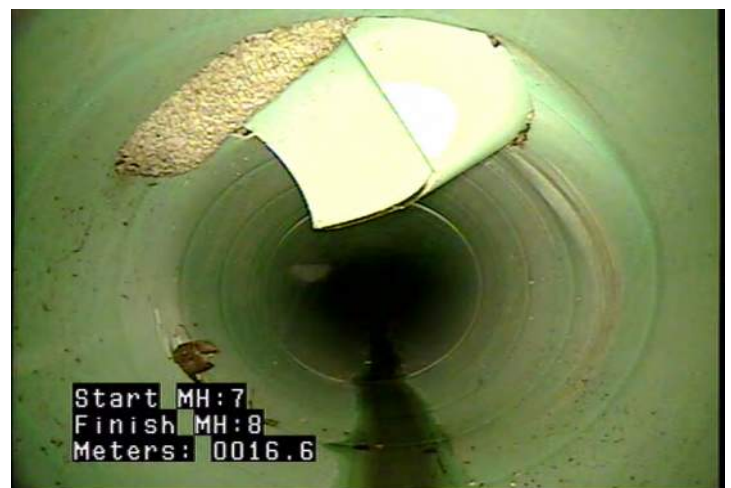
TBI - Tap, Break-in / Hammer: Intruding @ 16.6 m.

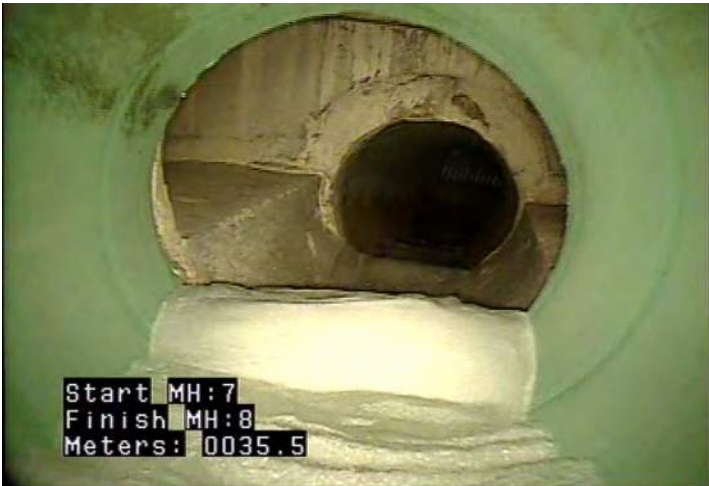
MWL - Water Level @ 35.5 m. Ice

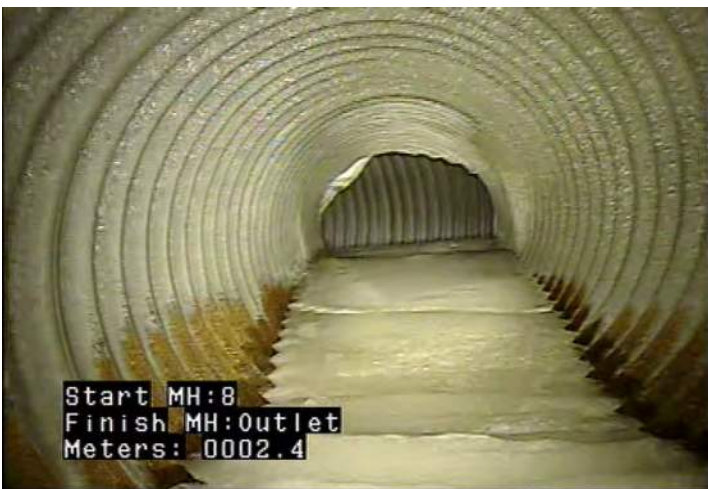
MWL - Water Level @ 2.4 m. Ice

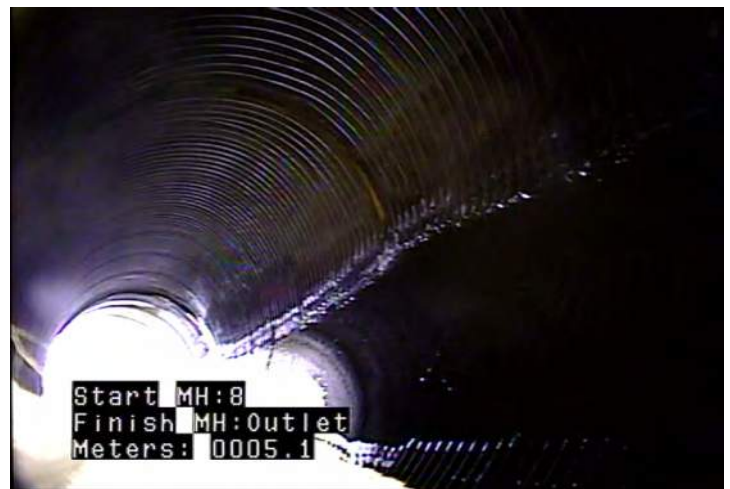
MSA - Survey Abandoned @ 5.1 m. Ts into a bigger storm line.

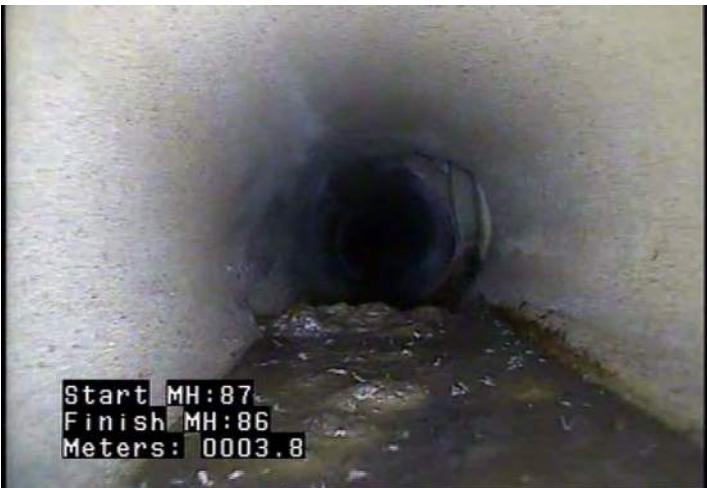
DSZ - Deposits Settled: Other @ 3.8 m.
Sewage

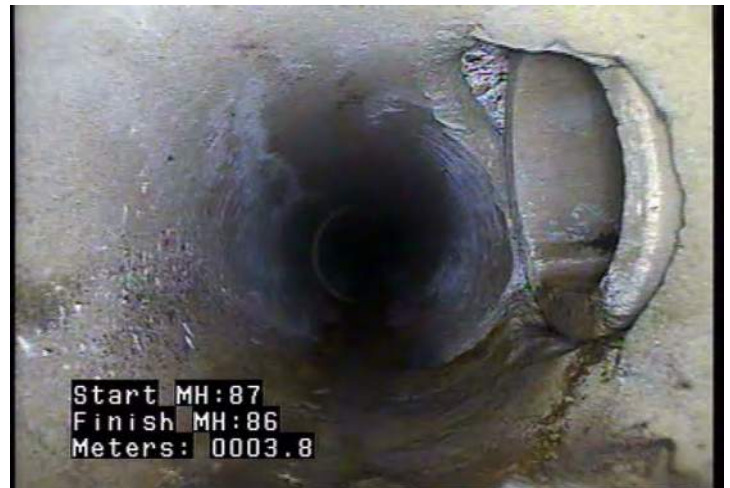
TB - Tap, Break-in / Hammer @ 3.8 m.

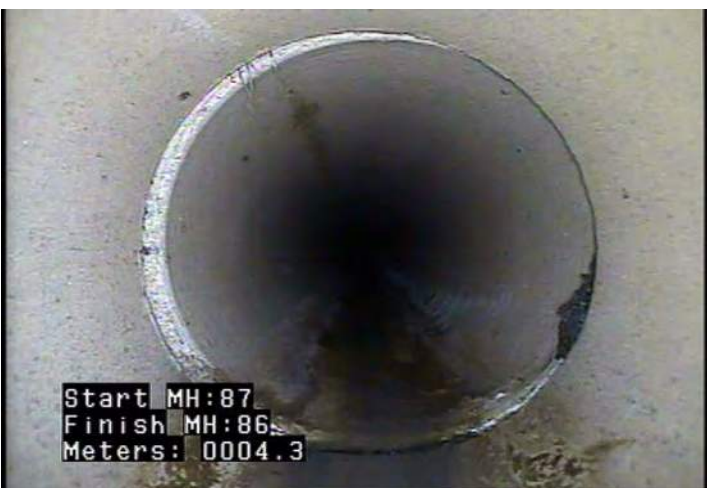
RFJ - Roots, Fine: Joint @ 4.3 m.

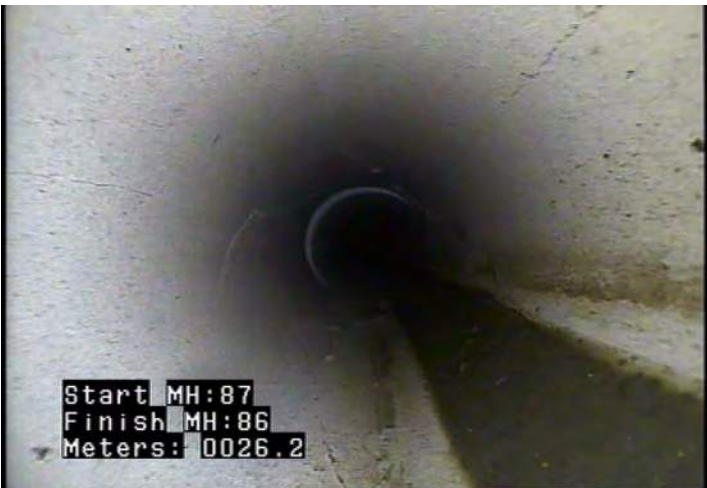
FM - Fracture Multiple @ 26.2 m.

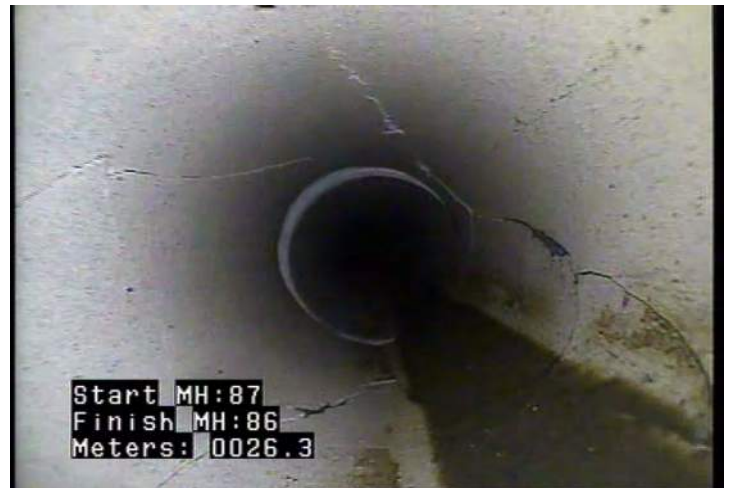
MGP - General Photograph @ 26.3 m.
Additional view of multiple fracture

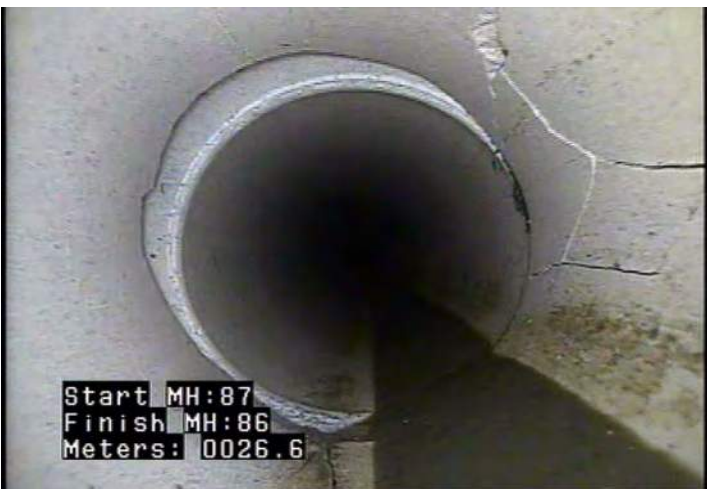
B - Pipe Broken @ 26.6 m. Broken joint, piece missing

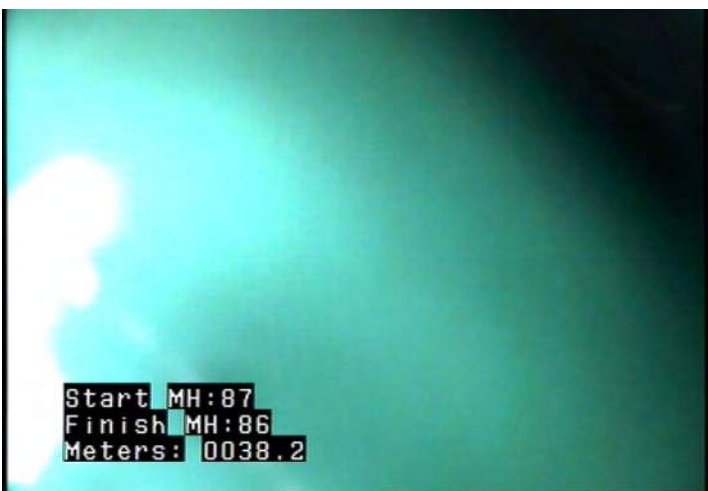
MSA - Survey Abandoned @ 38.2 m.
Unable to pass bend

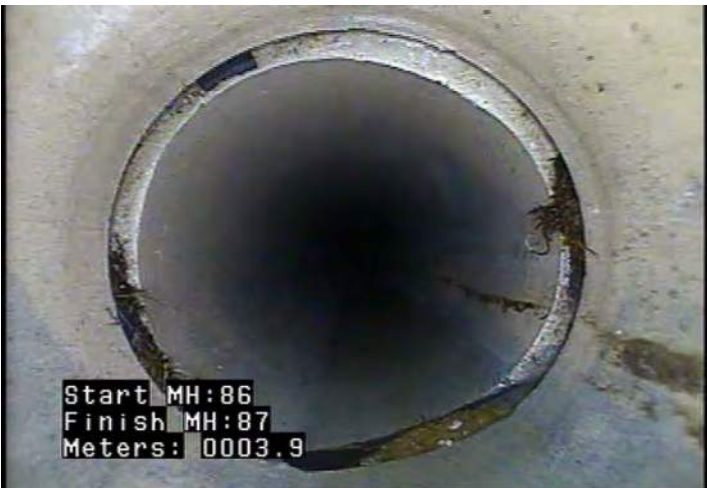
RFJ - Roots, Fine: Joint @ 3.9 m.

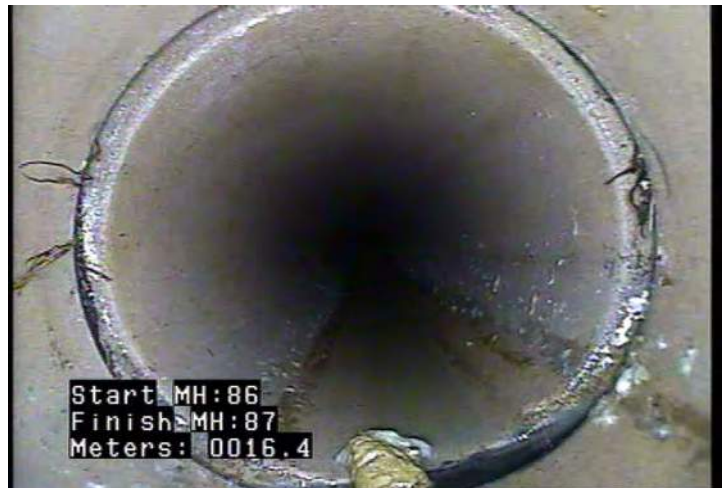
RFJ - Roots, Fine: Joint @ 16.4 m.

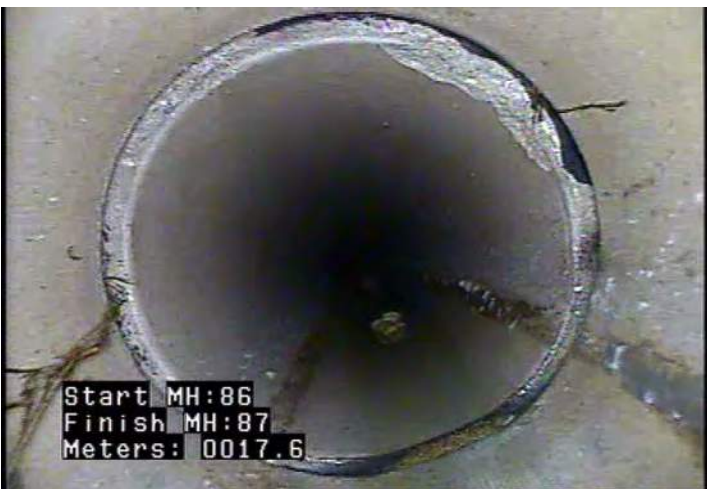
RFJ - Roots, Fine: Joint @ 17.6 m.

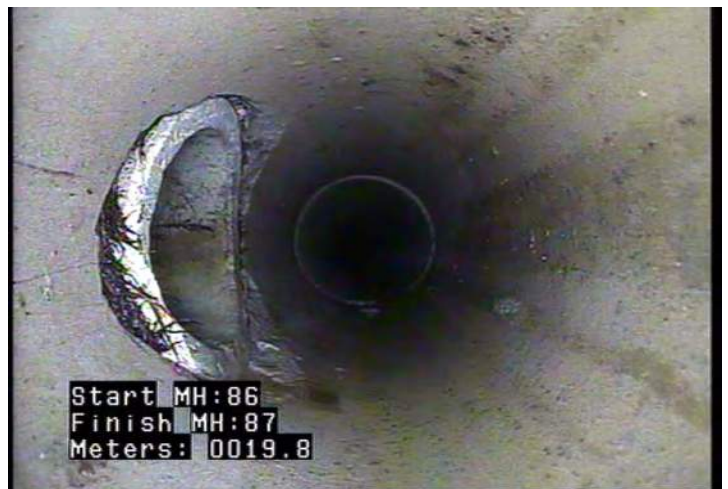
RFC - Roots, Fine: Connection @ 19.8 m.

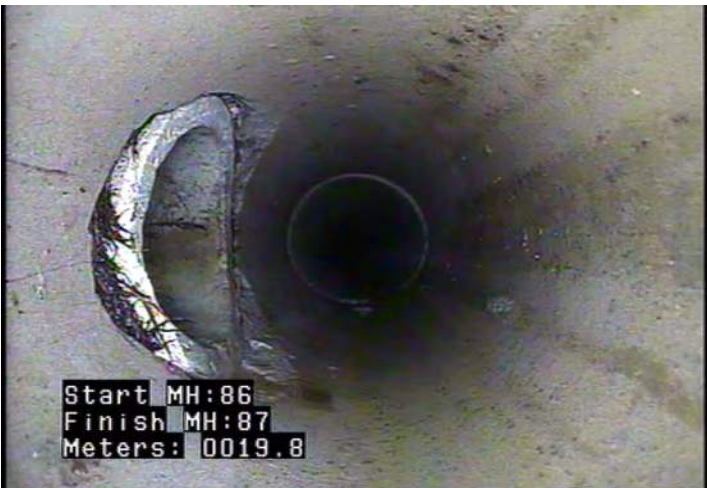
TB - Tap, Break-in / Hammer @ 19.8 m.

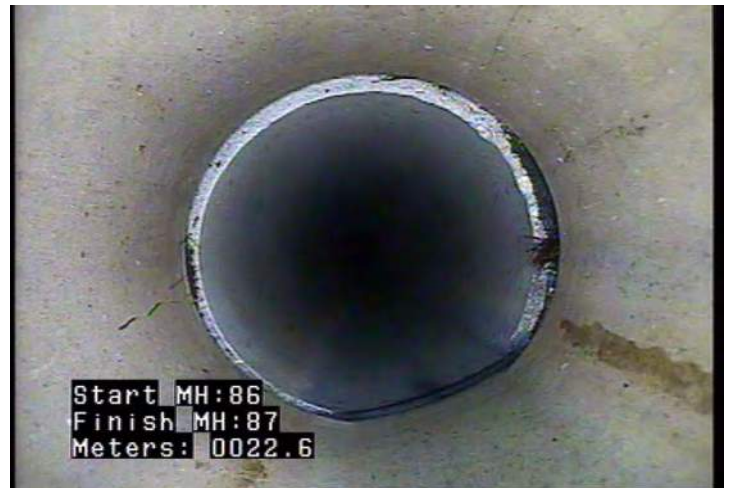
RFJ - Roots, Fine: Joint @ 22.6 m.

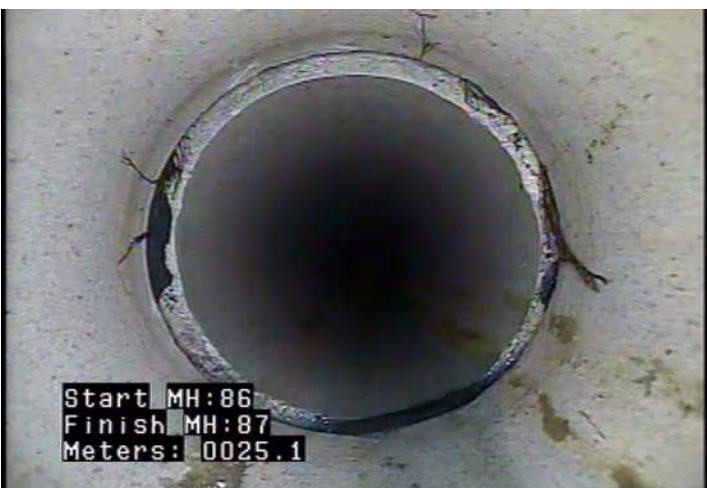
RFJ - Roots, Fine: Joint @ 25.1 m.

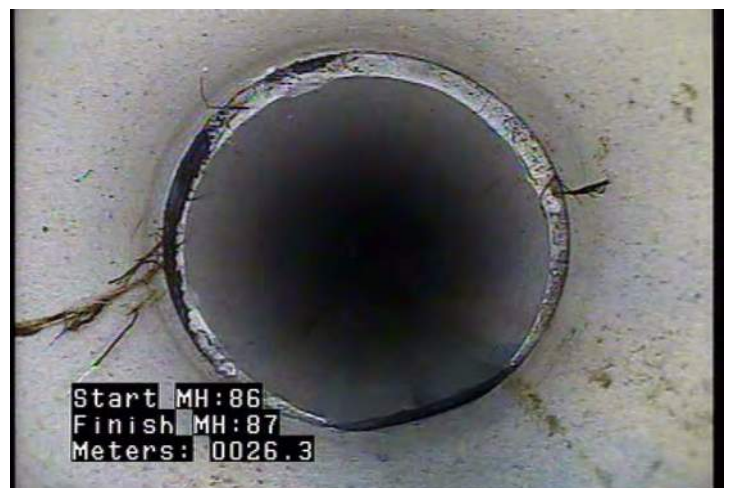
RFJ - Roots, Fine: Joint @ 26.3 m.

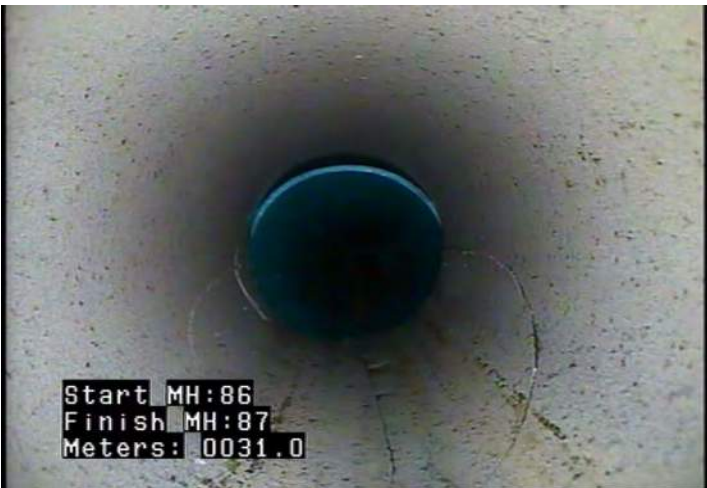
FM - Fracture Multiple @ 31.0 m.
