Appendix F CCTV Assessment

Client: CIMA
 Project: Pre-Rehabilitation Survey
 Date: 12/18/2020
 File: 14257

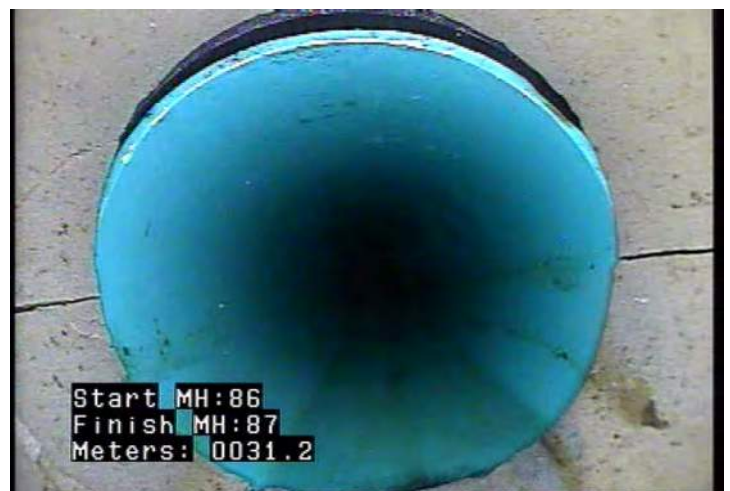
RPR - Point Repair - Pipe Replaced @ 31.2 m. PVC Repair

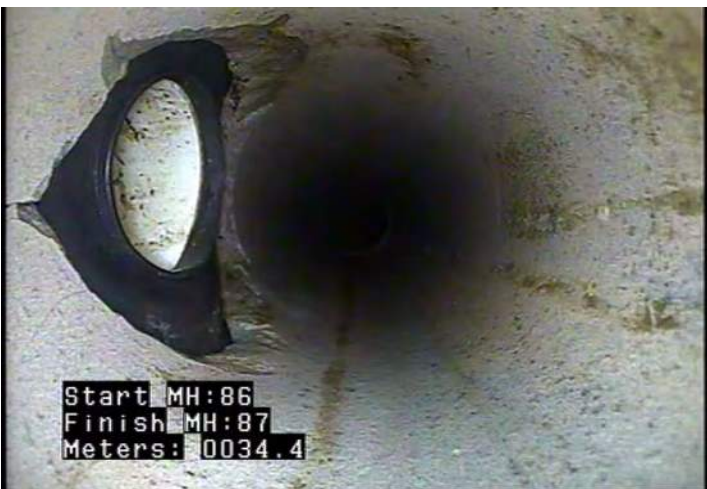
TBD - Tap, Break-in / Hammer: Defective @ 34.4 m. Hole overcut

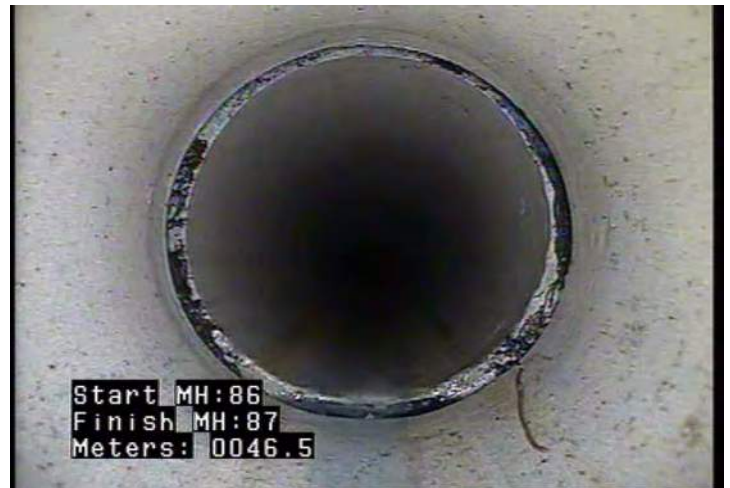
RFJ - Roots, Fine: Joint @ 46.5 m.

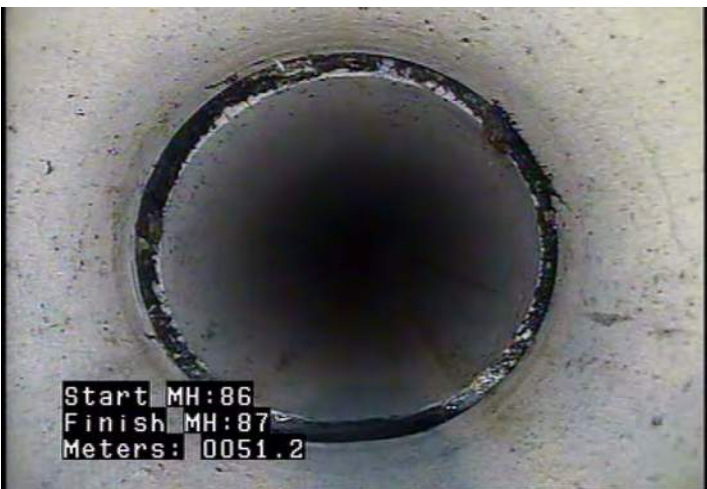
RFJ - Roots, Fine: Joint @ 51.2 m.

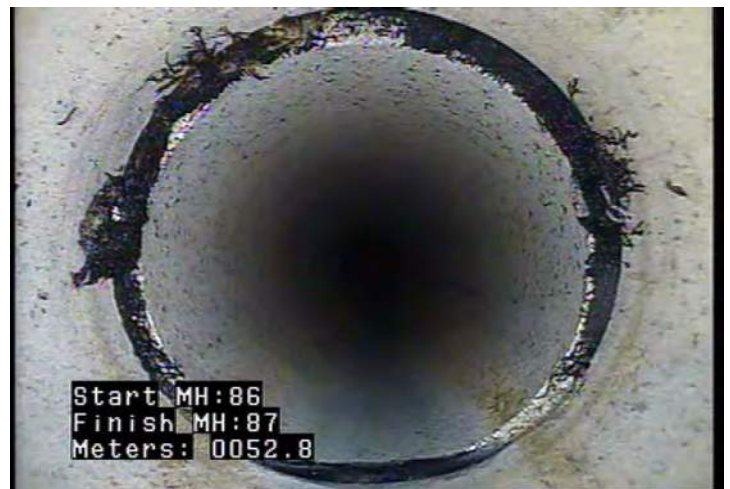
RFJ - Roots, Fine: Joint @ 52.8 m.

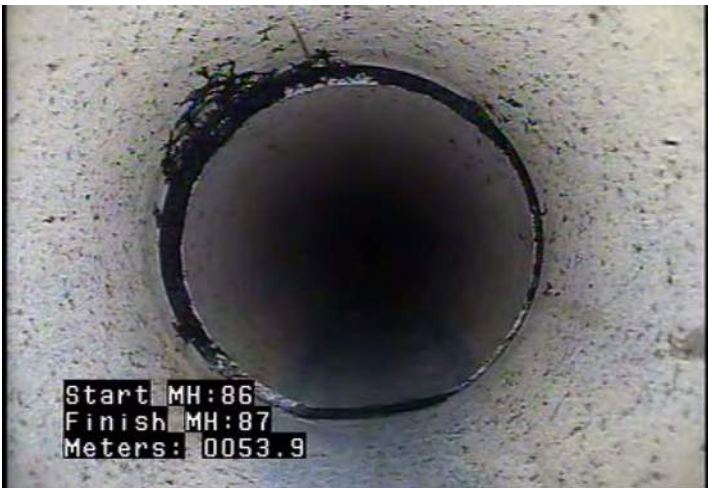
RFJ - Roots, Fine: Joint @ 53.9 m.

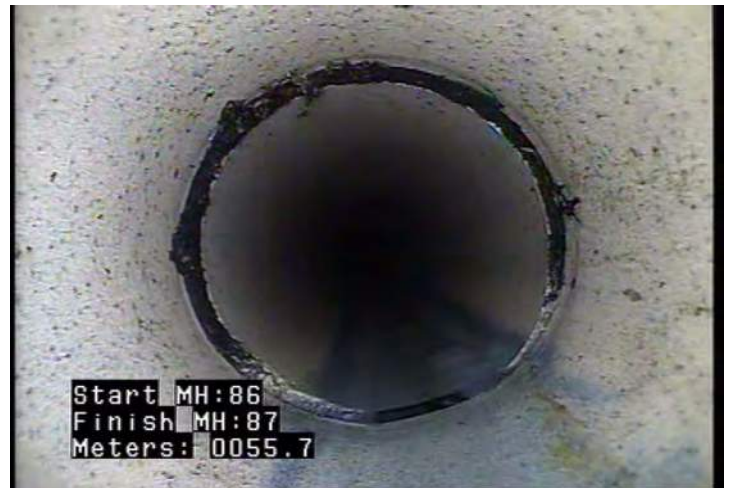
RFJ - Roots, Fine: Joint @ 55.7 m.

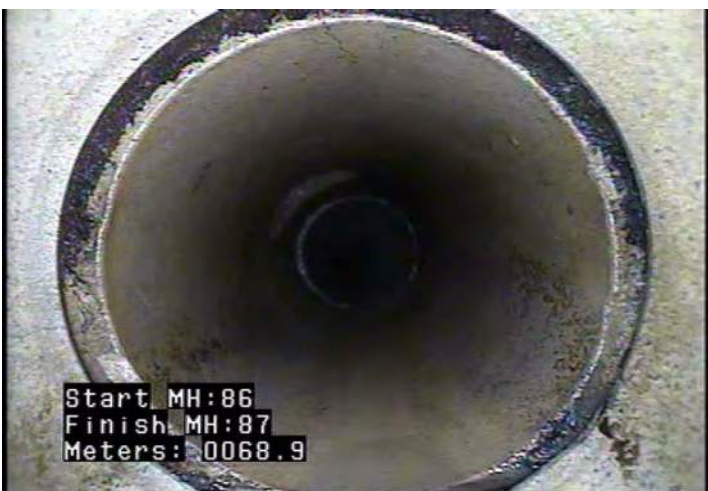
CL - Crack Longitudinal @ 68.9 m.

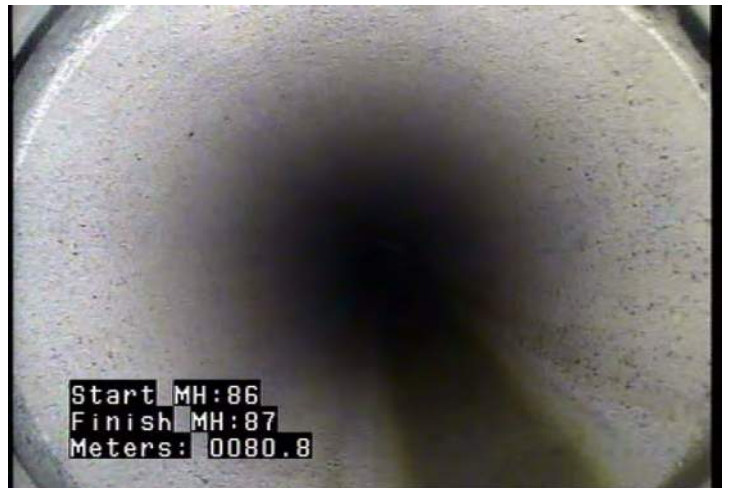
MWLS - Water Level: Sag @ 80.8 m.

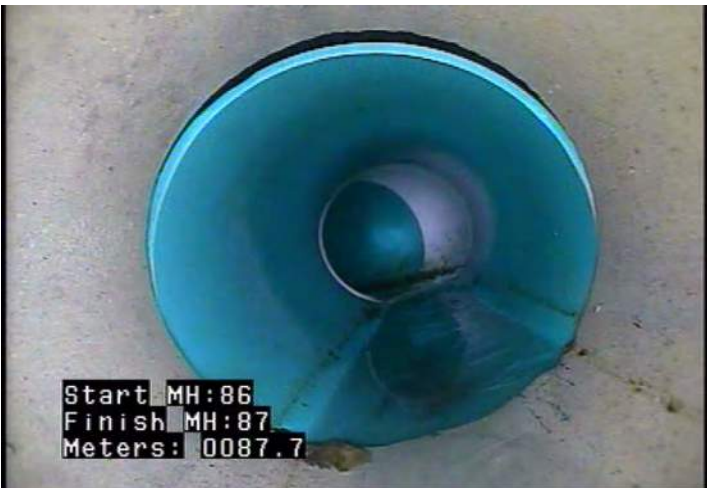
JOM - Joint Offset (displaced): Medium @ 87.7 m.

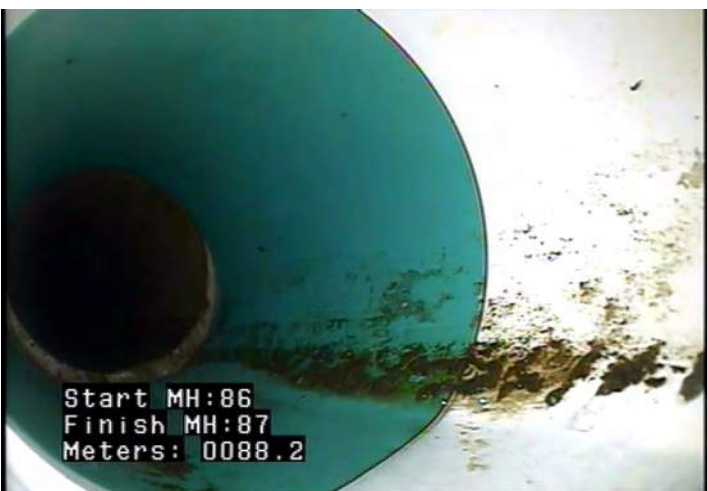
MSA - Survey Abandoned @ 88.2 m.
Unable to pass bend

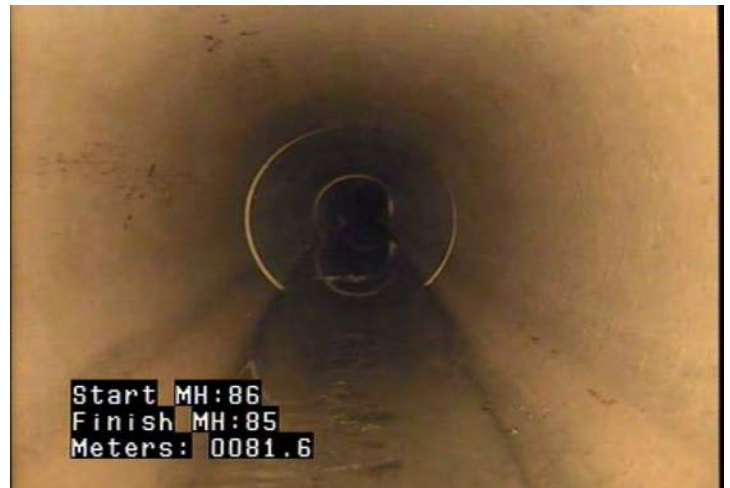
MWLS - Water Level: Sag @ 81.6 m.

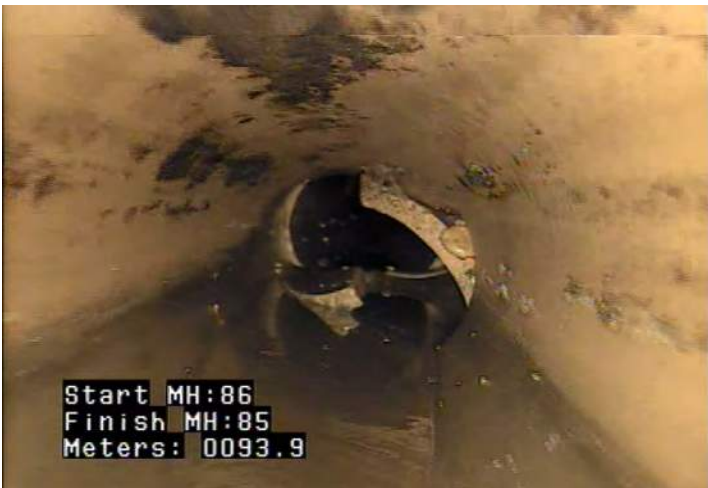
BSV - Pipe Broken: Soil Visible @ 94.4 m.

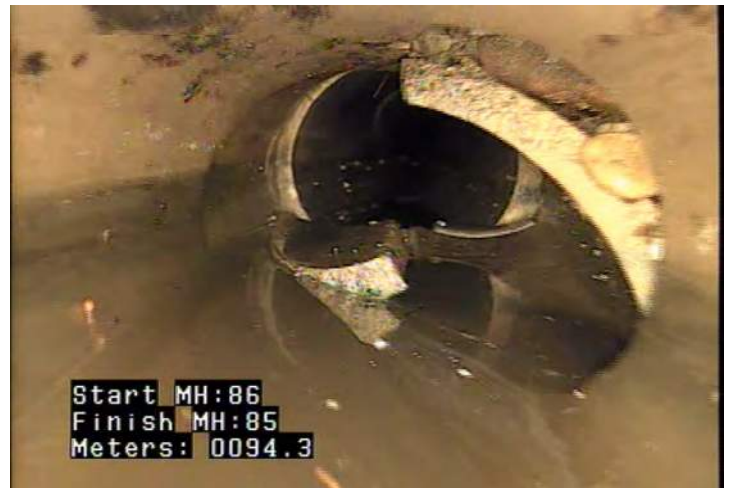
MSA - Survey Abandoned @ 94.5 m.
Unable to pass broken pipe

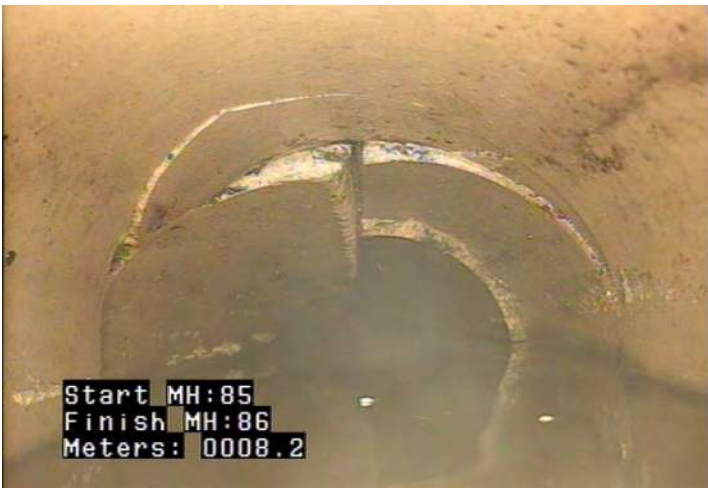
B - Pipe Broken @ 8.2 m.

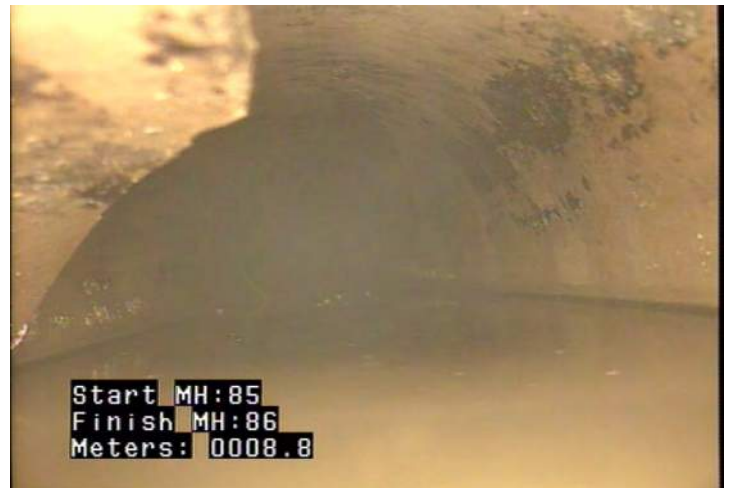
MSA - Survey Abandoned @ 8.8 m.
Unable to pass broken pipe.

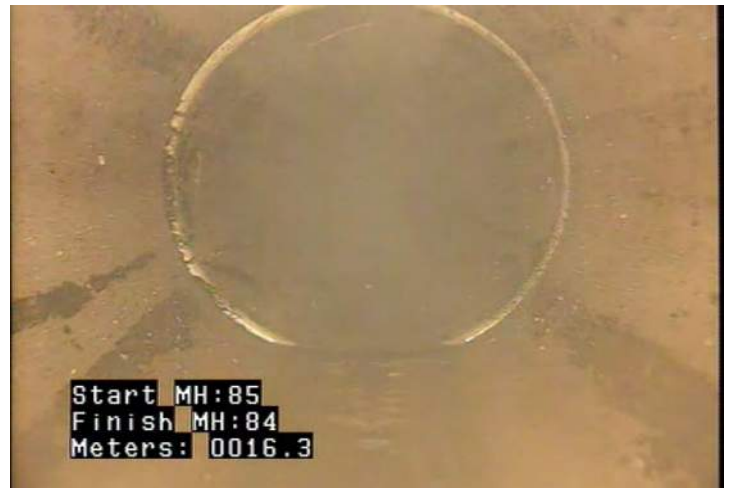
RFJ - Roots, Fine: Joint @ 16.3 m.

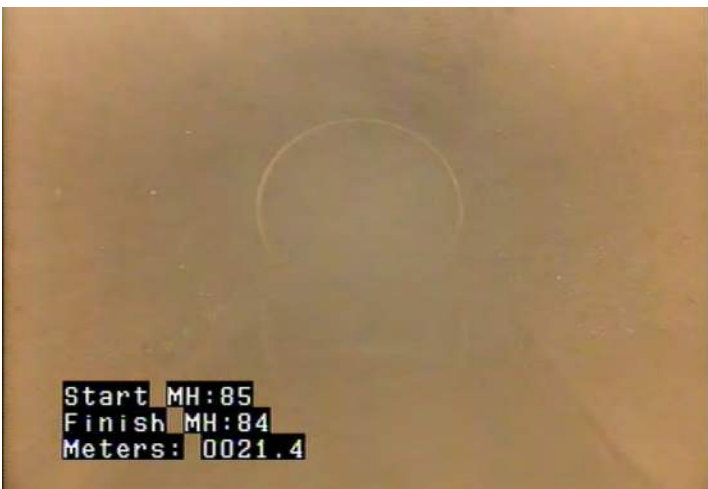
MWLS - Water Level: Sag @ 21.4 m.

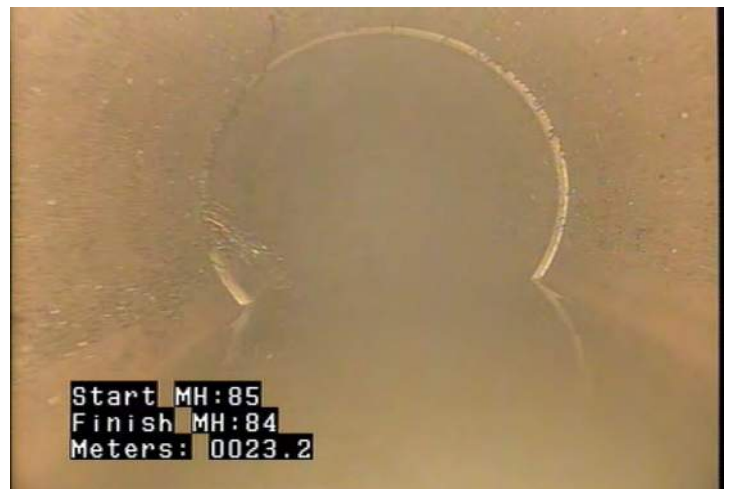
RFJ - Roots, Fine: Joint @ 23.4 m.

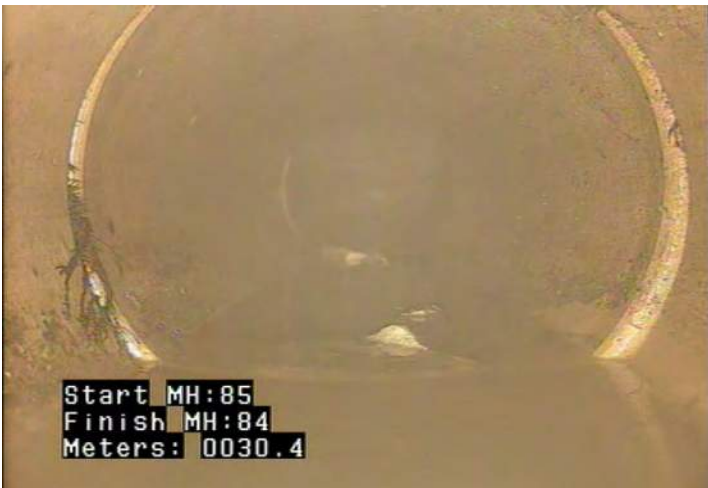
RFJ - Roots, Fine: Joint @ 30.4 m.

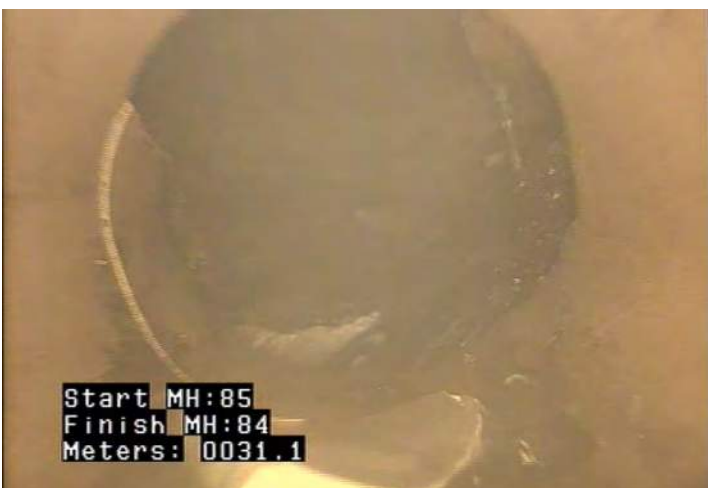
FC - Fracture Circumferential @ 31.1 m.

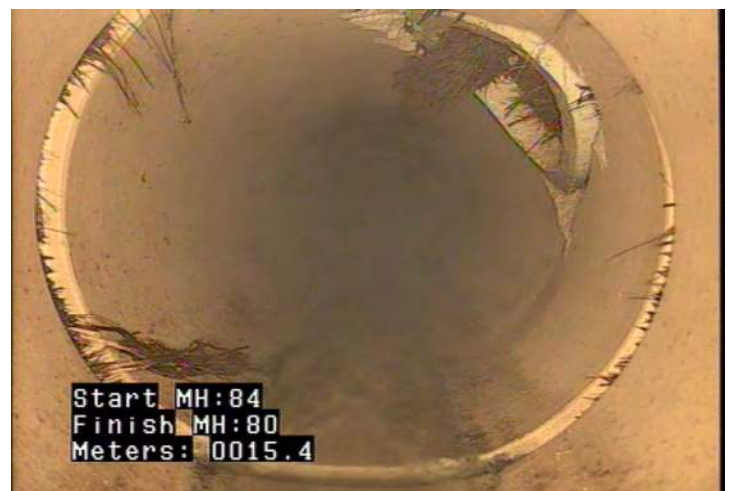
TBD - Tap, Break-in / Hammer: Defective @ 15.4 m. Roots

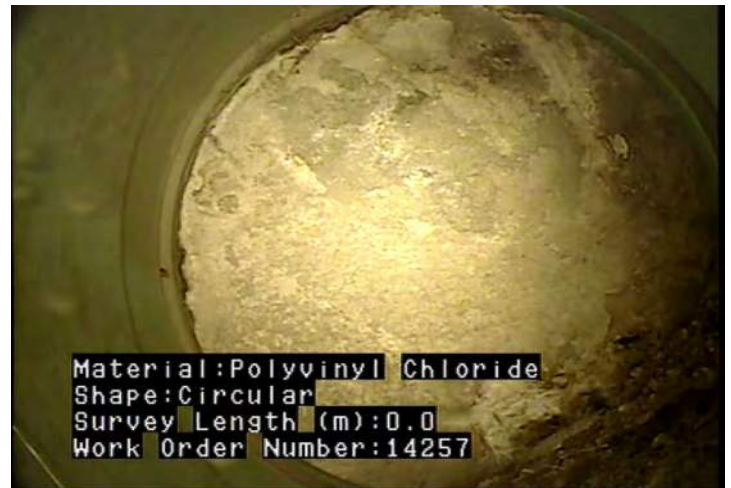
MSA - Survey Abandoned @ 1.7 m. Line plugged with concrete.

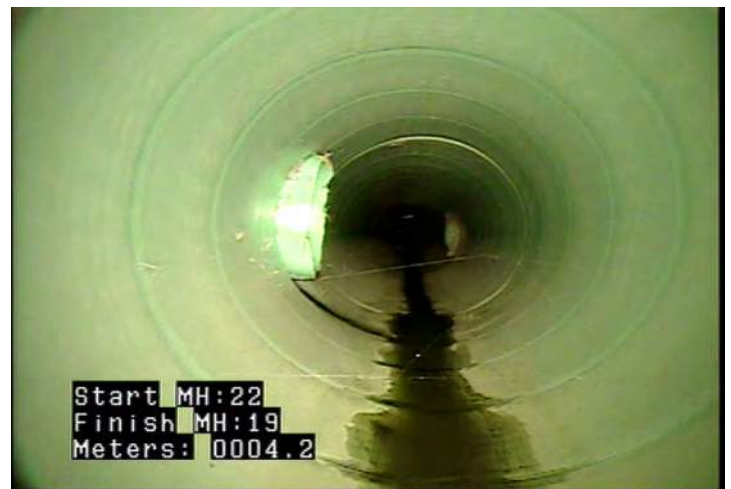
TSI - Tap, Saddle: Intruding @ 5.1 m.

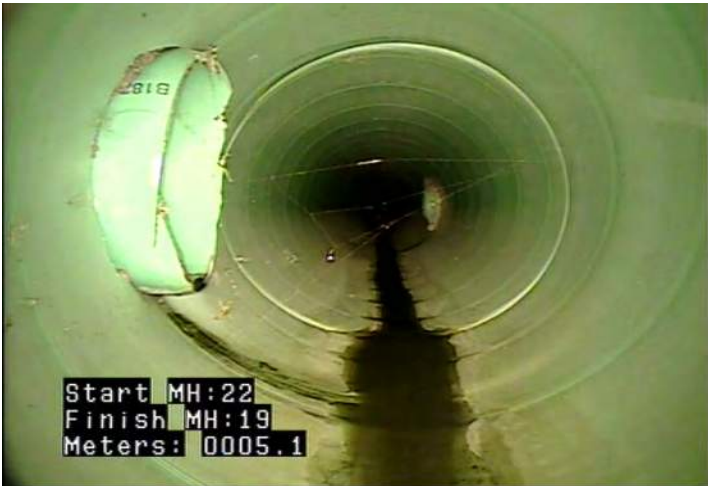
TB - Tap, Break-in / Hammer @ 8.3 m.
Concrete around service

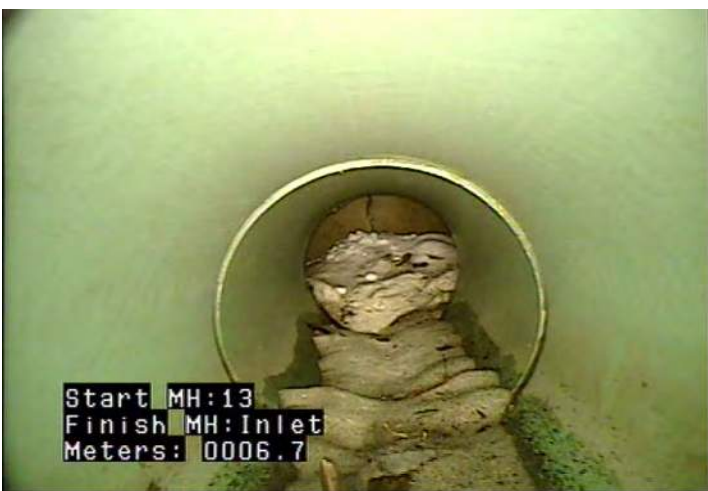
MWL - Water Level @ 6.7 m. Ice/Snow

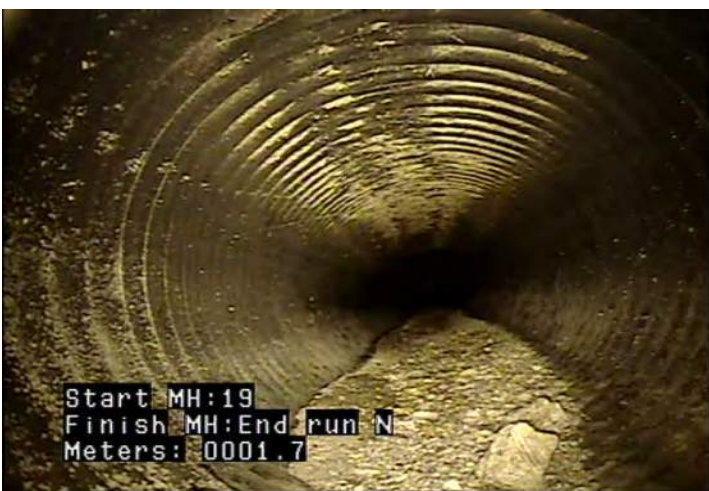
DSGV - Deposits Settled: Gravel @ 0.5 m.

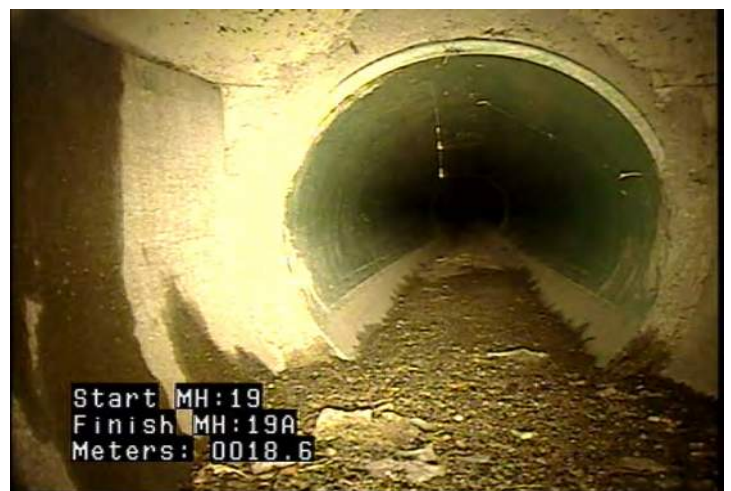
DSGV - Deposits Settled: Gravel @ 18.6 m.

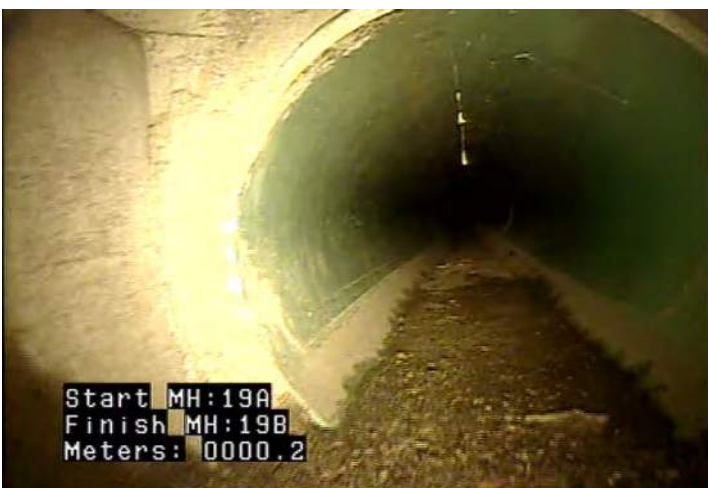
DSGV - Deposits Settled: Gravel @ 0.2 m.

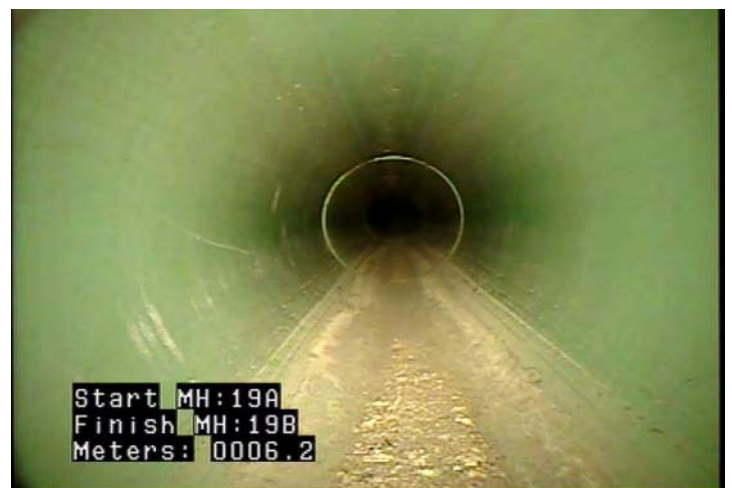
DSGV - Deposits Settled: Gravel @ 6.2 m.

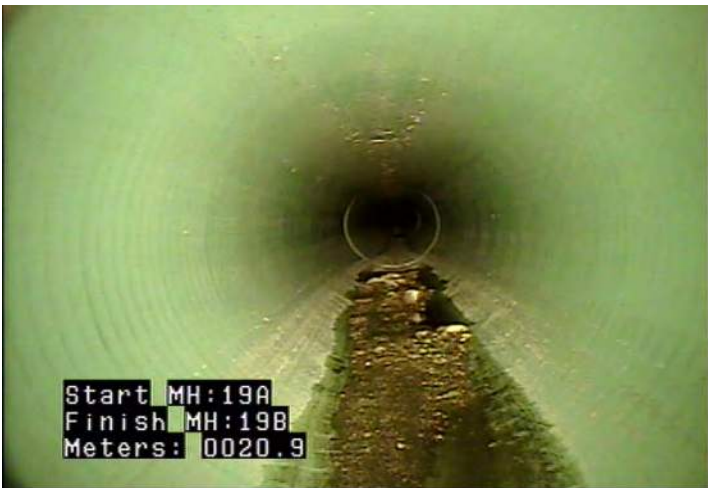
DSGV - Deposits Settled: Gravel @ 20.9 m.

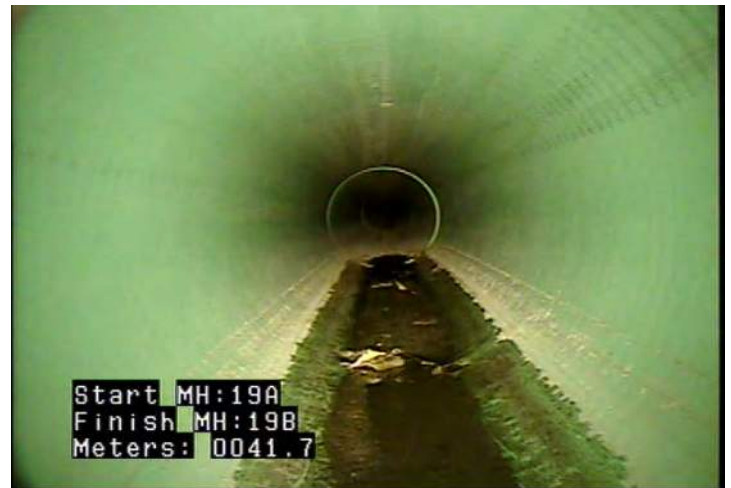
DSF - Deposits Settled: Fine @ 41.7 m.

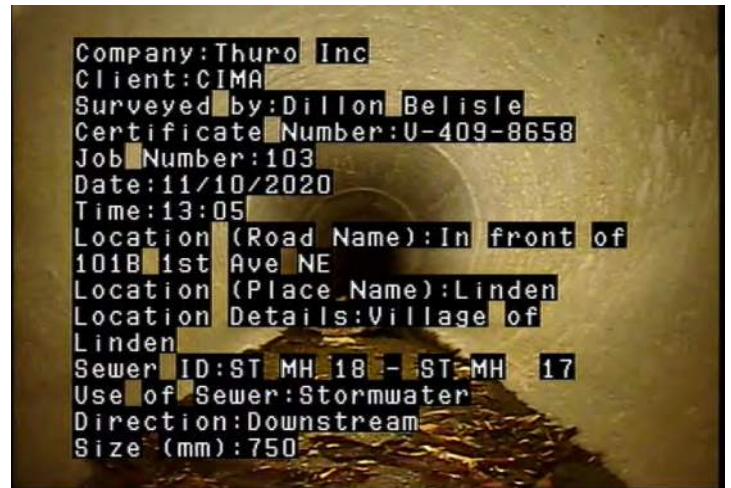
DSGV - Deposits Settled: Gravel @ 0.0 m.

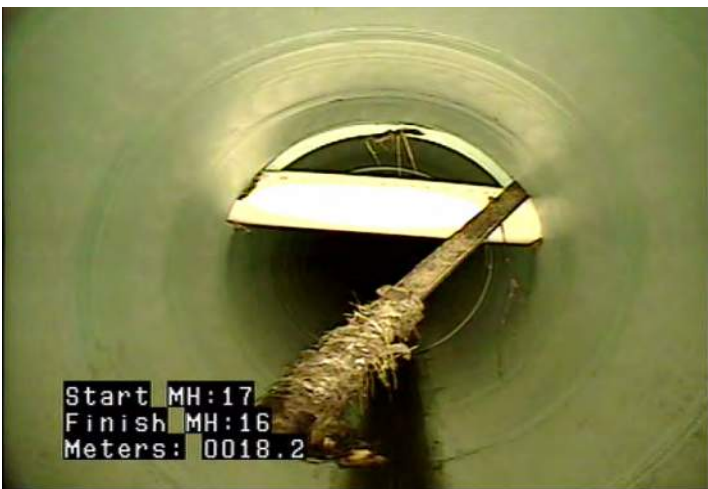
OBP - Obstacle - External Pipe or Cable in
Sewer @ 18.2 m.

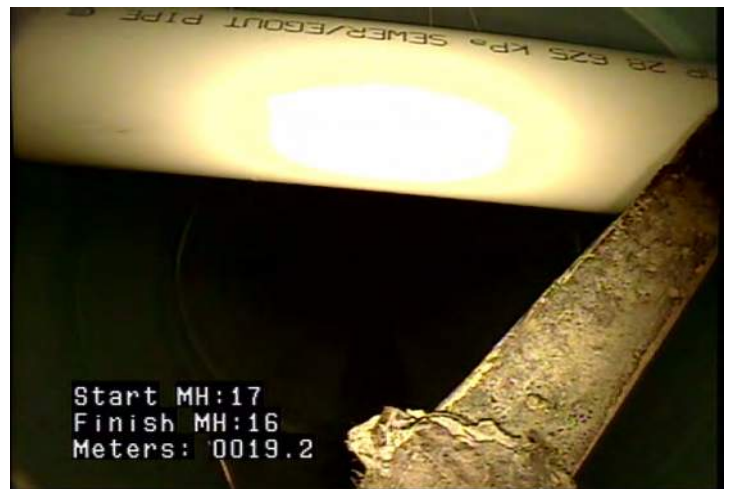
MSA - Survey Abandoned @ 19.2 m.
Unable to pass pipe

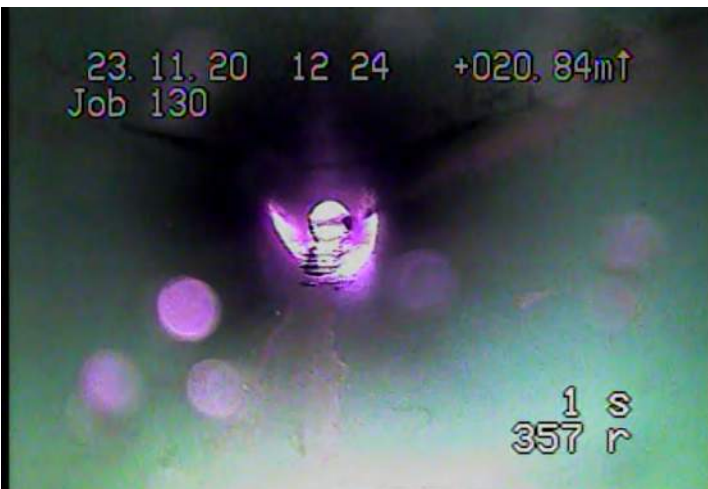
MWL - Water Level @ 19.9 m. Ice

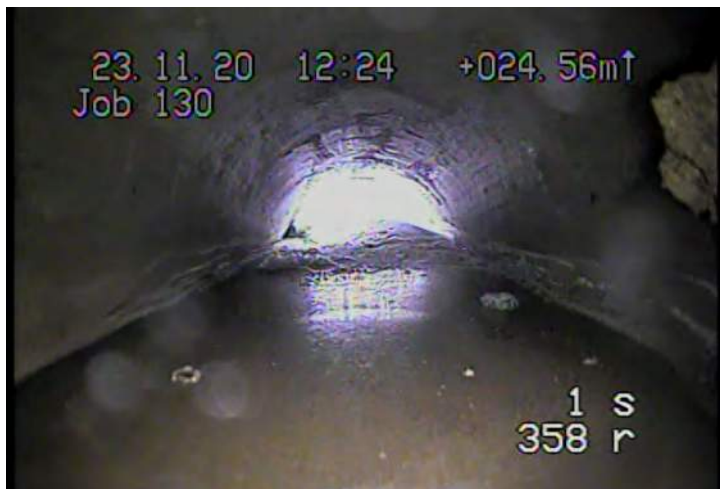
MWL - Water Level @ 24.1 m. Ice

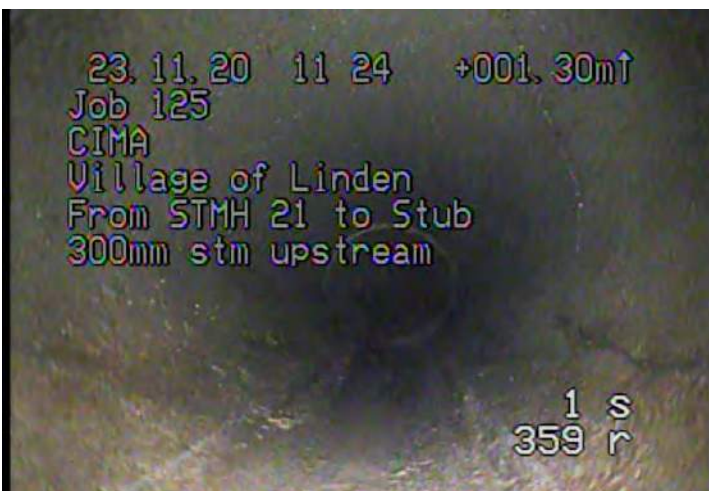
CM - Crack Multiple @ 0.5 m.

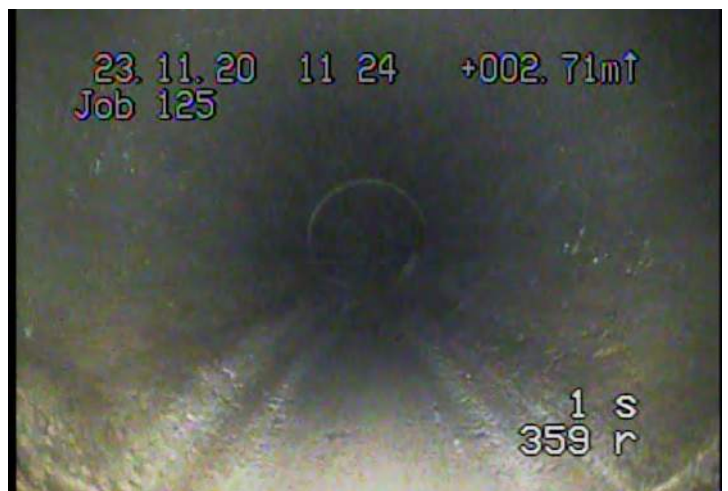
ISGT - Intruding Seal Material - Grout @ 1.6 m.

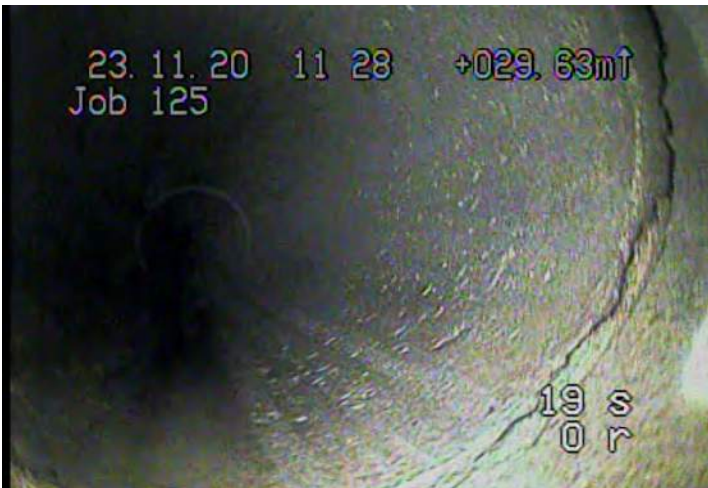
MGO - General Observation @ 29.6 m.
Chipped joint

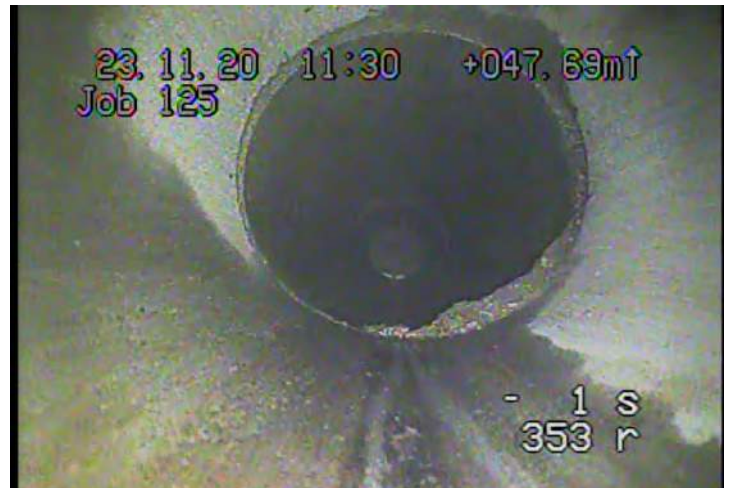
ISGT - Intruding Seal Material - Grout @
47.9 m.

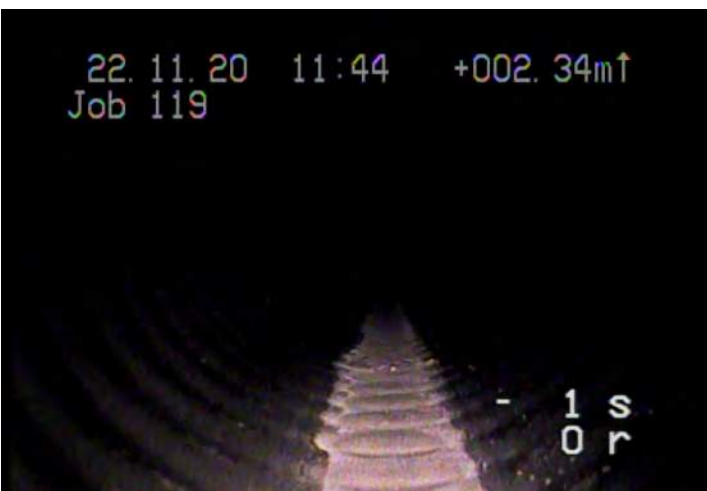
MMC - Material Change @ 2.0 m. PVC to Corrugated Plastic

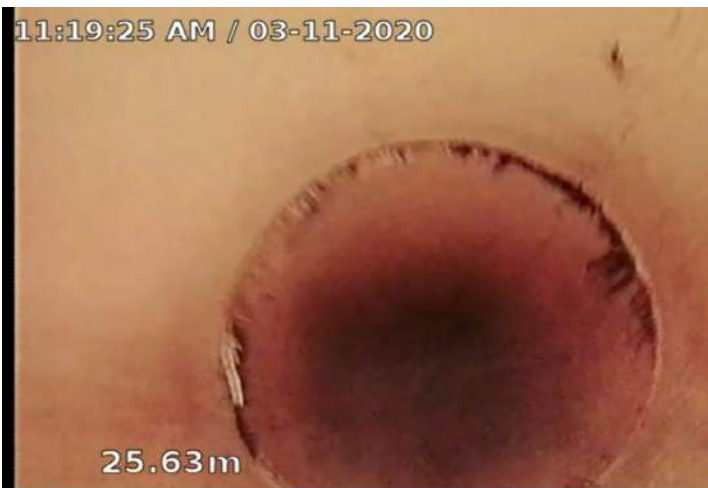
RFJ - Roots, Fine: Joint @ 25.6 m.

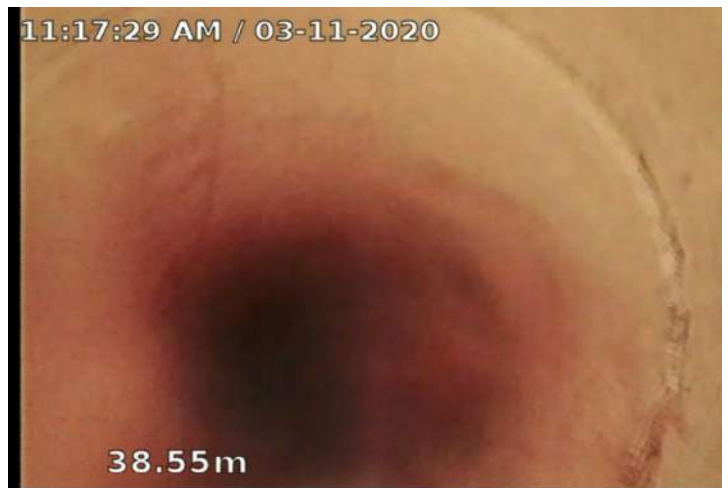
CL - Crack Longitudinal @ 38.5 m.

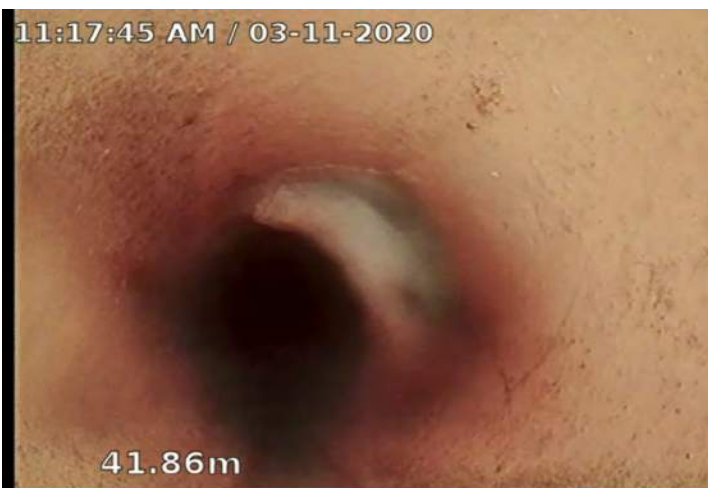
H - Hole in Pipe @ 41.9 m. Patched on outside

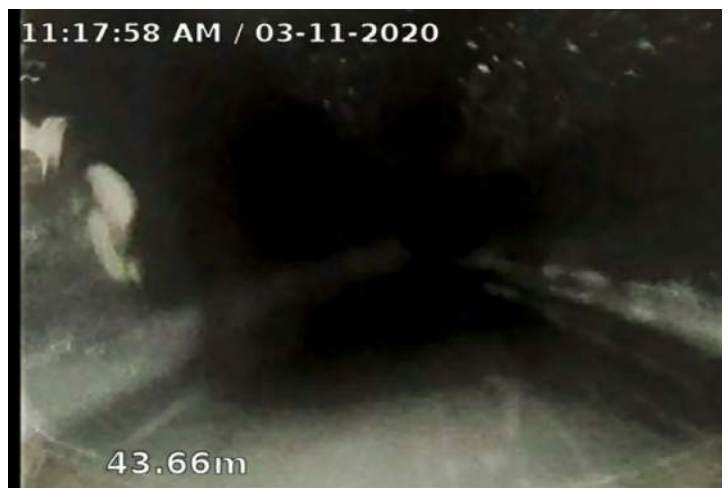
MMC - Material Change @ 43.7 m. Clay tile to ABS

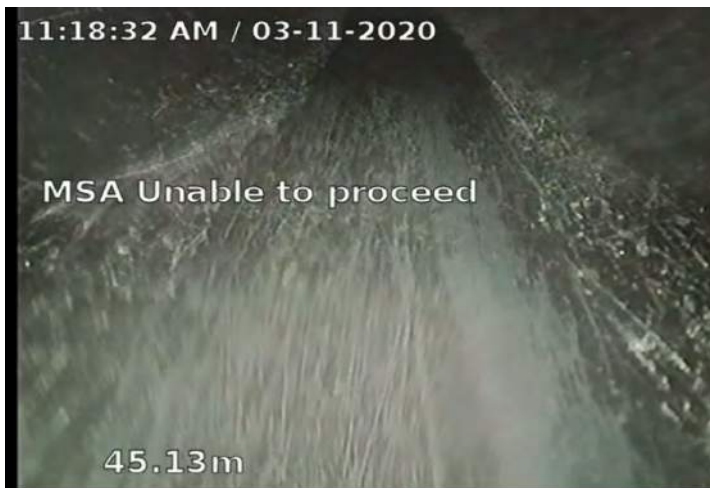
MSA - Survey Abandoned @ 45.1 m.
Unable to proceed.

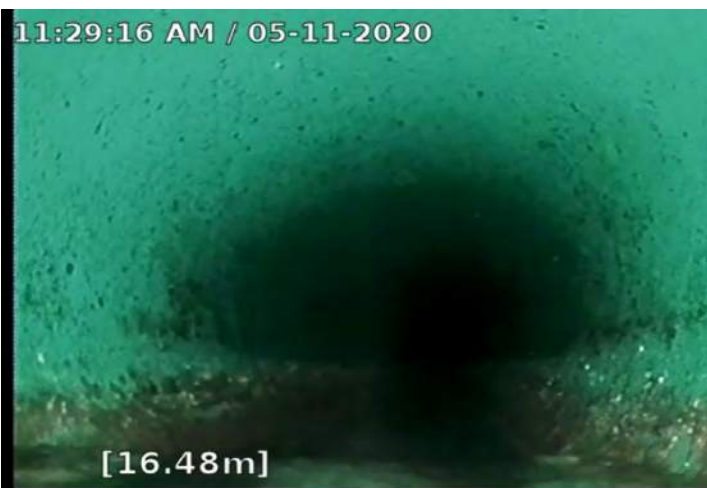
MWLS - Water Level: Sag @ 16.9 m.

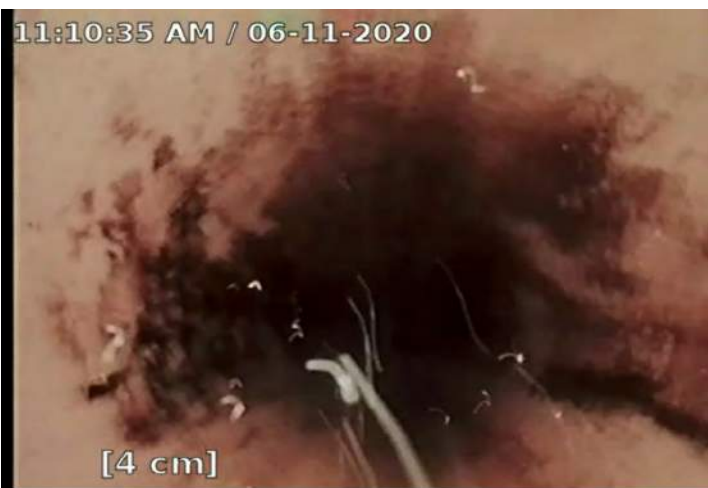
RFJ - Roots, Fine: Joint @ 0.2 m.

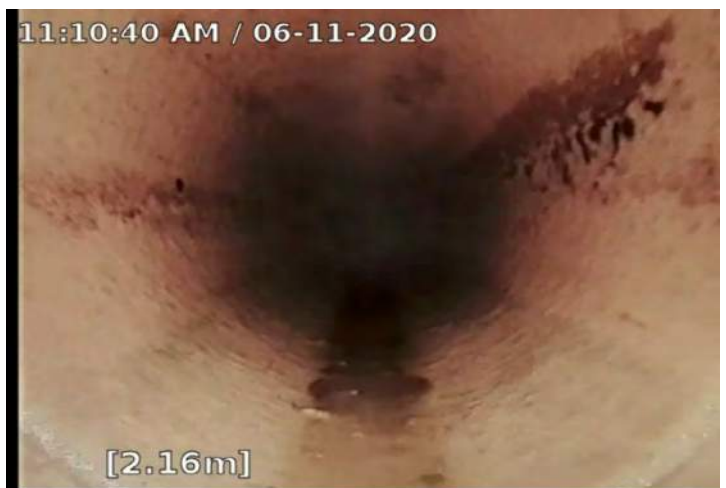
RFJ - Roots, Fine: Joint @ 2.2 m.

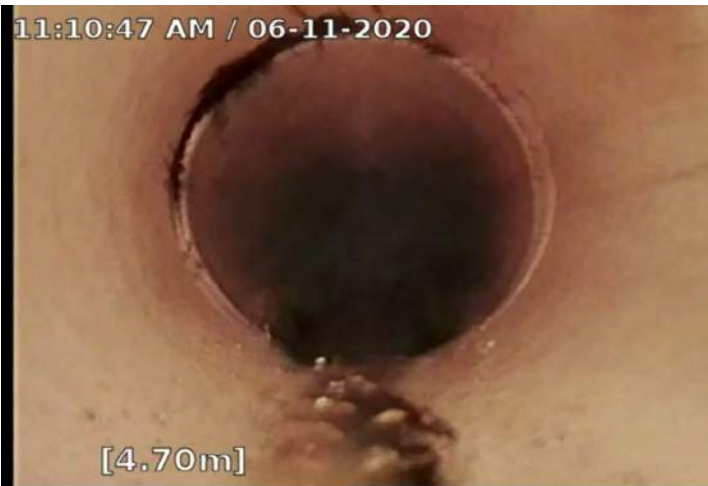
RFJ - Roots, Fine: Joint @ 4.7 m.

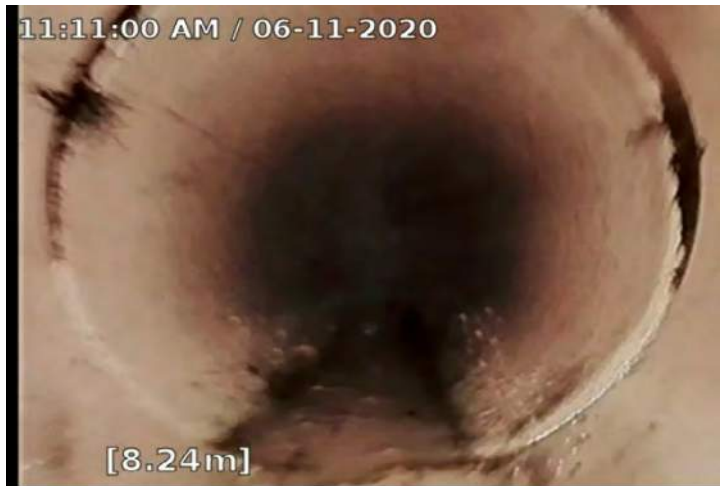
RFJ - Roots, Fine: Joint @ 8.1 m.

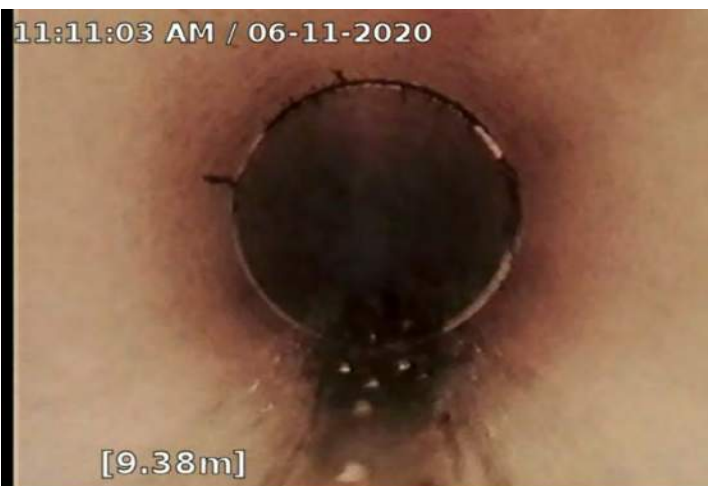
RFJ - Roots, Fine: Joint @ 9.4 m.

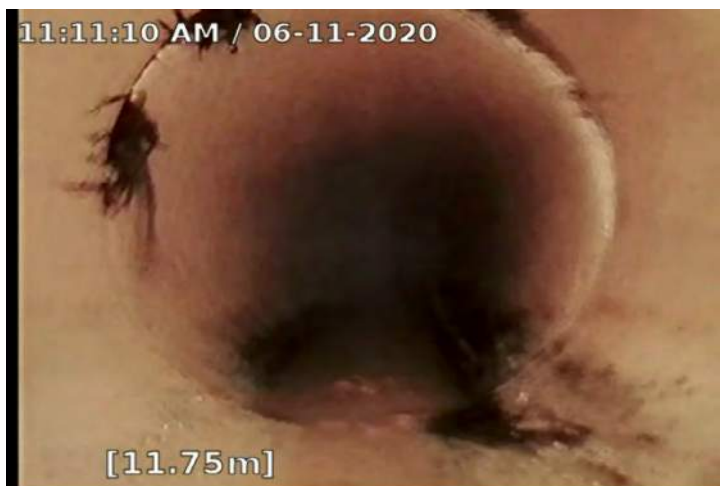
RFJ - Roots, Fine: Joint @ 11.8 m.

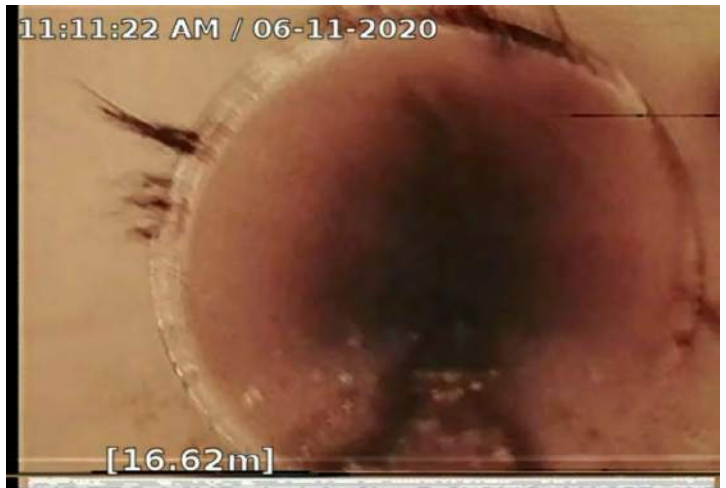
RFJ - Roots, Fine: Joint @ 16.6 m.

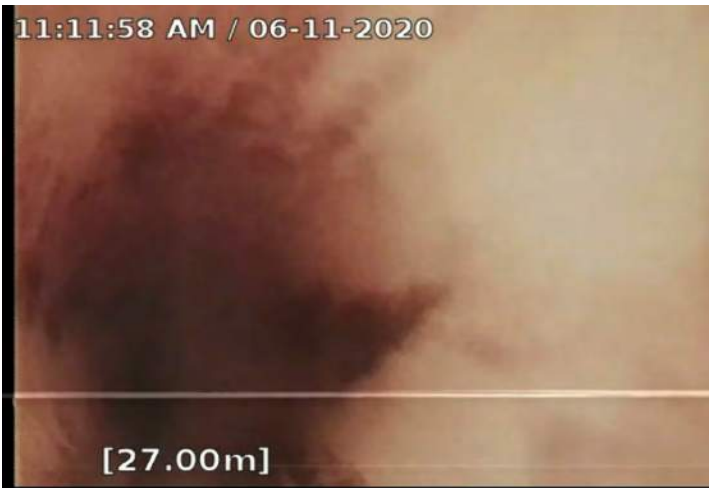
RMJ - Roots, Medium, Joint @ 26.9 m.

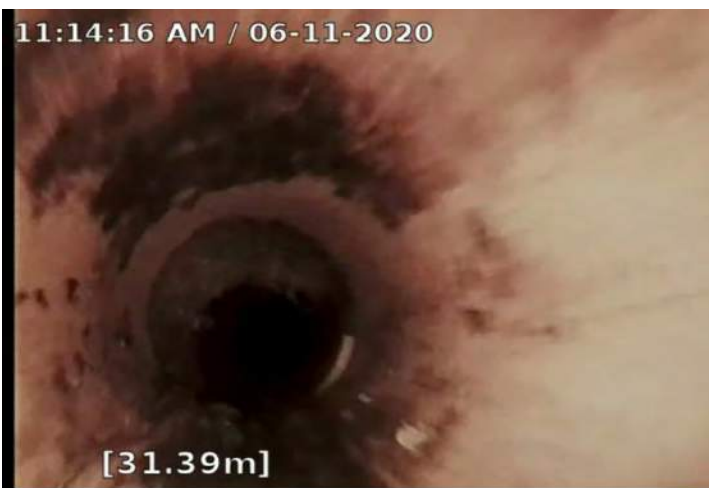
RMJ - Roots, Medium, Joint @ 28.4 m.

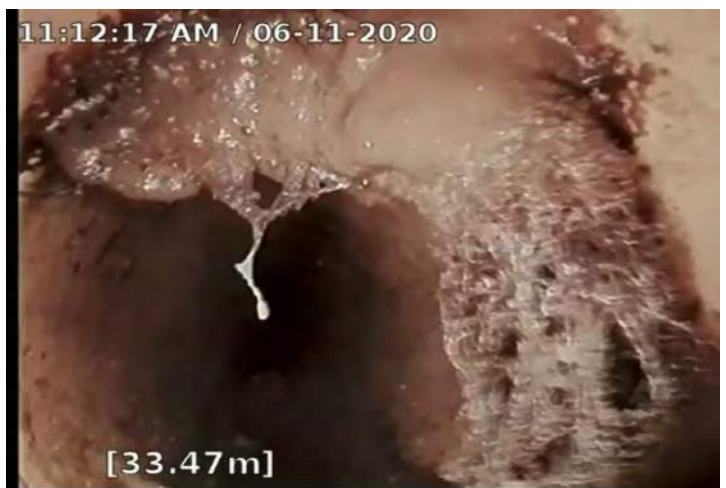
RMJ - Roots, Medium, Joint @ 31.3 m.

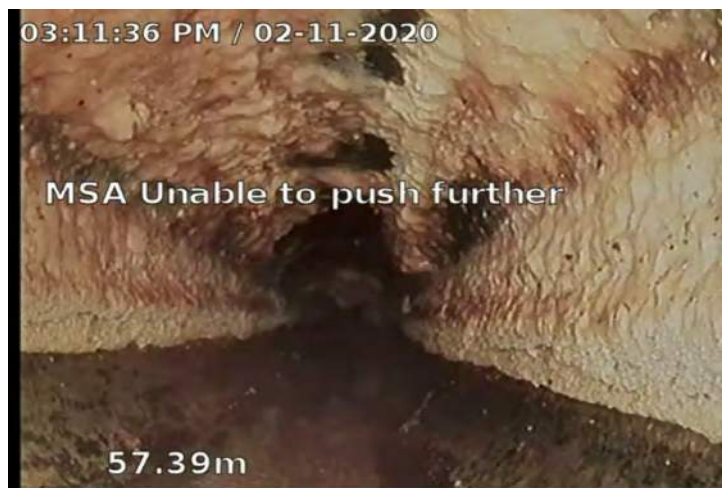
DAGS - Deposits Attached: Grease @ 57.4 m.

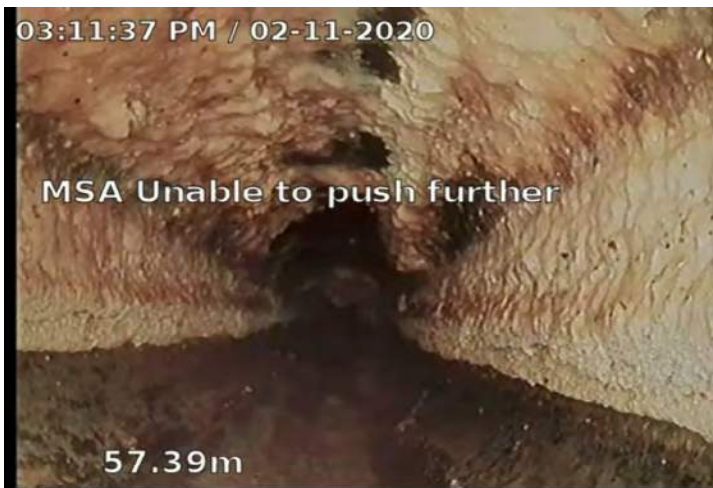
MSA - Survey Abandoned @ 57.4 m.
 Unable to push further.

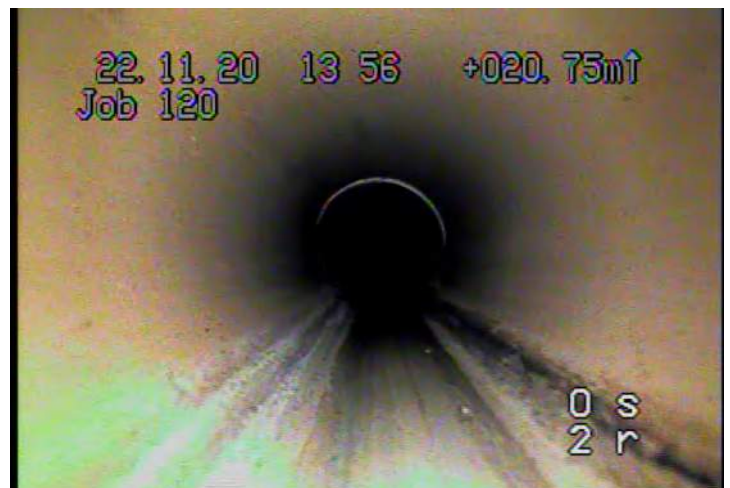
TBA - Tap, Break-in / Hammer: Active @
25.2 m.

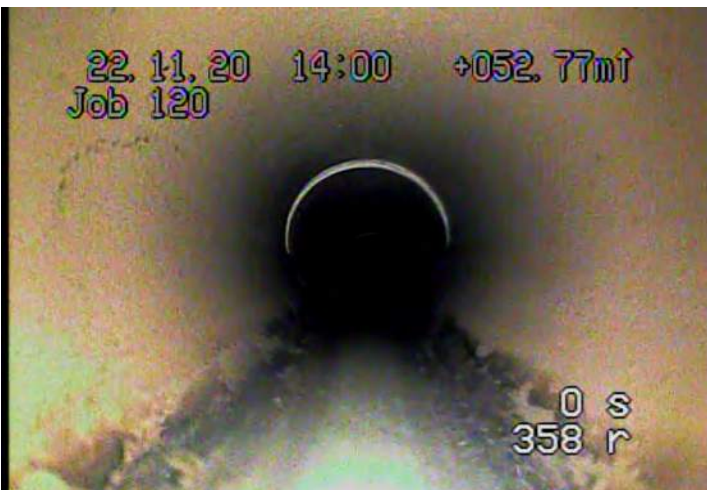
RMJ - Roots, Medium, Joint @ 51.7 m.

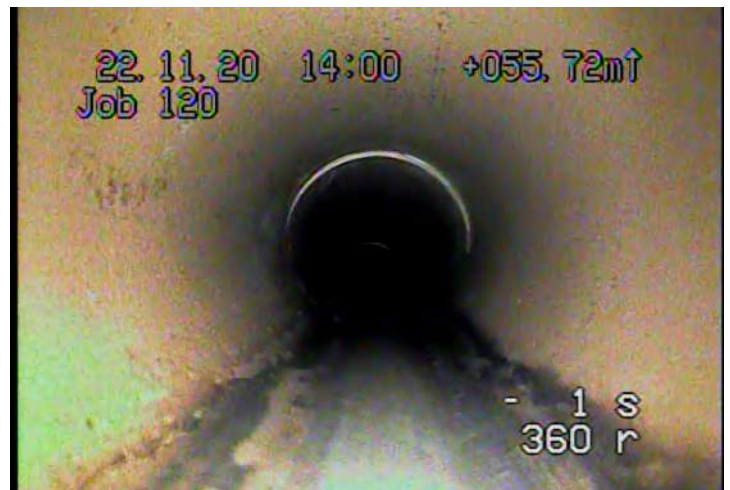
RMJ - Roots, Medium, Joint @ 54.8 m.

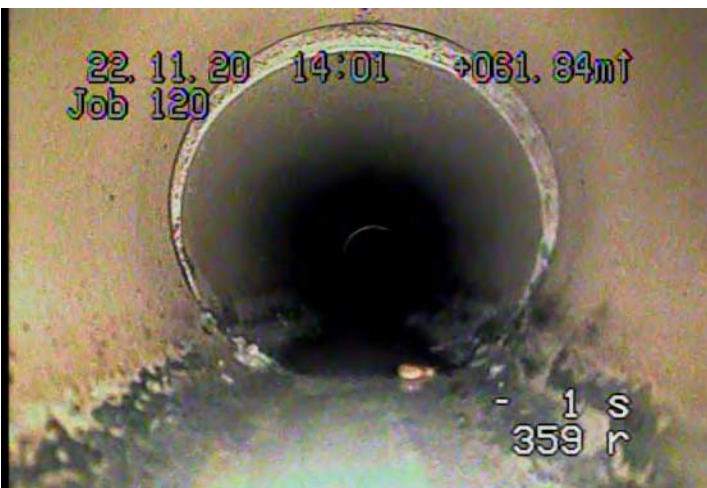
60.4		RMJ	Roots, Medium, Joint	7 to 5	10			
	60.4		FS	Fracture Spiral	10 to 11			J

RMJ - Roots, Medium, Joint @ 60.4 m.
