Appendix F CCTV Assessment

Client: CIMA
 Project: Pre-Rehabilitation Survey
 Date: 12/18/2020
 File: 14257

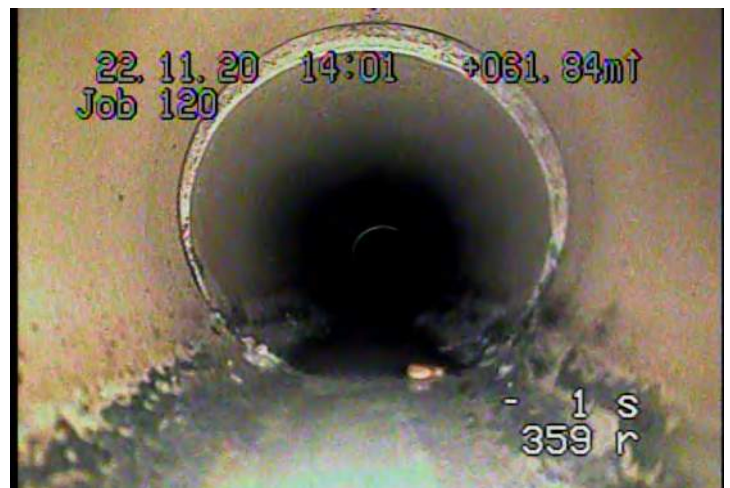
60.4		RMJ	Roots, Medium, Joint	7 to 5	10			
	60.4		FS	Fracture Spiral	10 to 11			J

FS - Fracture Spiral @ 60.4 m.

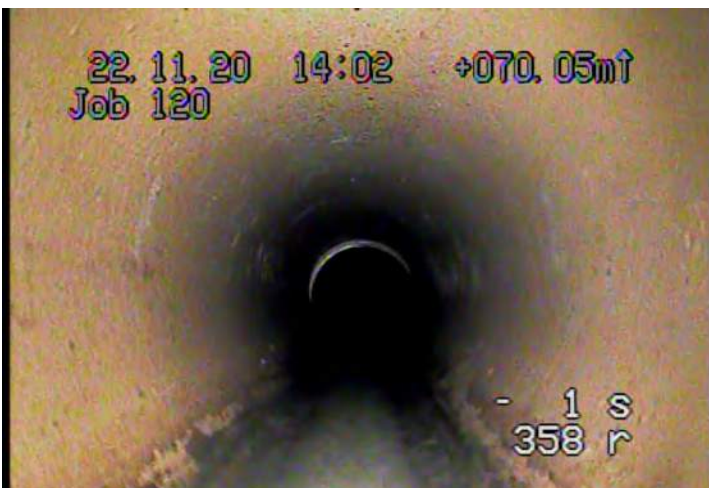
69.0		JOL	Joint Offset (displaced): Large					Unable to crawl over joint.
	70.3		MSA	Survey Abandoned

JOL - Joint Offset (displaced): Large @ 69.0 m.

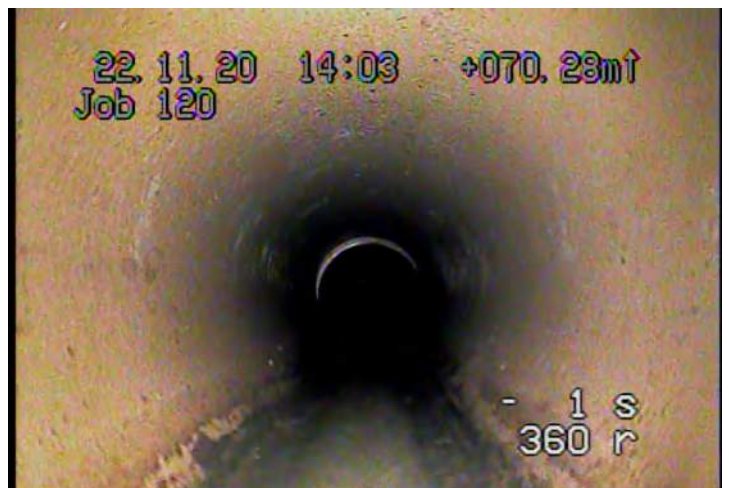
MSA - Survey Abandoned @ 70.3 m.
Unable to crawl over joint.

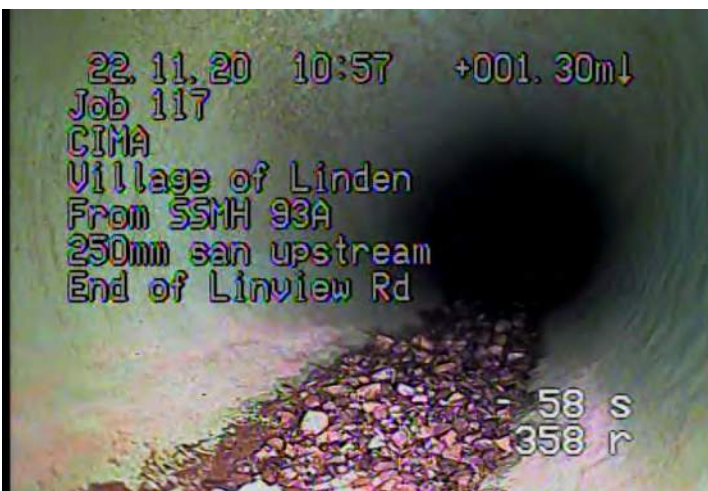
DSGV - Deposits Settled: Gravel @ 0.0 m.

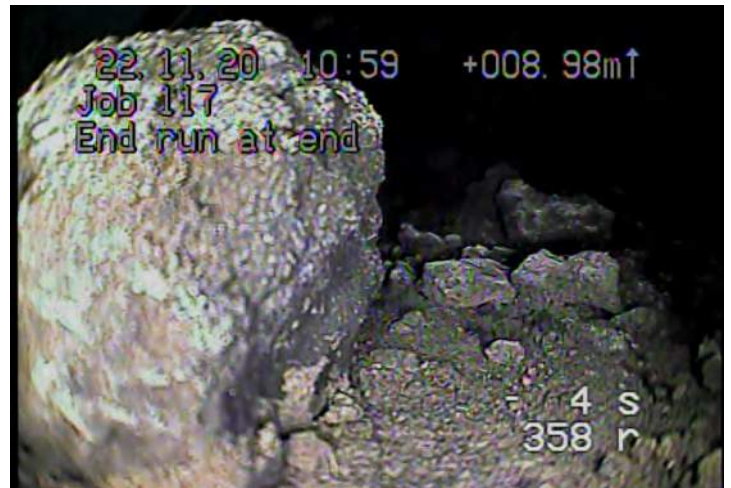
DNGV - Deposits Ingress: Gravel @ 8.9 m.

MSA - Survey Abandoned @ 9.0 m. Pipe ends in gravel

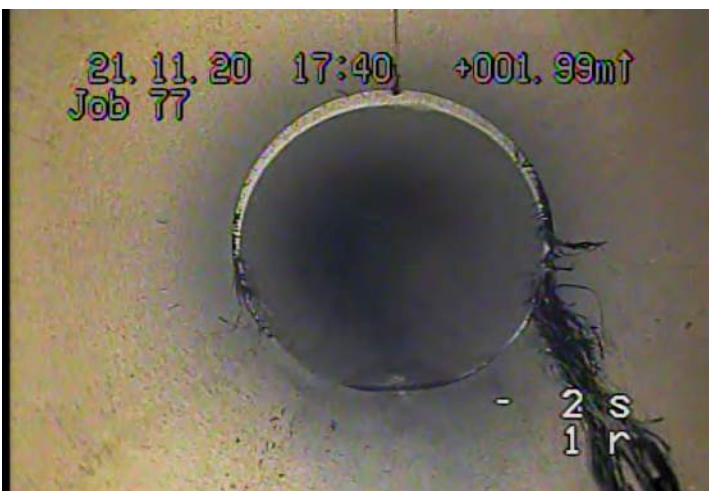
RFJ - Roots, Fine: Joint @ 1.3 m.

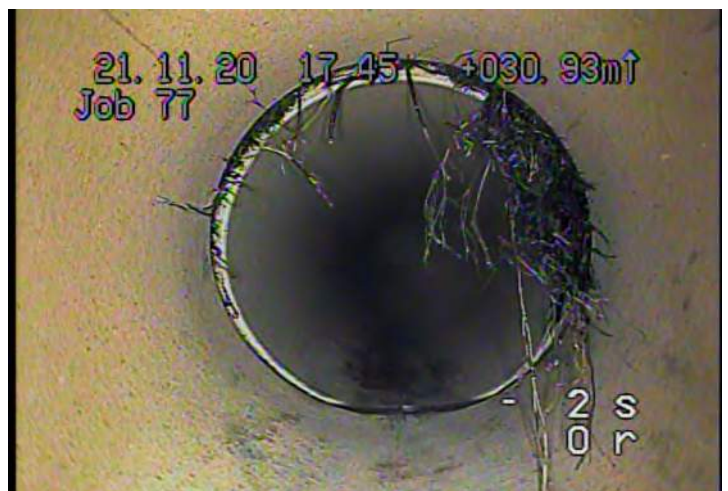
RFJ - Roots, Fine: Joint @ 30.9 m.

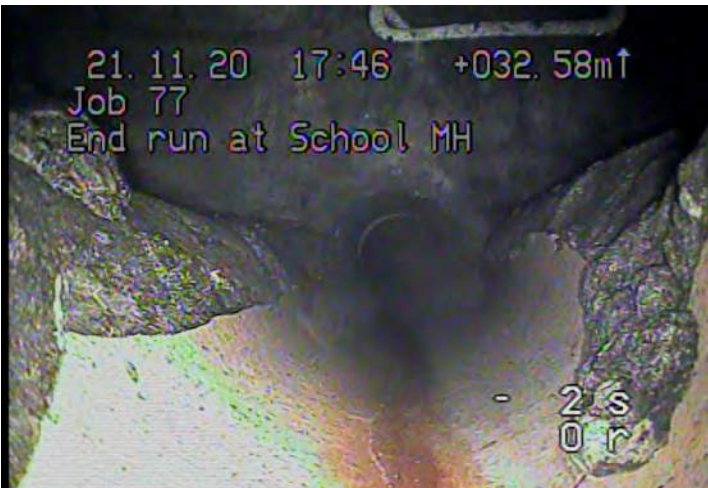
AMH - Access Point - Manhole @ 32.6 m.
School MH - Troughing in MH Broken

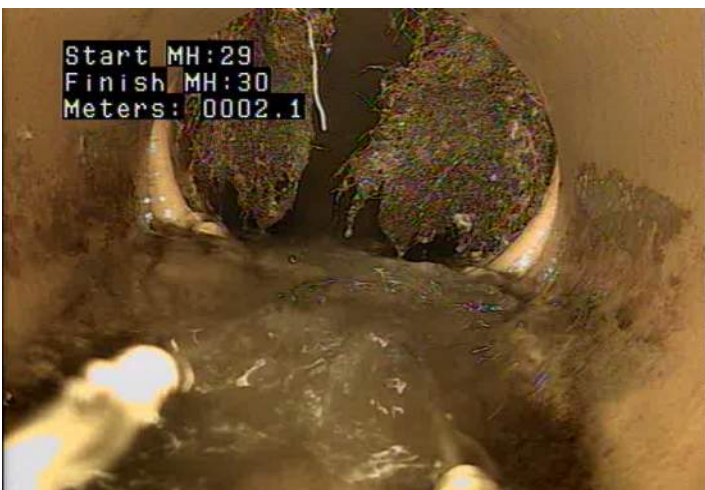
JOL - Joint Offset (displaced): Large @ 2.1 m.

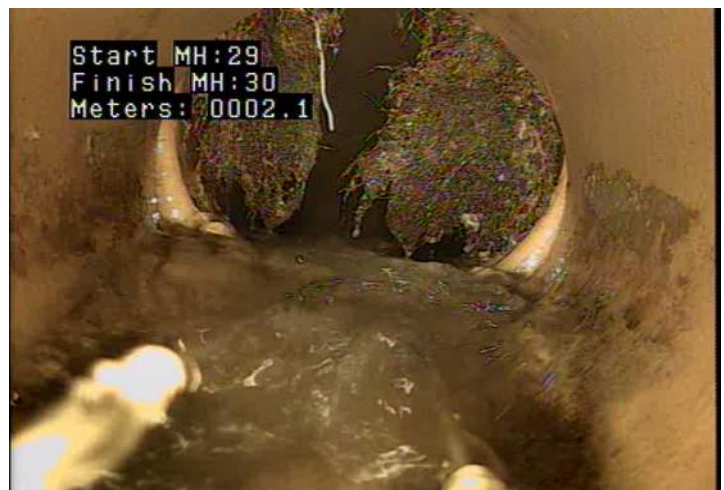
RBJ - Roots, Ball, Joint @ 2.1 m.

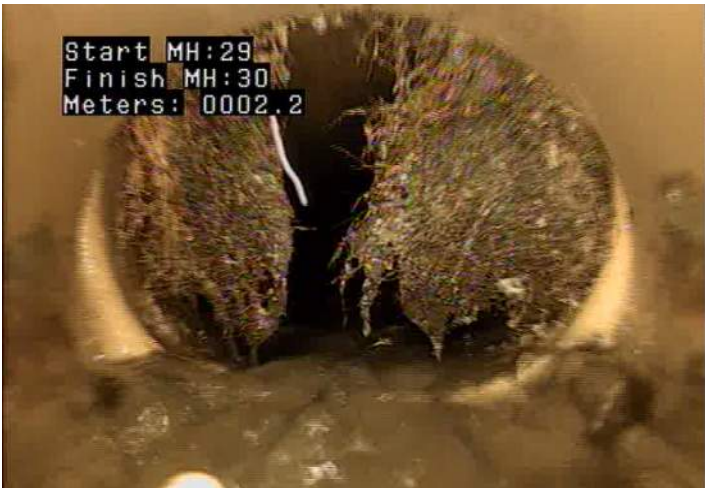
ID - Infiltration - Dripper @ 2.2 m.

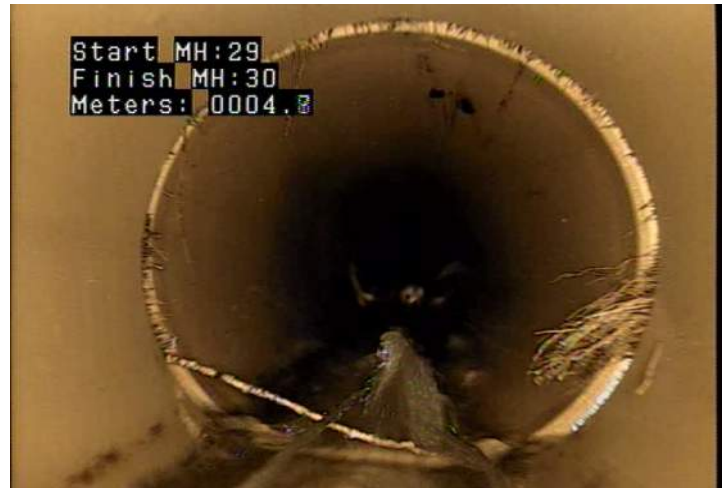
RFJ - Roots, Fine: Joint @ 4.8 m.

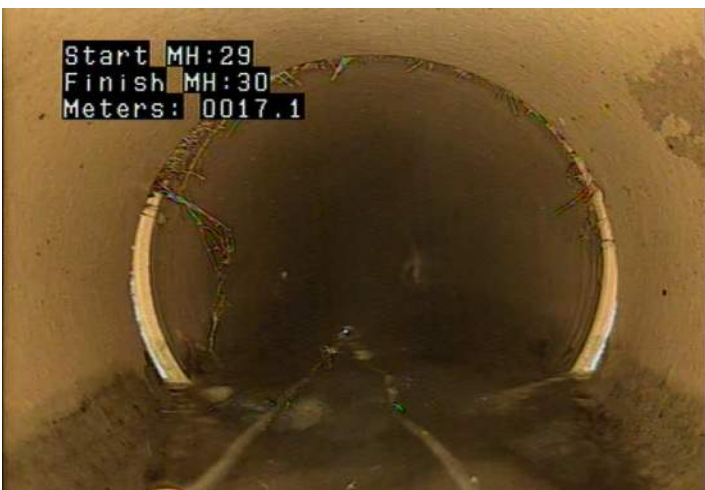
MWLS - Water Level: Sag @ 17.1 m.

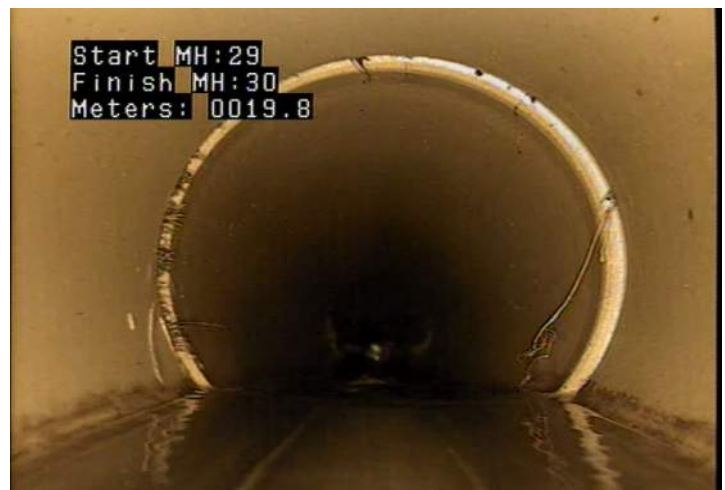
MWLS - Water Level: Sag @ 19.8 m.

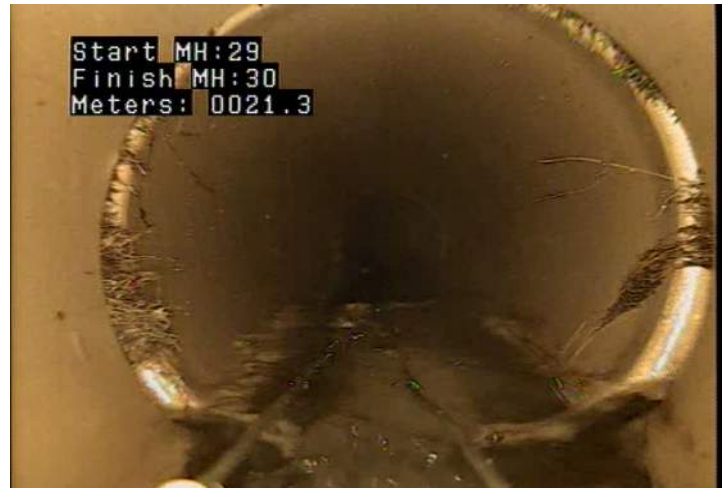
MWLS - Water Level: Sag @ 21.3 m.

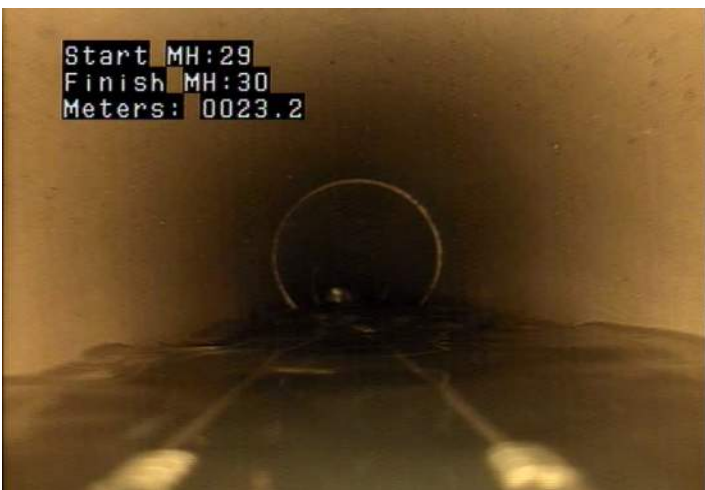
DSGV - Deposits Settled: Gravel @ 23.2 m.

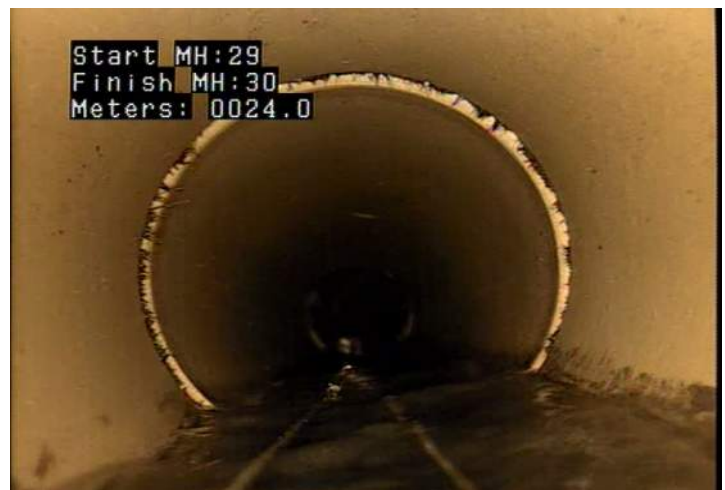
MWLS - Water Level: Sag @ 24.0 m.

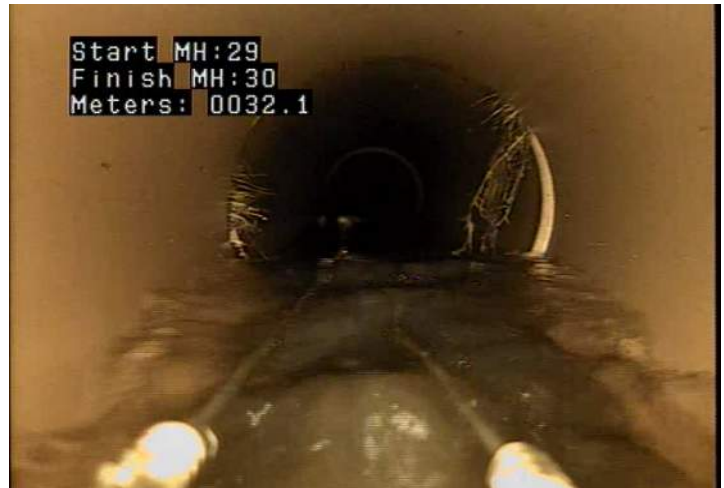
MWLS - Water Level: Sag @ 32.1 m.

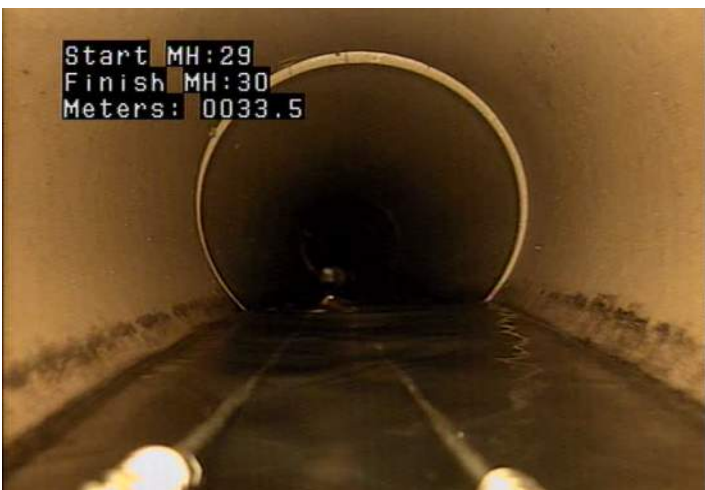
MWLS - Water Level: Sag @ 33.6 m.

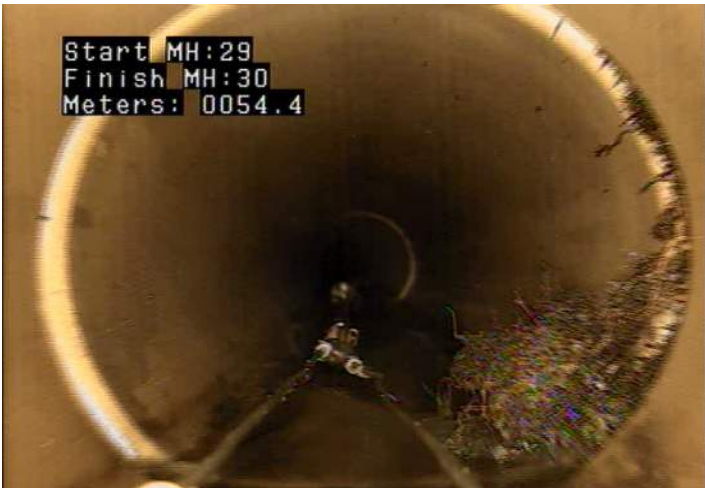
RMJ - Roots, Medium, Joint @ 54.4 m.

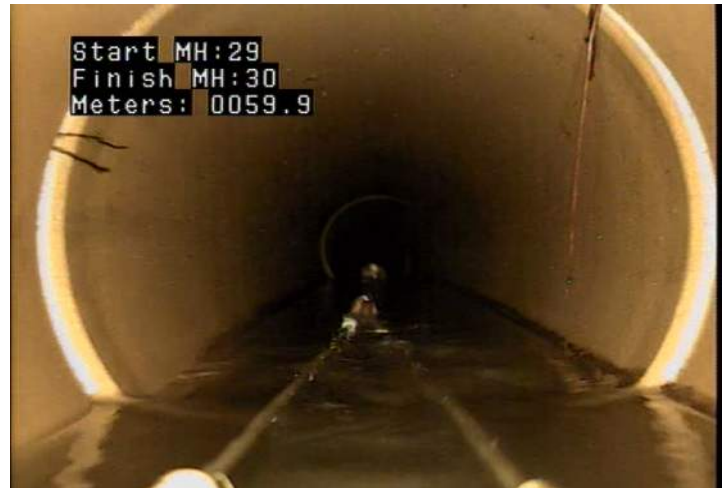
RFJ - Roots, Fine: Joint @ 59.9 m.

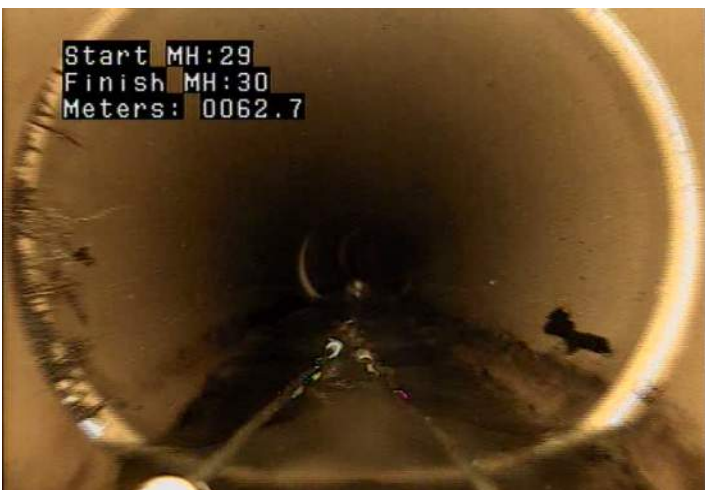
RFJ - Roots, Fine: Joint @ 62.7 m.

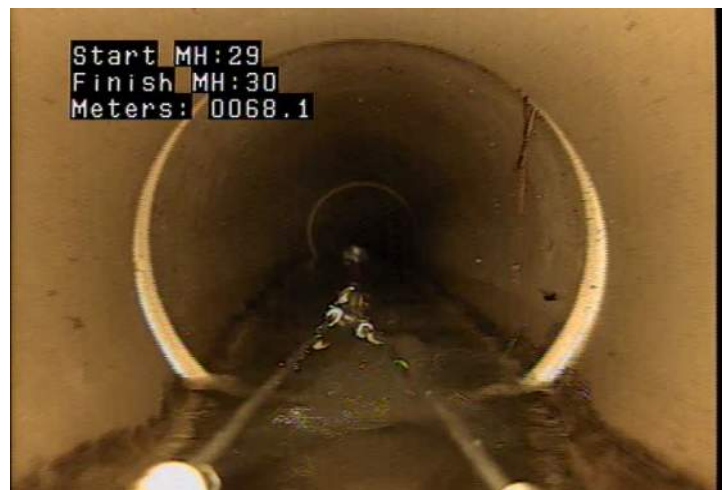
RFJ - Roots, Fine: Joint @ 68.1 m.

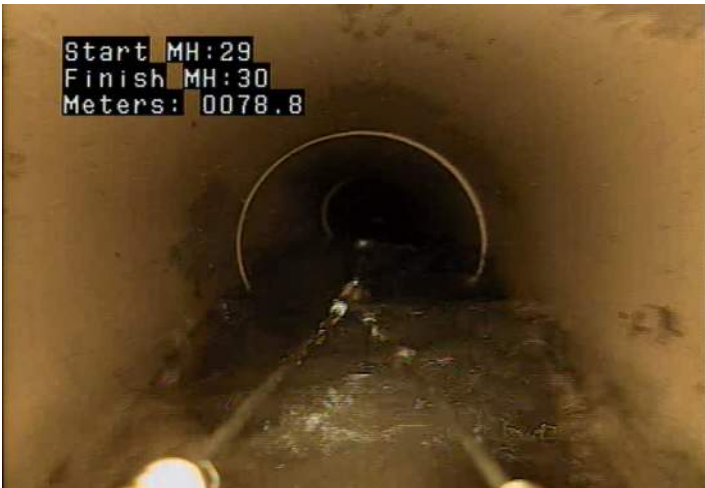
MWLS - Water Level: Sag @ 78.8 m.

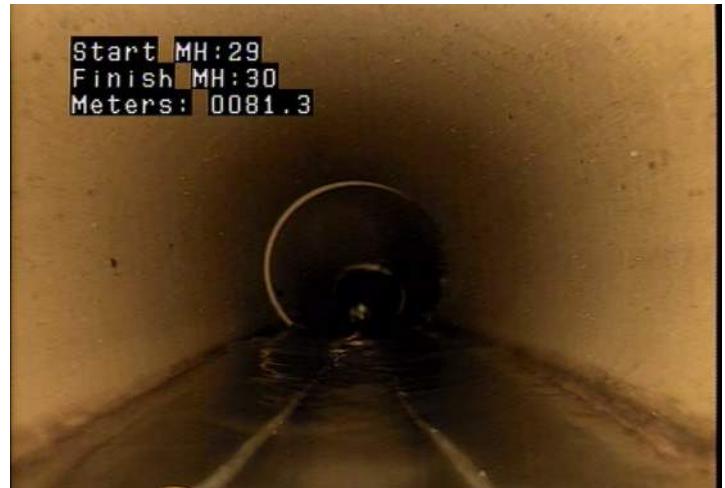
MWLS - Water Level: Sag @ 81.3 m.

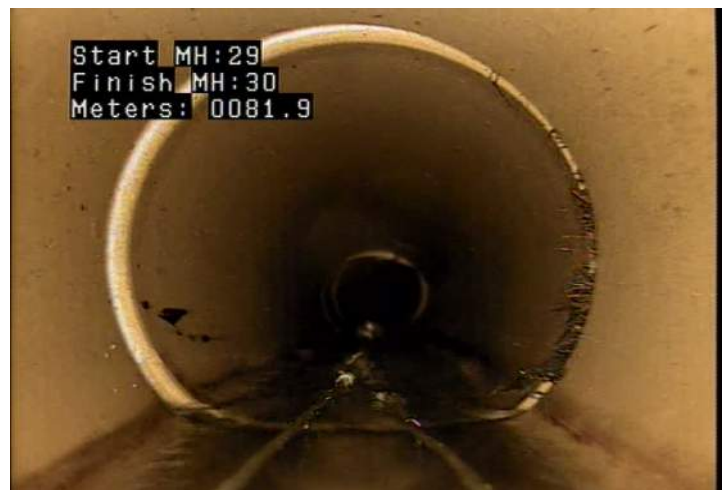
RFJ - Roots, Fine: Joint @ 81.9 m.

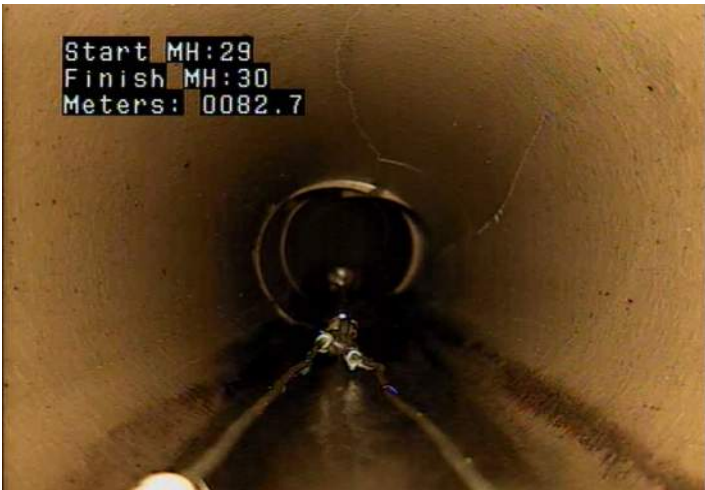
B - Pipe Broken @ 82.7 m.

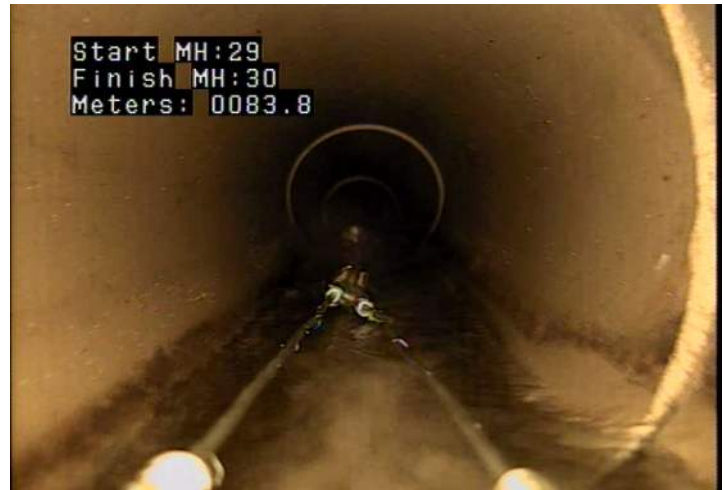
B - Pipe Broken @ 83.8 m.

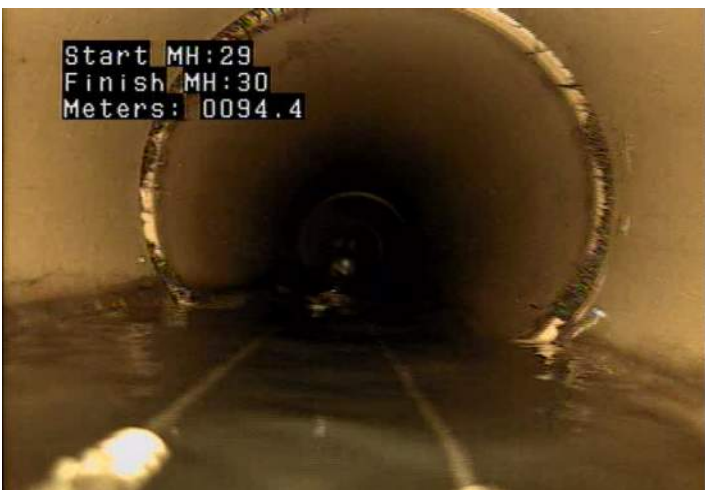
RFJ - Roots, Fine: Joint @ 94.4 m.

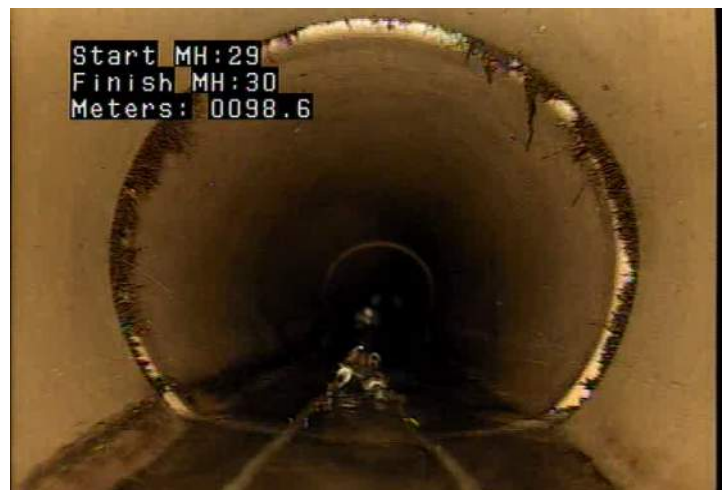
RFJ - Roots, Fine: Joint @ 98.6 m.

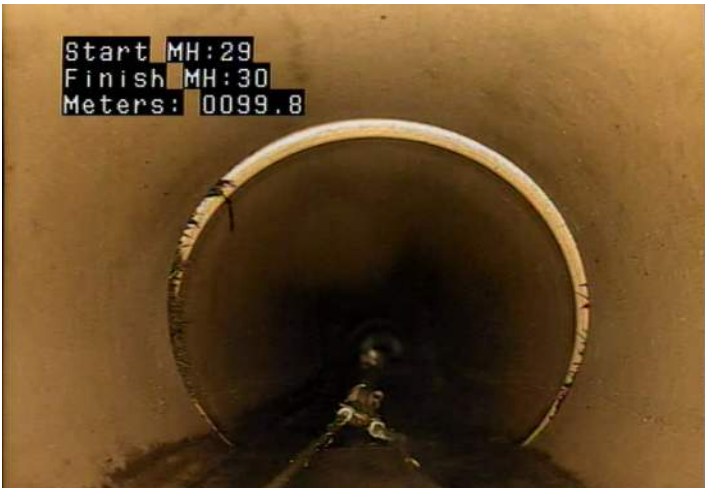
RFJ - Roots, Fine: Joint @ 99.8 m.

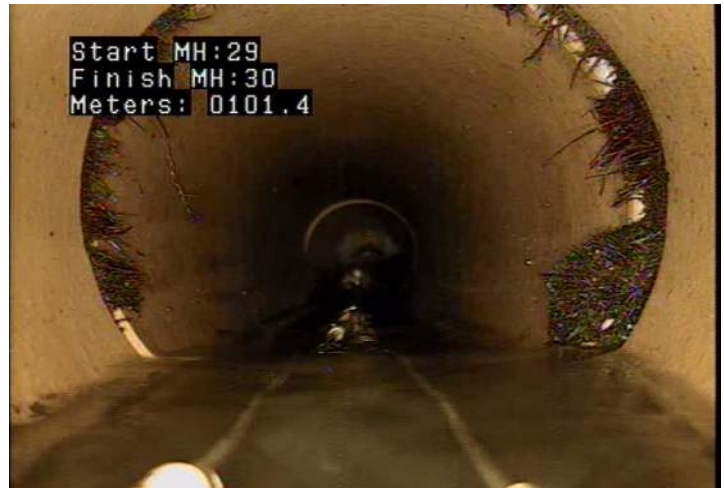
RMJ - Roots, Medium, Joint @ 101.4 m.

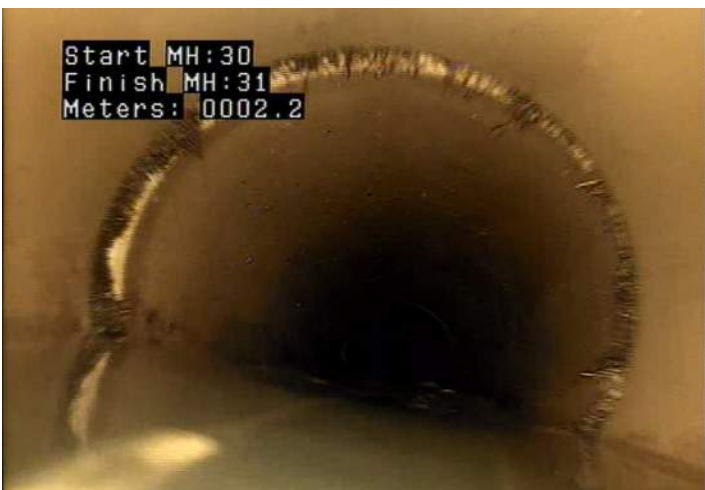
RFJ - Roots, Fine: Joint @ 2.2 m.

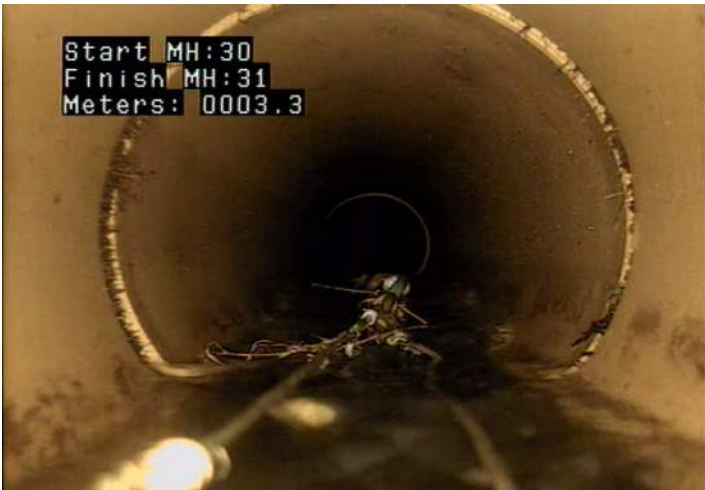
RFJ - Roots, Fine: Joint @ 3.3 m.

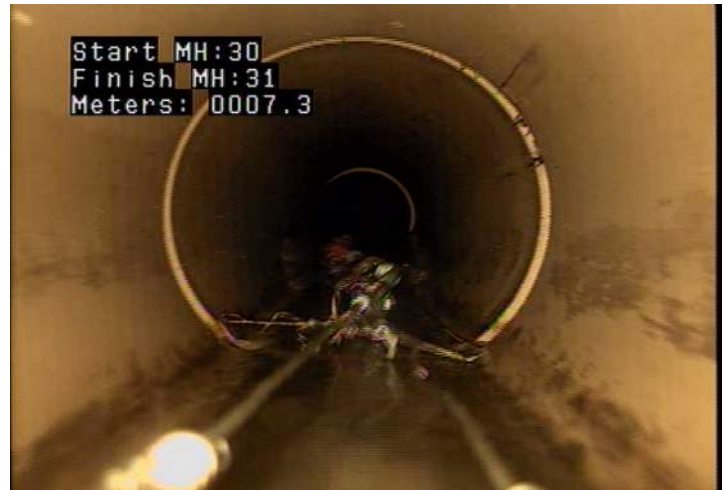
RFJ - Roots, Fine: Joint @ 7.3 m.

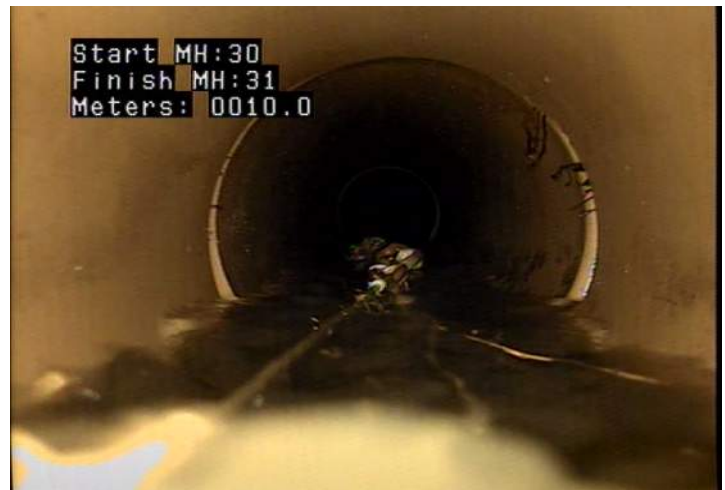
RFJ - Roots, Fine: Joint @ 10.0 m.

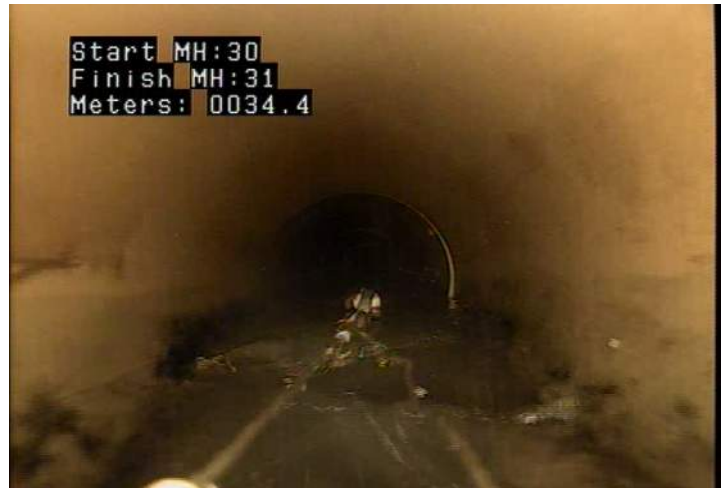
MWLS - Water Level: Sag @ 34.4 m.

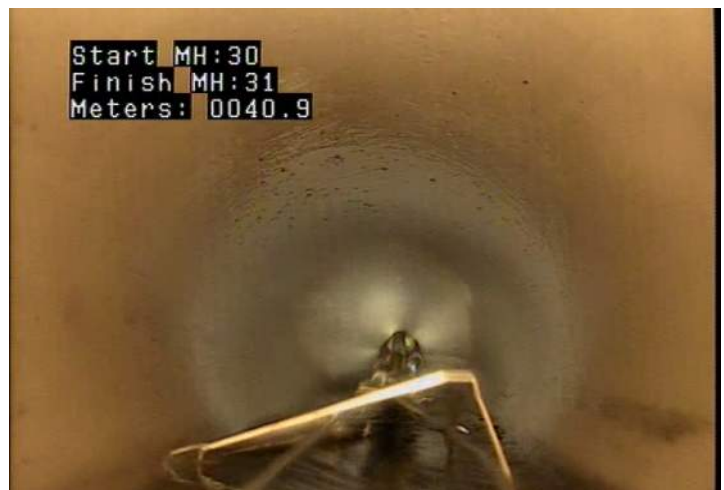
MWLS - Water Level: Sag @ 40.9 m.

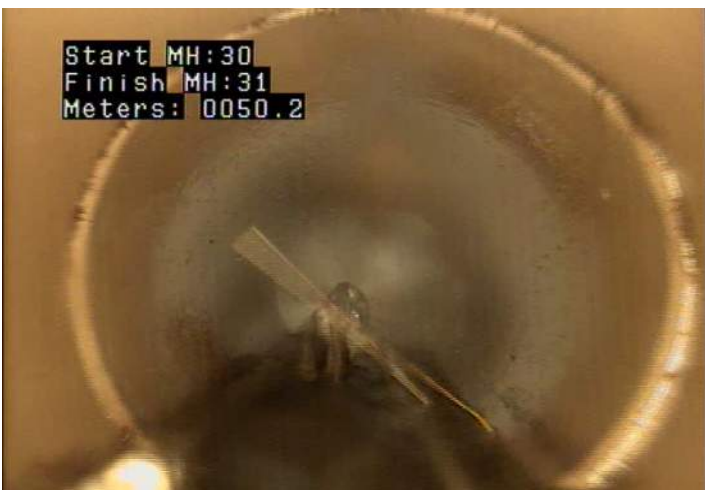
RFJ - Roots, Fine: Joint @ 50.2 m.

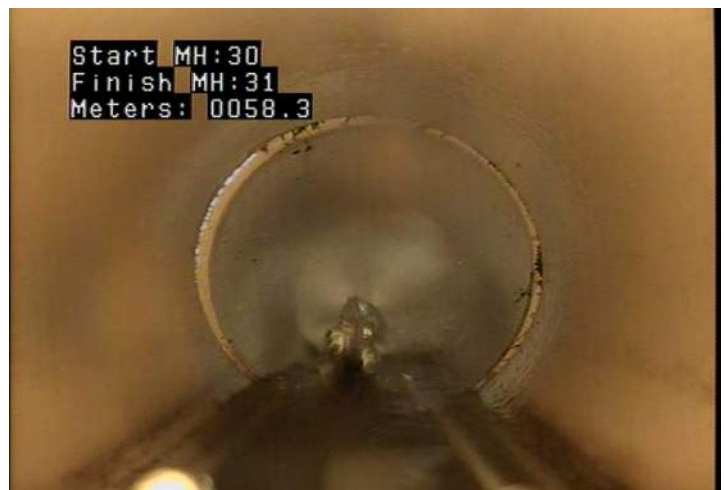
RFJ - Roots, Fine: Joint @ 58.3 m.

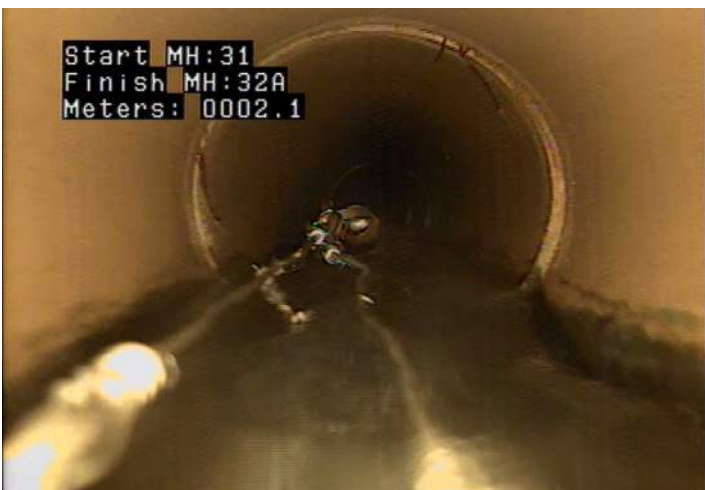
RFJ - Roots, Fine: Joint @ 2.1 m.

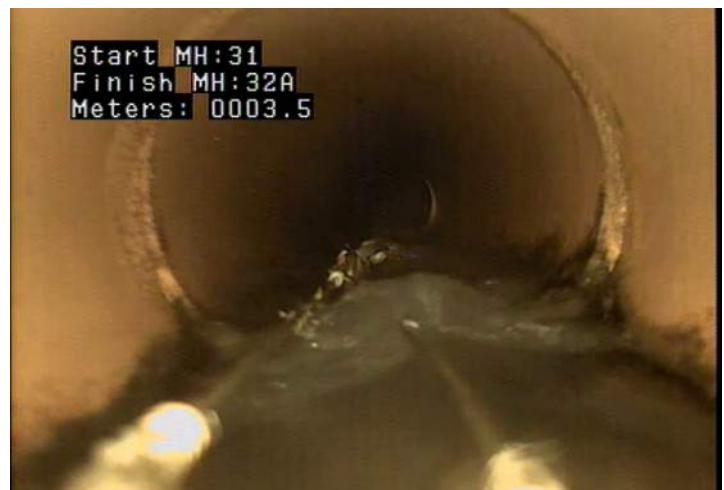
DAE - Deposits Attached: Encrustation @ 3.5 m.

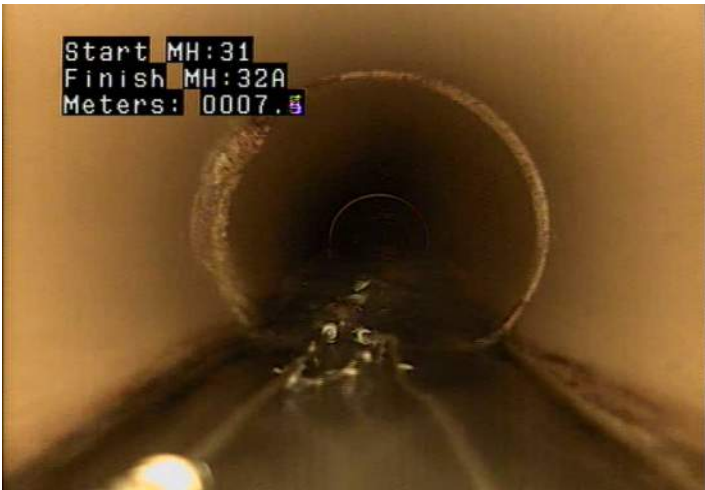
DAE - Deposits Attached: Encrustation @ 7.4 m.

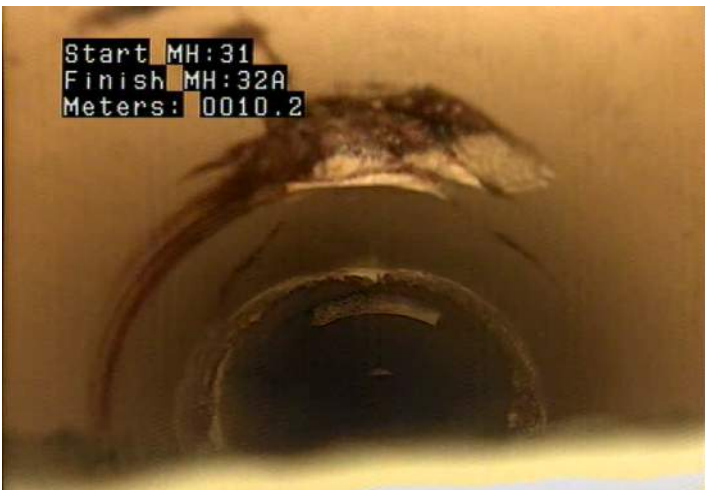
H - Hole in Pipe @ 10.2 m.

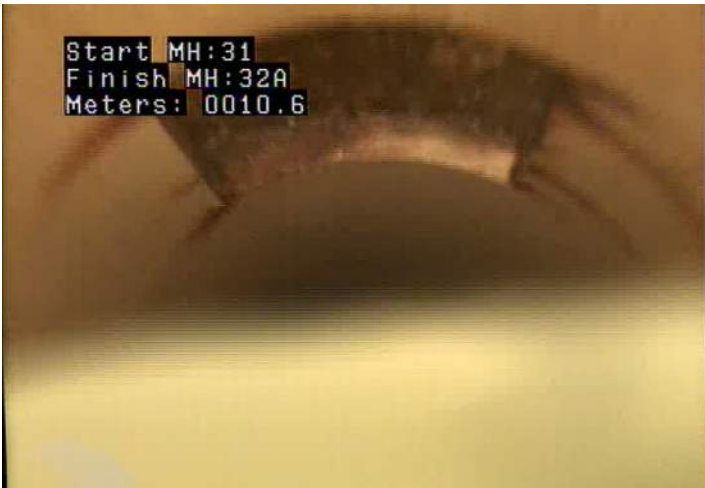
H - Hole in Pipe @ 10.6 m. Cut into pipe

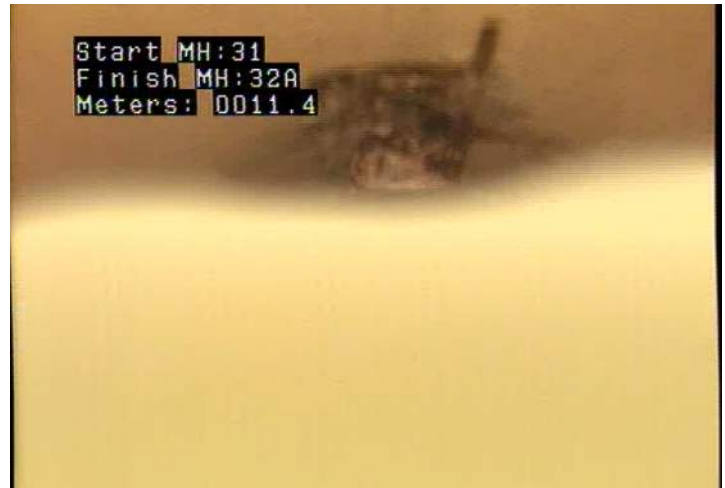
H - Hole in Pipe @ 11.4 m. Hole cut

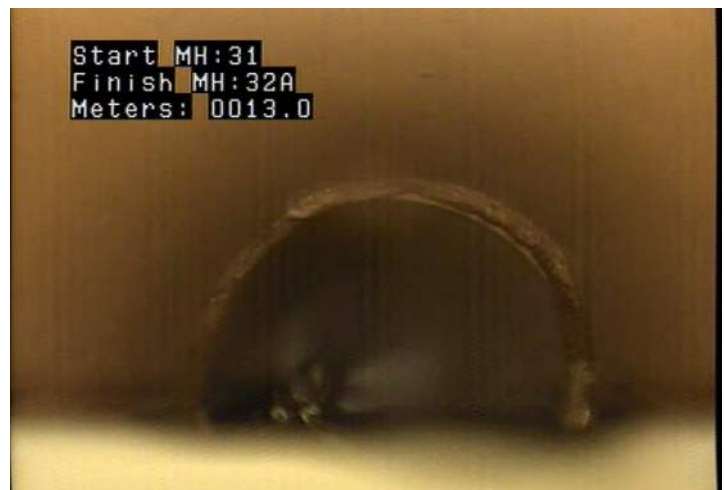
DAE - Deposits Attached: Encrustation @ 13.0 m.

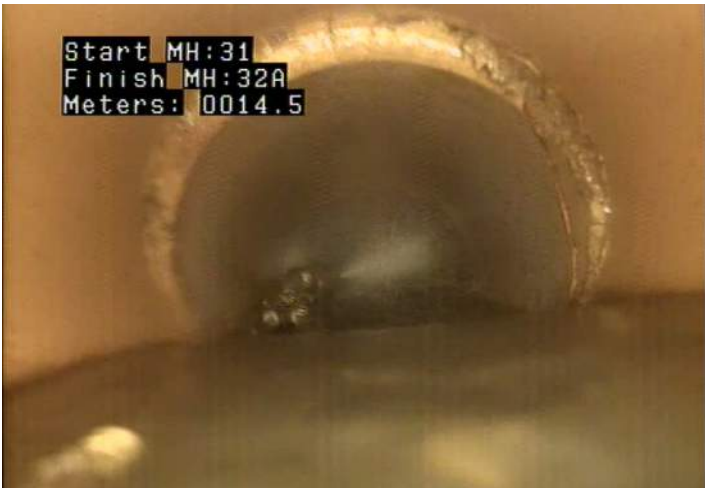
RFJ - Roots, Fine: Joint @ 14.5 m.

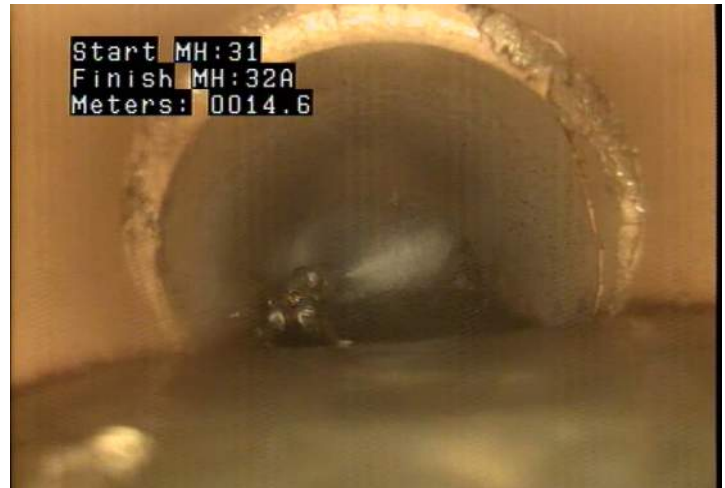
JOM - Joint Offset (displaced): Medium @ 14.6 m.

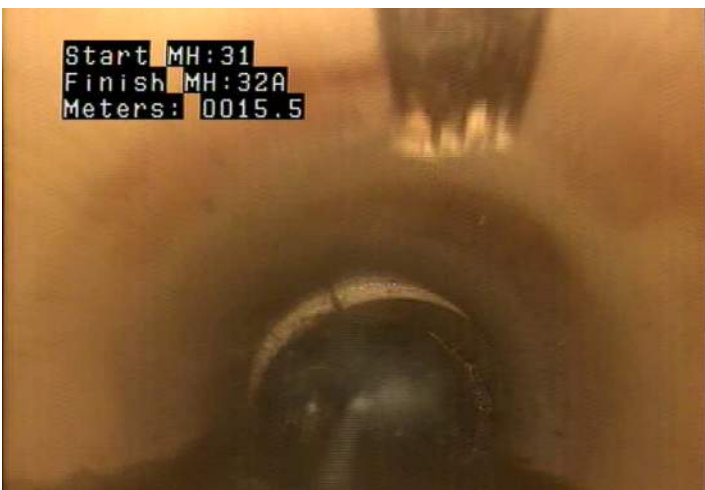
H - Hole in Pipe @ 15.5 m. Hole cut

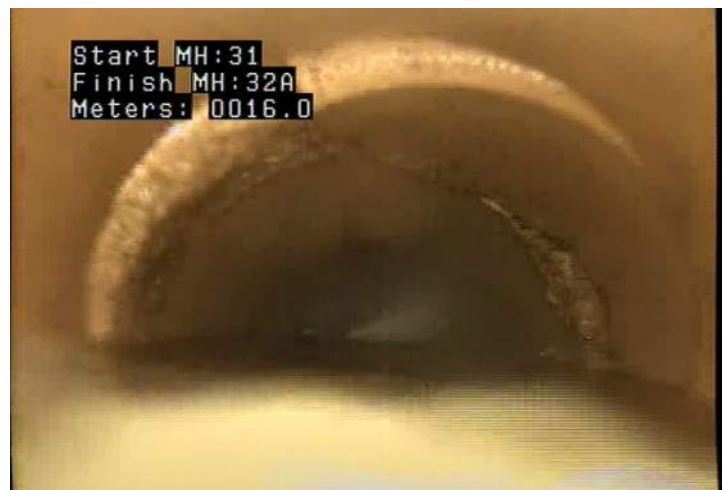
16.0		B	Pipe Broken	8 to 4			J	
25.3		DAE	Deposits Attached: Encrustation	11 to 4	5		J	
26.8		MCU	Camera Underwater					
31.0		MWL	Water Level		20			
33.7		RFJ	Roots, Fine: Joint	9 to 3

B - Pipe Broken @ 16.0 m.

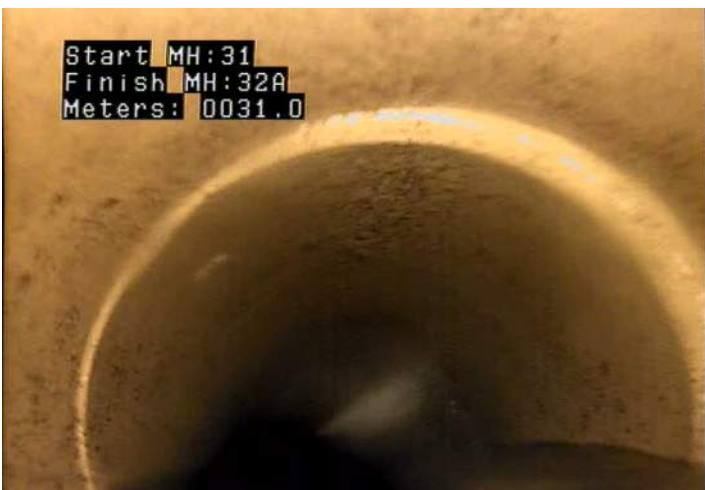
MWL - Water Level @ 31.0 m.

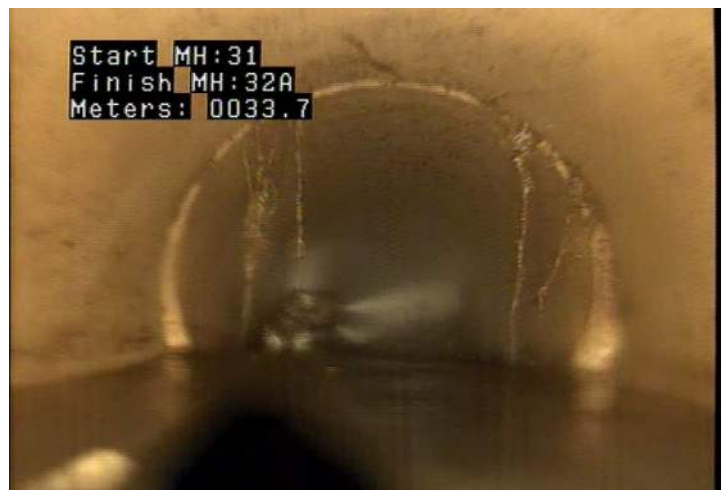
RFJ - Roots, Fine: Joint @ 33.7 m.

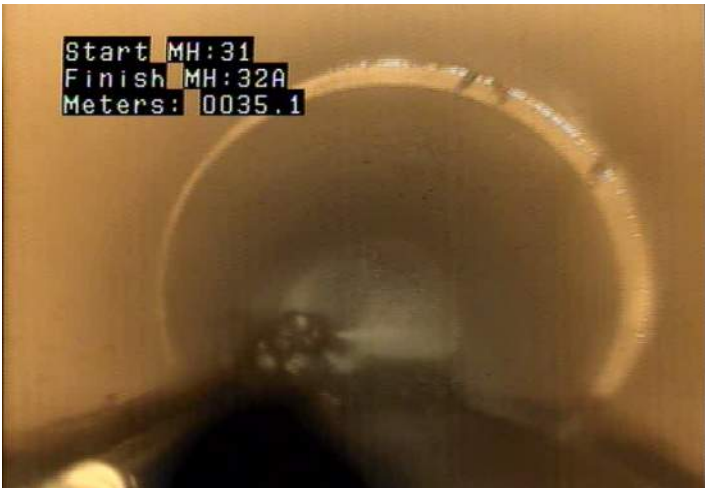
RFJ - Roots, Fine: Joint @ 35.1 m.

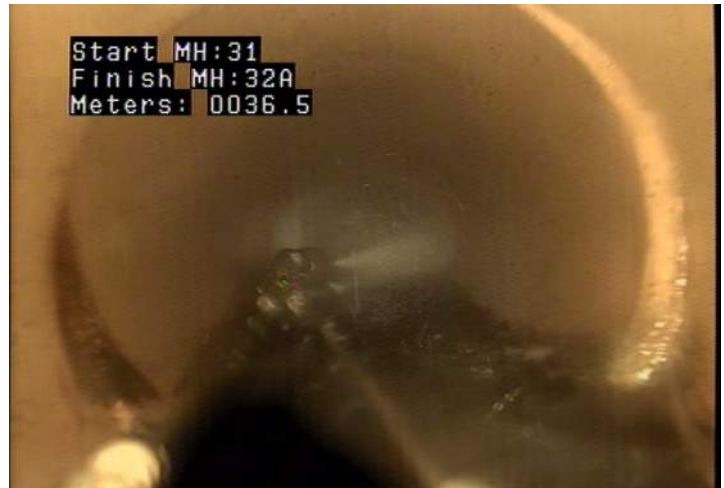
DAE - Deposits Attached: Encrustation @ 36.5 m.

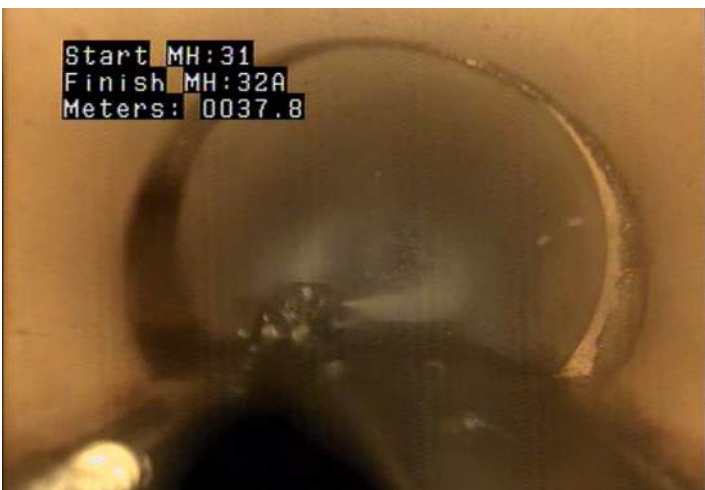
DAE - Deposits Attached: Encrustation @ 37.8 m.

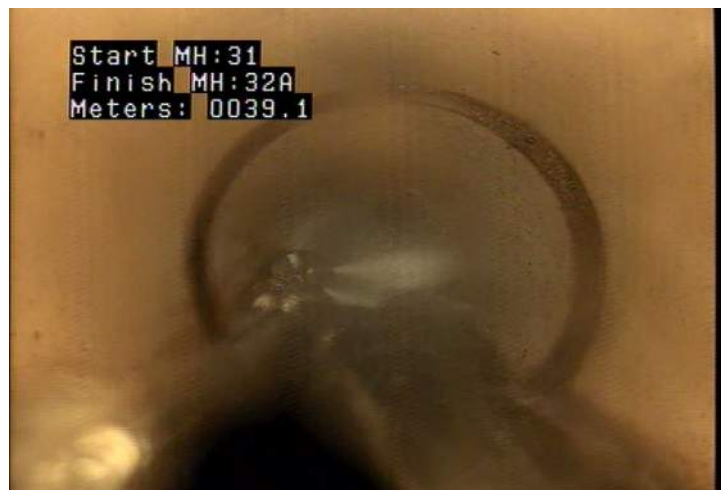
DAE - Deposits Attached: Encrustation @ 39.1 m.

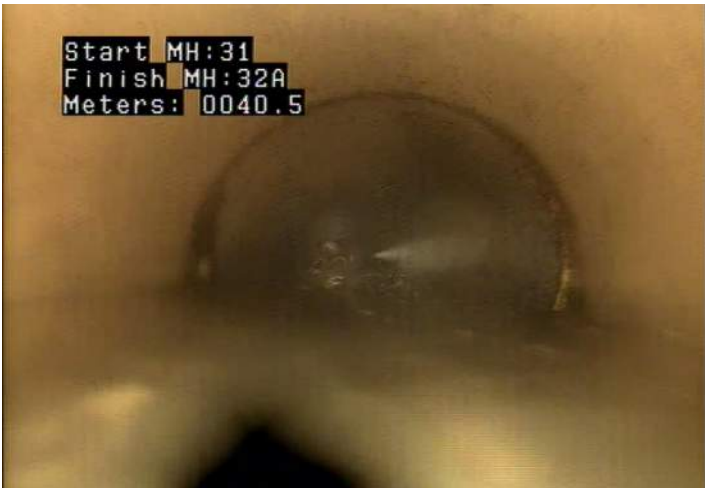
DAE - Deposits Attached: Encrustation @ 40.5 m.

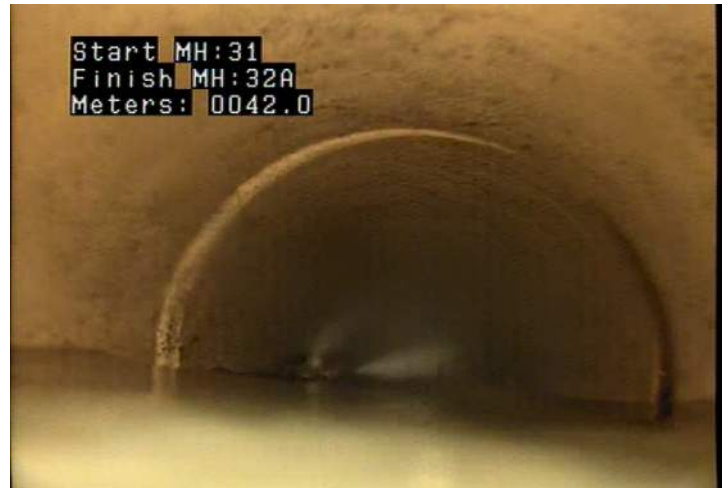
DAE - Deposits Attached: Encrustation @ 42.0 m.

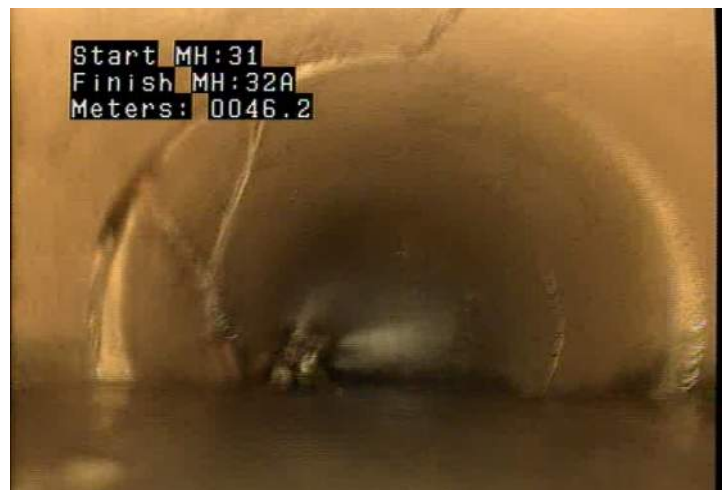
RFJ - Roots, Fine: Joint @ 46.2 m.

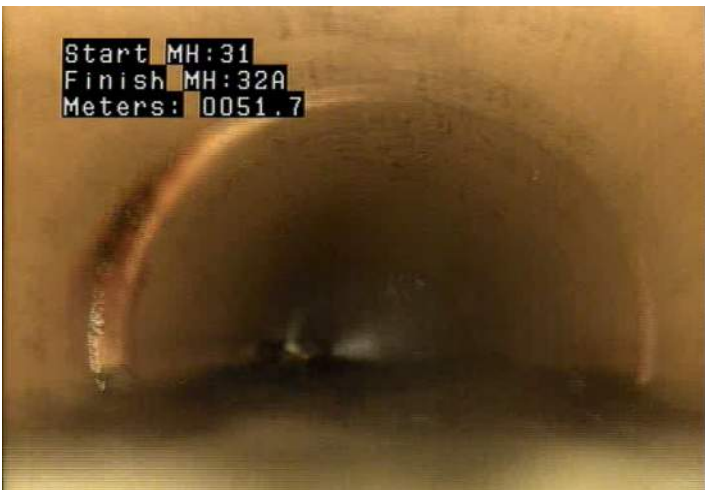
DAE - Deposits Attached: Encrustation @ 51.7 m.

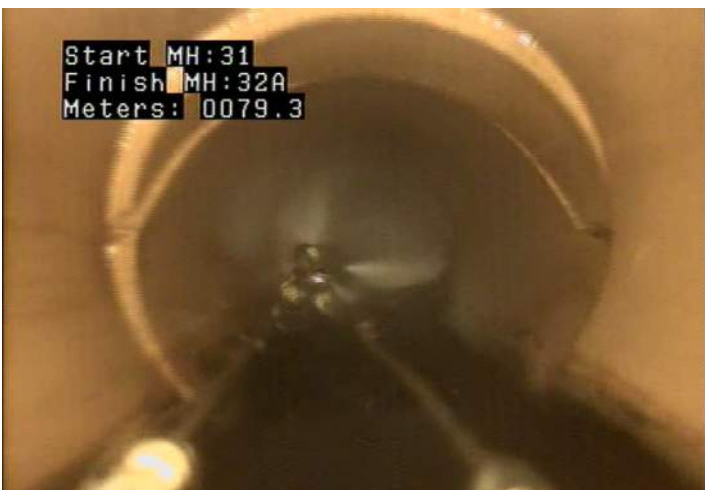
76.0		MWL	Water Level		10			
79.3		FC	Fracture Circumferential	9 to 3				
80.7		RFJ	Roots, Fine: Joint	8 to 11				
85.6		MWL	Water Level		30			
87.5		AMH	Access Point - Manhole					S MH 32A

FC - Fracture Circumferential @ 79.3 m.

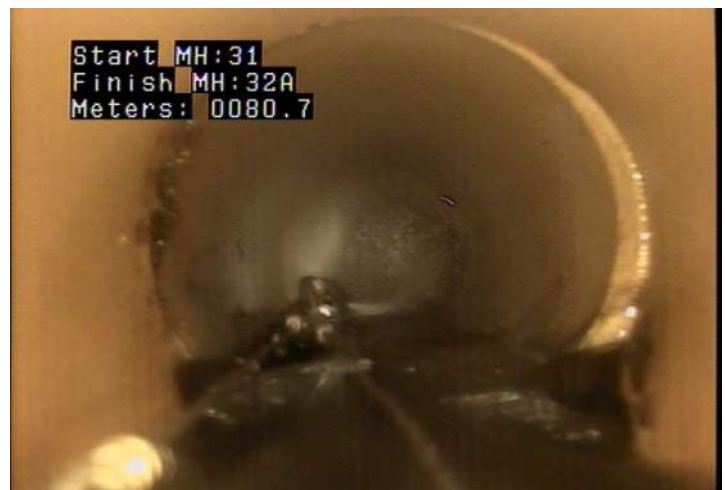
RFJ - Roots, Fine: Joint @ 80.7 m.

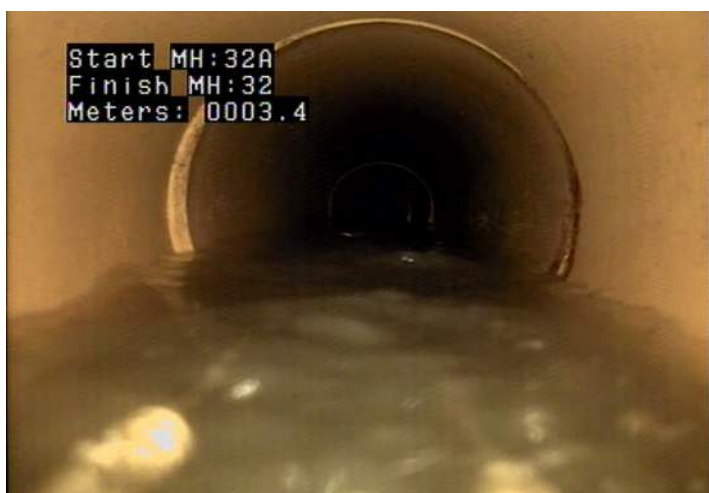
DAE - Deposits Attached: Encrustation @ 3.4 m.
