Appendix F CCTV Assessment

Client: CIMA
 Project: Pre-Rehabilitation Survey
 Date: 12/18/2020
 File: 14257

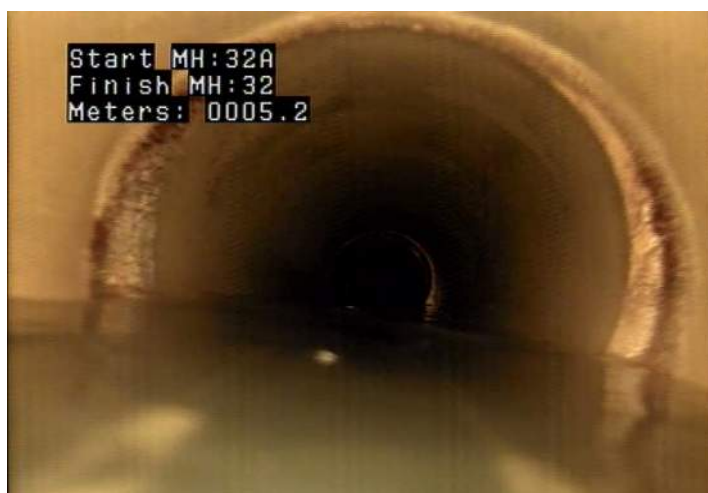
DAE - Deposits Attached: Encrustation @ 5.2 m.

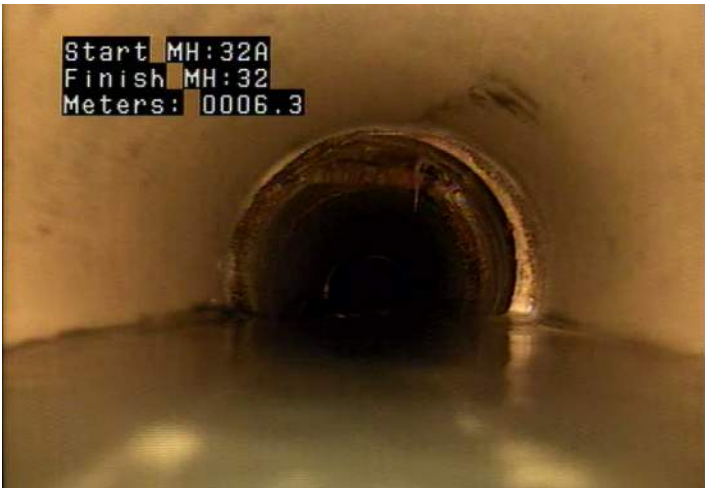
CL - Crack Longitudinal @ 6.3 m.

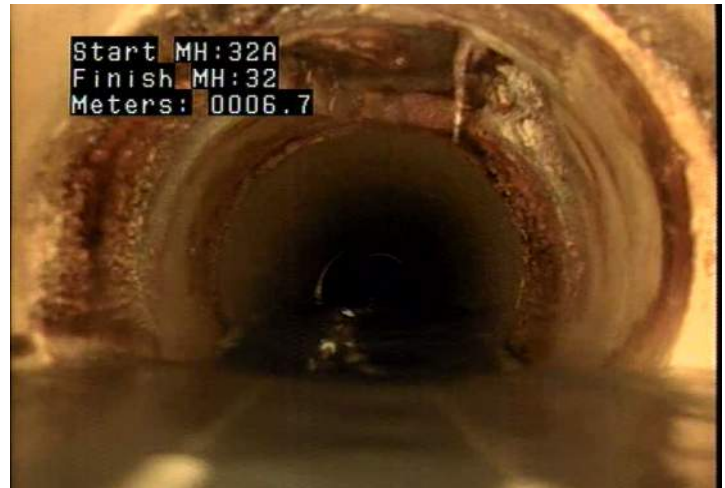
RPPD - Point Repair - Patch Repair:
Defective @ 6.7 m. Leaking

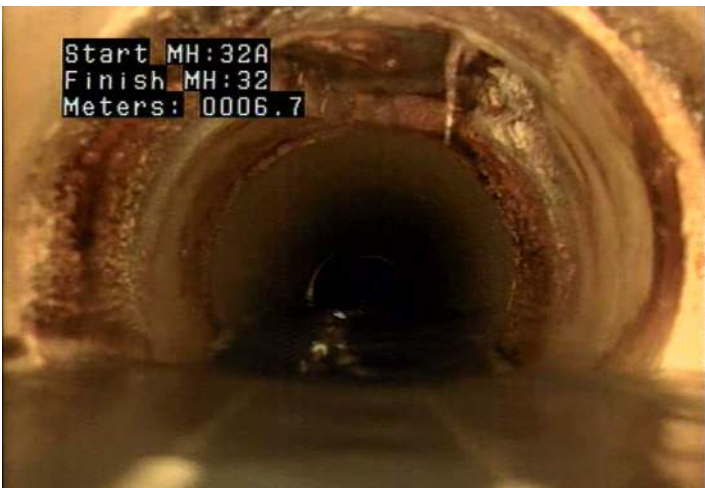
DAE - Deposits Attached: Encrustation @
6.7 m.

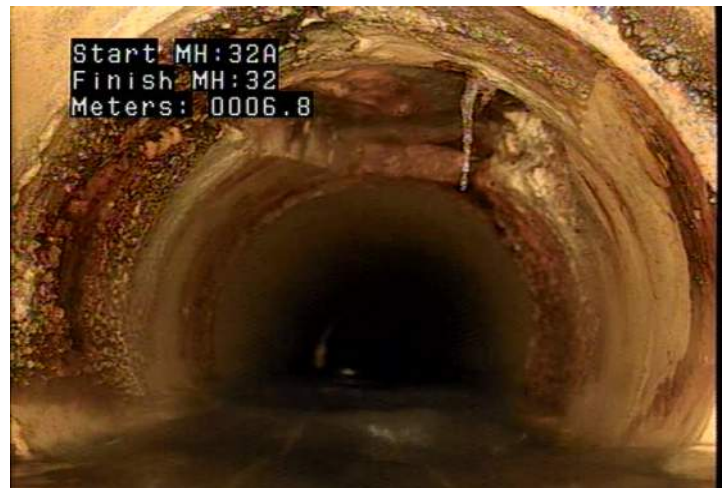
ID - Infiltration - Dripper @ 6.8 m.

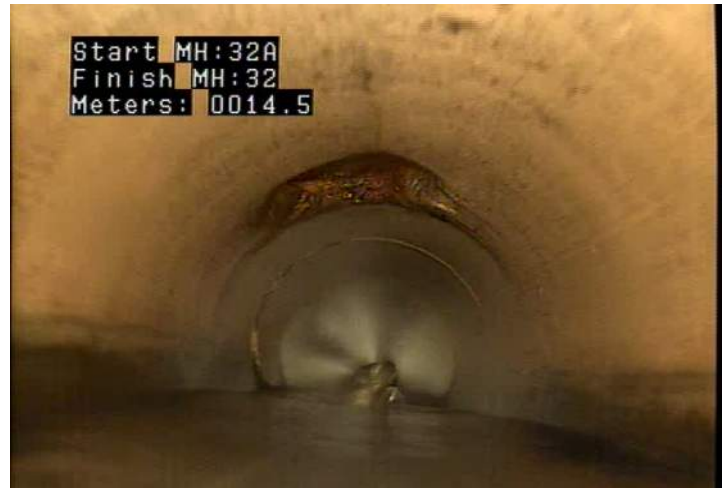
H - Hole in Pipe @ 14.5 m.

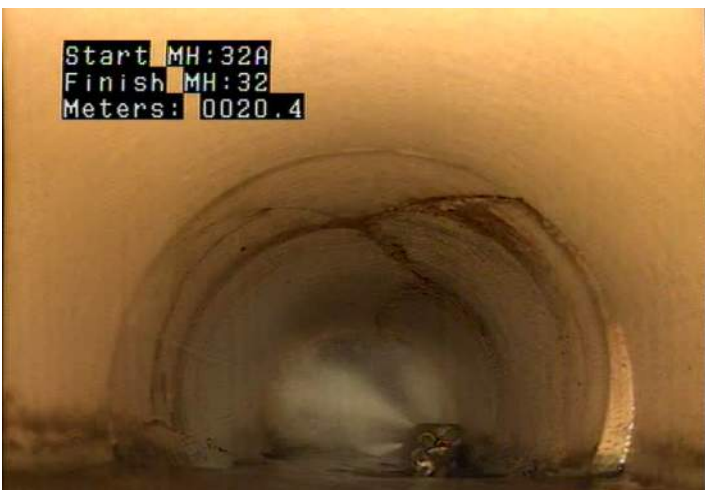
CM - Crack Multiple @ 20.4 m.

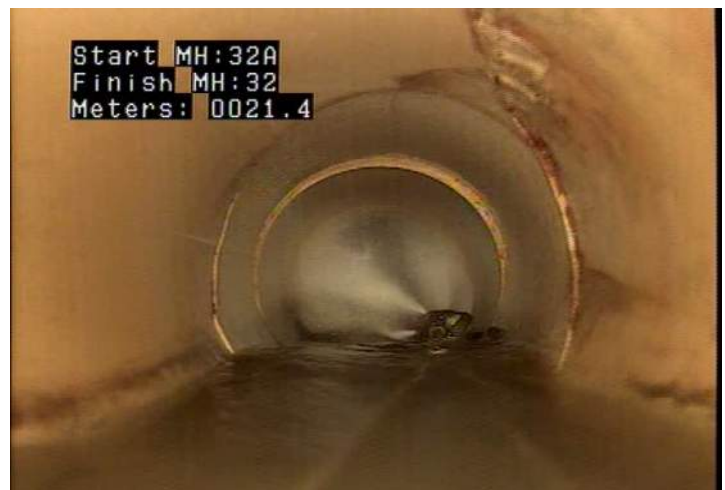
FM - Fracture Multiple @ 21.4 m.

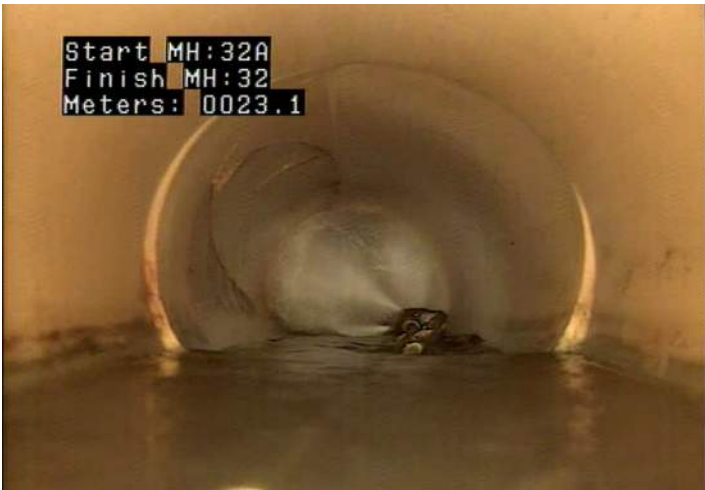
CM - Crack Multiple @ 23.1 m.

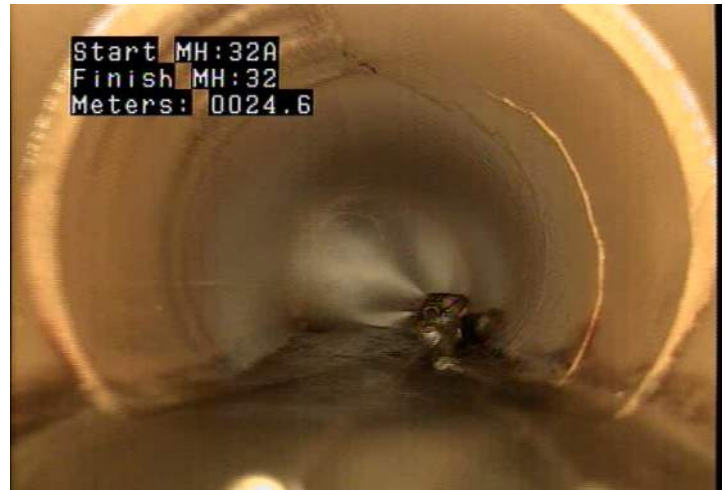
CM - Crack Multiple @ 24.6 m.

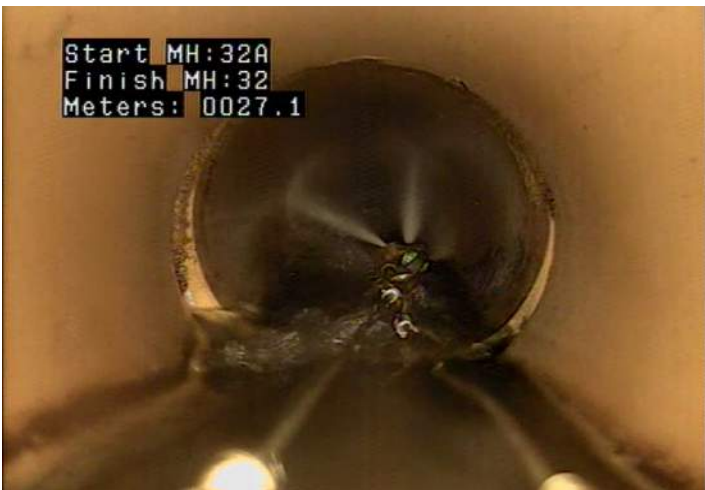
DAE - Deposits Attached: Encrustation @ 27.1 m.

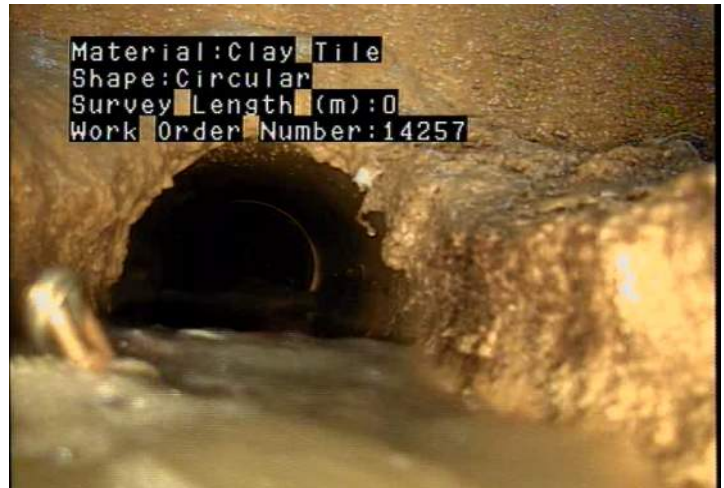
CM - Crack Multiple @ 3.8 m.

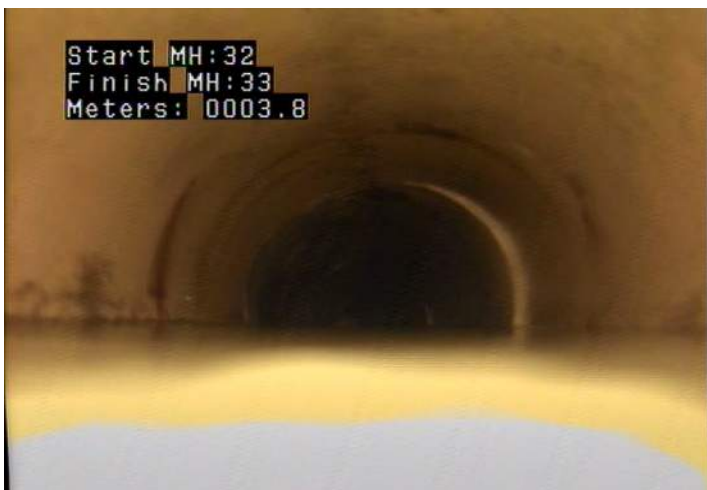
DAE - Deposits Attached: Encrustation @ 4.1 m.

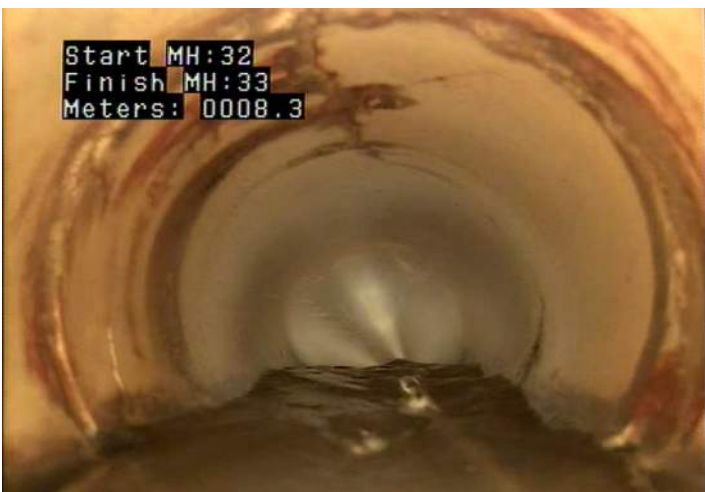
CC - Crack Circumferential @ 8.6 m.

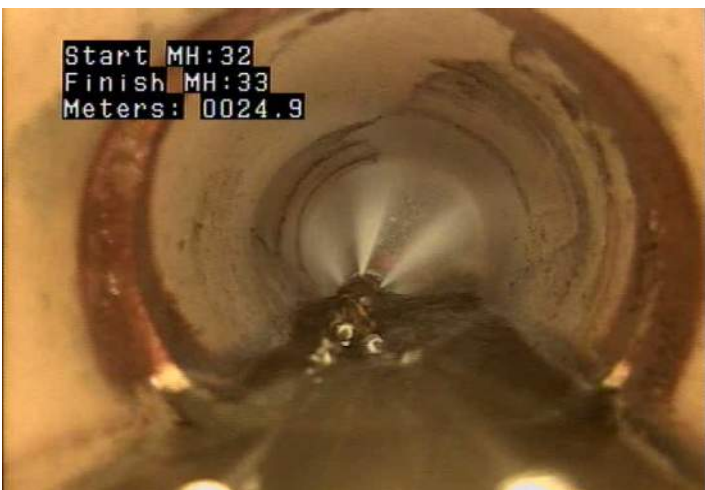
CM - Crack Multiple @ 25.1 m.

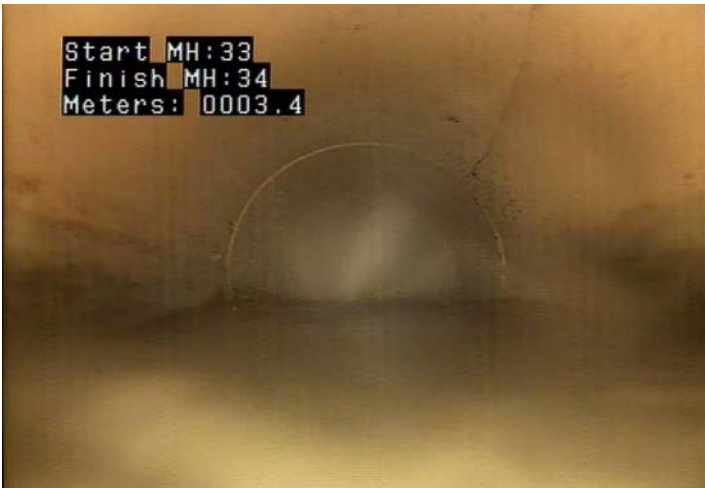
CL - Crack Longitudinal @ 3.4 m.

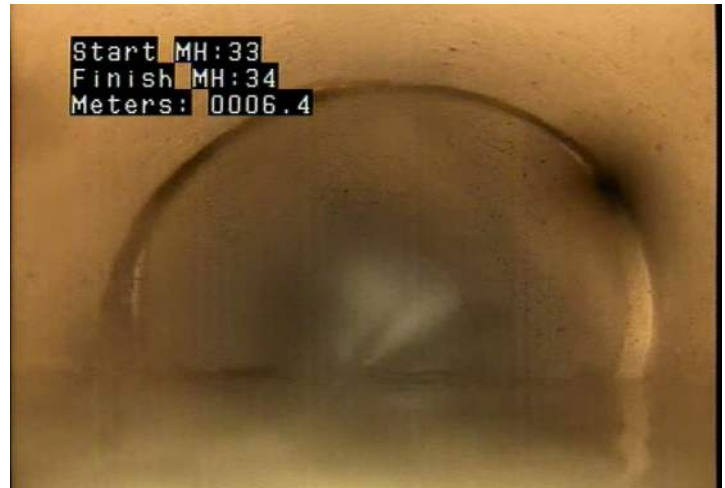
DAE - Deposits Attached: Encrustation @ 6.4 m.

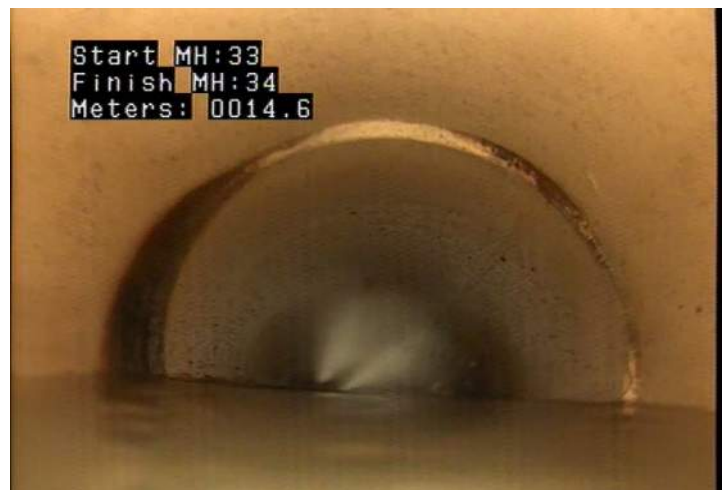
DAE - Deposits Attached: Encrustation @ 14.6 m.

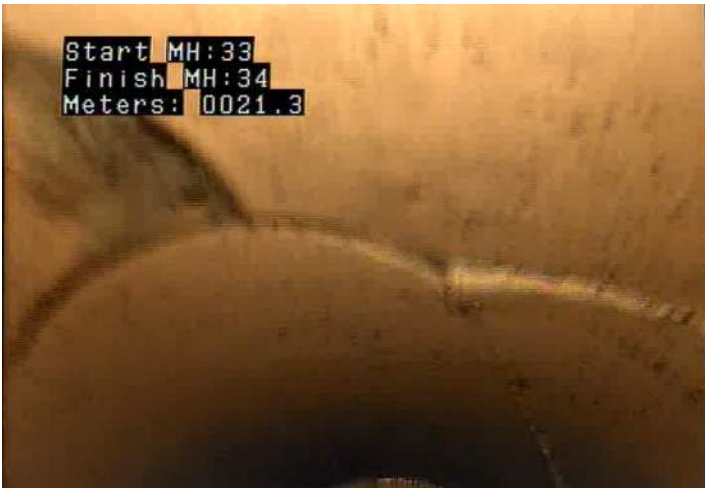
B - Pipe Broken @ 21.3 m.

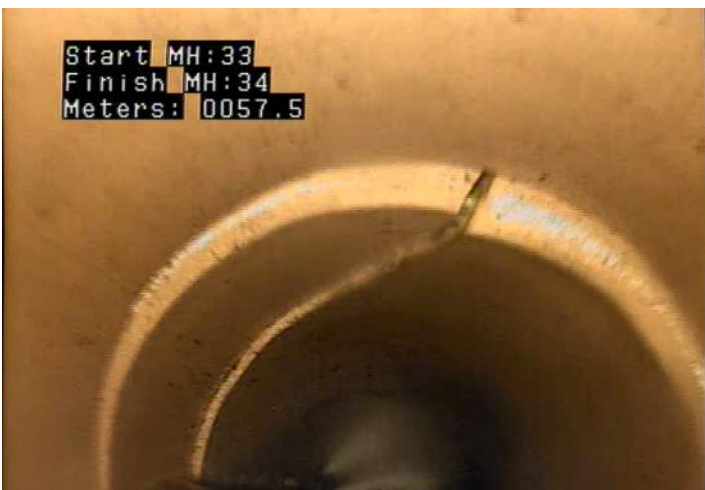
FC - Fracture Circumferential @ 57.5 m.

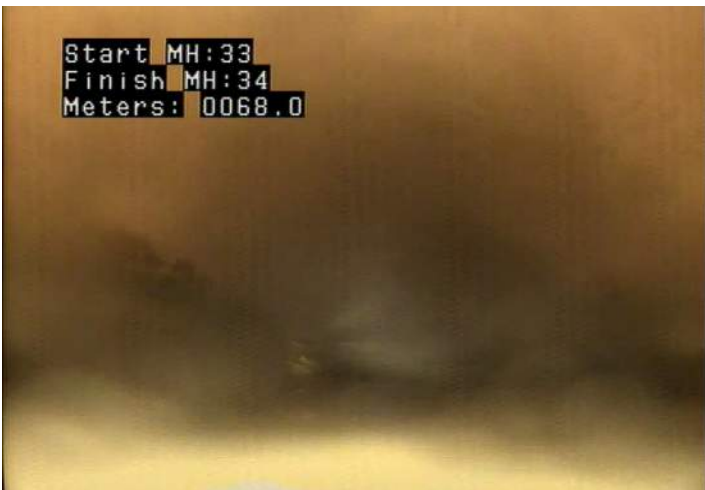
MWL - Water Level @ 68.0 m.

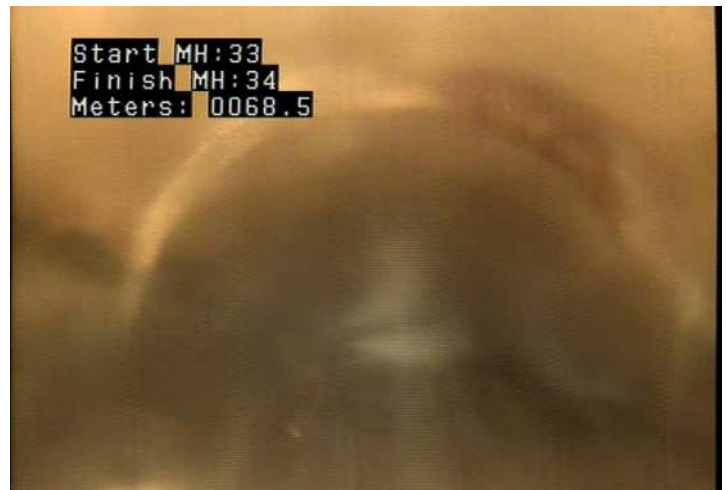
DAE - Deposits Attached: Encrustation @ 68.5 m.

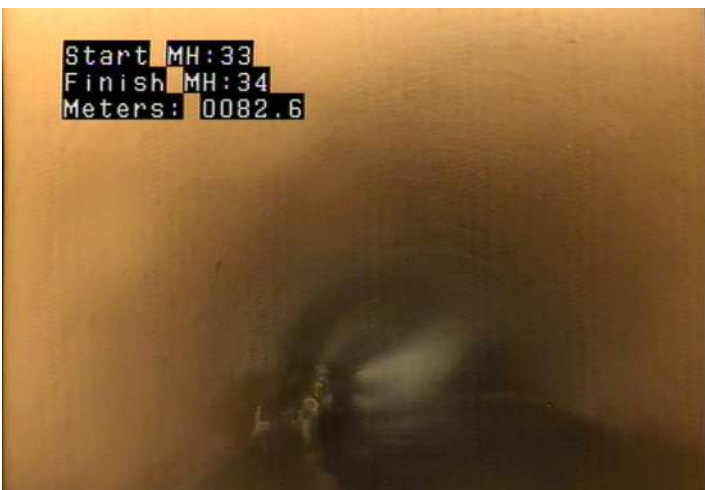
MWL - Water Level @ 82.6 m.

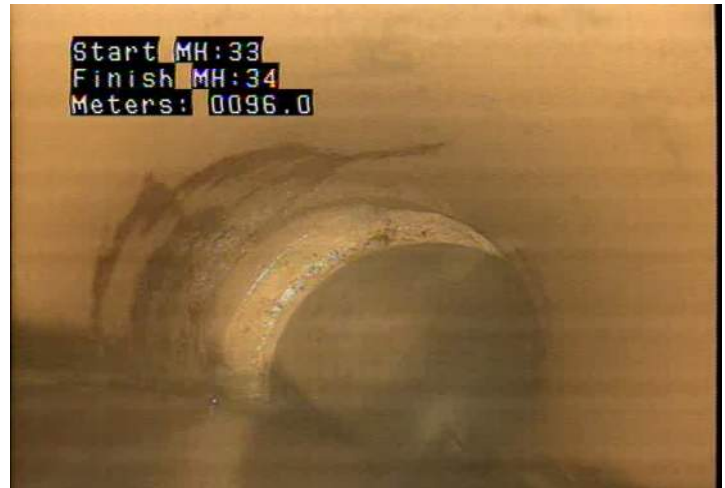
JAM - Joint Angular: Medium @ 96.0 m.

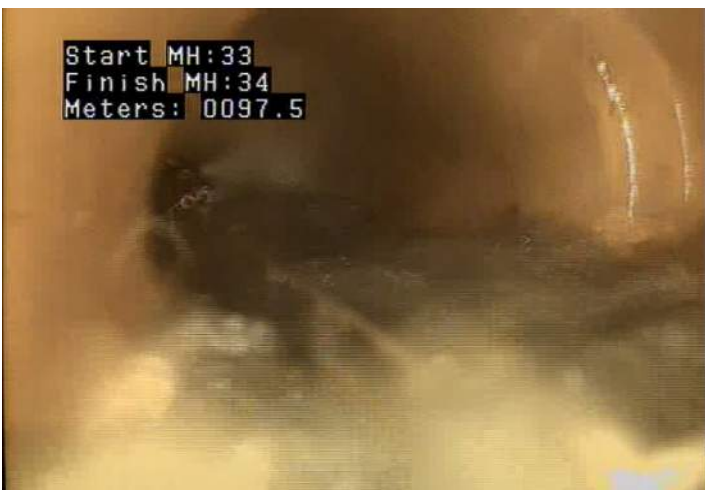
JAM - Joint Angular: Medium @ 97.5 m.

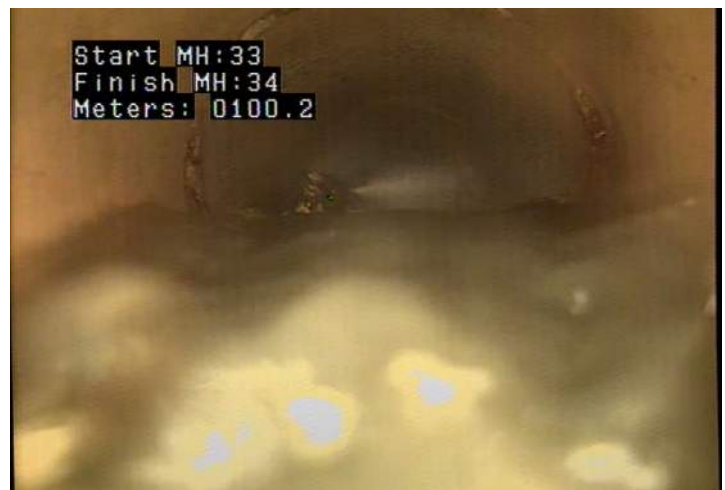
DAE - Deposits Attached: Encrustation @ 100.2 m.

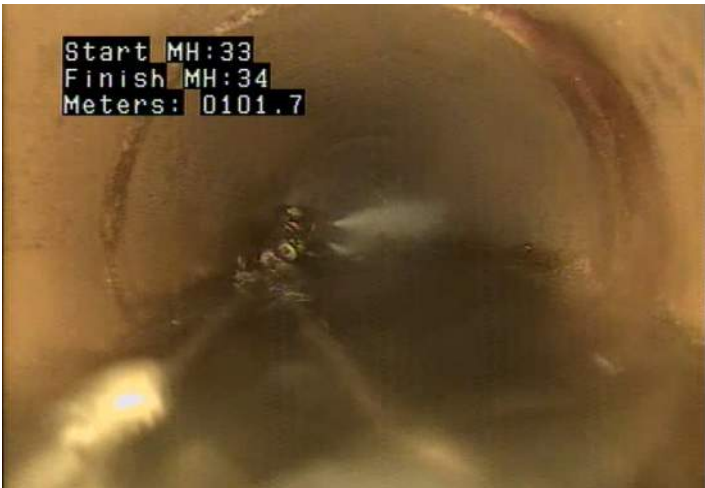
DAE - Deposits Attached: Encrustation @ 101.7 m.

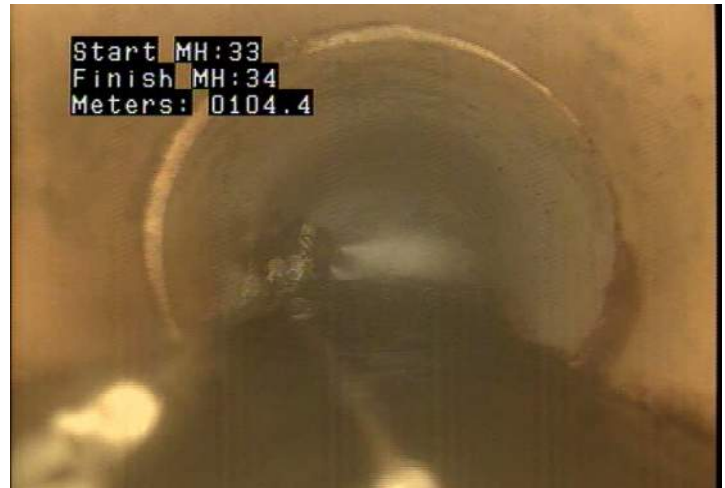
DAE - Deposits Attached: Encrustation @ 104.4 m.

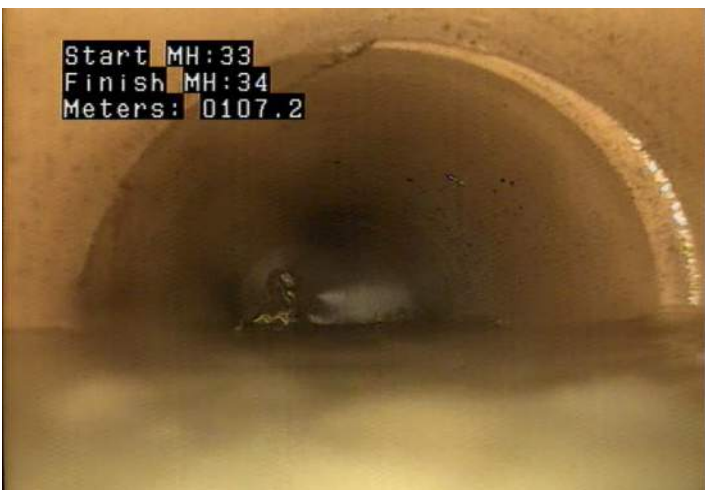
CC - Crack Circumferential @ 107.2 m.

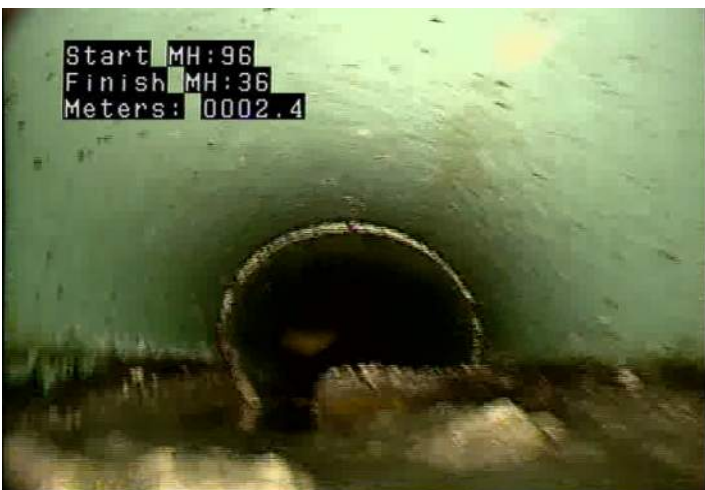
DSZ - Deposits Settled: Other @ 2.4 m.
Excrement

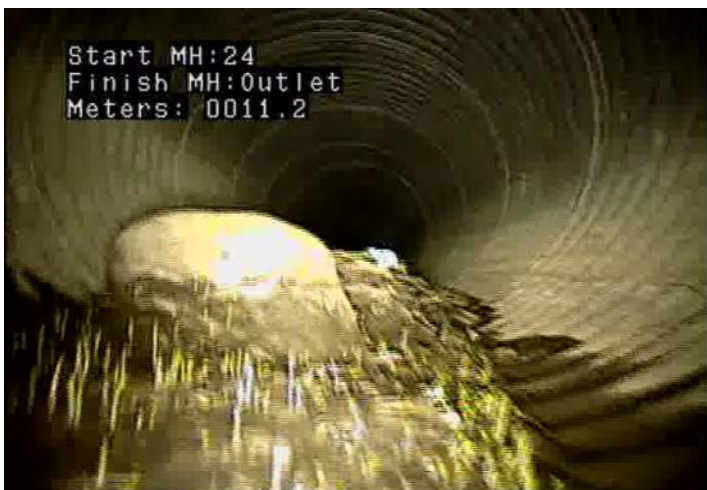
OBR - Obstacle - Rocks @ 11.2 m.

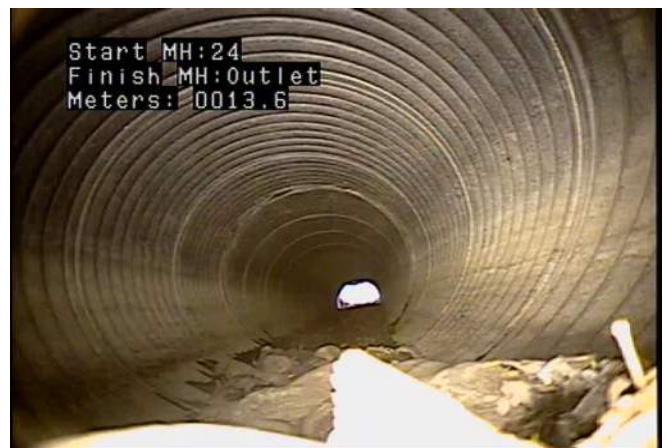
MSA - Survey Abandoned @ 13.6 m.
Unable to pass rocks. Rest of line
examined with zoom. 10% gravel viewed.

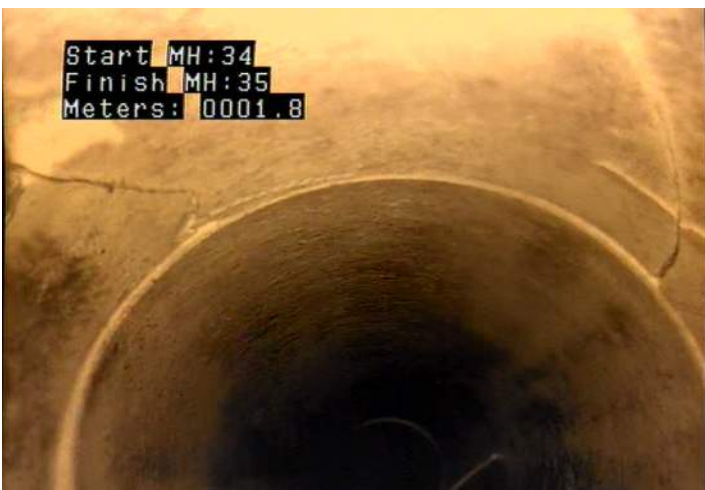
FM - Fracture Multiple @ 1.0 m.

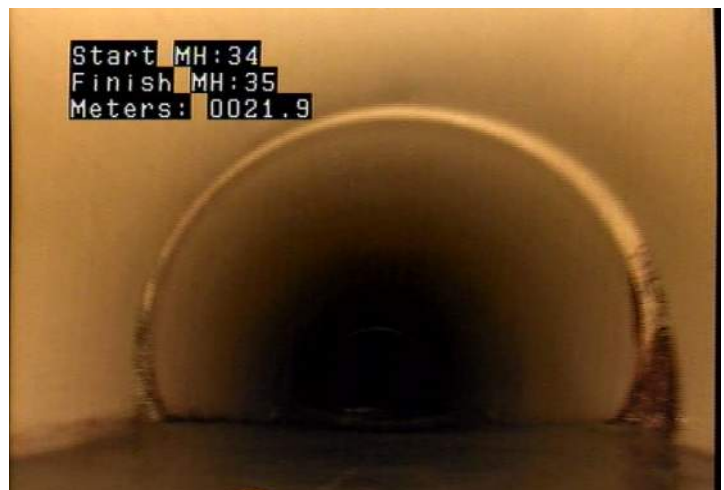
DAE - Deposits Attached: Encrustation @ 21.9 m.

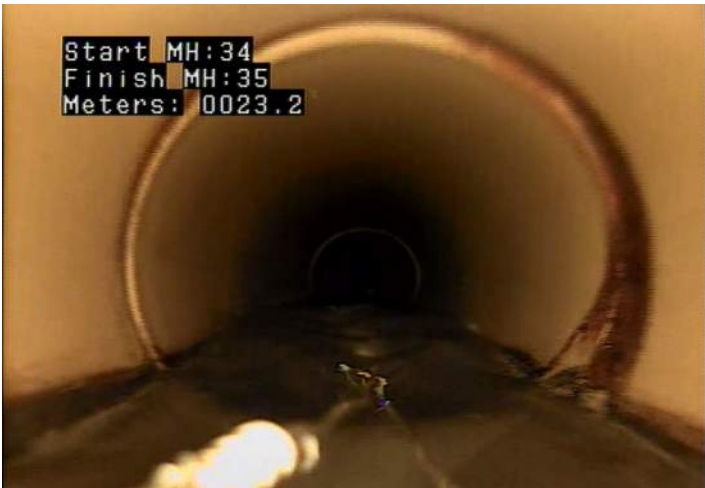
DAE - Deposits Attached: Encrustation @ 23.2 m.

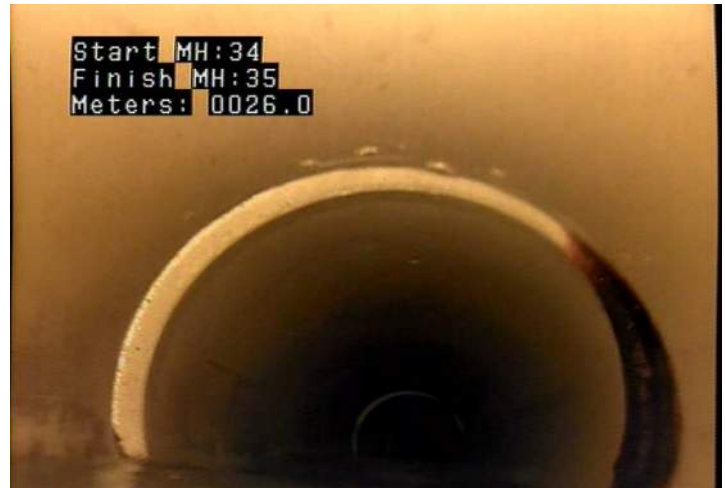
DAE - Deposits Attached: Encrustation @ 26.0 m.

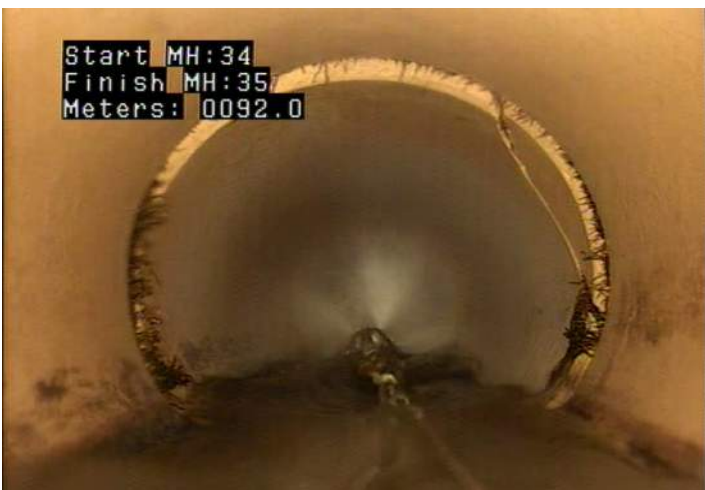
FC - Fracture Circumferential @ 92.0 m.

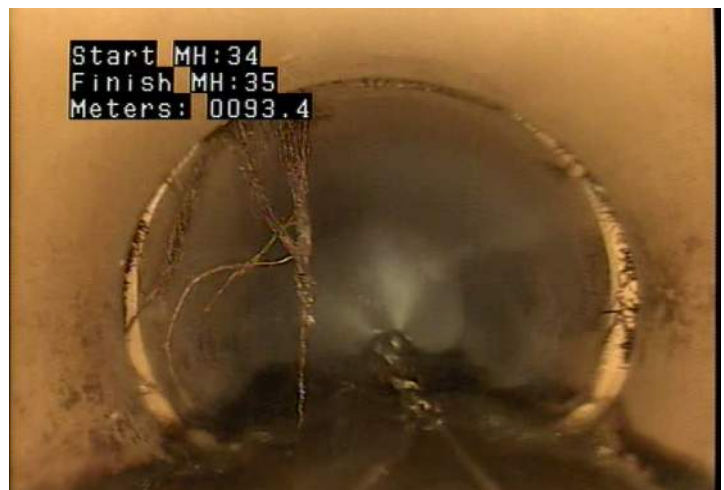
RMJ - Roots, Medium, Joint @ 93.4 m.

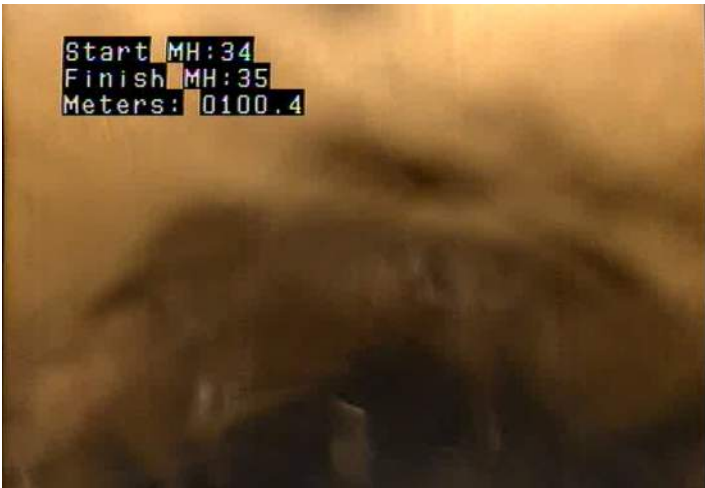
RMJ - Roots, Medium, Joint @ 100.4 m.

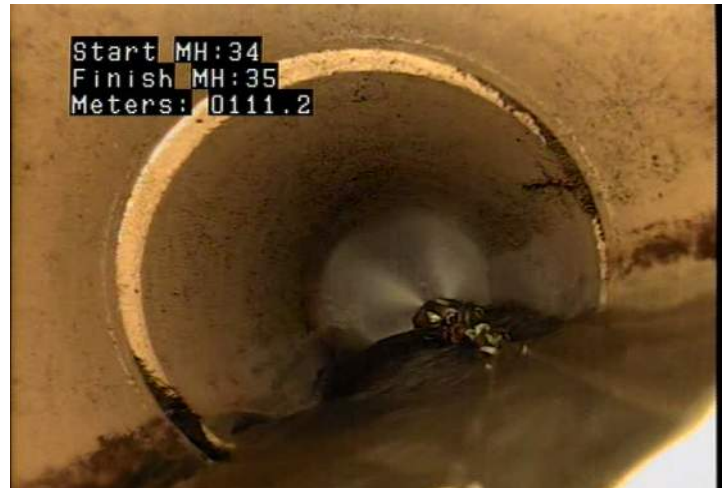
RFJ - Roots, Fine: Joint @ 111.2 m.

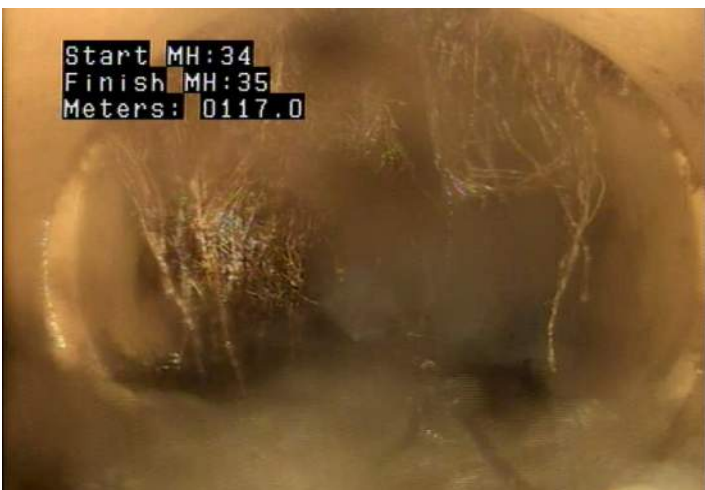
RMJ - Roots, Medium, Joint @ 117.0 m.

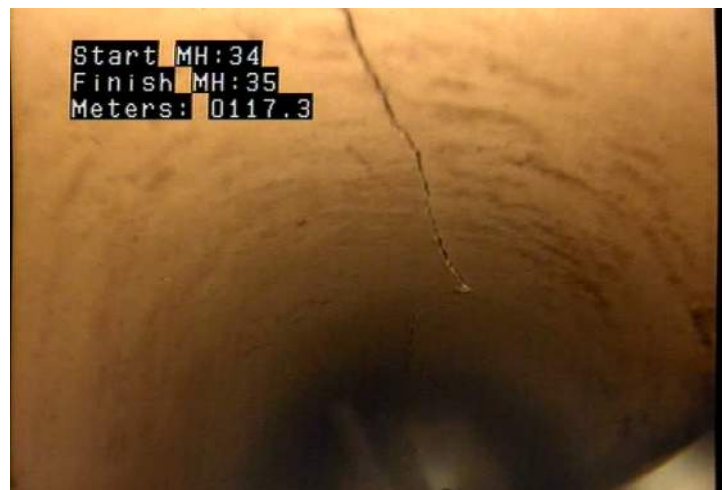
FL - Fracture Longitudinal @ 117.3 m.

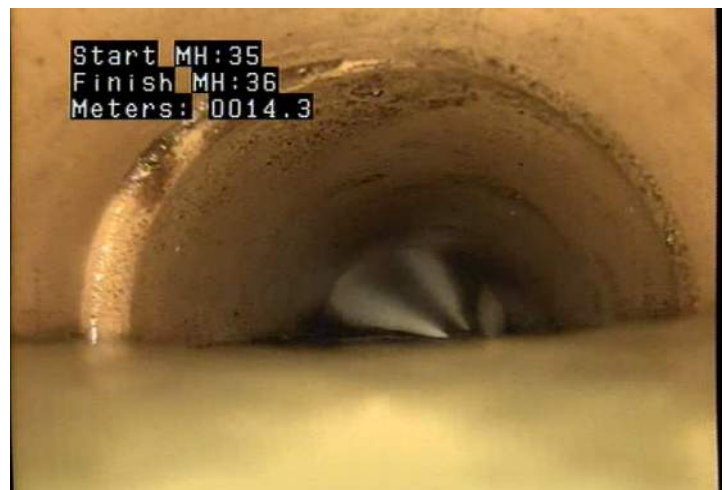
DAE - Deposits Attached: Encrustation @ 14.3 m.

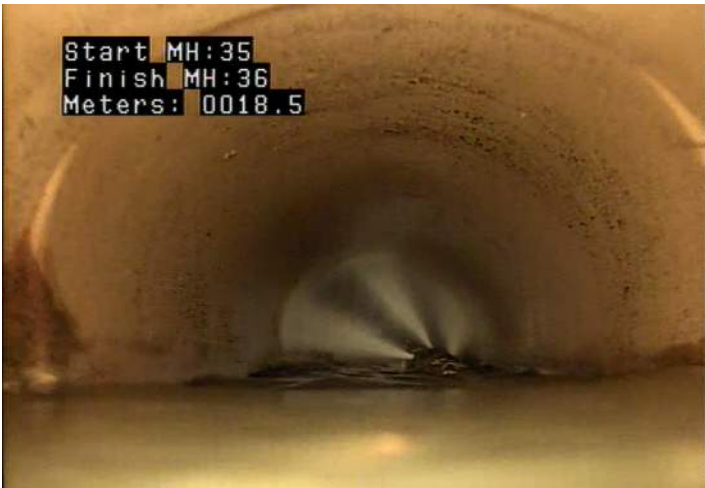
DAE - Deposits Attached: Encrustation @ 18.5 m.

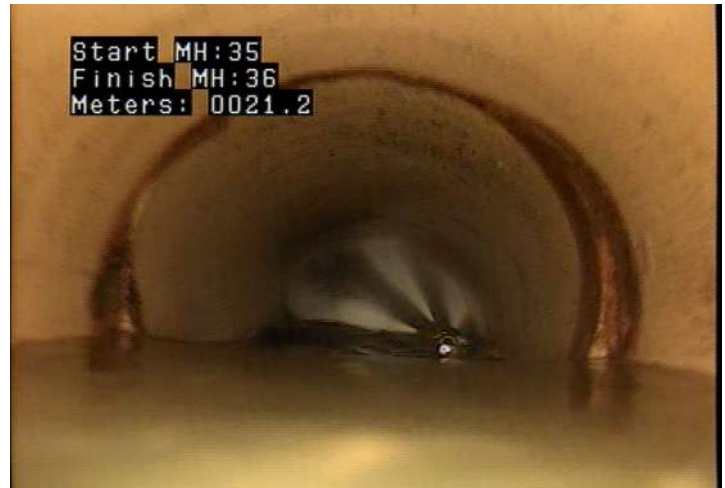
DAE - Deposits Attached: Encrustation @ 21.2 m.

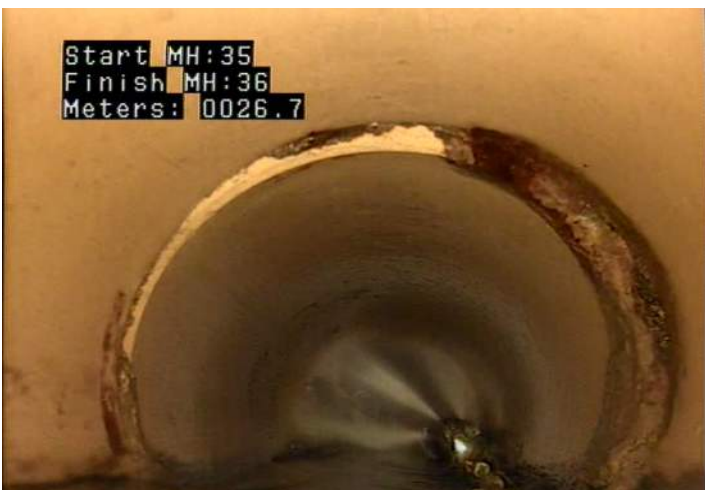
DAE - Deposits Attached: Encrustation @ 26.7 m.

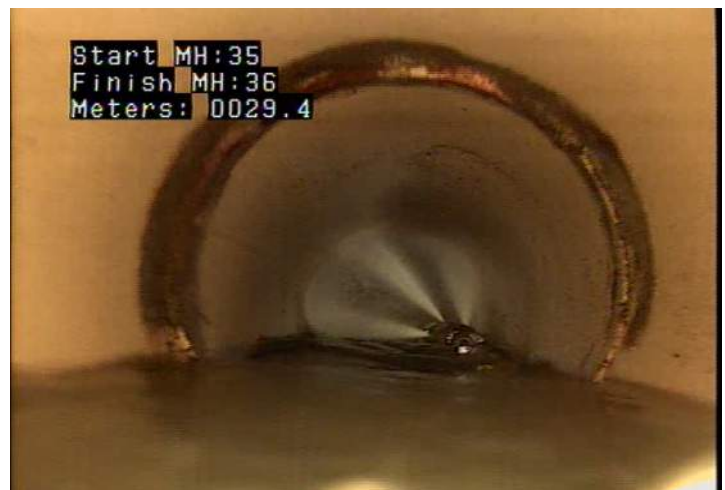
DAE - Deposits Attached: Encrustation @ 29.4 m.

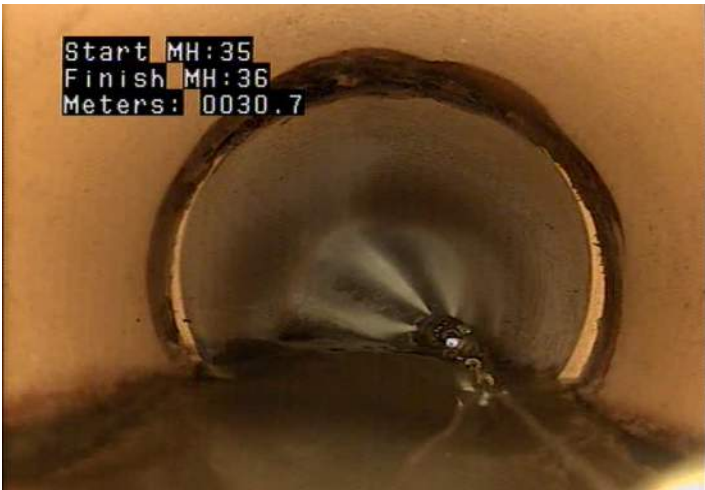
DAE - Deposits Attached: Encrustation @ 30.7 m.

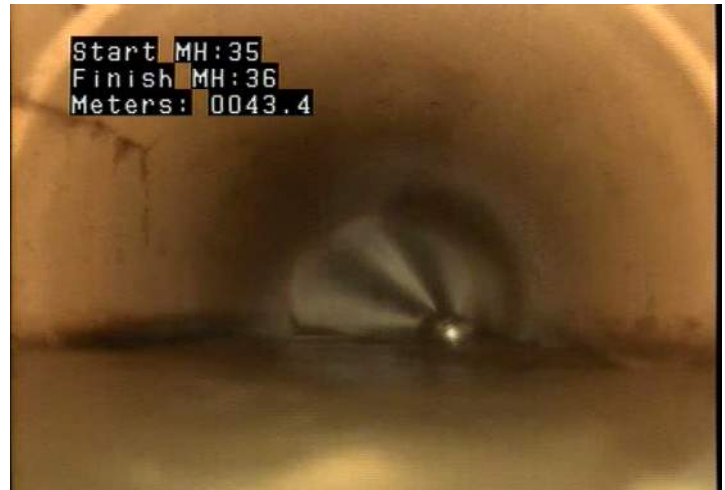
CL - Crack Longitudinal @ 43.4 m.

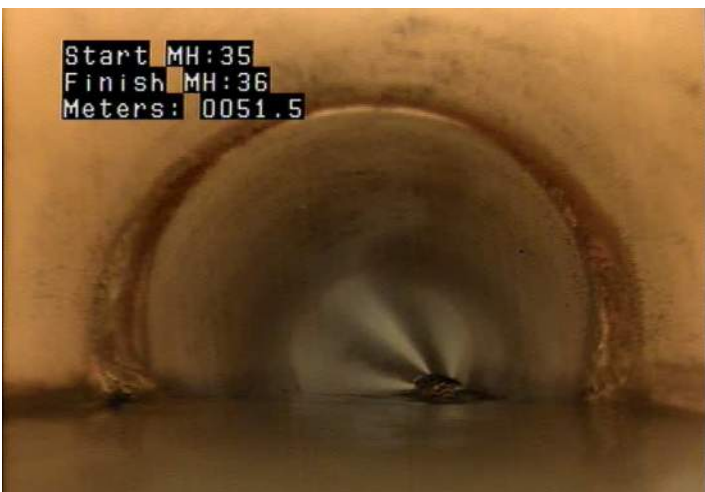
DAE - Deposits Attached: Encrustation @ 51.5 m.

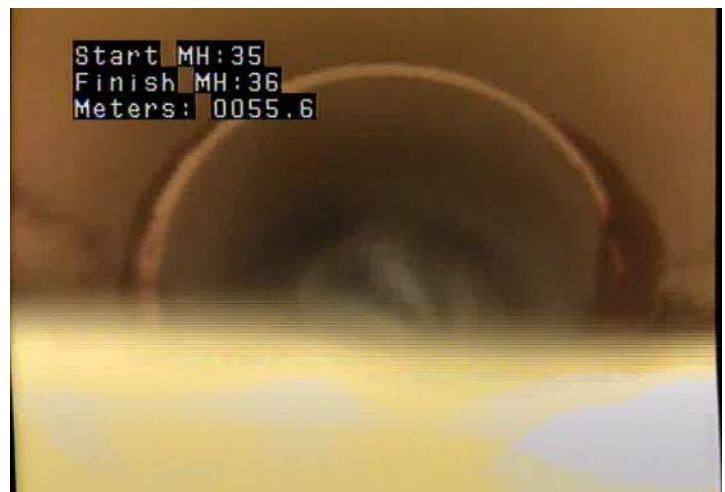
DAE - Deposits Attached: Encrustation @ 55.6 m.

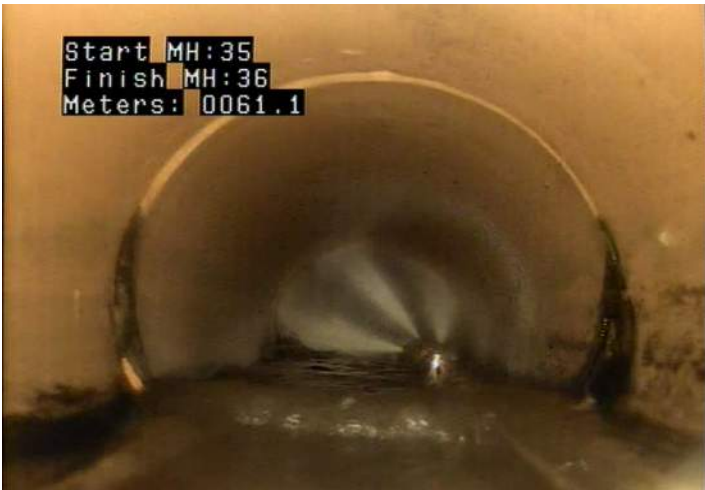
DAE - Deposits Attached: Encrustation @ 61.1 m.

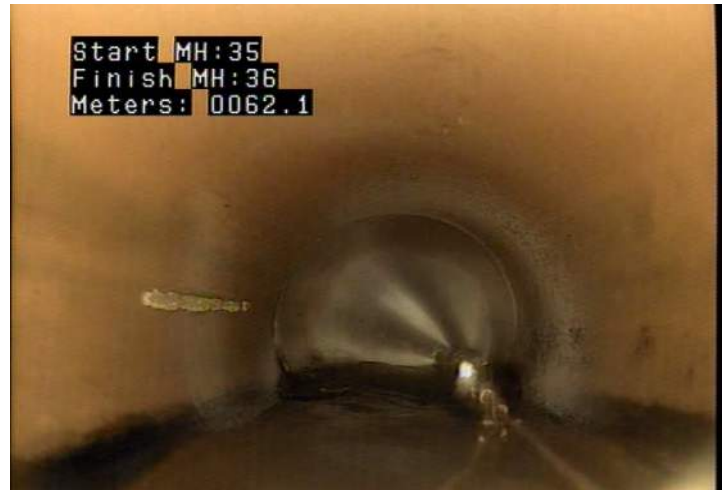
DAGS - Deposits Attached: Grease @ 62.1 m.

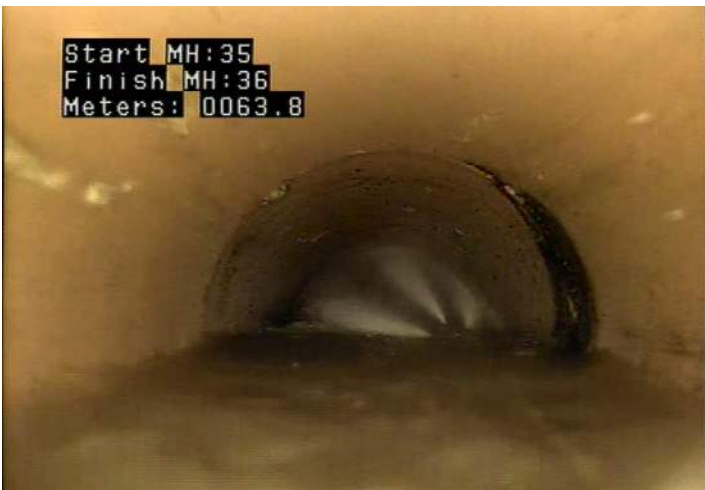
DAGS - Deposits Attached: Grease @ 63.8 m.

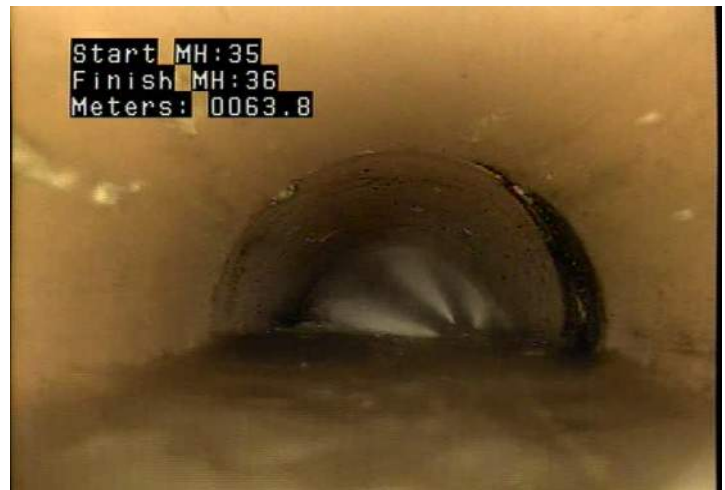
DAE - Deposits Attached: Encrustation @ 63.8 m.

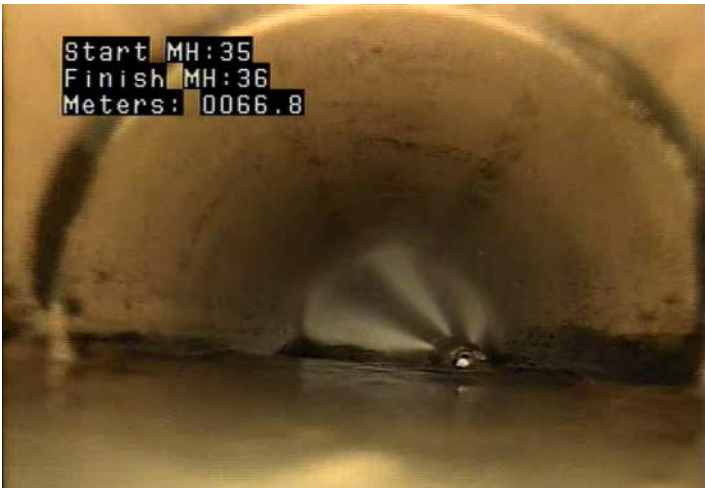
DAE - Deposits Attached: Encrustation @ 66.8 m.

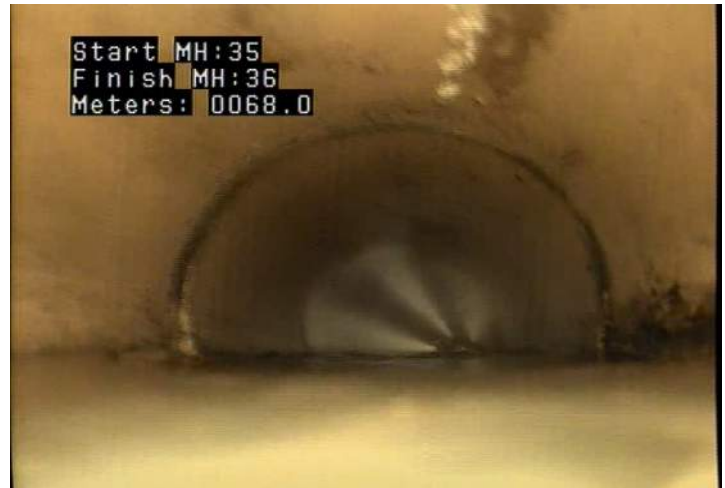
DAE - Deposits Attached: Encrustation @ 68.0 m.

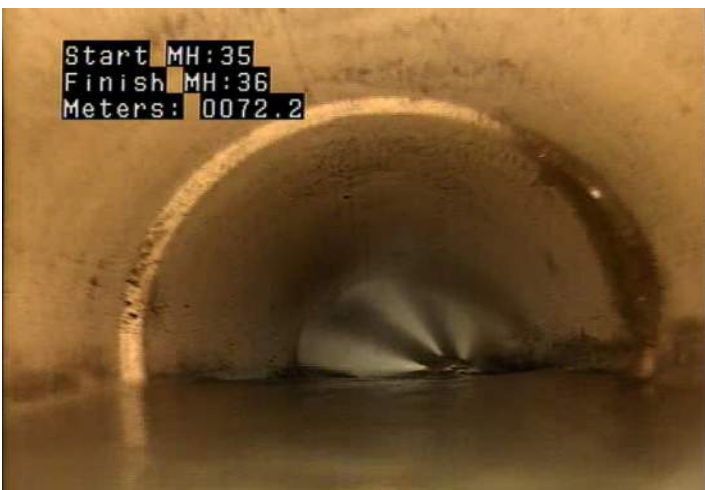
DAE - Deposits Attached: Encrustation @ 72.2 m.

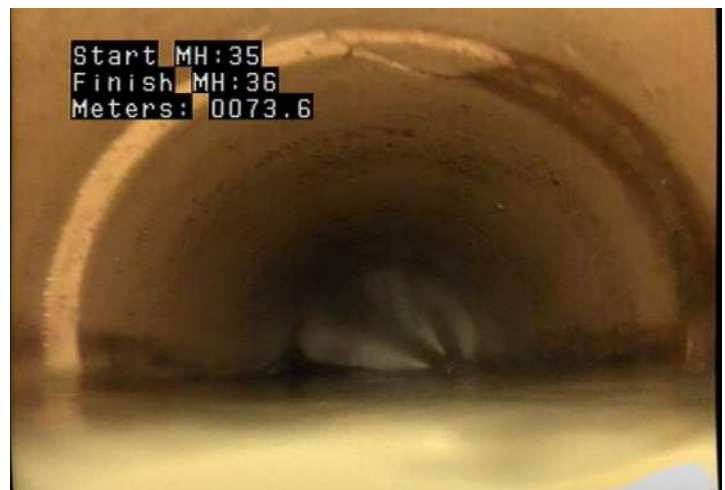
73.6		FC	Fracture Circumferential	11 to 2			J	
73.6		DAE	Deposits Attached: Encrustation	1 to 5	5		J	
79.2		DAE	Deposits Attached: Encrustation	12 to 4	5		J

FC - Fracture Circumferential @ 73.6 m.

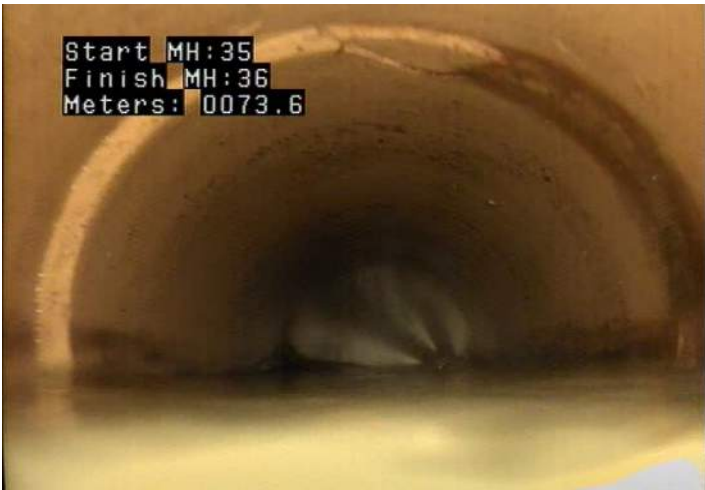
DAE - Deposits Attached: Encrustation @ 73.6 m.

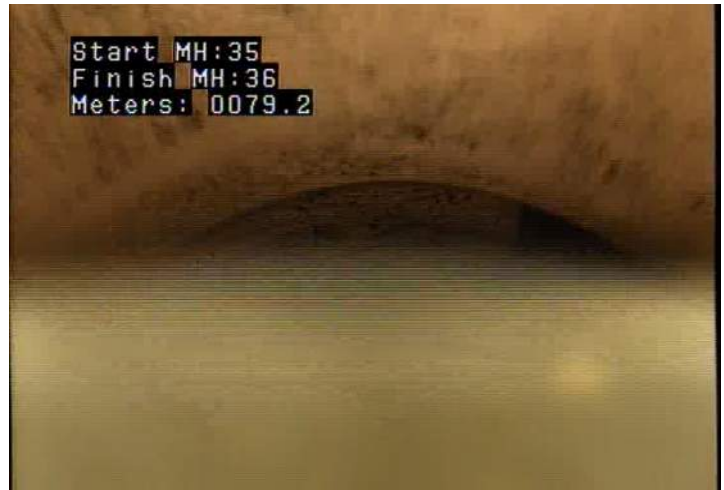
DAE - Deposits Attached: Encrustation @ 79.2 m.

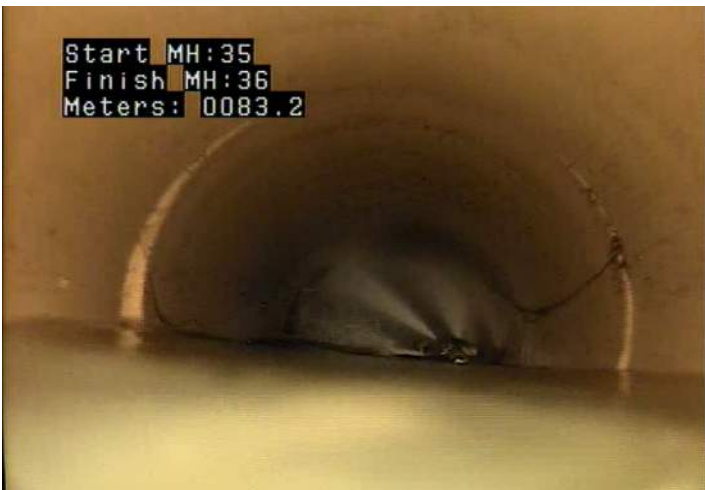
RFJ - Roots, Fine: Joint @ 83.2 m.

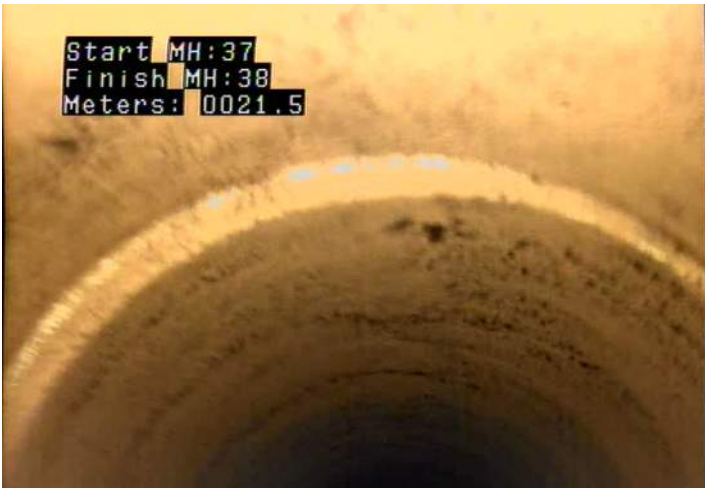
MWL - Water Level @ 21.5 m.

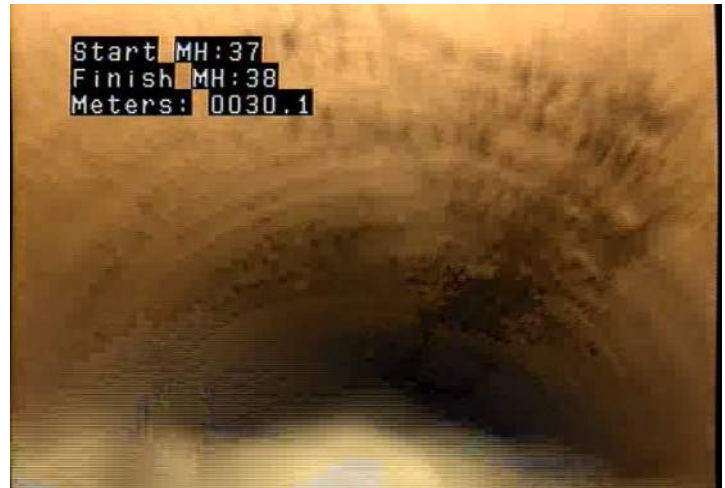
MCU - Camera Underwater @ 30.1 m.
