Appendix F CCTV Assessment

Client: CIMA
 Project: Pre-Rehabilitation Survey
 Date: 12/18/2020
 File: 14257

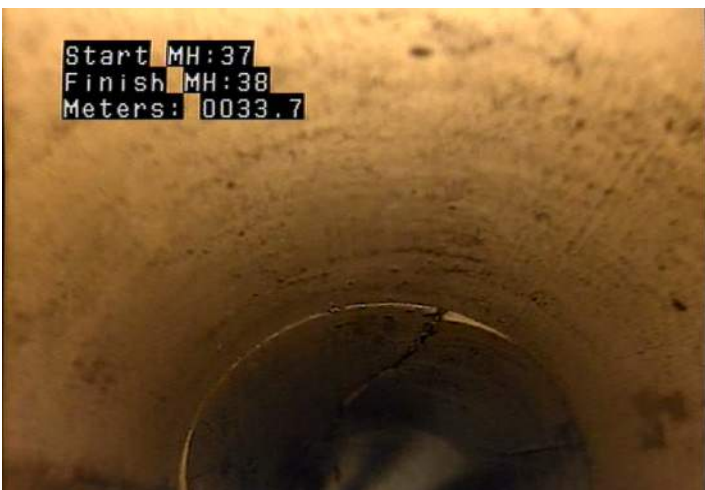
MWL - Water Level @ 33.6 m.

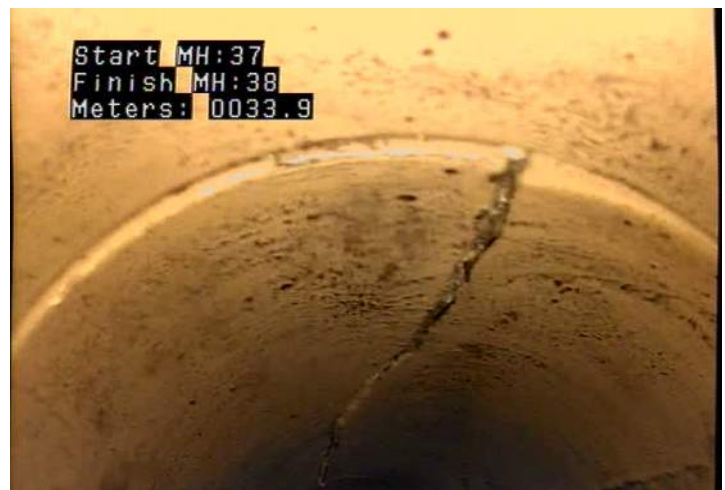
B - Pipe Broken @ 33.9 m.

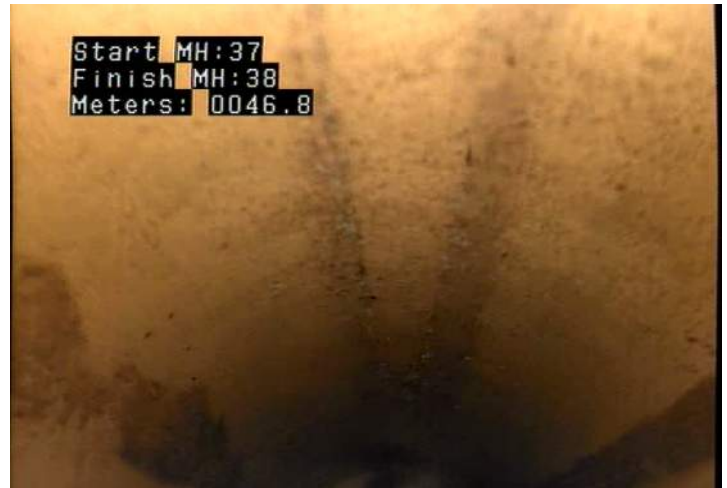
MWL - Water Level @ 46.8 m.

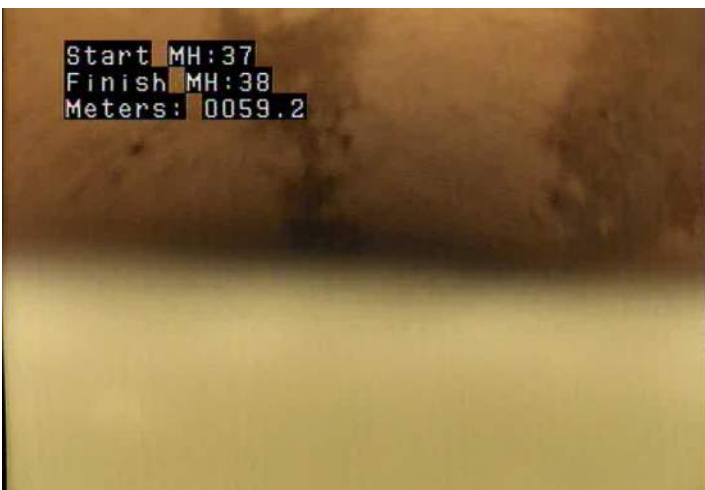
MCU - Camera Underwater @ 59.2 m.

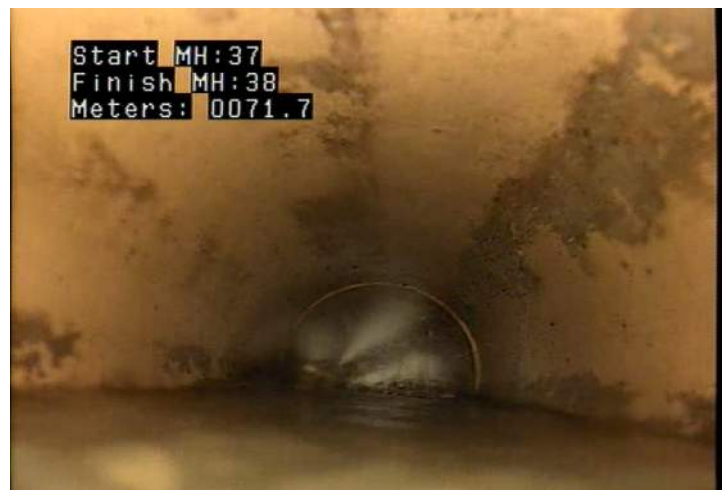
MWL - Water Level @ 71.7 m.

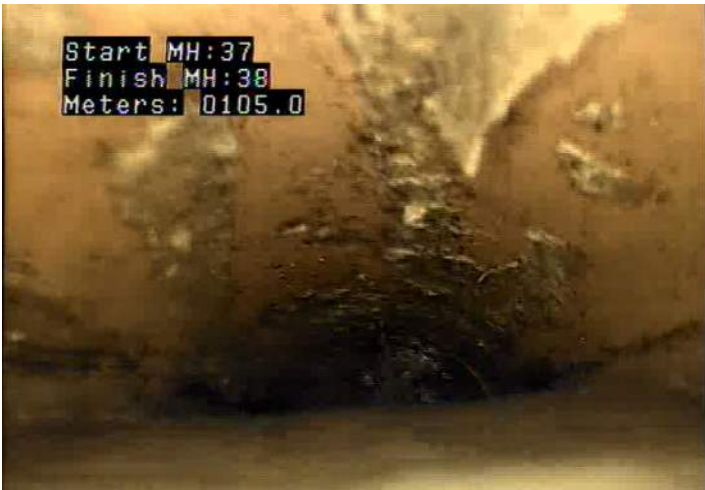
MCU - Camera Underwater @ 105.0 m.

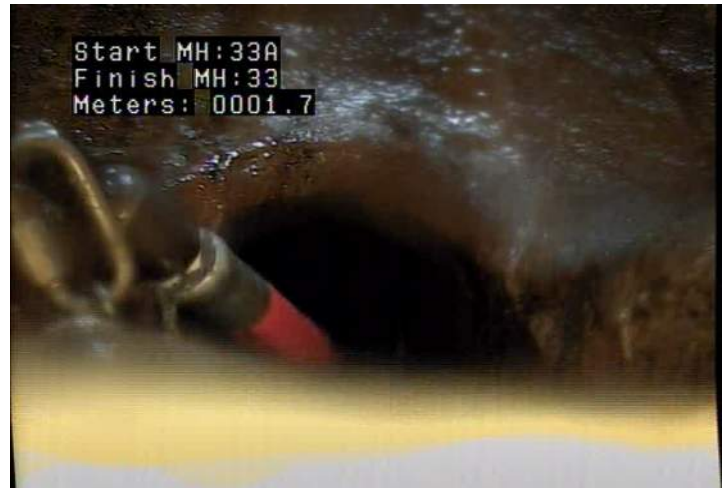
MWL - Water Level @ 0.0 m.

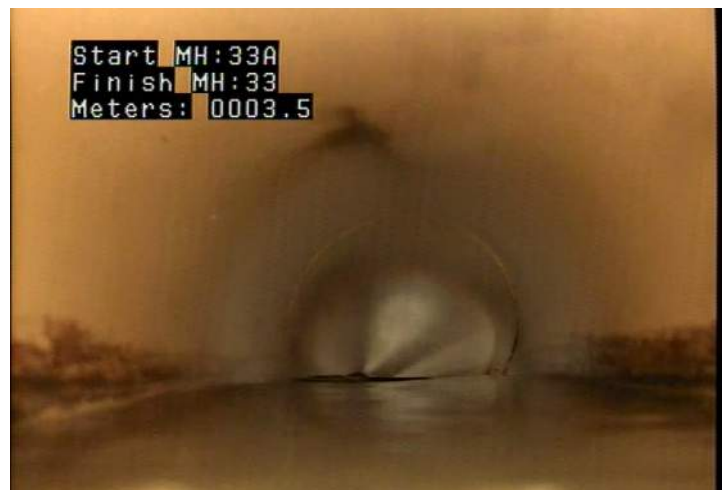
CL - Crack Longitudinal @ 3.5 m.

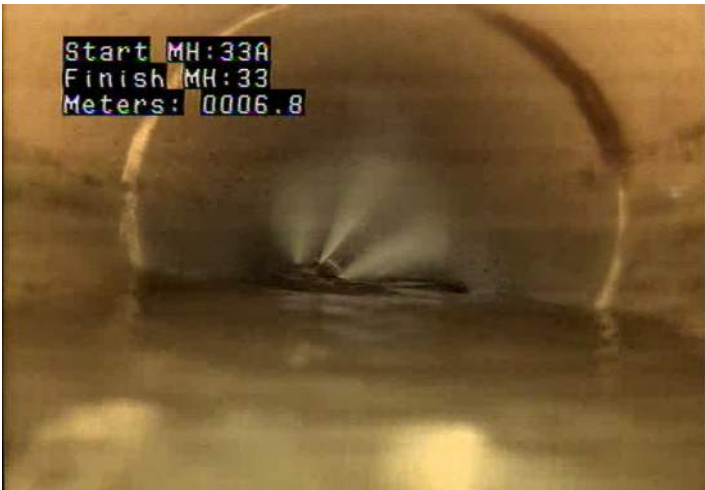
DAE - Deposits Attached: Encrustation @ 6.8 m.

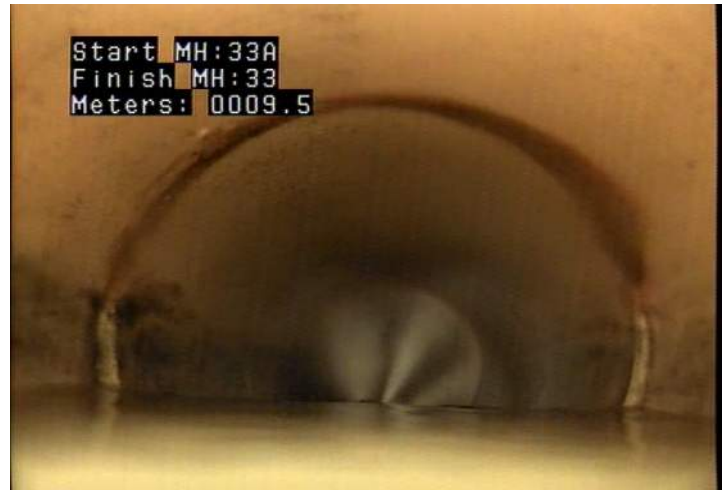
DAE - Deposits Attached: Encrustation @ 9.5 m.

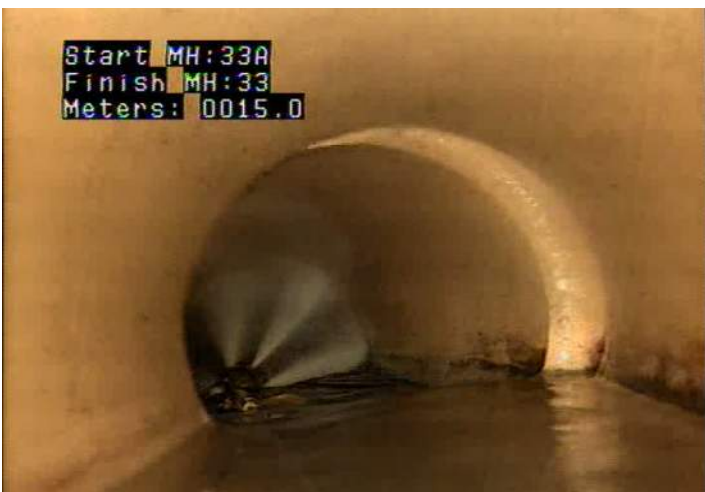
JAL - Joint Angular: Large @ 15.0 m.

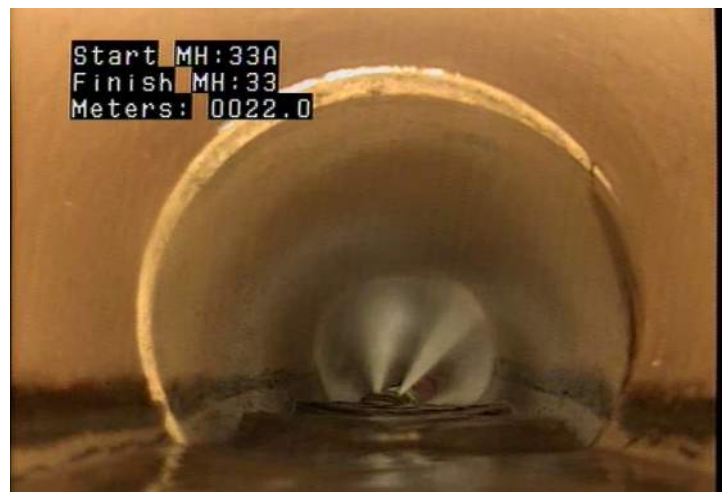
CC - Crack Circumferential @ 22.0 m.

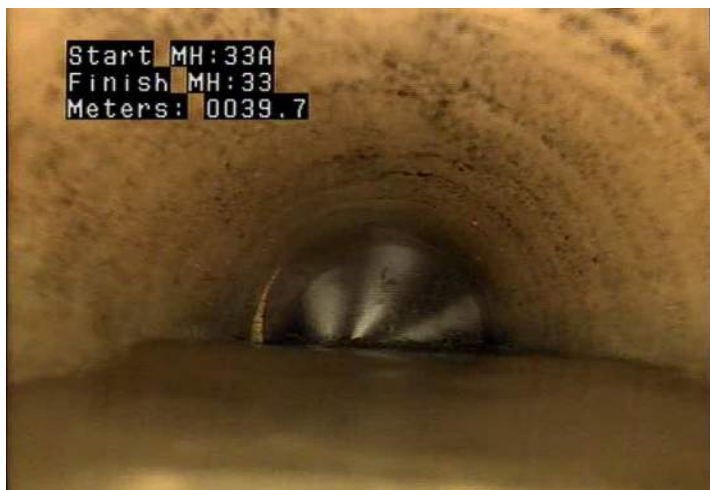
MCU - Camera Underwater @ 39.7 m.

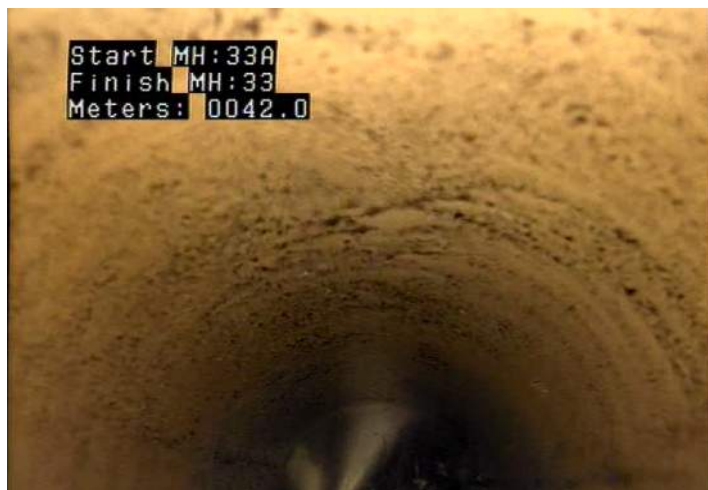
MWL - Water Level @ 42.0 m.

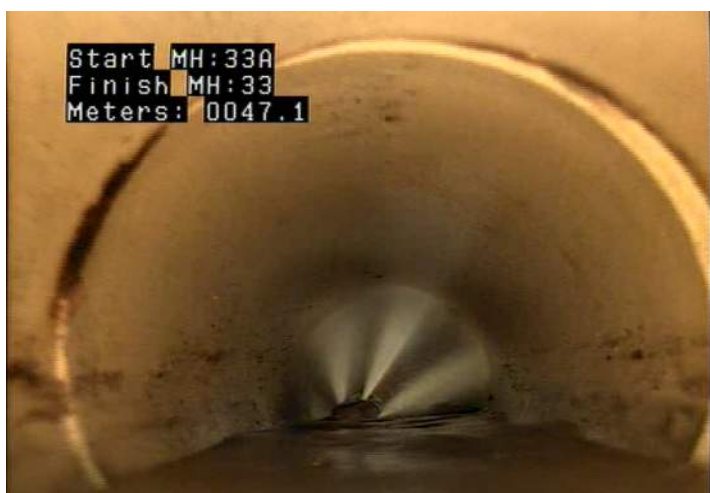
DAE - Deposits Attached: Encrustation @ 47.1 m.

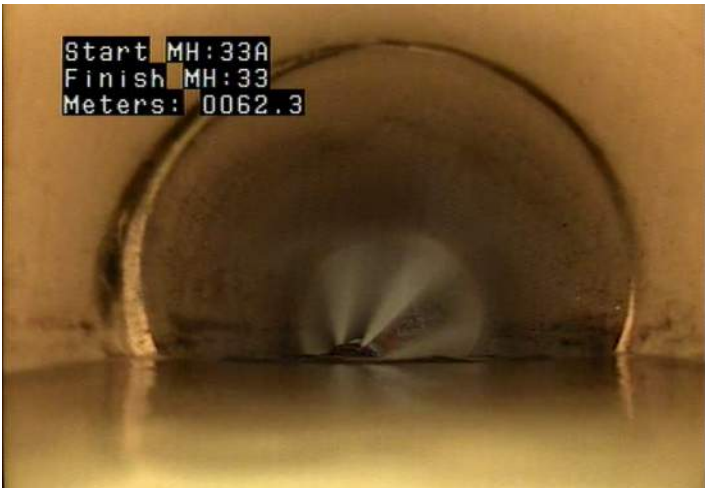
DAE - Deposits Attached: Encrustation @ 62.3 m.

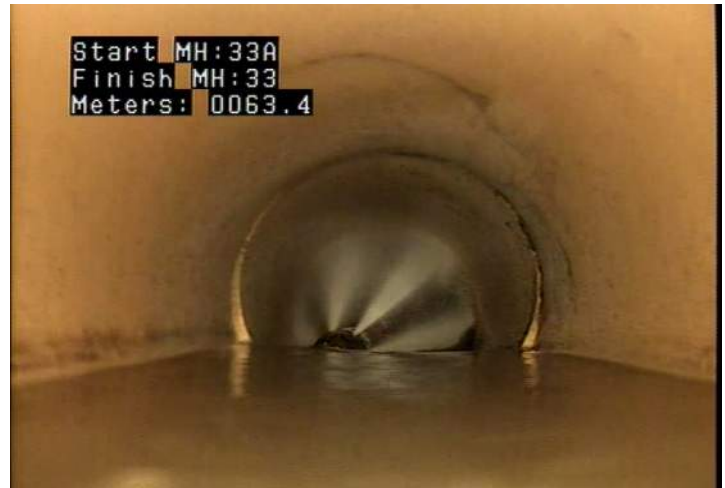
CC - Crack Circumferential @ 63.4 m.

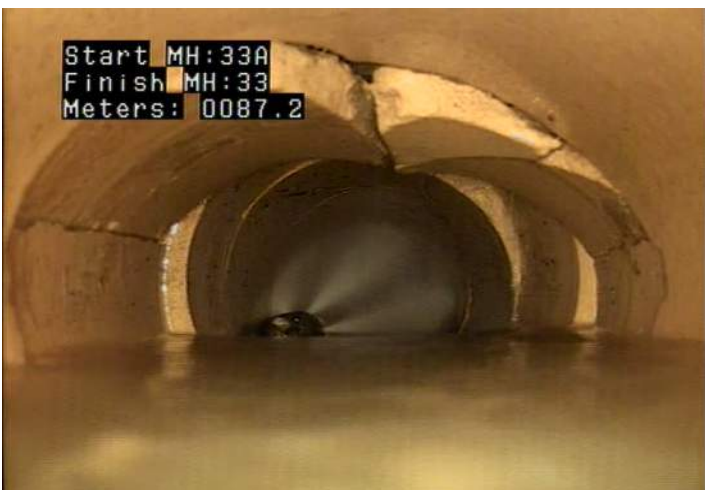
B - Pipe Broken @ 87.2 m.

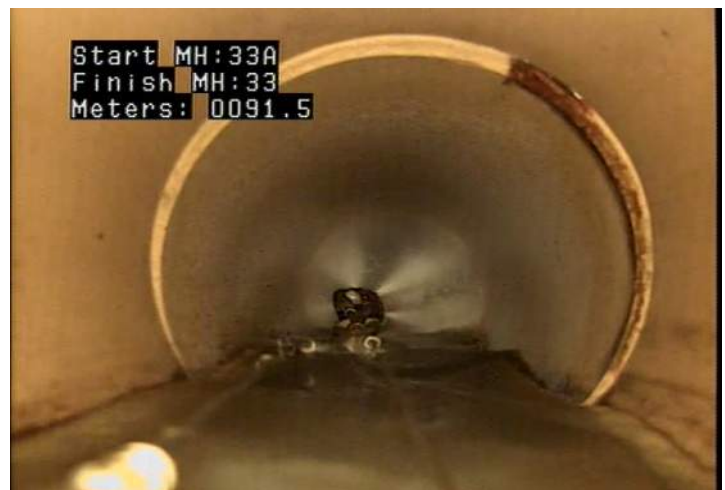
DAE - Deposits Attached: Encrustation @ 91.5 m.

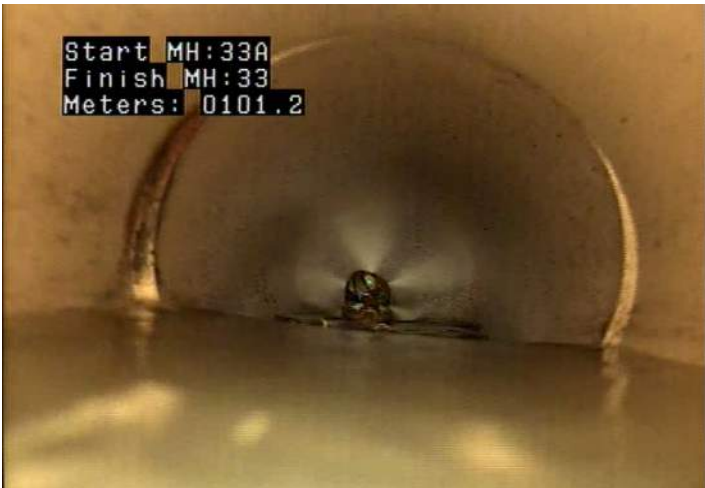
DAE - Deposits Attached: Encrustation @ 101.2 m.
